**PE07-012**  
**FREIGHTLINER**  
**4/20/2007**  
**ATTACHMENT**  
**PART 1 OF 7**

Problem Ticket Report

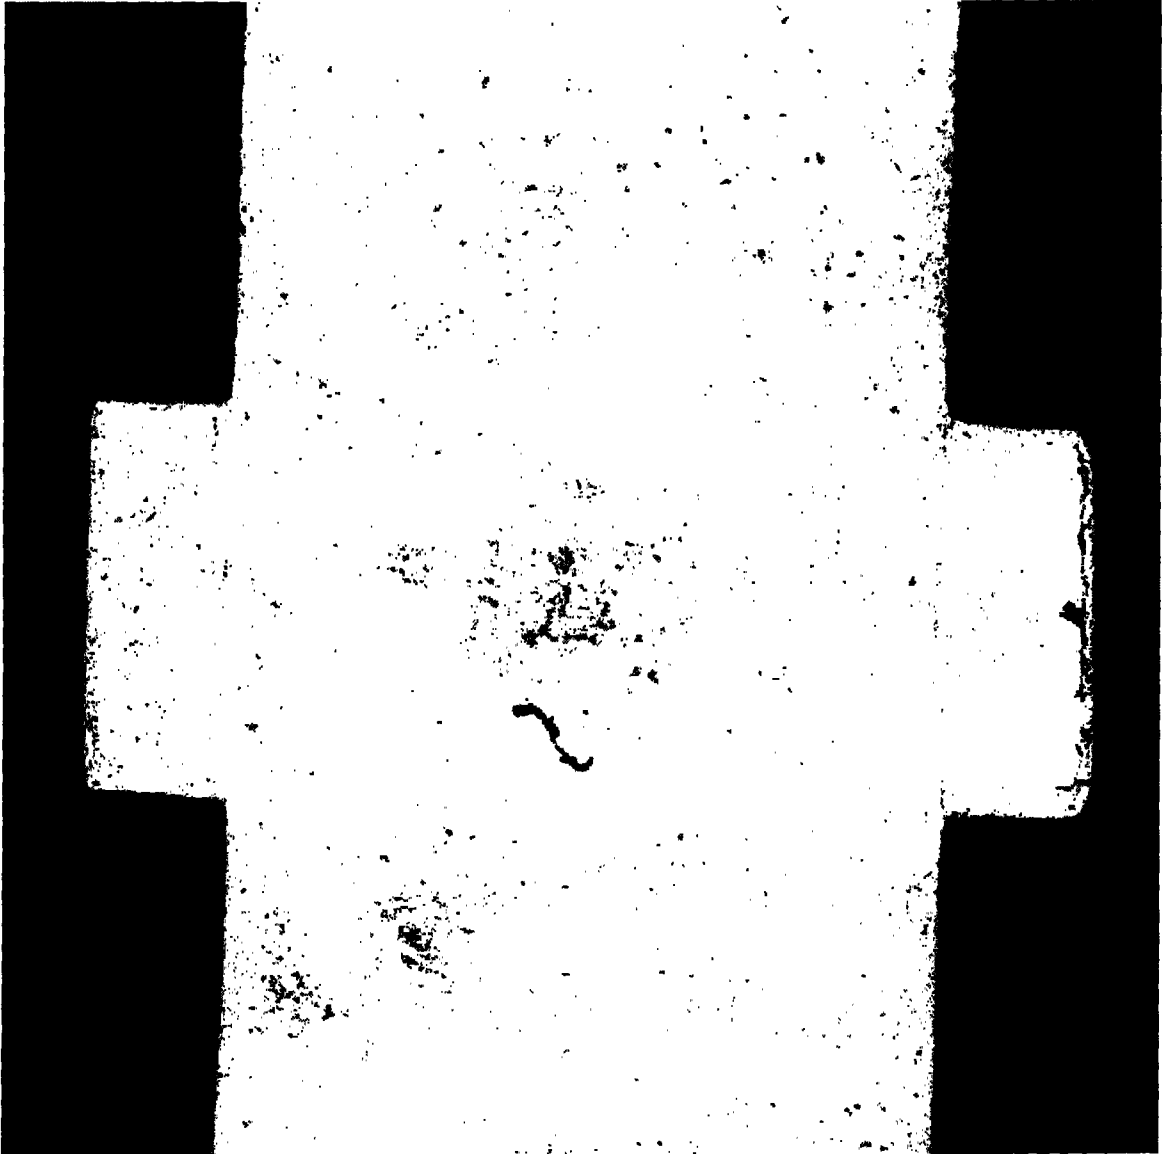
FIGURE 1: IFN 1448A\_1 [22X], Sample A – Lever #1. This is a BSE SEM image of the area around the pivot point on the lever. There is a little silicone lubricant here (dark areas).

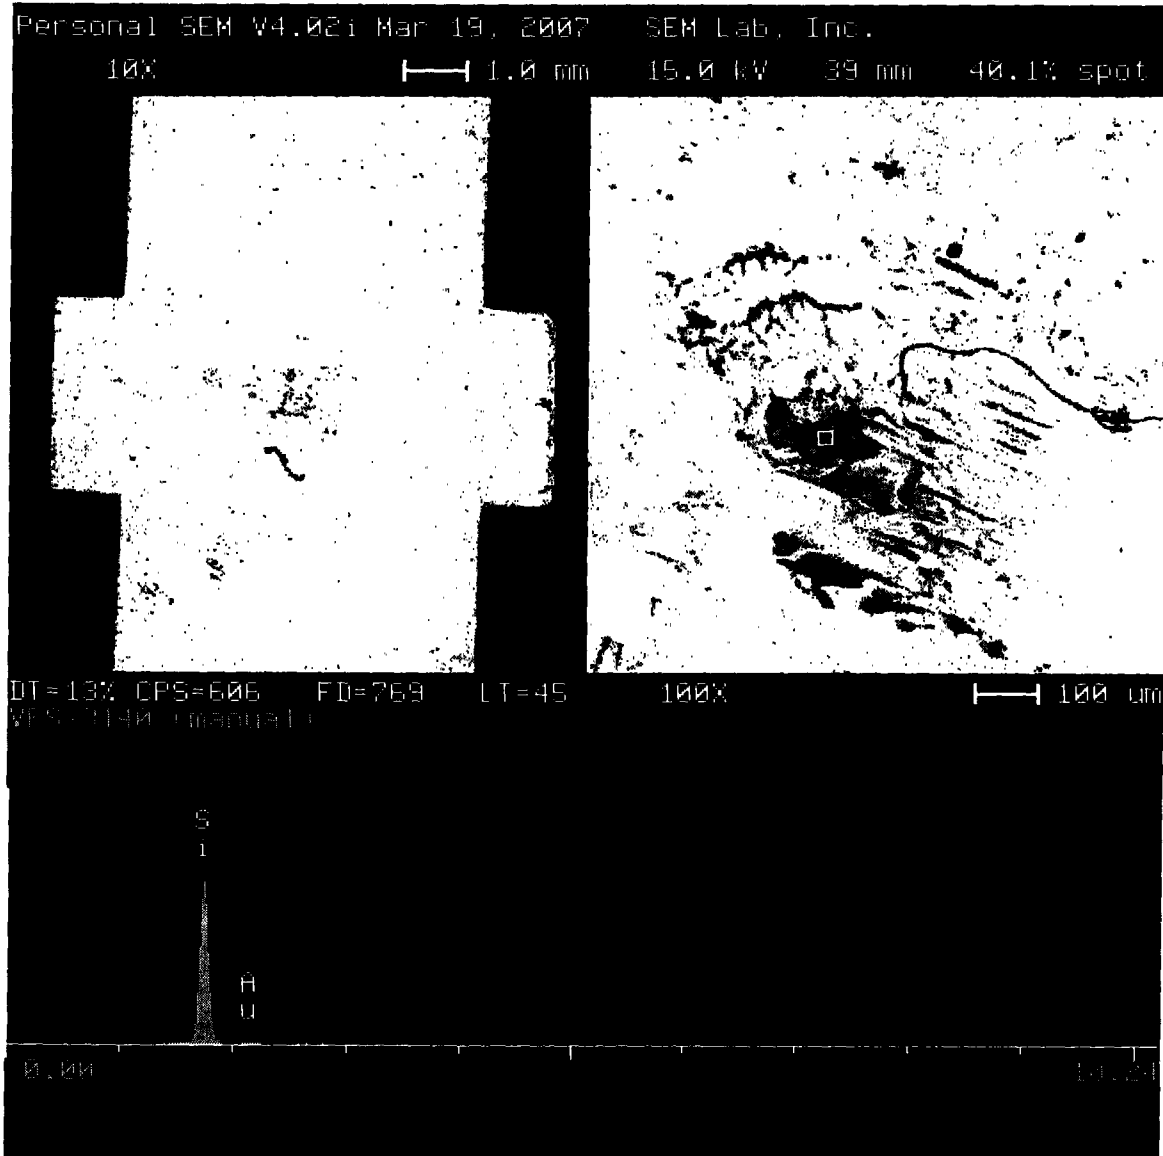
FIGURE 2: IFN 1448A\_2, Sample A – Lever #1. This spectrum suggests the dark contrast material on the surface is silicone lubricant.

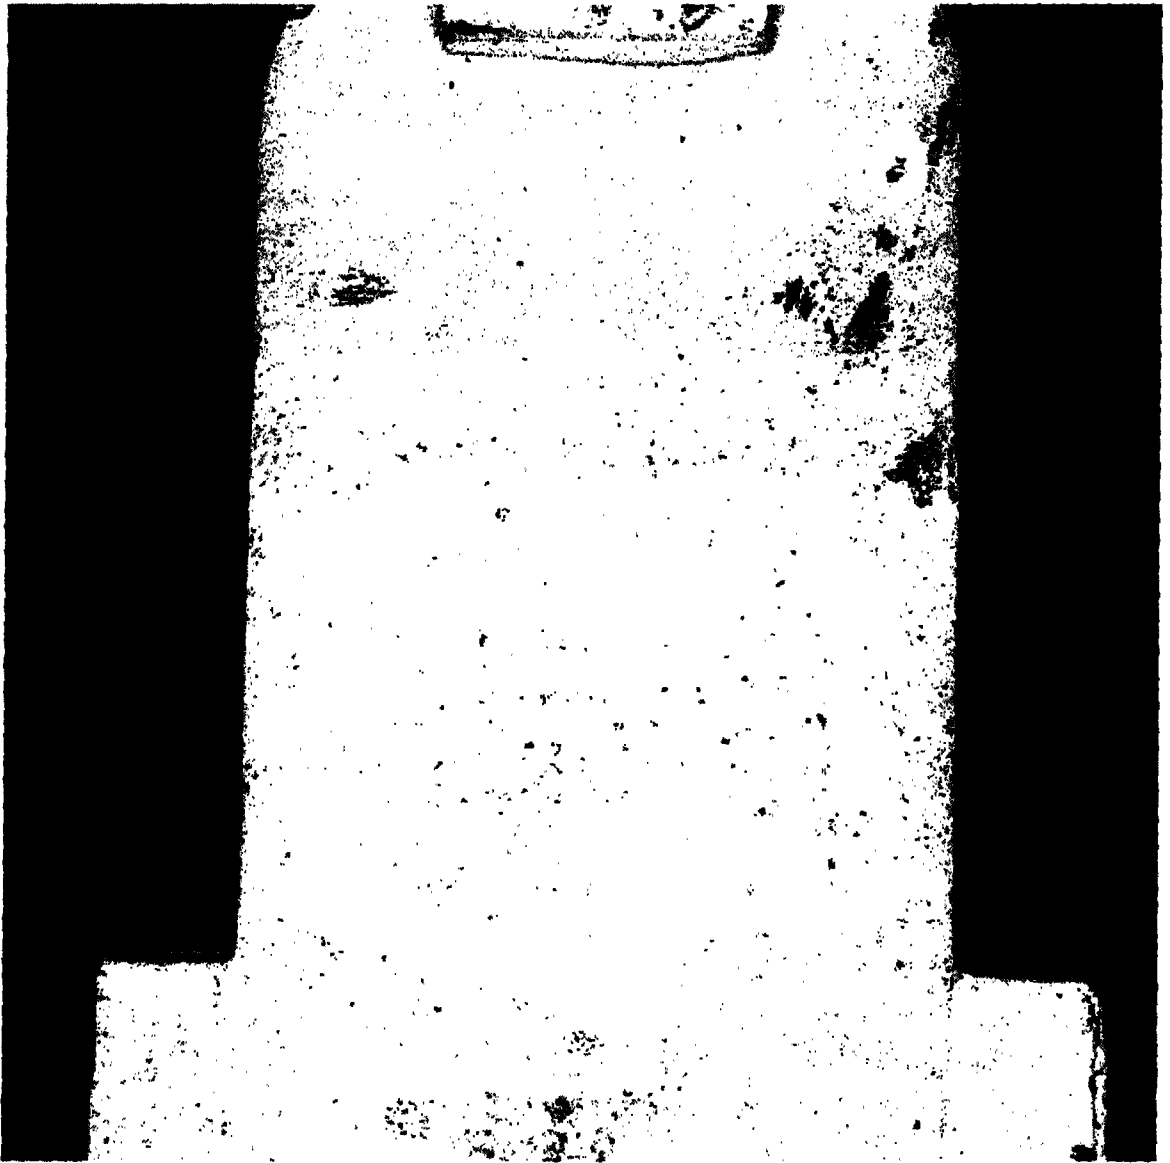
FIGURE 3: IFN 1448A\_3 [22X], Sample A – Lever #1. This image shows the distribution of lubricant on the lever arm.

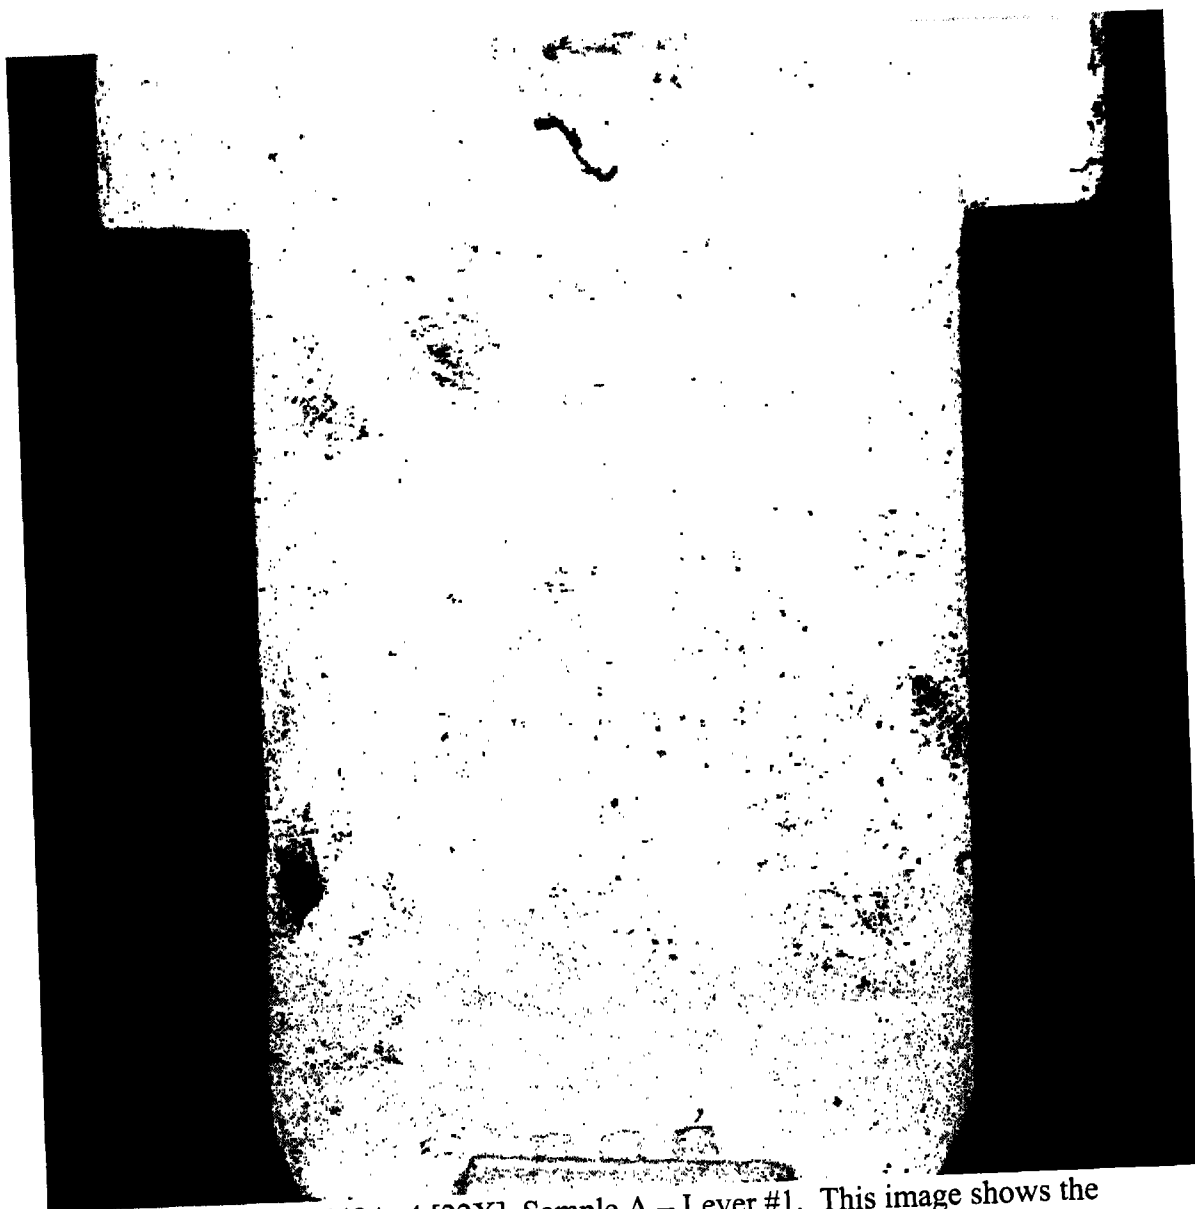
FIGURE 4: IFN 1448A\_4 [22X], Sample A – Lever #1. This image shows the distribution of lubricant on the lever arm.

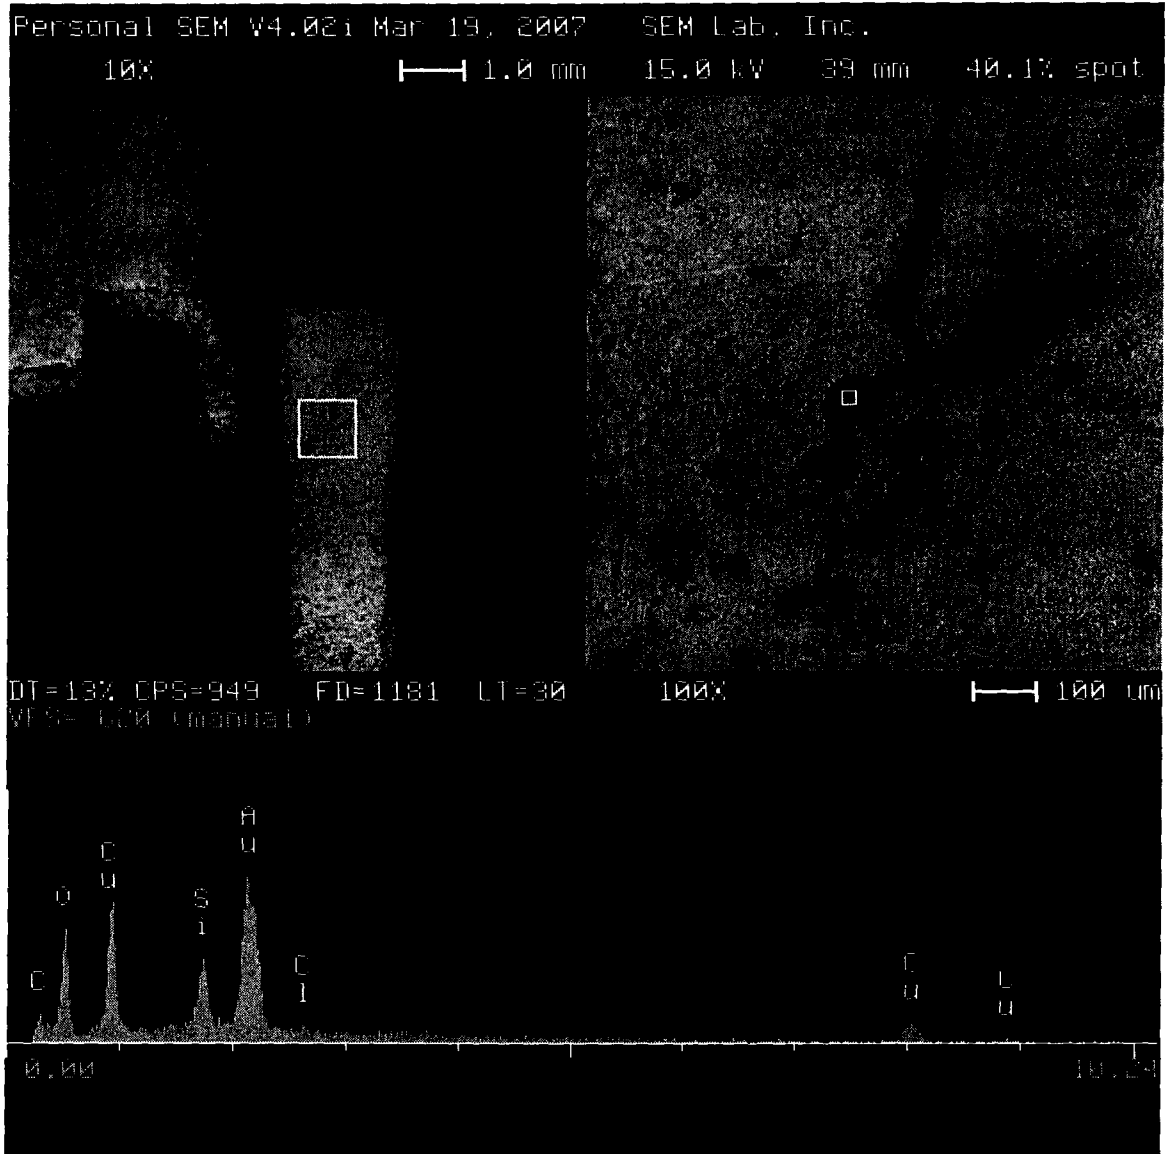
FIGURE 6: IFN 1448B\_2, Sample B – Terminal #1. This spectrum suggests that there is silicone lubricant and oxidized copper at this location.

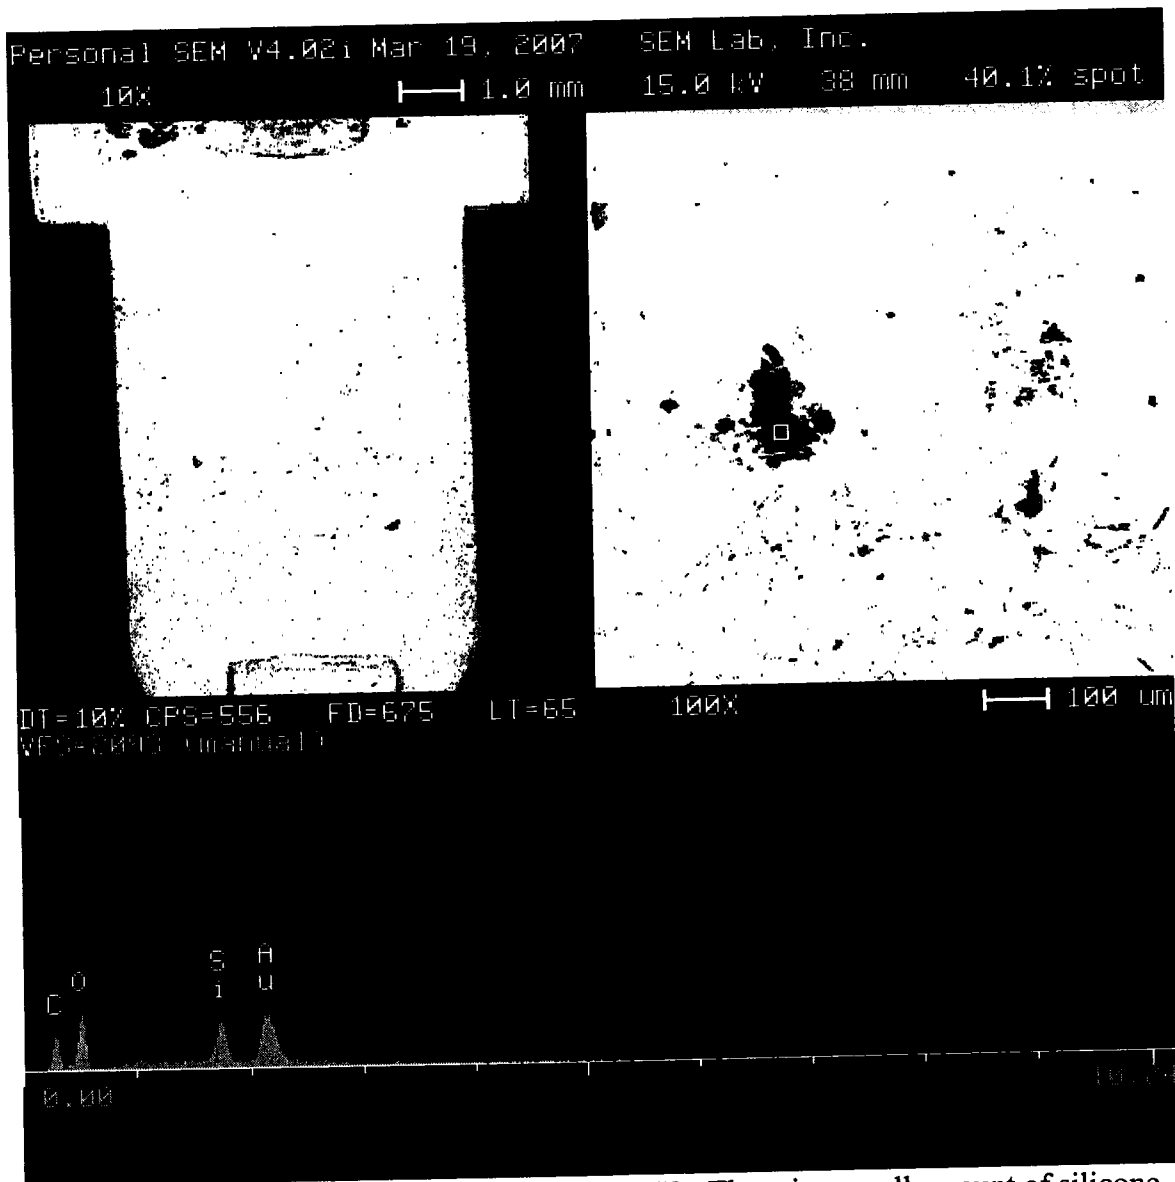
FIGURE 7: IFN 1448C\_1, Sample C – Lever #2. There is a small amount of silicone lubricant at this location.

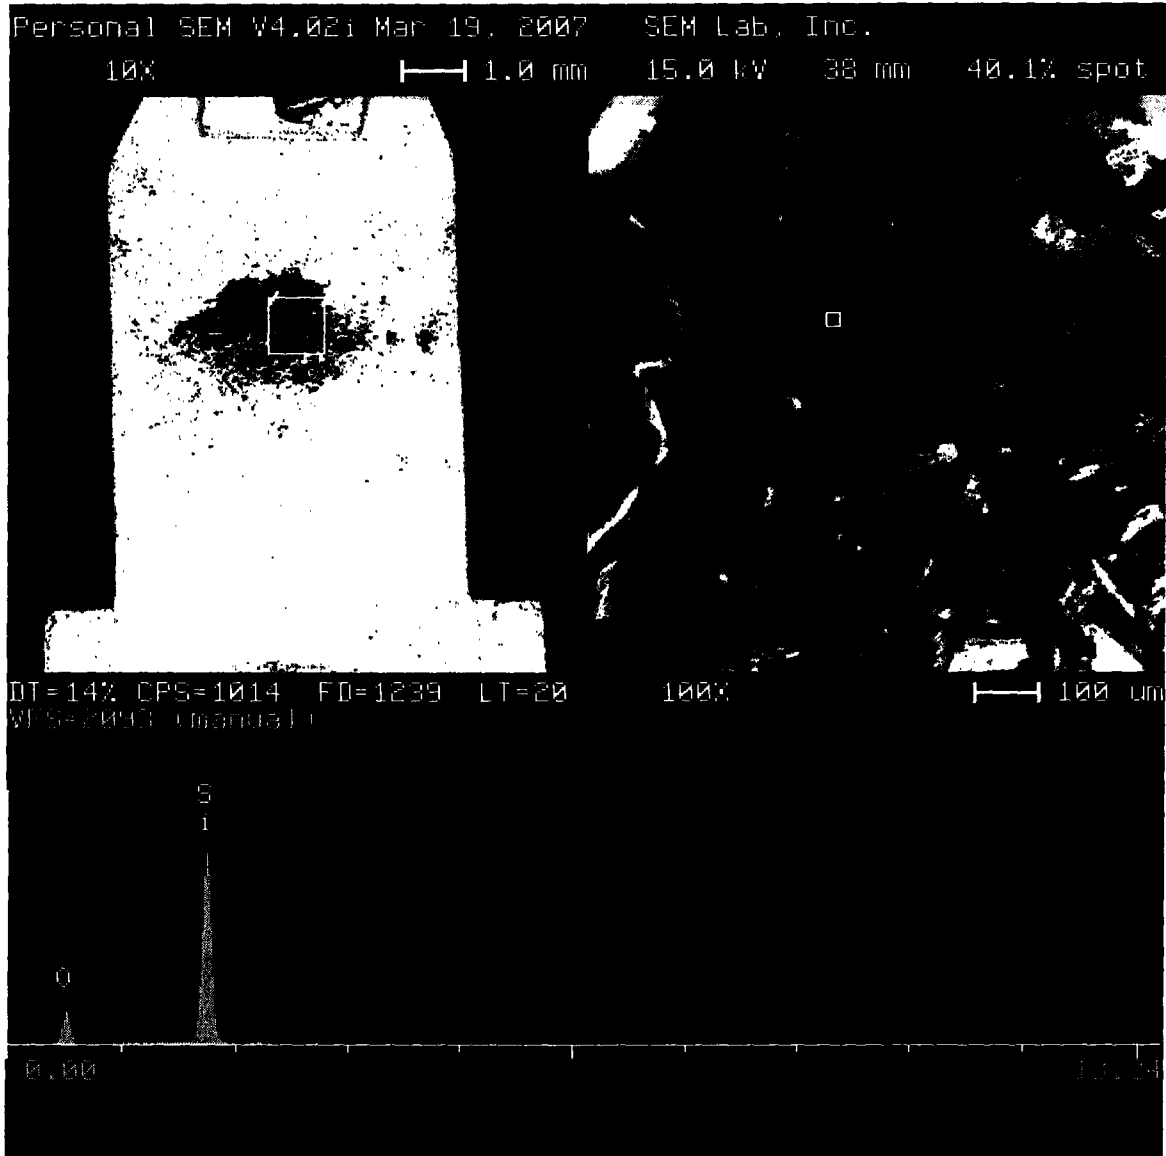
FIGURE 8: IFN 1448C\_2, Sample C – Lever #2. There is a large amount of silicone lubricant at this location.

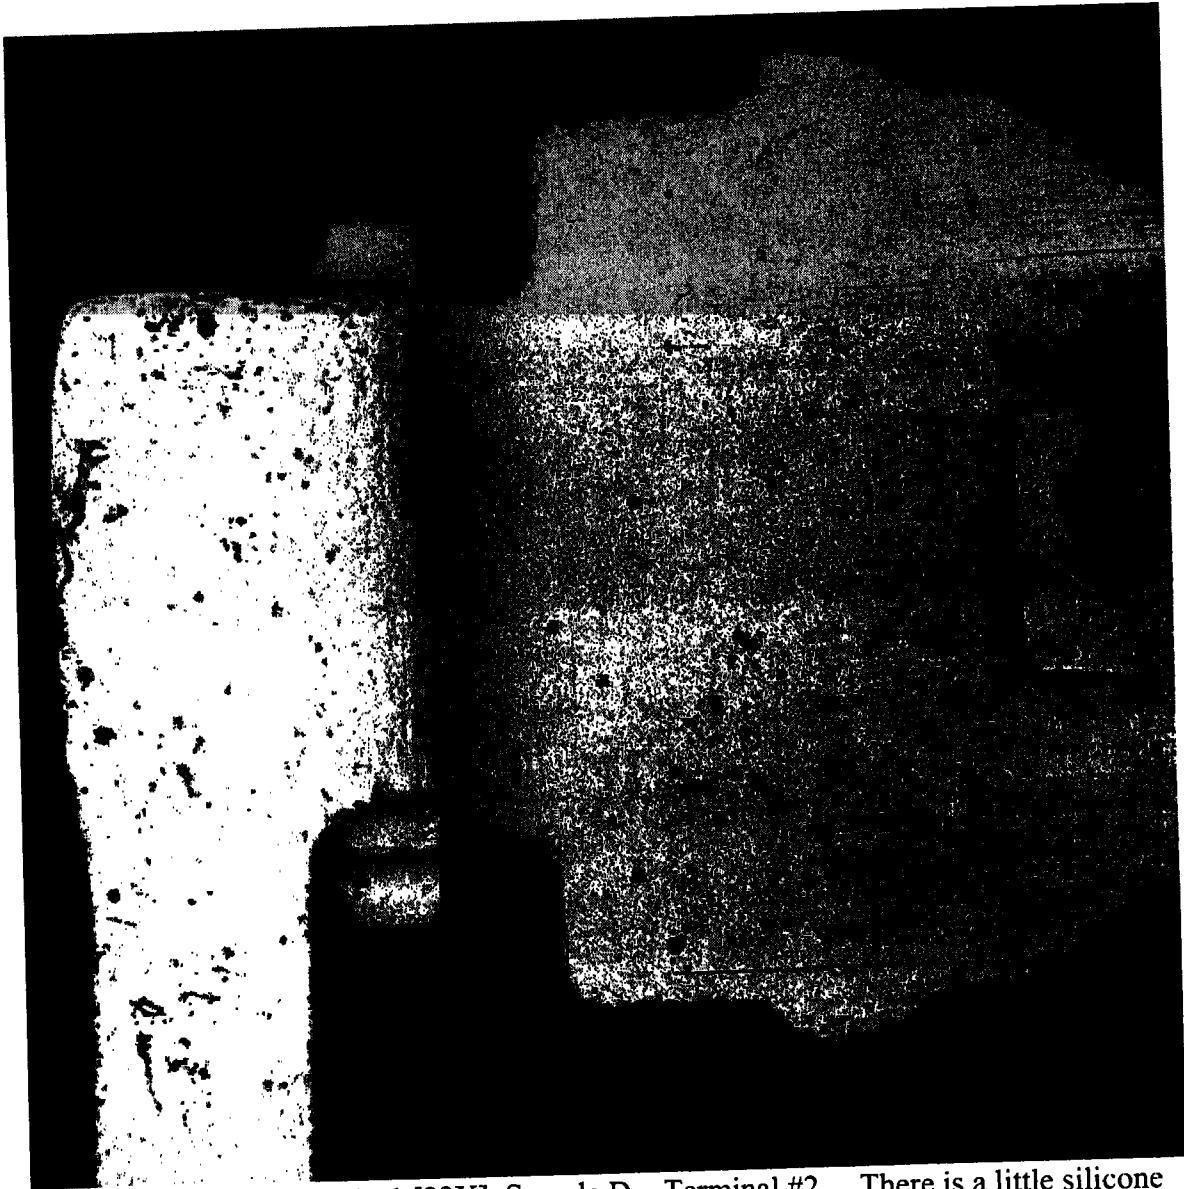
FIGURE 9: IFN 1448D\_1 [22X], Sample D – Terminal #2. There is a little silicone lubricant on the side of the pivot contact.

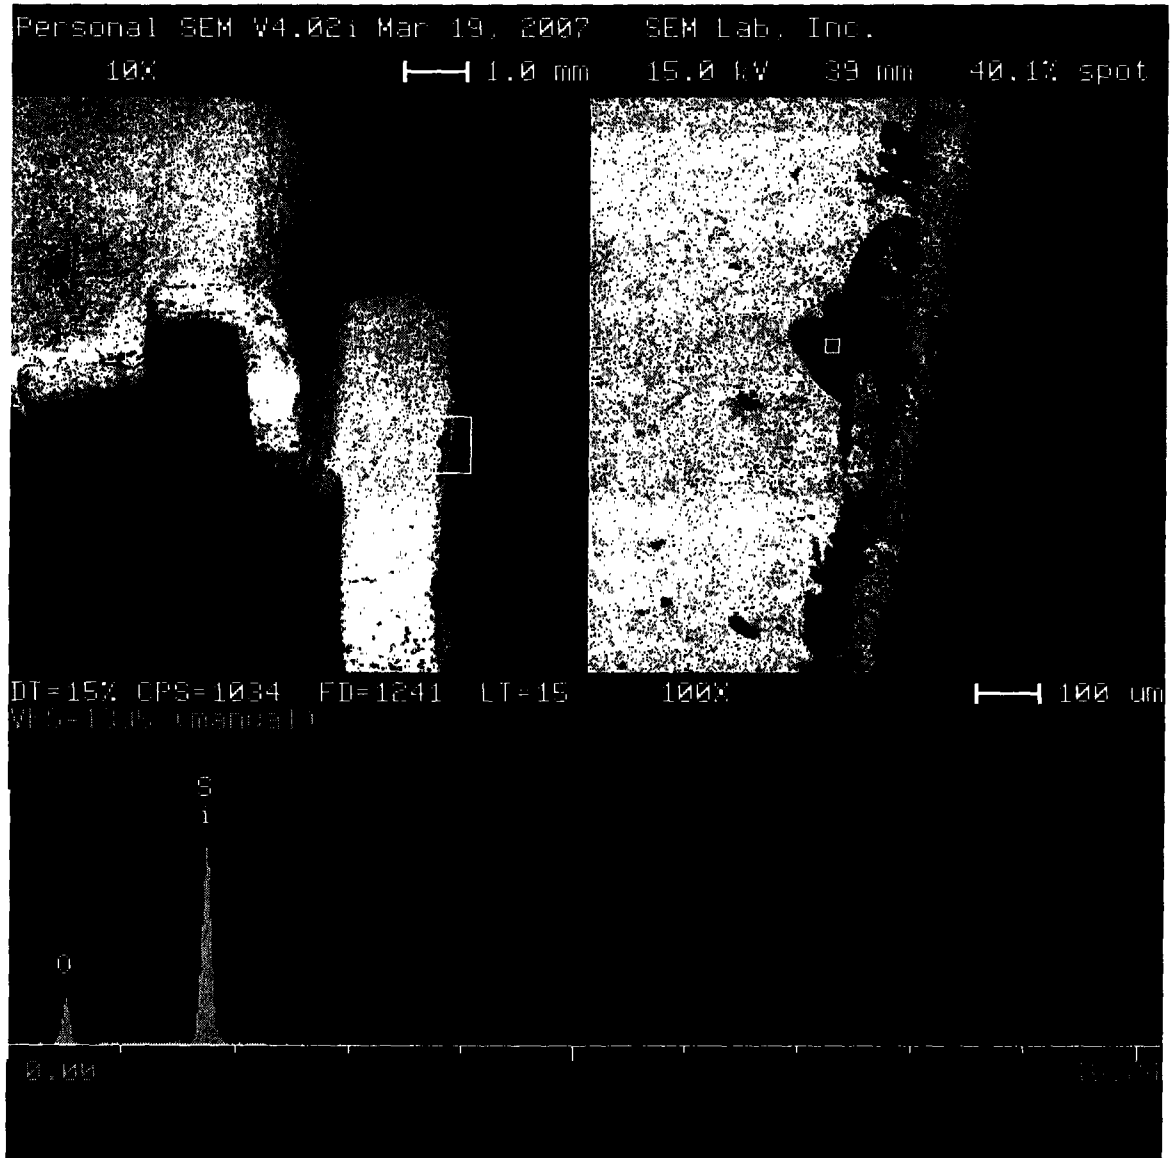
FIGURE 10: IFN 1448D\_2, Sample D – Terminal #2. There is a small amount of silicone lubricant on the opposite side of the pivot contact.

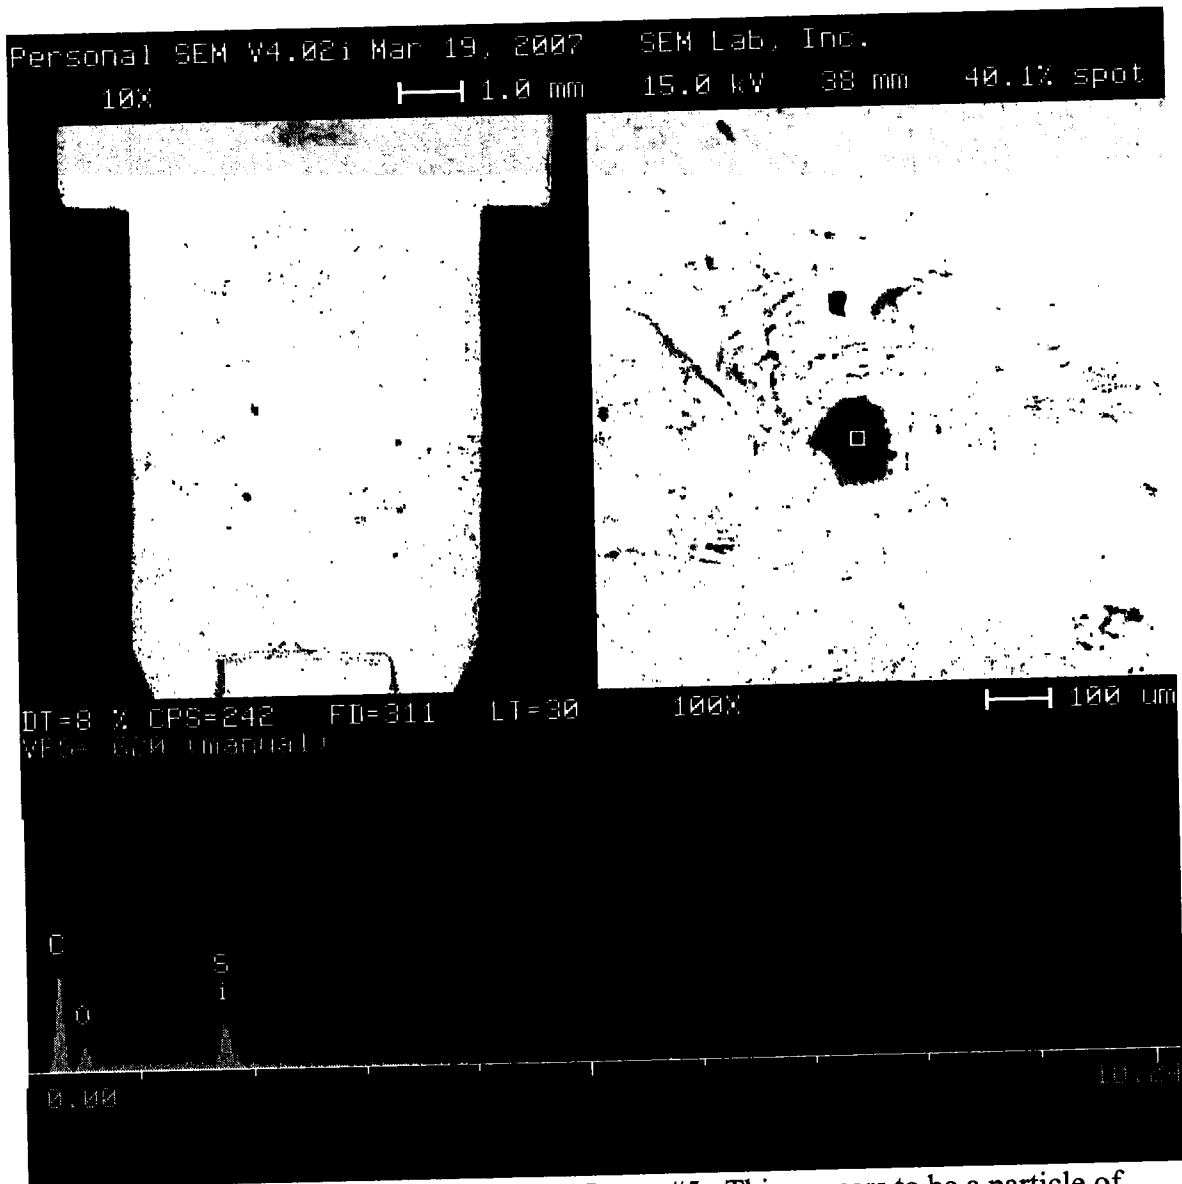
FIGURE 11: IFN 1448E\_1, Sample E – Lever #5. This appears to be a particle of dried lubricant.

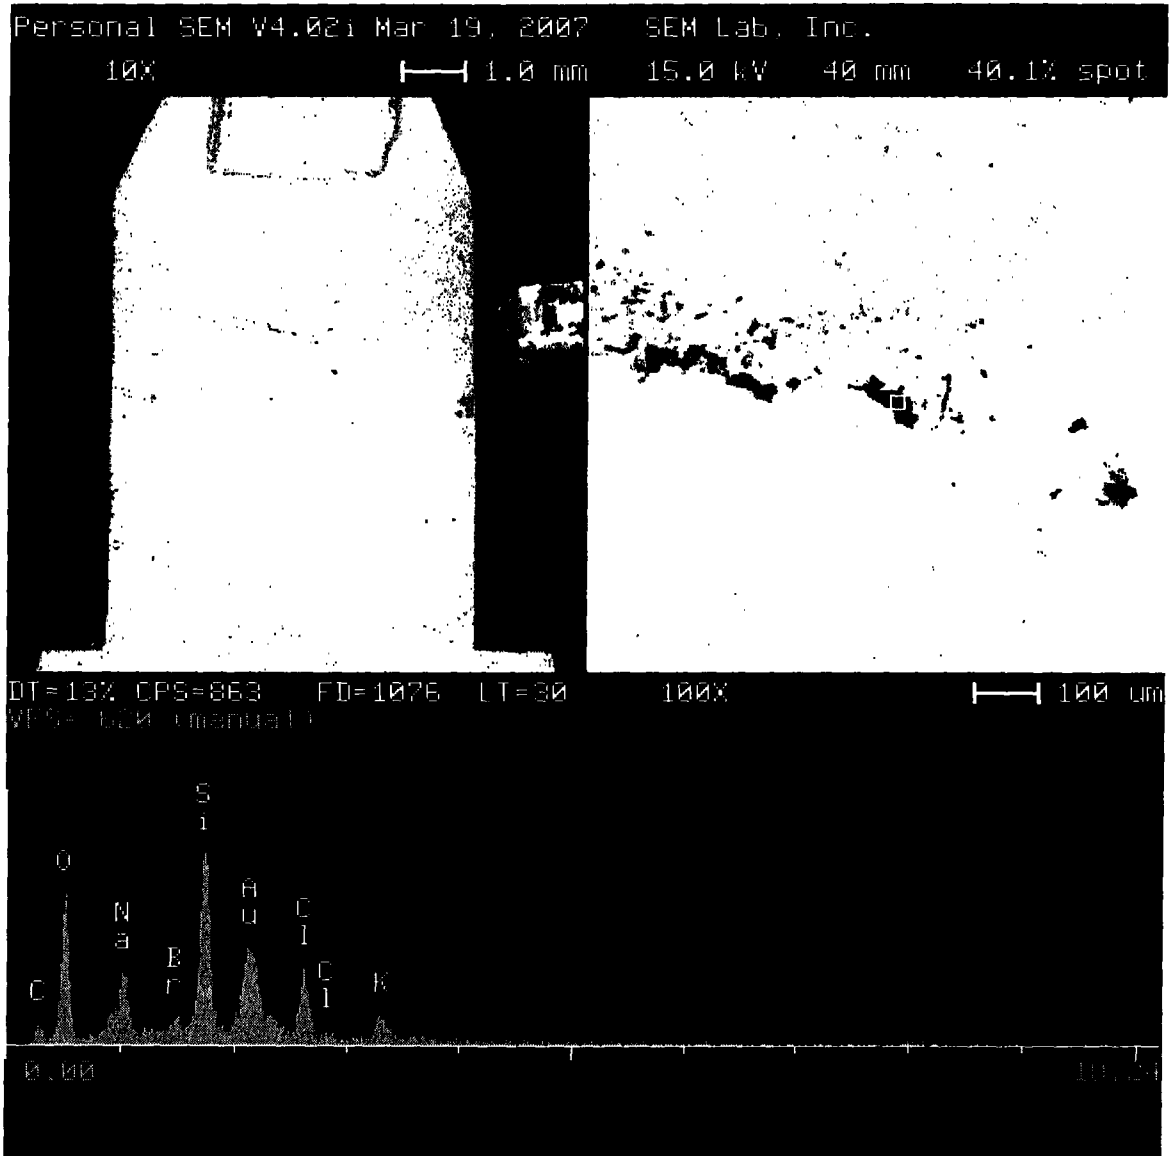
FIGURE 12: IFN 1448E\_2, Sample E – Lever #5. This appears to be lubricant mixed with salts.

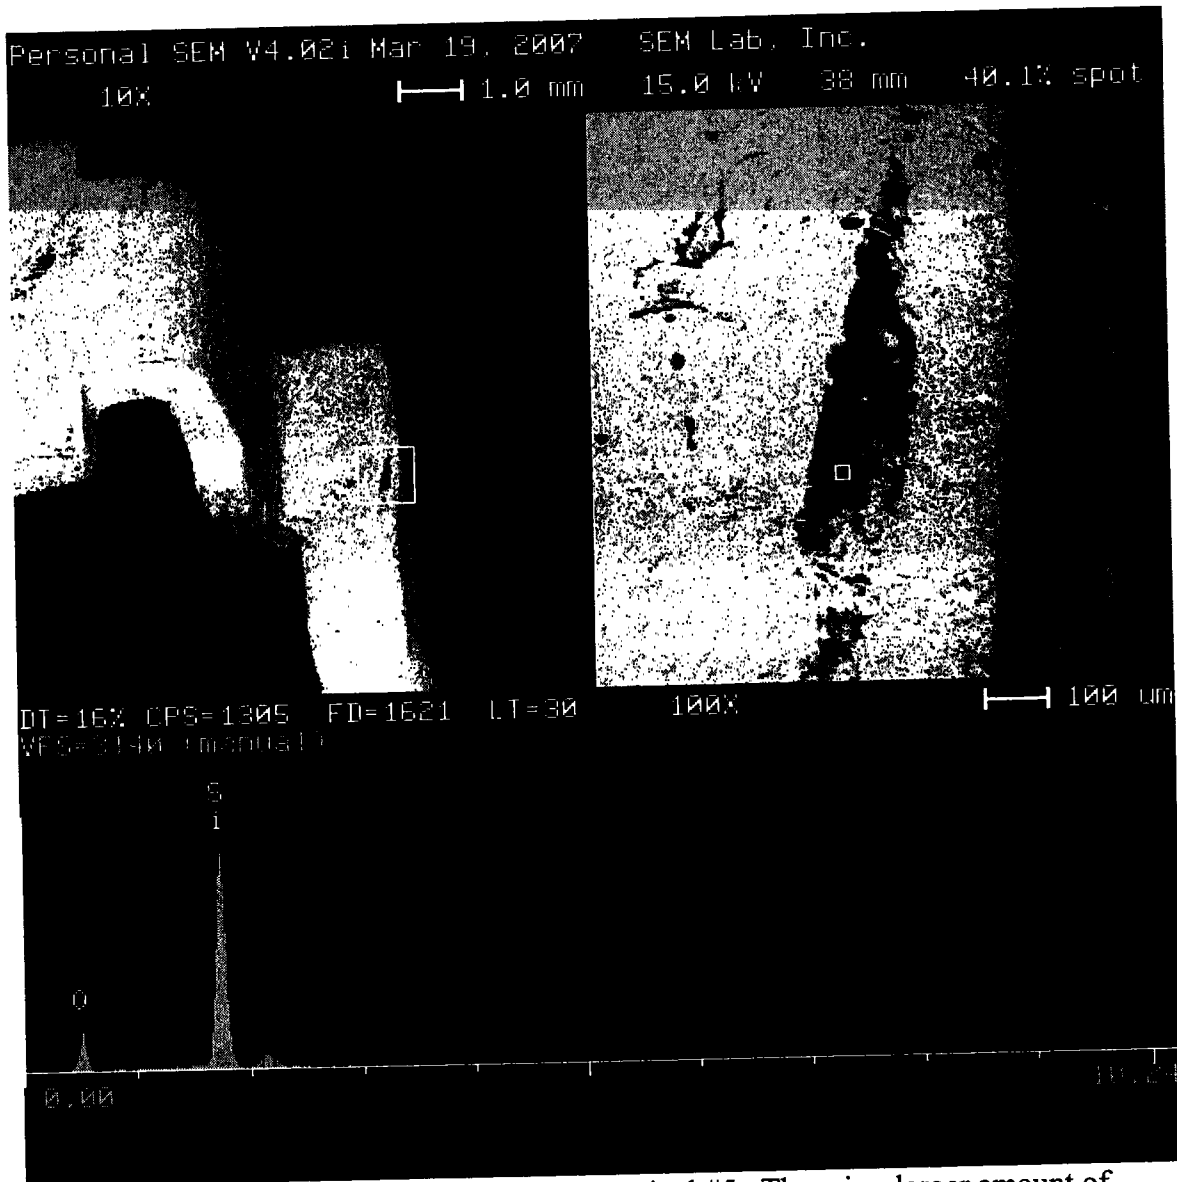
FIGURE 14: IFN 1448F\_2, Sample F – Terminal #5. There is a larger amount of silicone lubricant on the opposite side of the pivot contact.

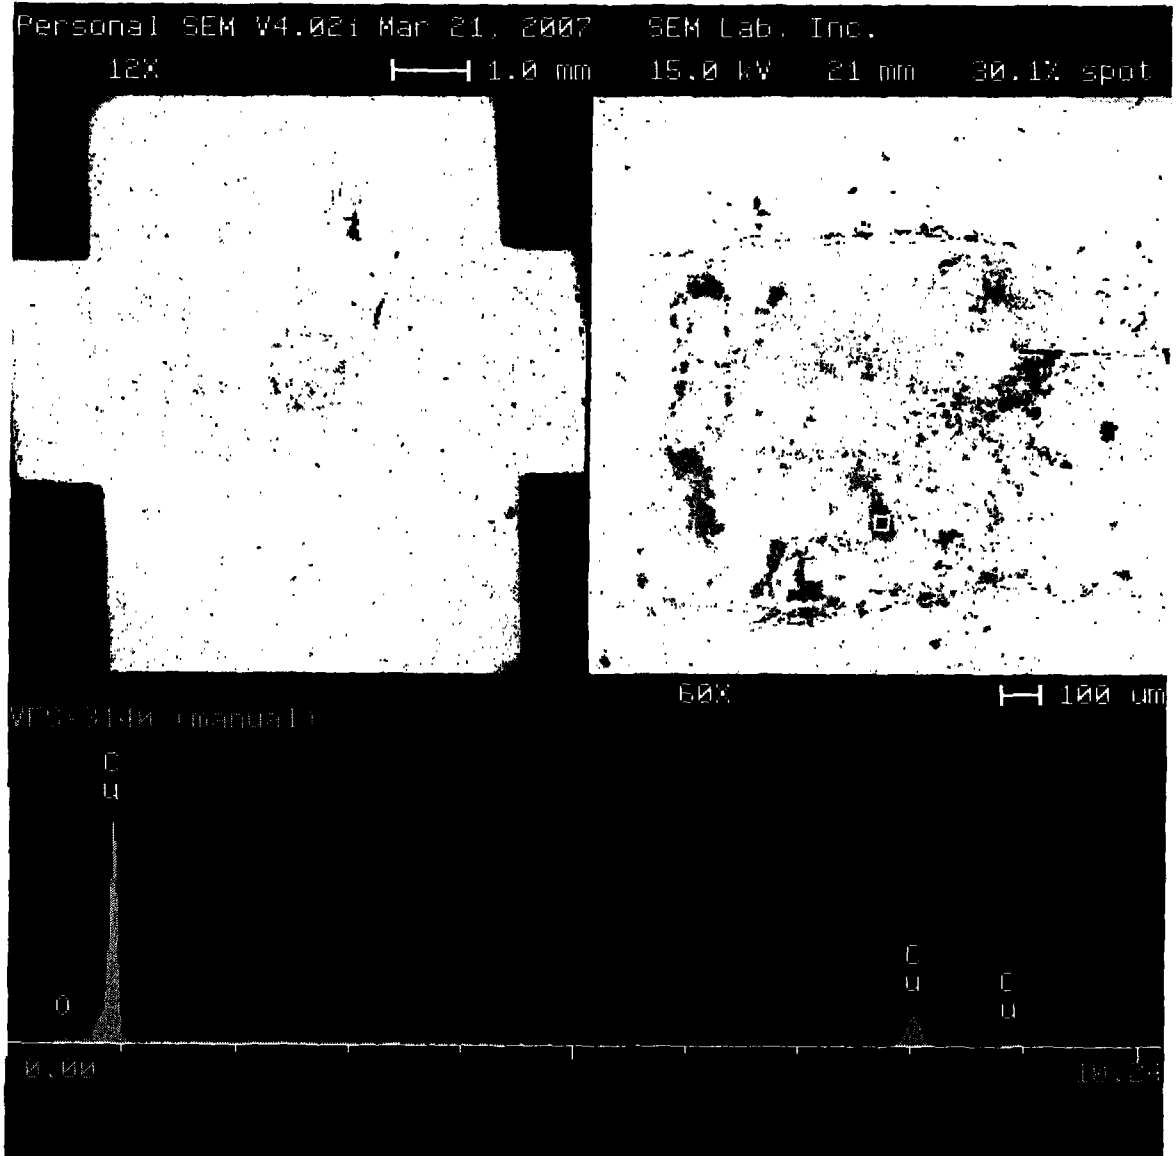
FIGURE 15: IFN 1448G\_1, Sample G – Lever #9. This is exposed copper in the contact region.

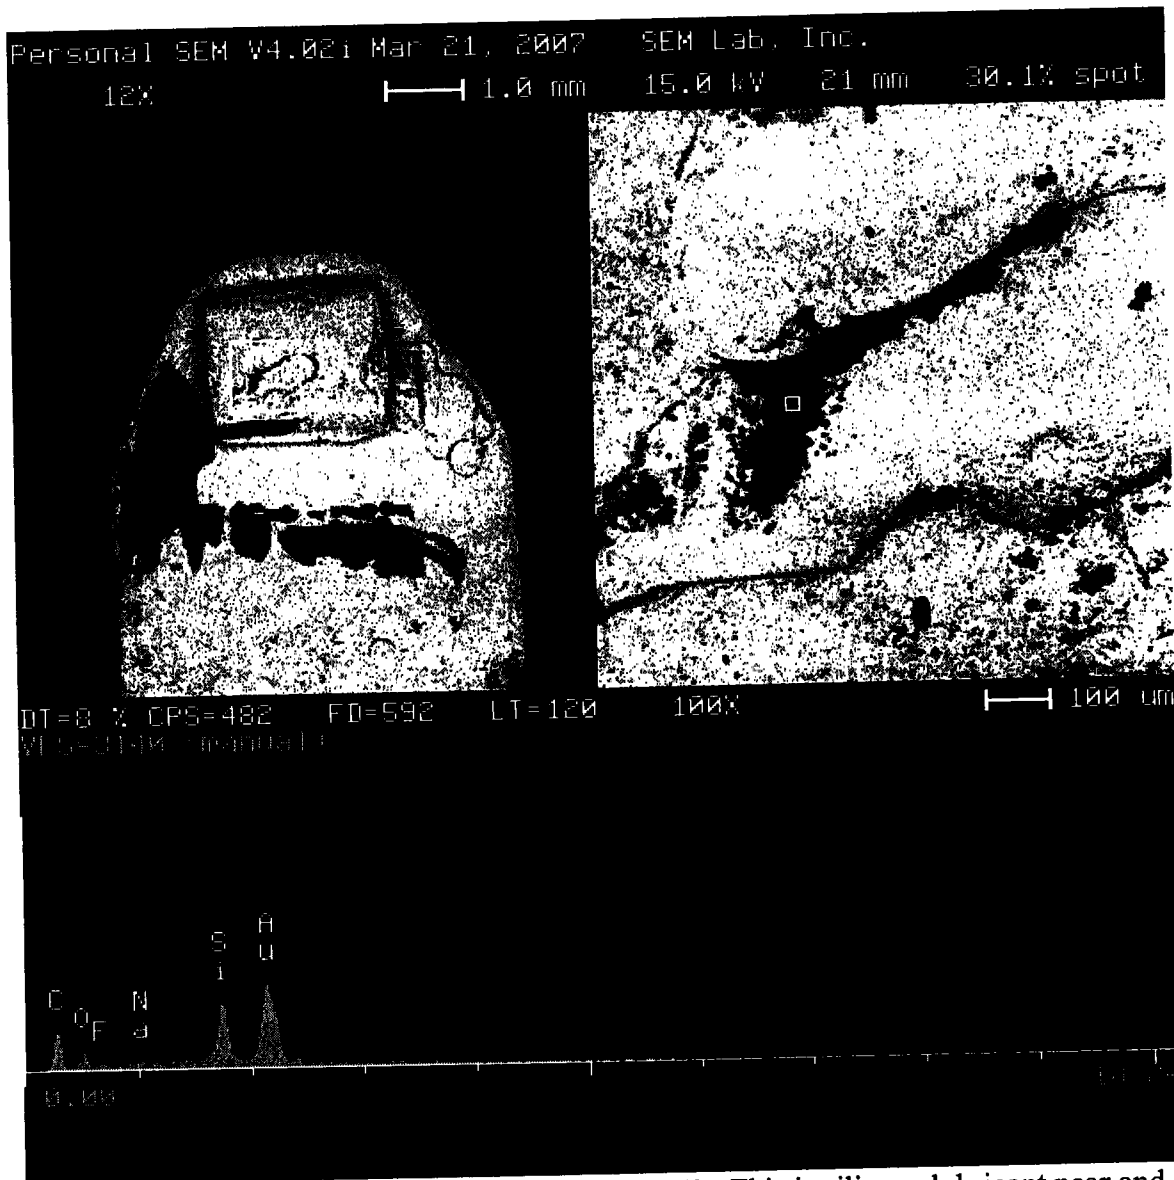
FIGURE 16: IFN 1448G\_2, Sample G – Lever #9. This is silicone lubricant near and on the contact.

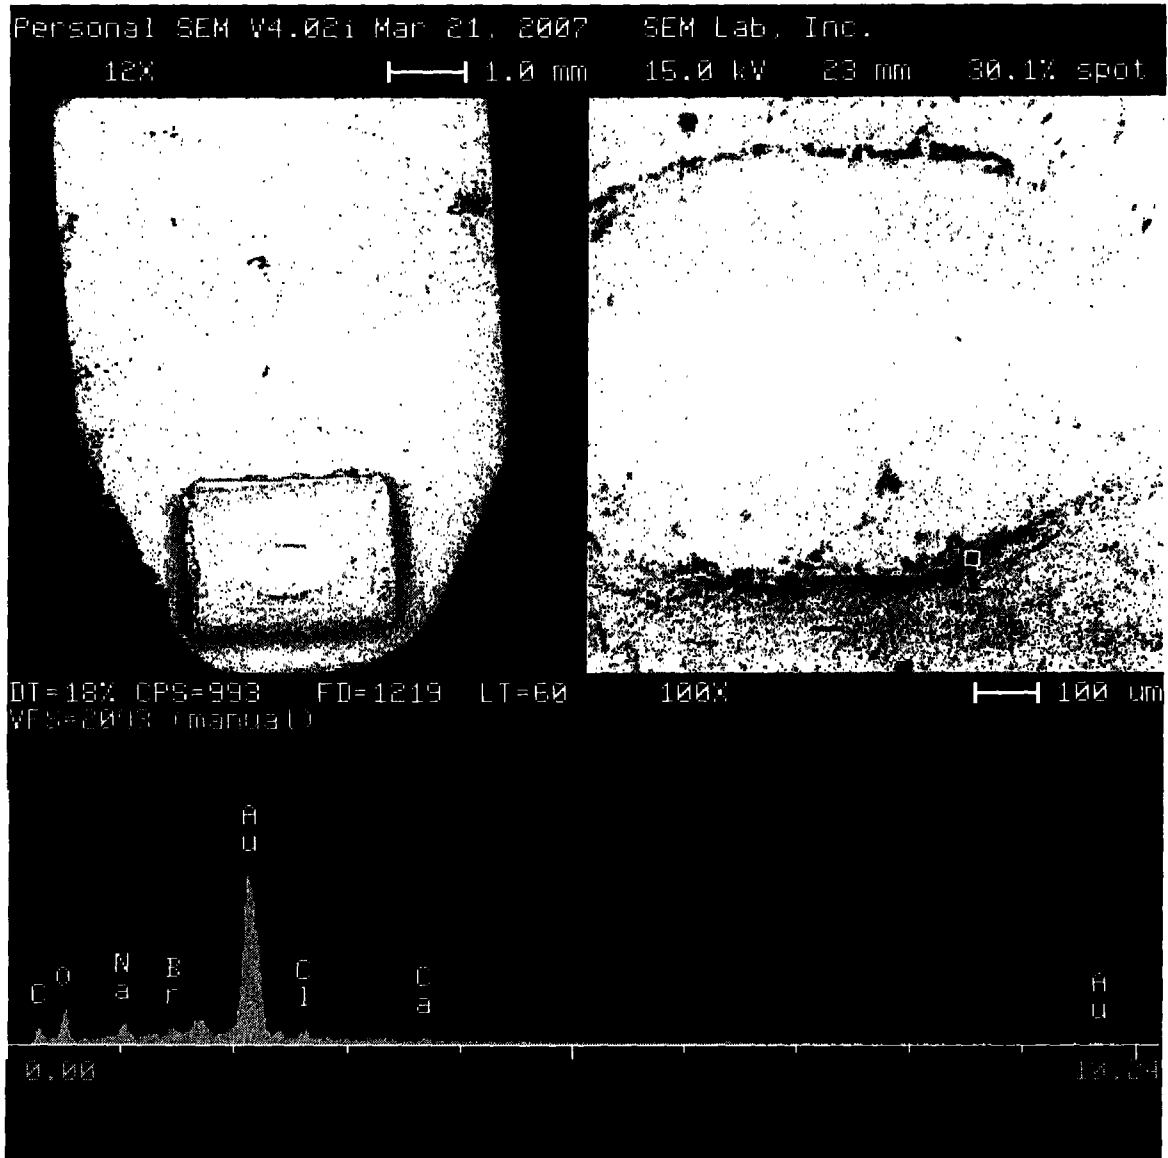
FIGURE 17: IFN 1448G\_3, Sample G – Lever #9. This appears to be salt and hydrocarbon residue.

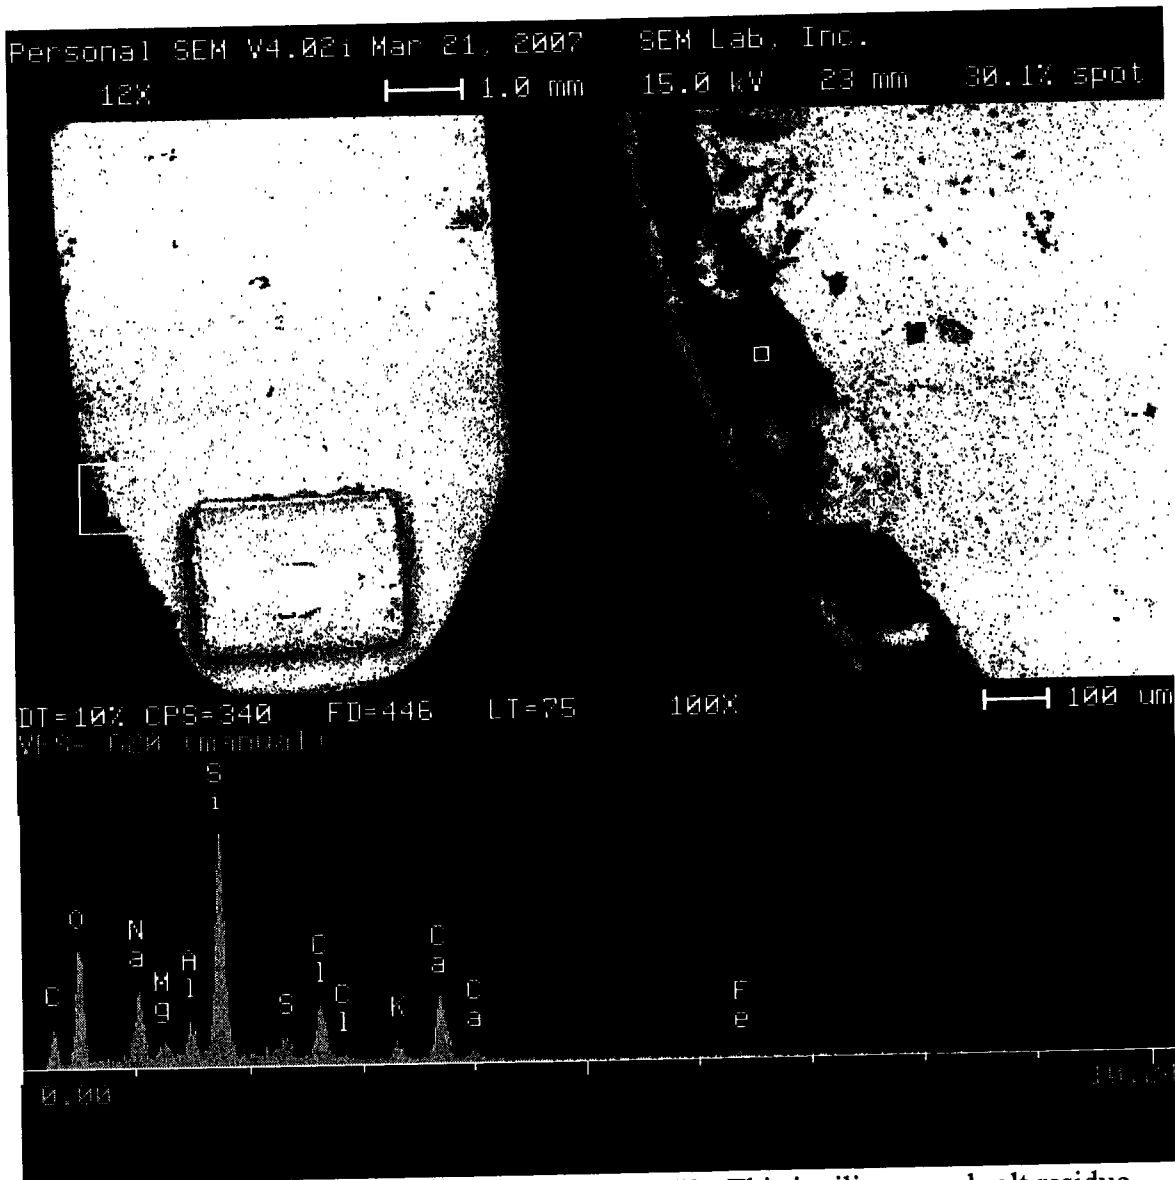
FIGURE 18: IFN 1448G\_4, Sample G – Lever #9. This is silicone and salt residue.
