**PE07-012**  
**FREIGHTLINER**  
**4/20/2007**  
**ATTACHMENT**  
**PART 1 OF 7**

Problem Ticket Report

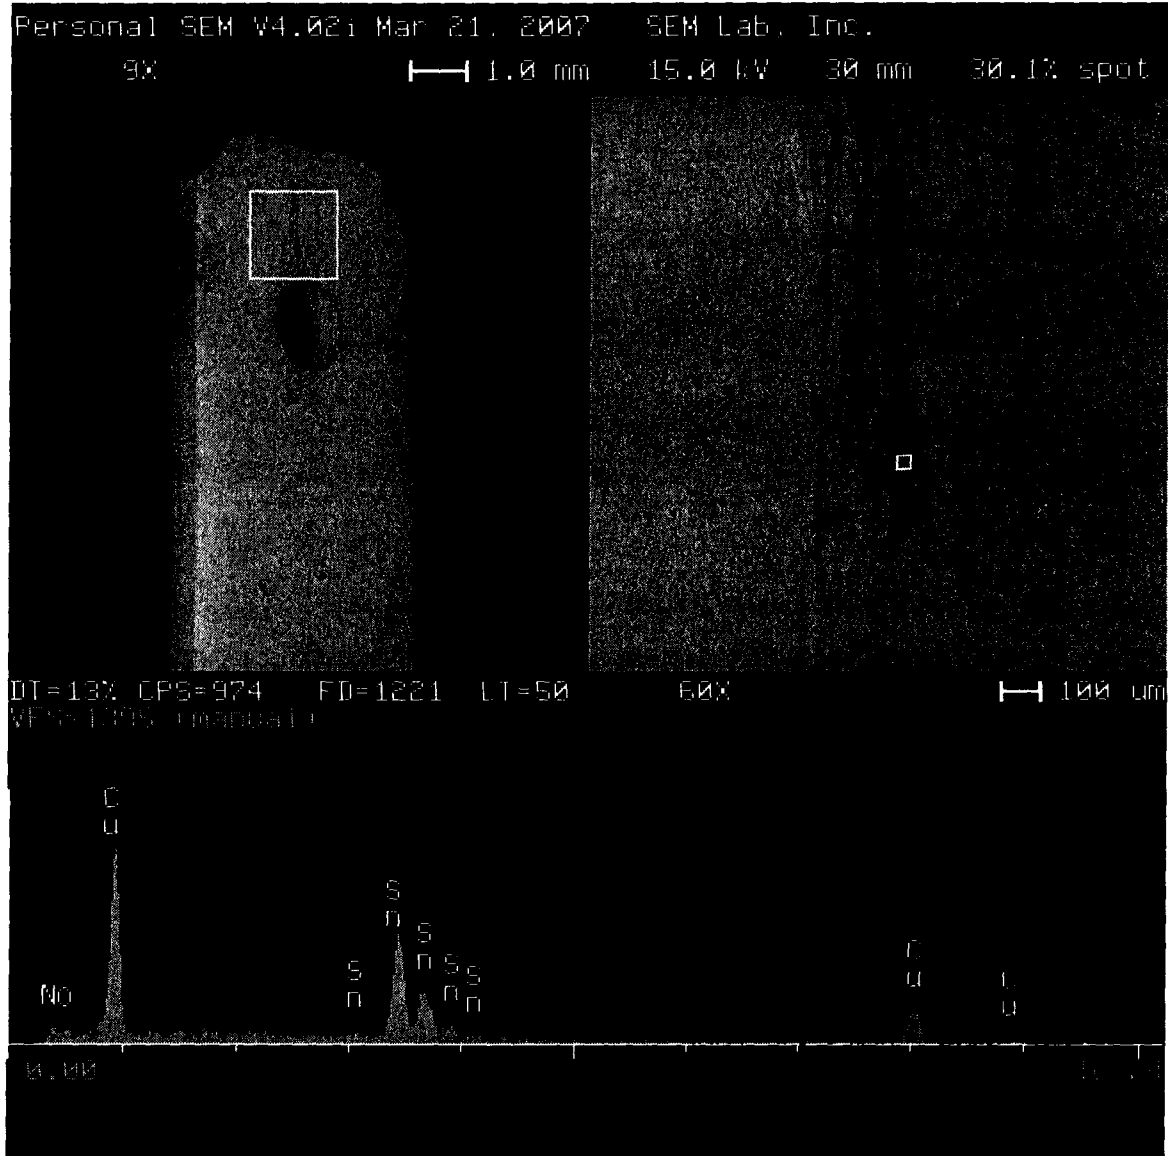
FIGURE 19: IFN 1448H\_1, Sample H – Pivot Terminal #9. This is exposed tin and copper on the blade surface.

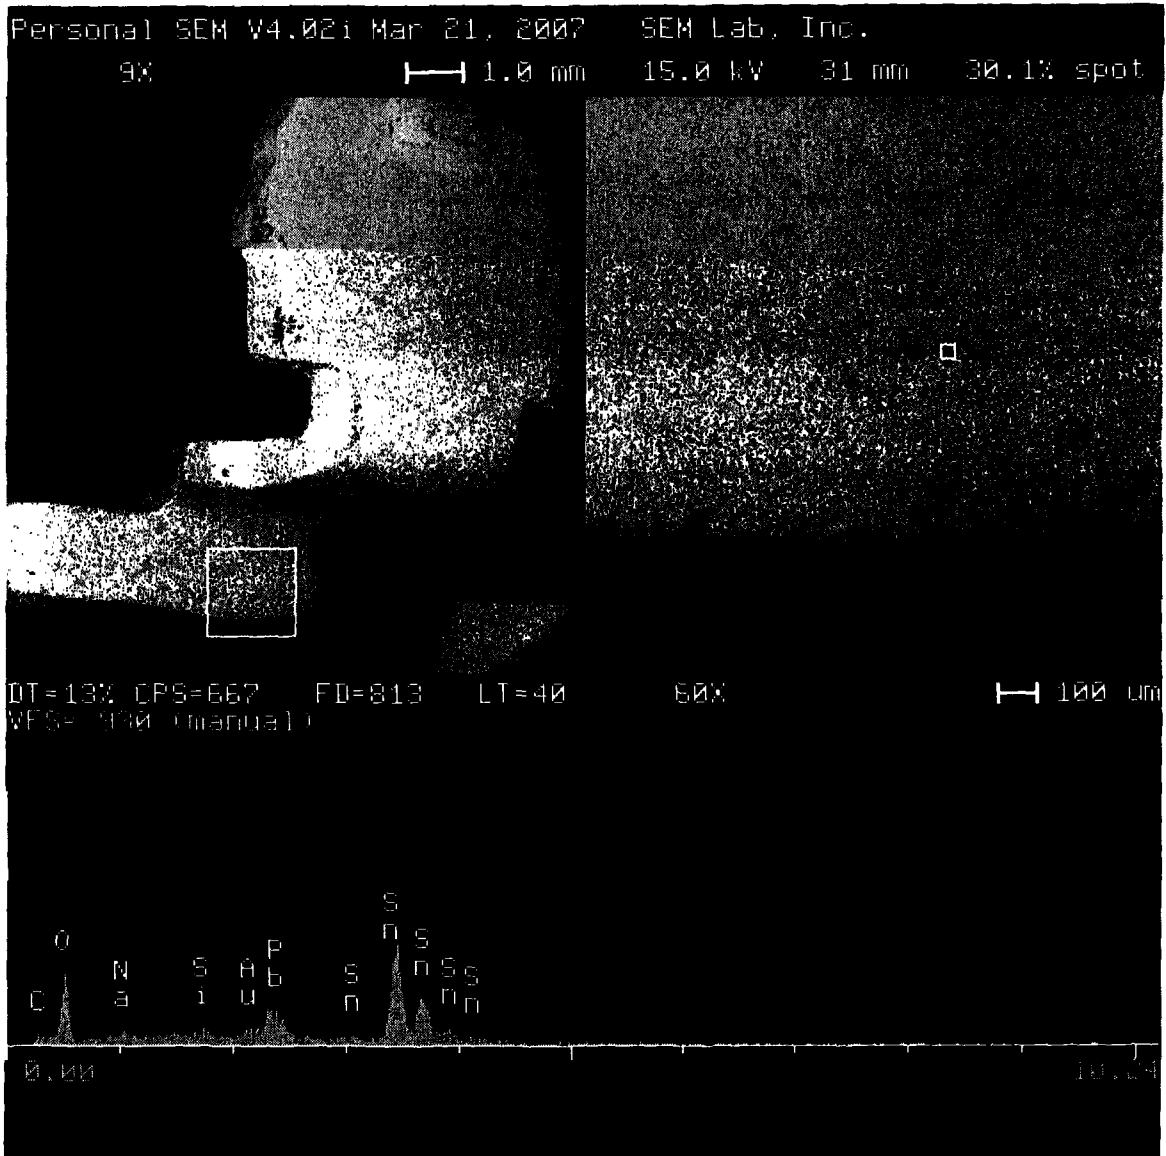
FIGURE 20: IFN 1448H\_2, Sample H – Pivot Terminal #9. This may be a small area of solder (Sn-Pb) splash.

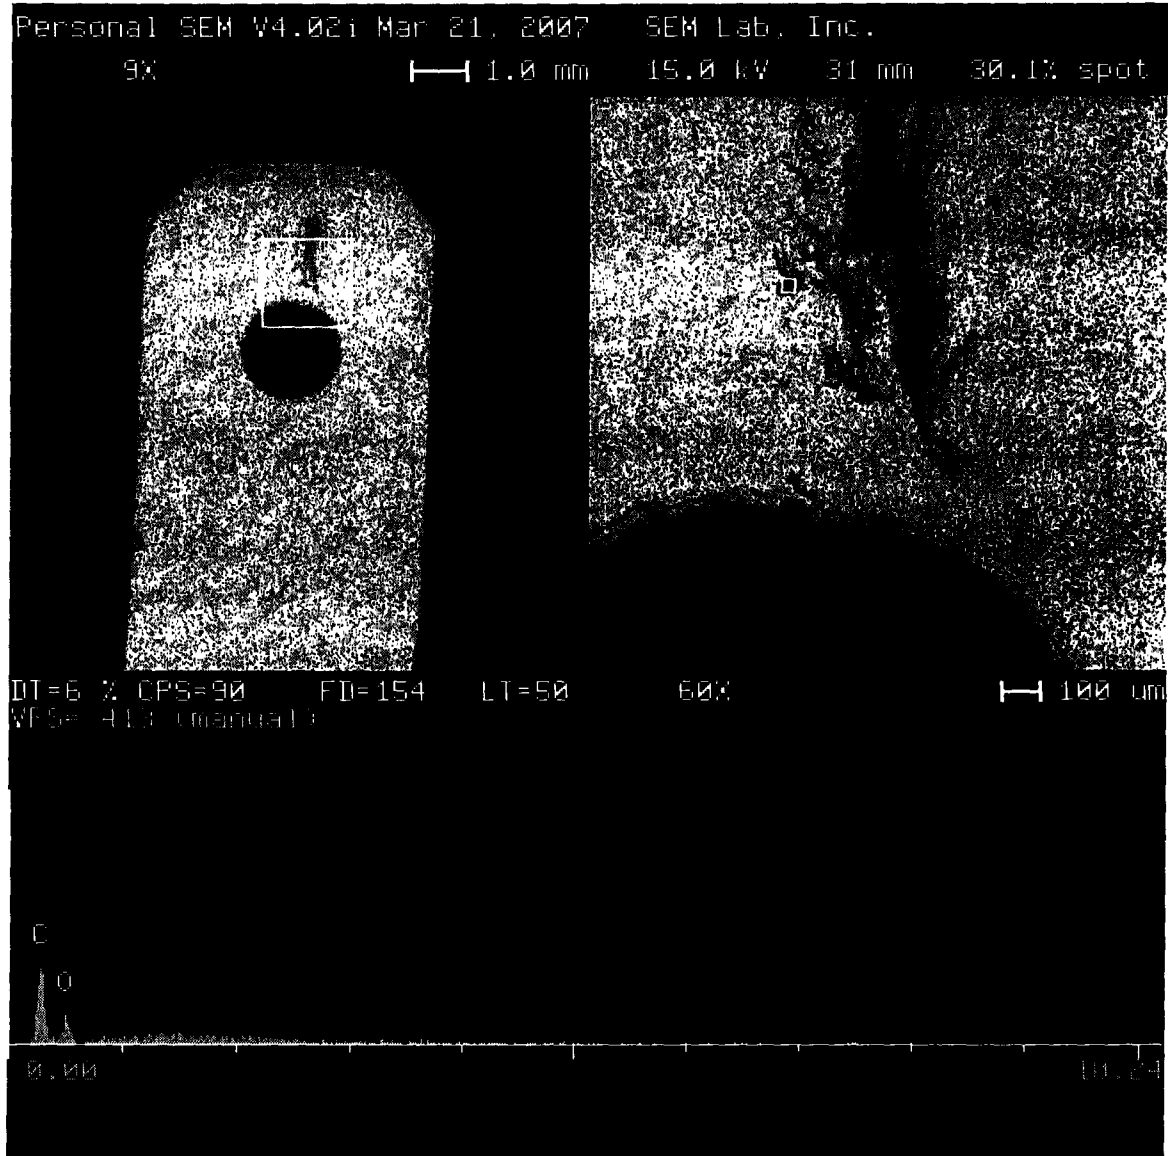
FIGURE 21: IFN 1448H\_3, Sample H – Pivot Terminal #9. This appears to be a hydrocarbon or polymer particle.

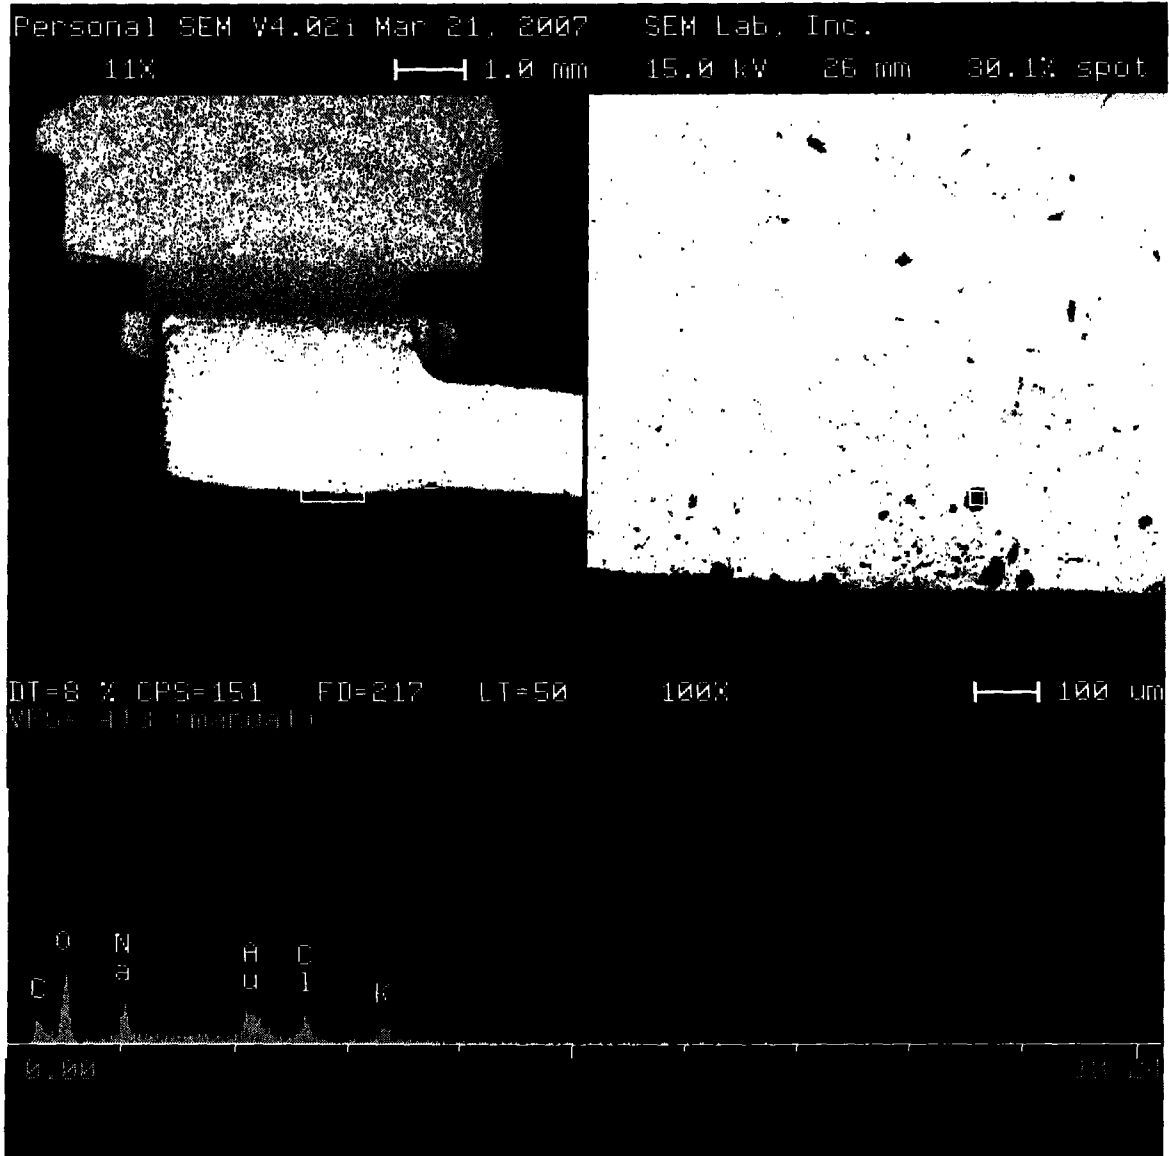
FIGURE 22: IFN 1448H\_4, Sample H – Pivot Terminal #9. This appears to be salt and hydrocarbon.

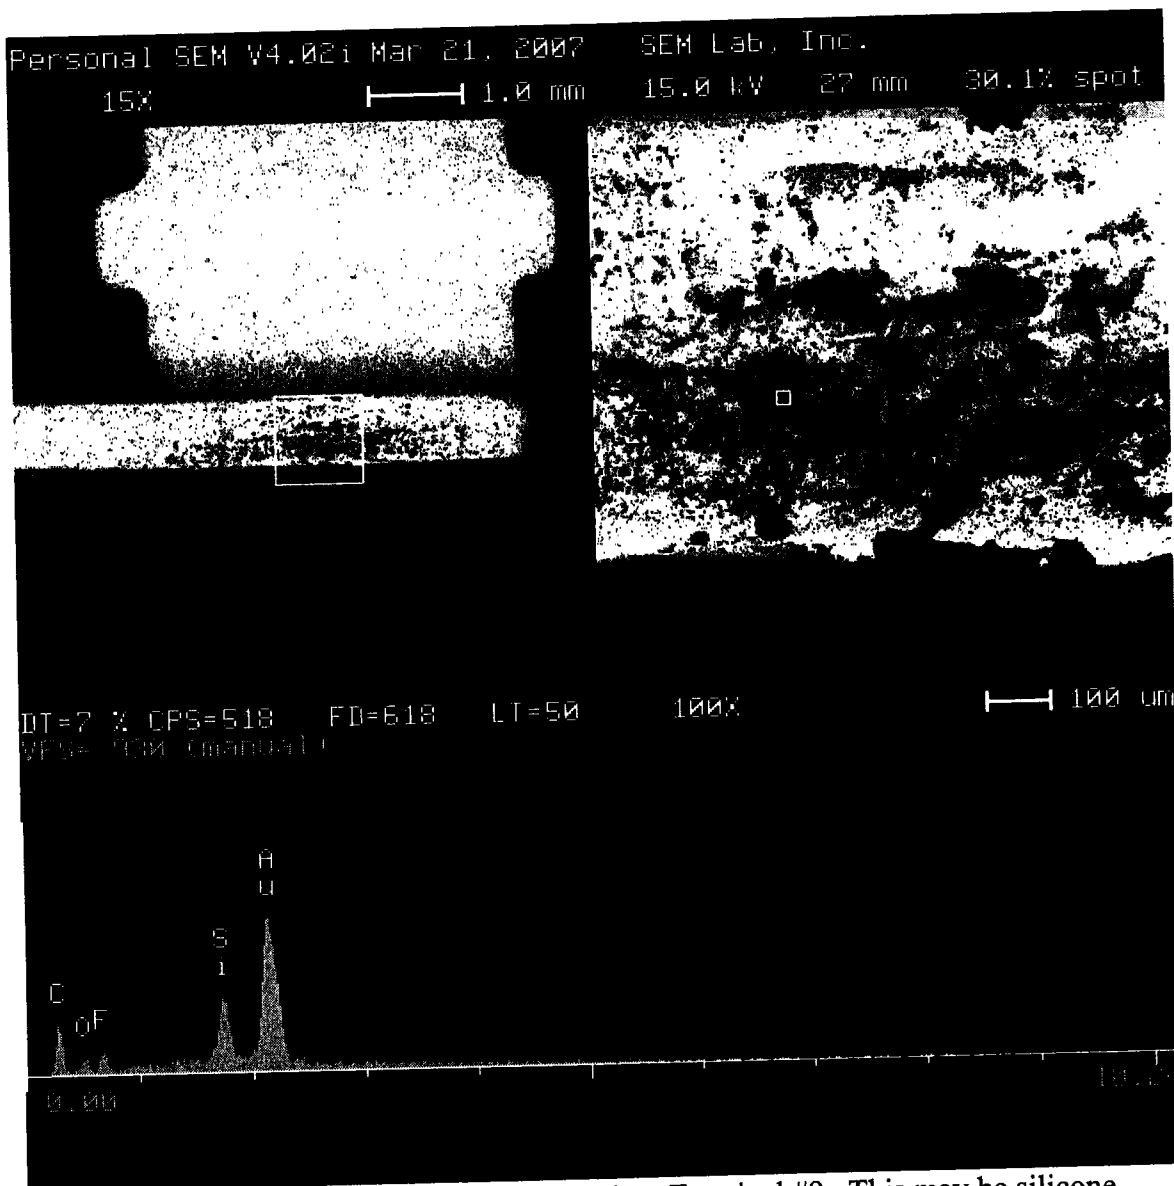
FIGURE 23: IFN 1448H\_5, Sample H - Pivot Terminal #9. This may be silicone lubricant with Teflon.

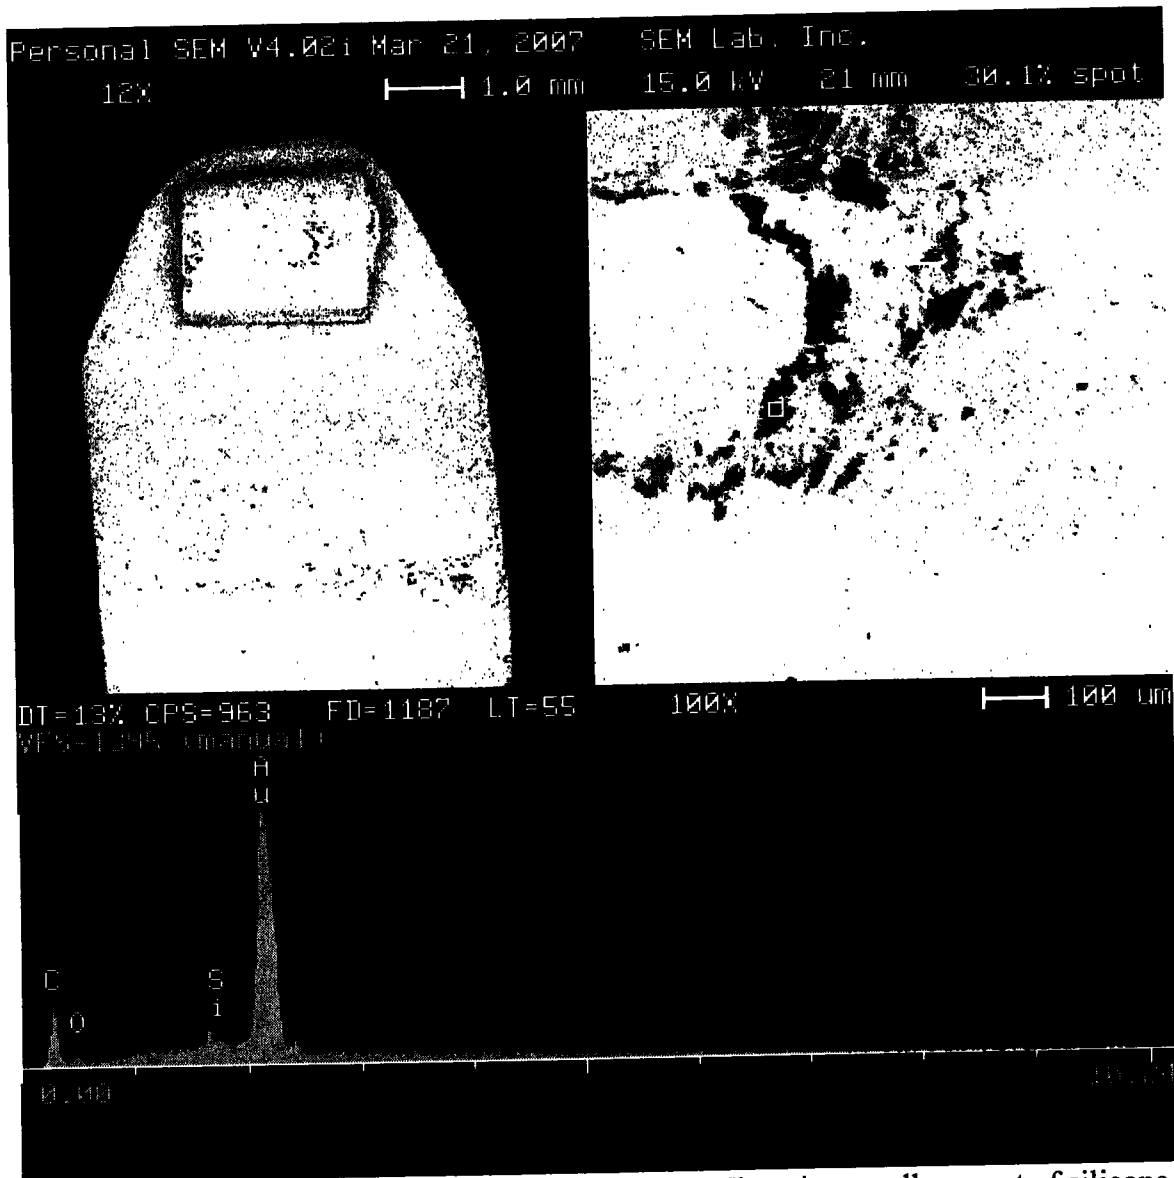
FIGURE 25: IFN 1448I\_2, Sample I – Lever #11. There is a small amount of silicone lubricant and hydrocarbon at this location.

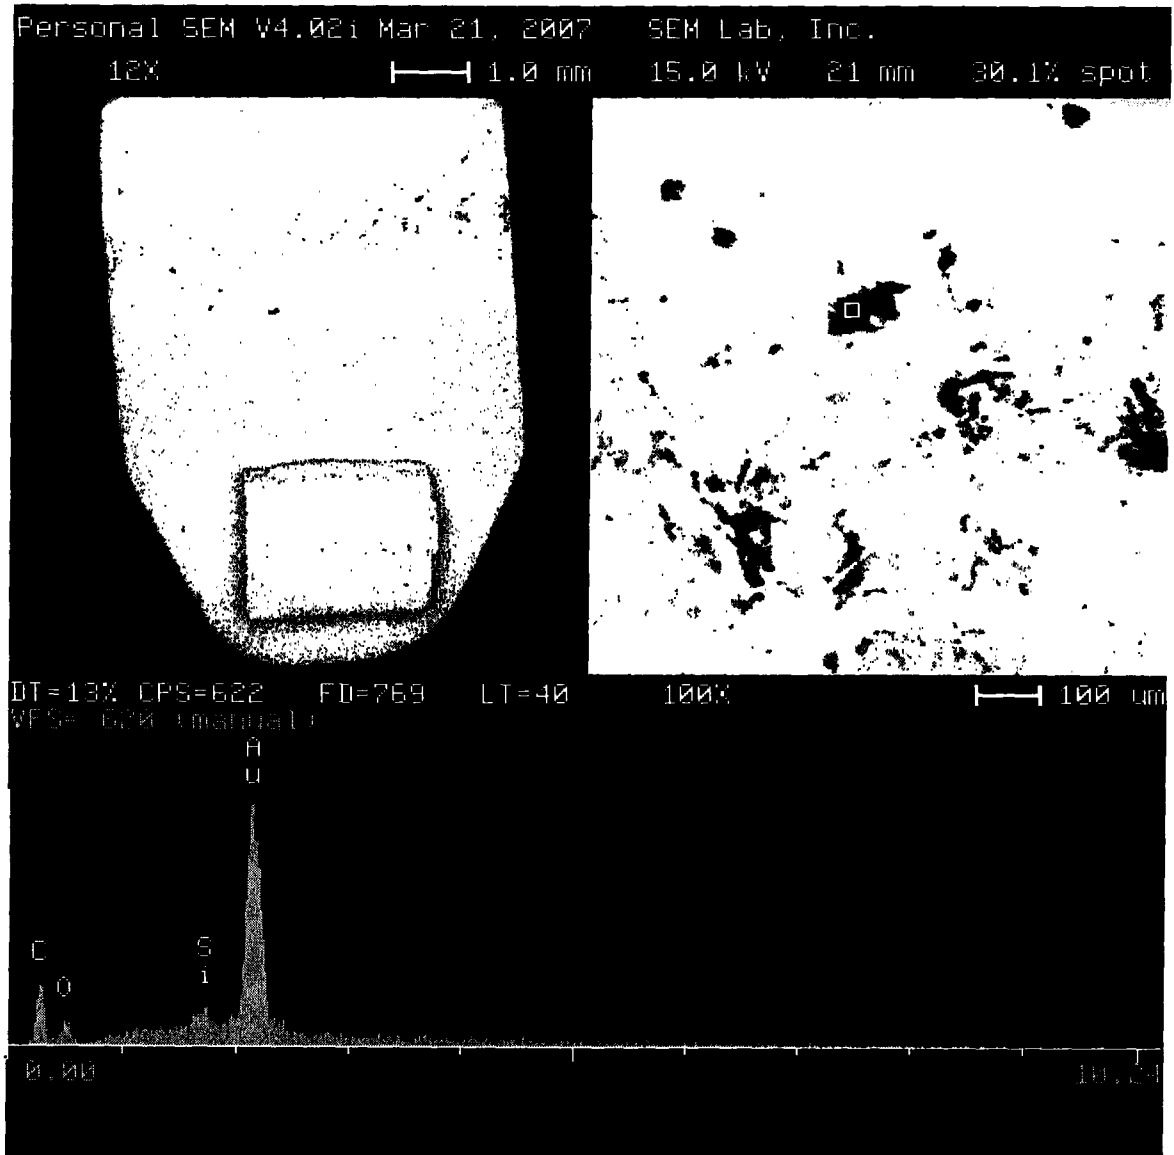
FIGURE 26: IFN 1448I\_3, Sample I - Lever #11. This appears to be silicone plus hydrocarbon.

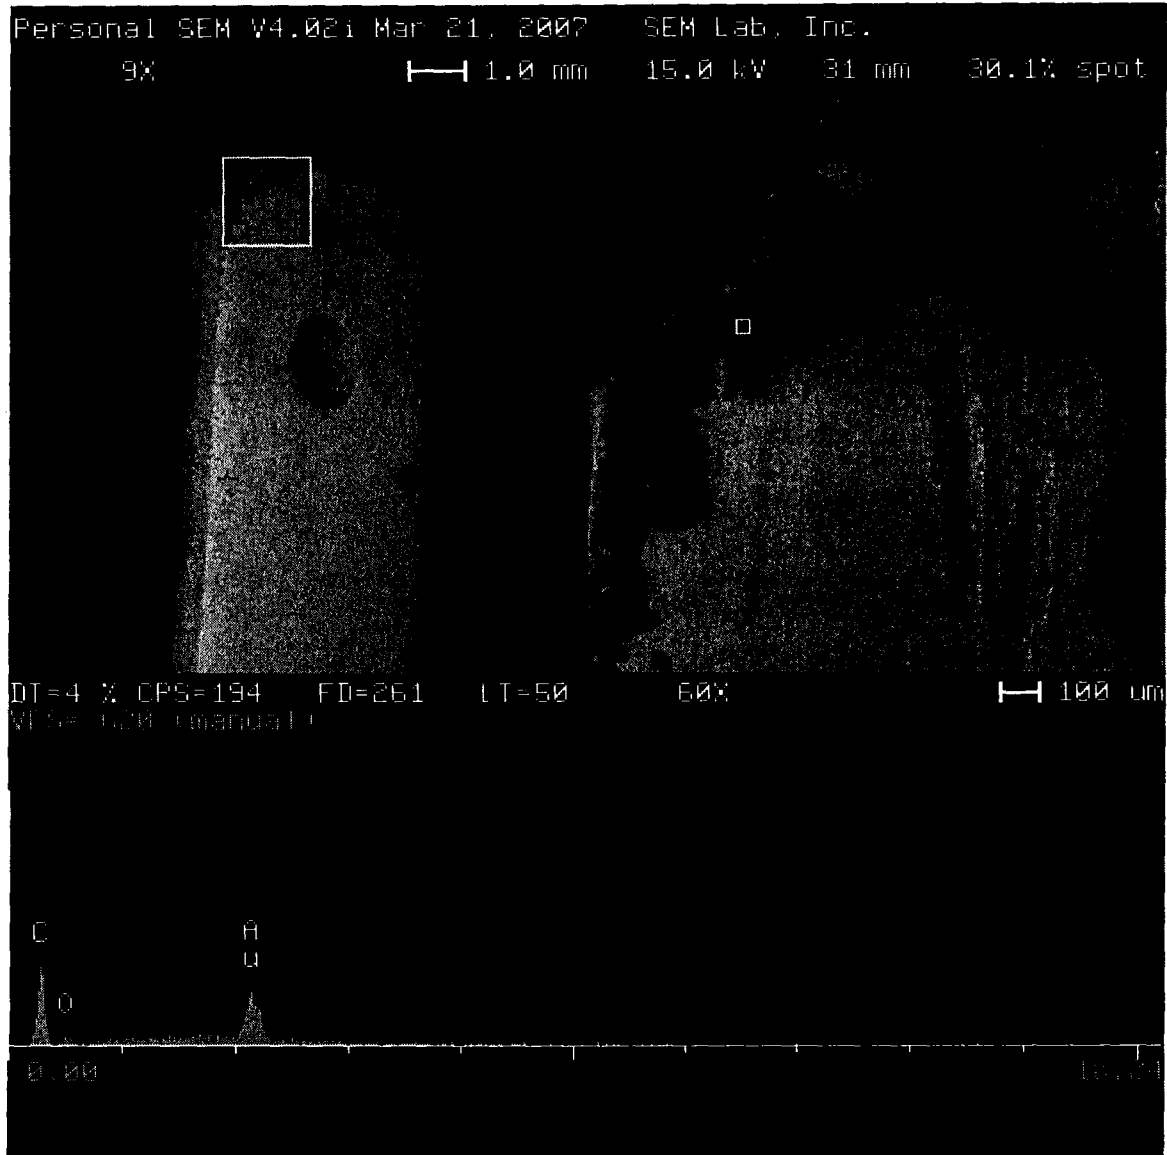
FIGURE 27: IFN 1448j\_1, Sample J – Pivot Terminal #11. This may be polymeric debris.

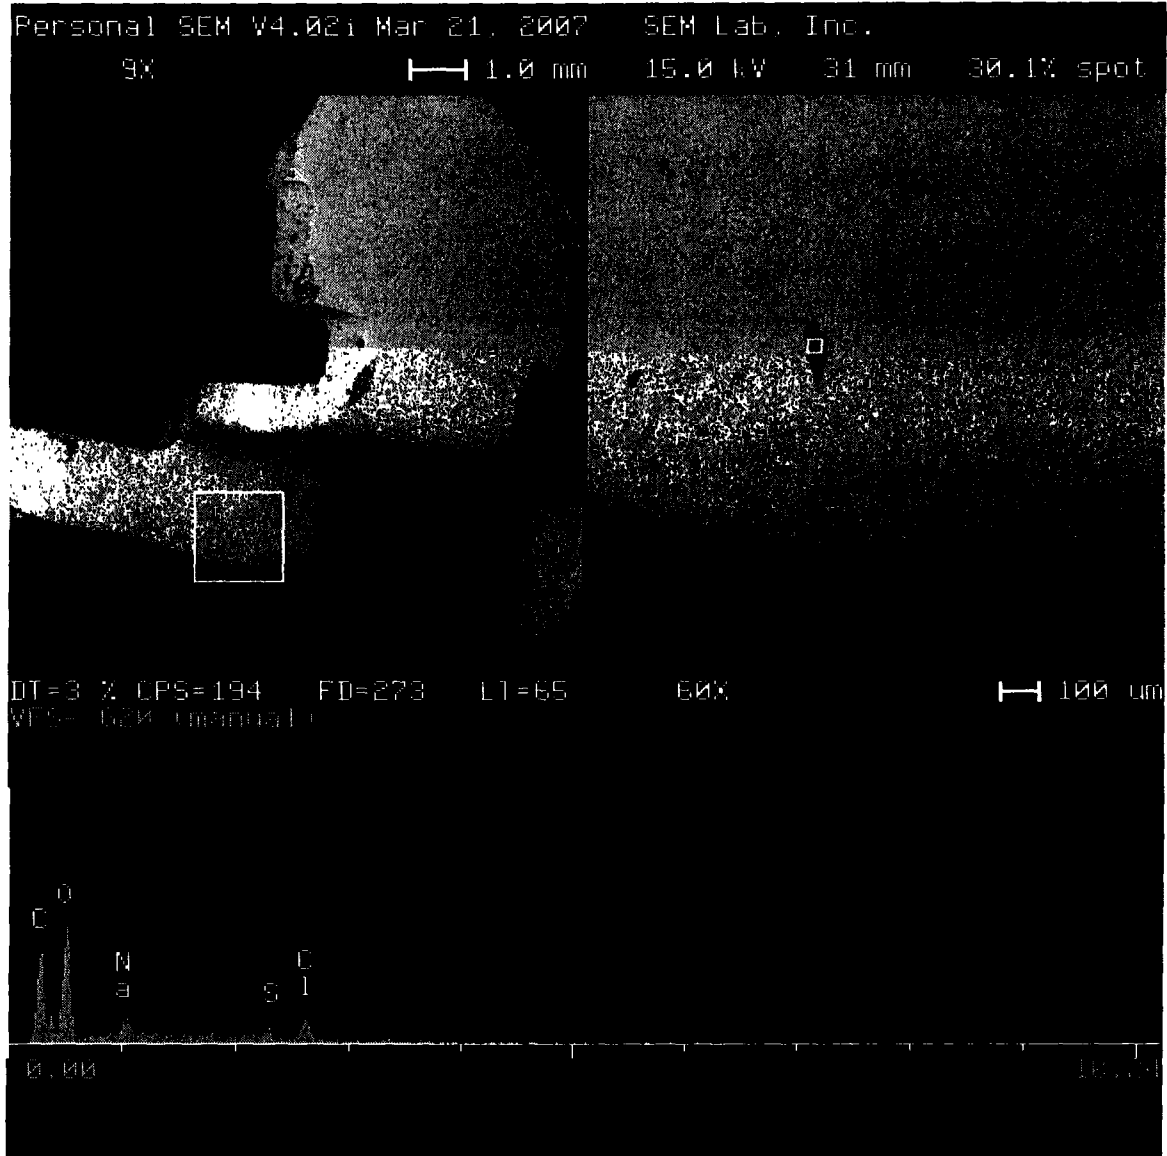
FIGURE 28: IFN 1448j\_2, Sample J – Pivot Terminal #11. This is salt and hydrocarbon or polymer.

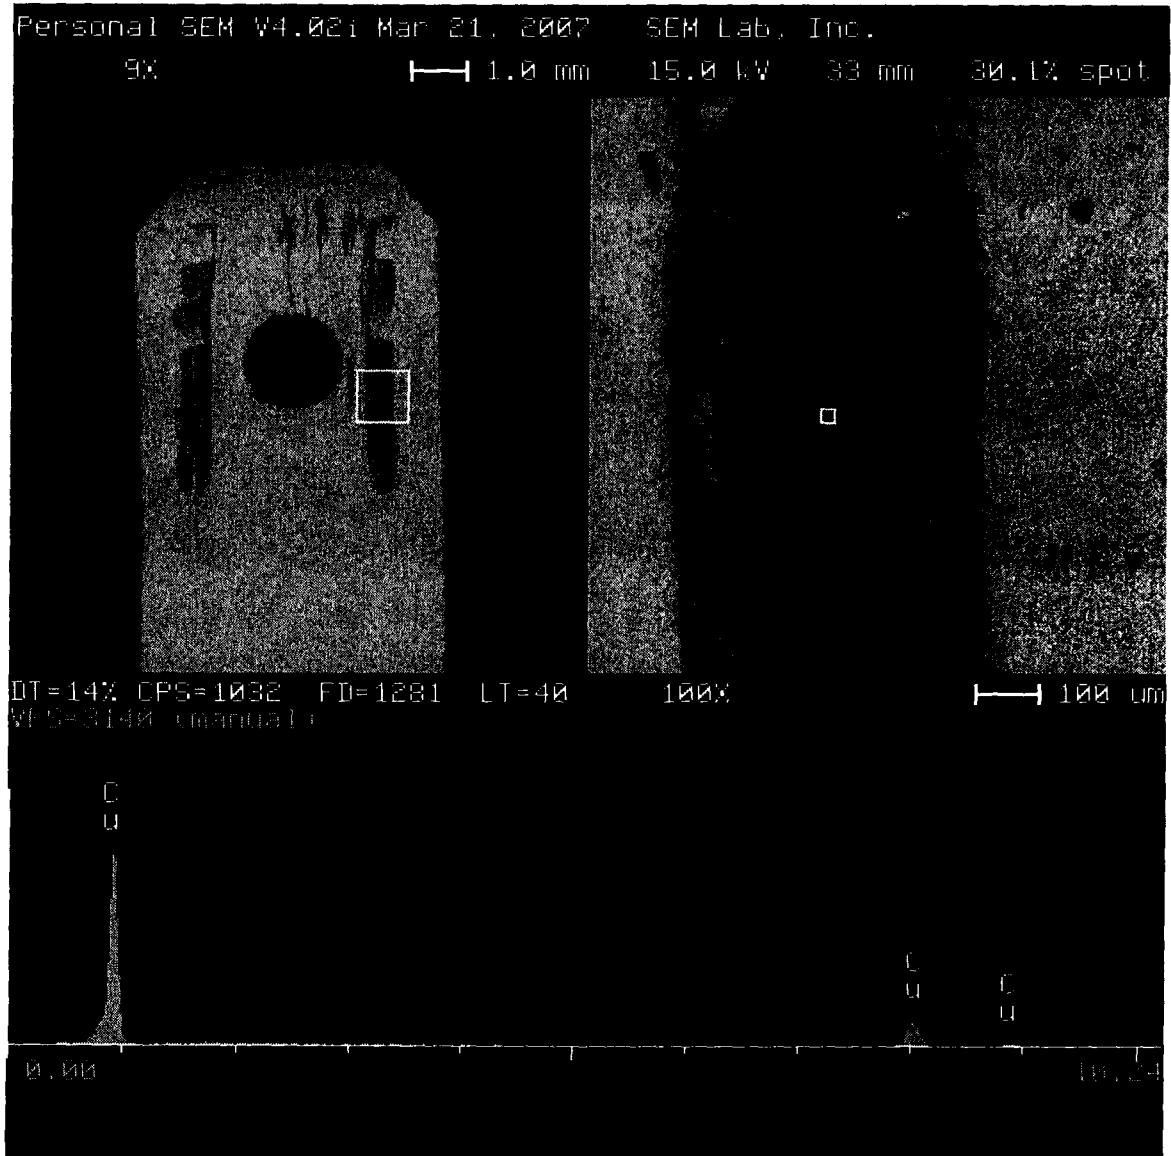
FIGURE 29: IFN 1448J\_3, Sample J – Pivot Terminal #11. This is a heavily worn area on the blade.

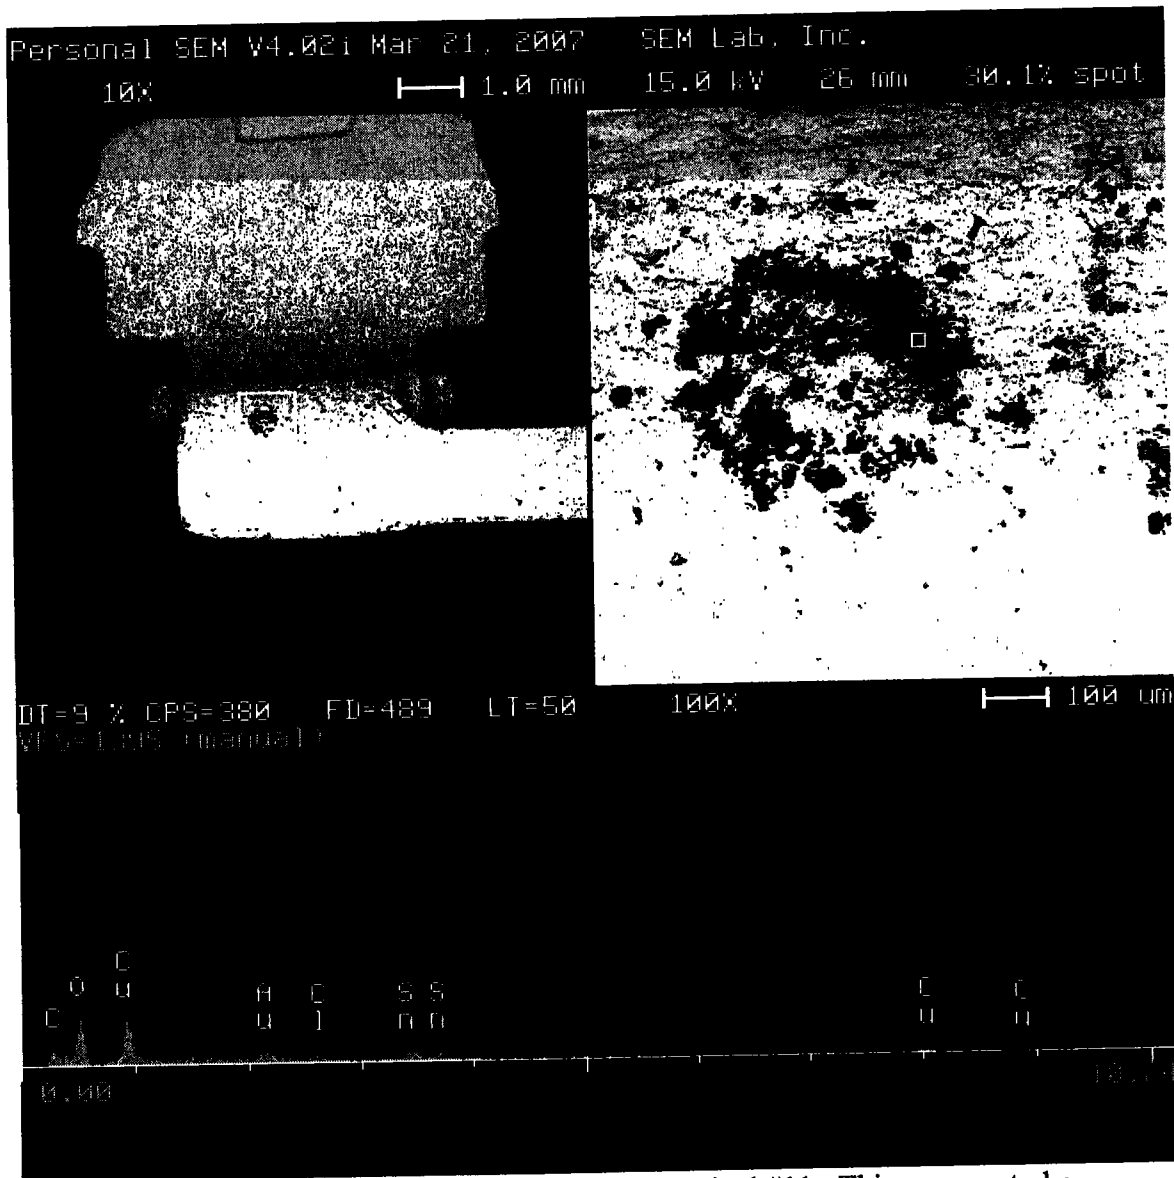
FIGURE 30: IFN 1448J\_4, Sample J – Pivot Terminal #11. This appears to be oxidized copper, salt and hydrocarbon.

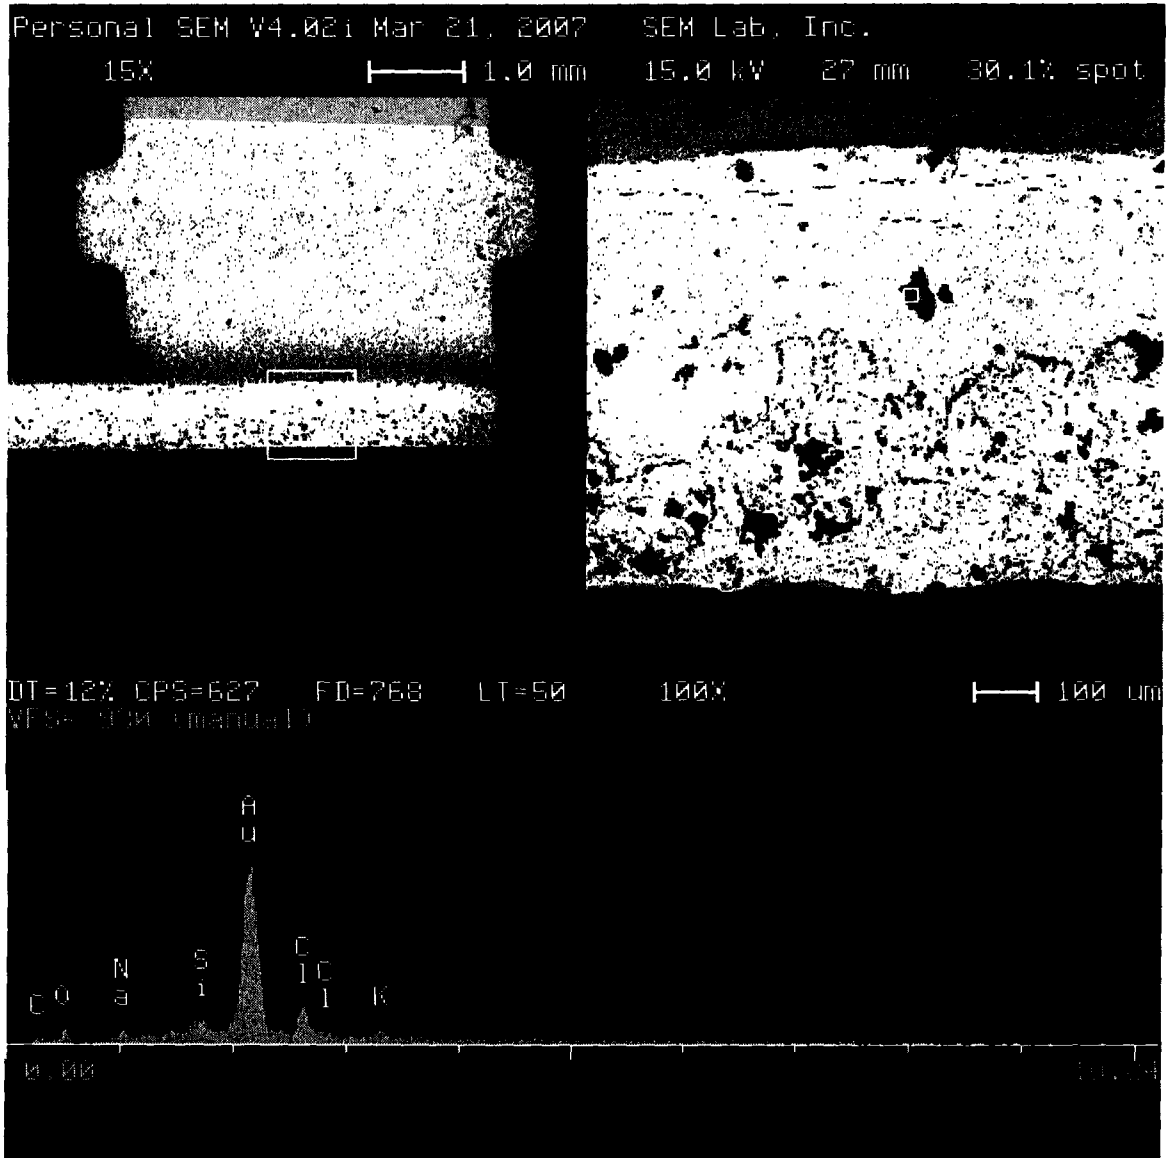
FIGURE 31: IFN 1448J\_5, Sample J - Pivot Terminal #11. This appears to be salt, silicone and hydrocarbon.

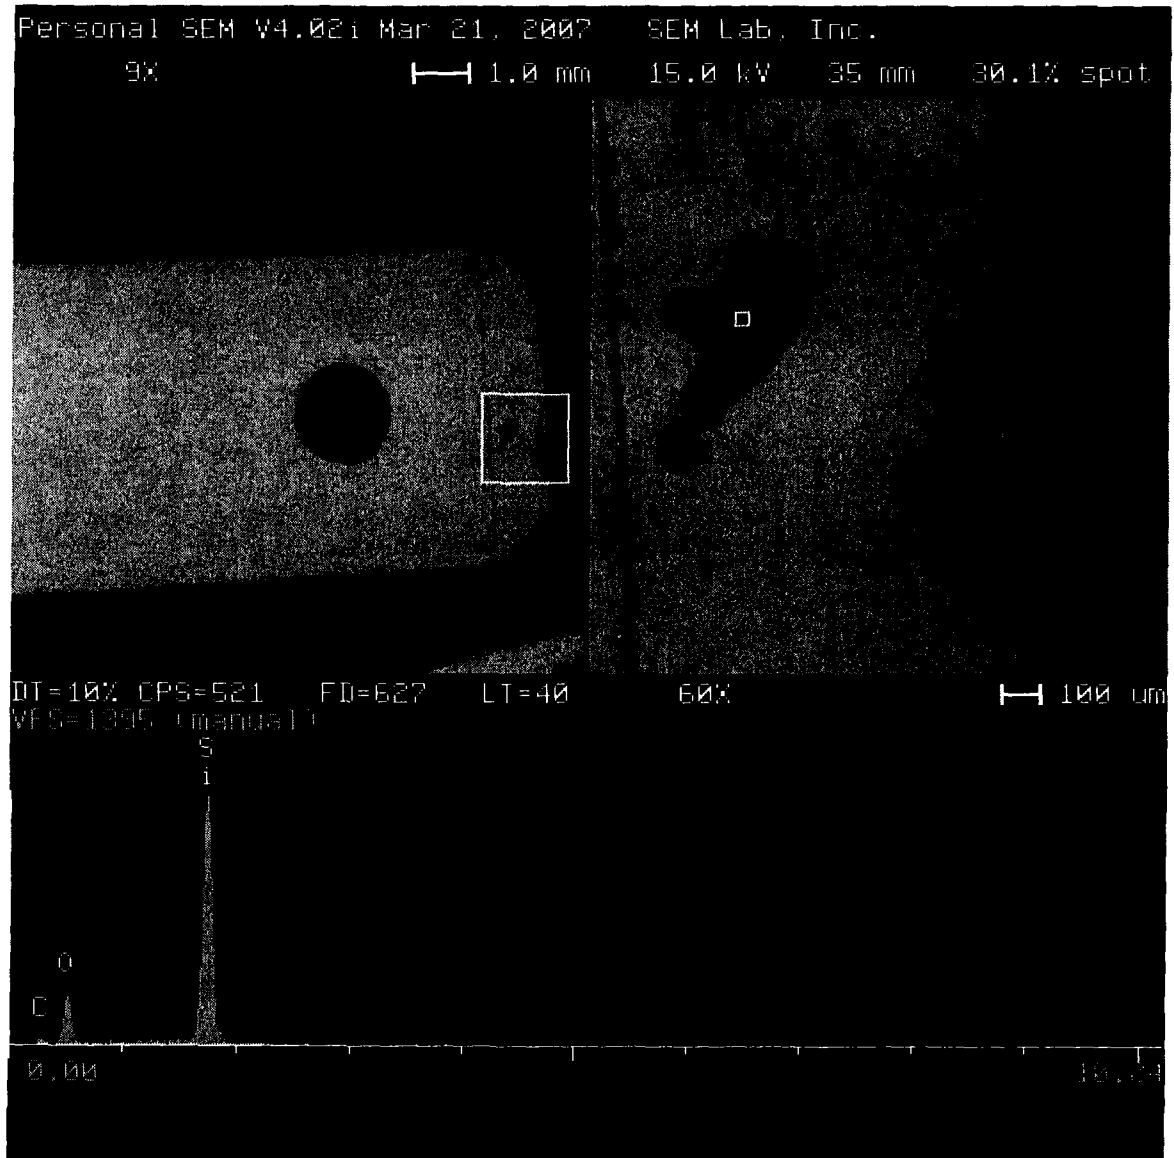
FIGURE 32: IFN 1448K\_1, Sample K – Contact Terminal #11. This is silicone.

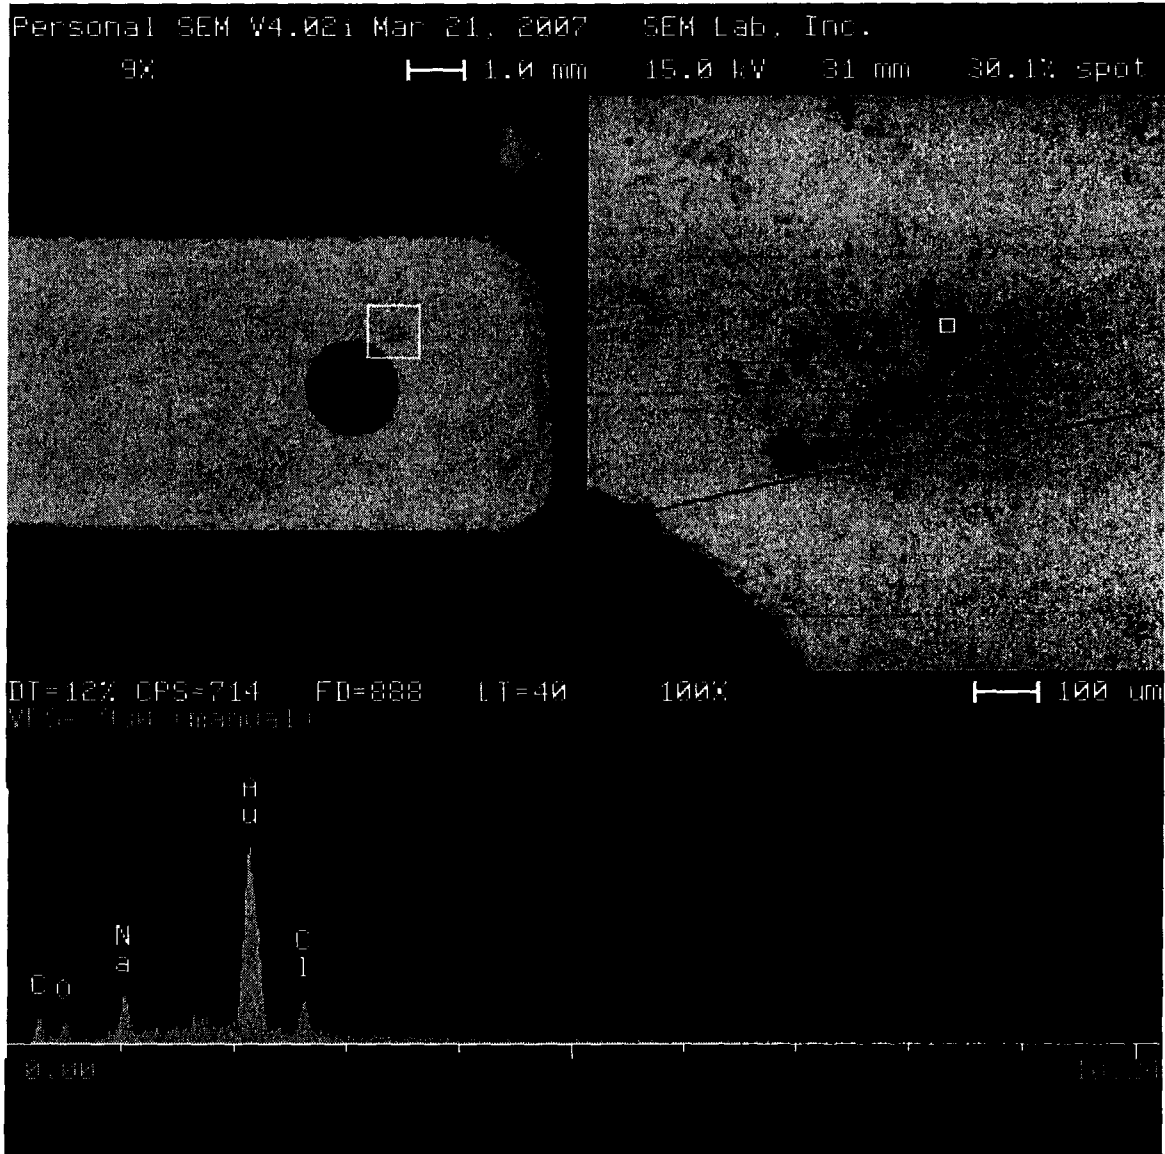
FIGURE 34: IFN 1448k\_3, Sample K – Contact Terminal #11. This appears to be salt and hydrocarbon.

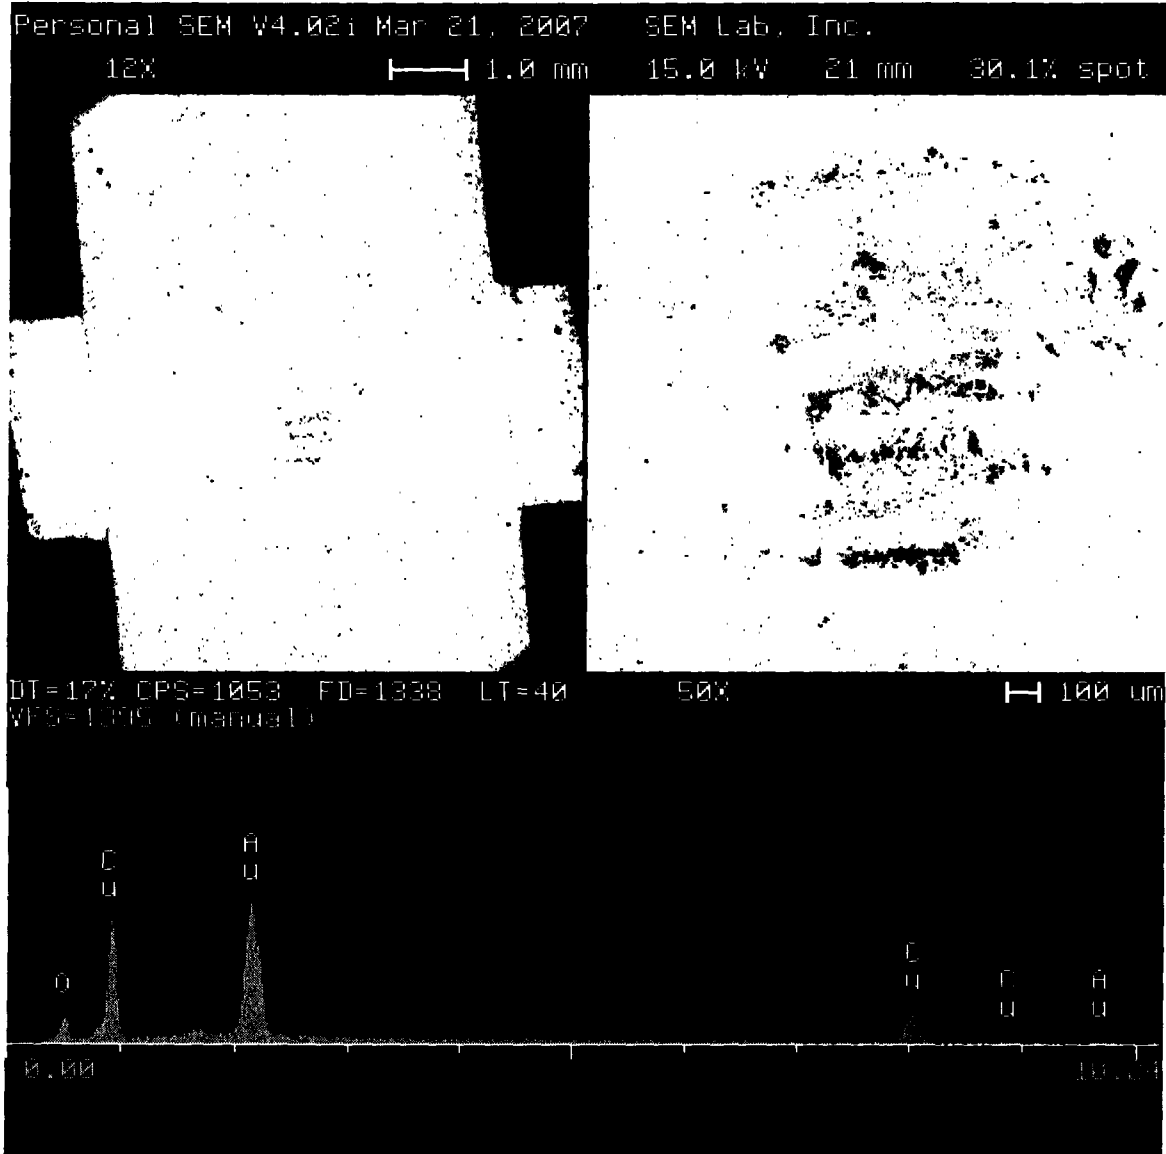
FIGURE 36: IFN 1448L\_1, Sample L – Lever #15. This is the worn contact area at the pivot point.

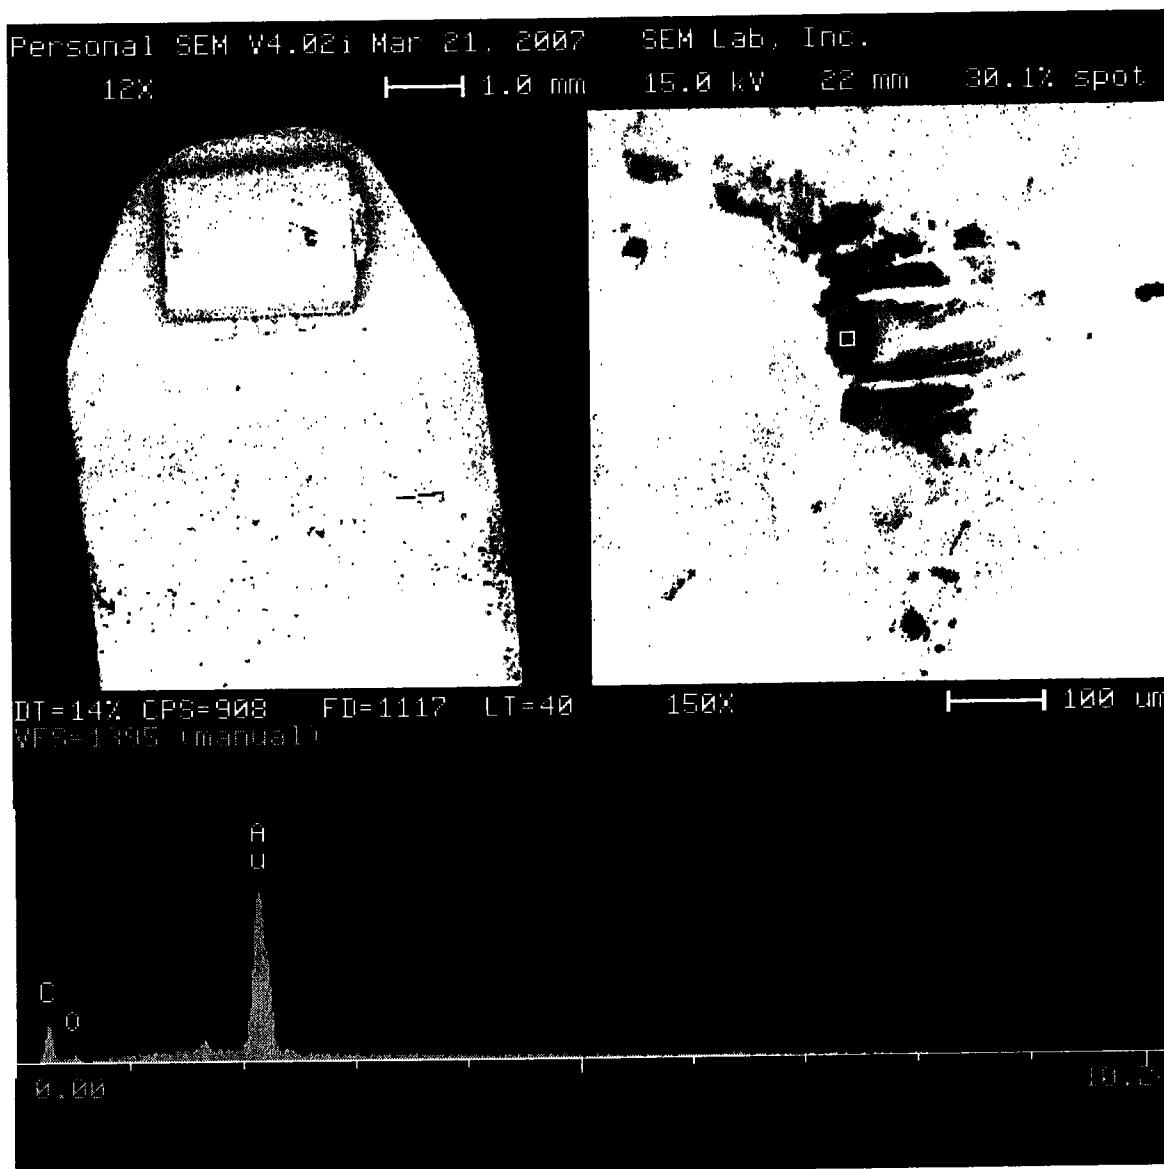
FIGURE 37: IFN 1448L\_2, Sample L – Lever #15. This appears to be hydrocarbon residue.
