**PE07-012**  
**FREIGHTLINER**  
**4/20/2007**  
**ATTACHMENT**  
**PART 1 OF 7**

Problem Ticket Report

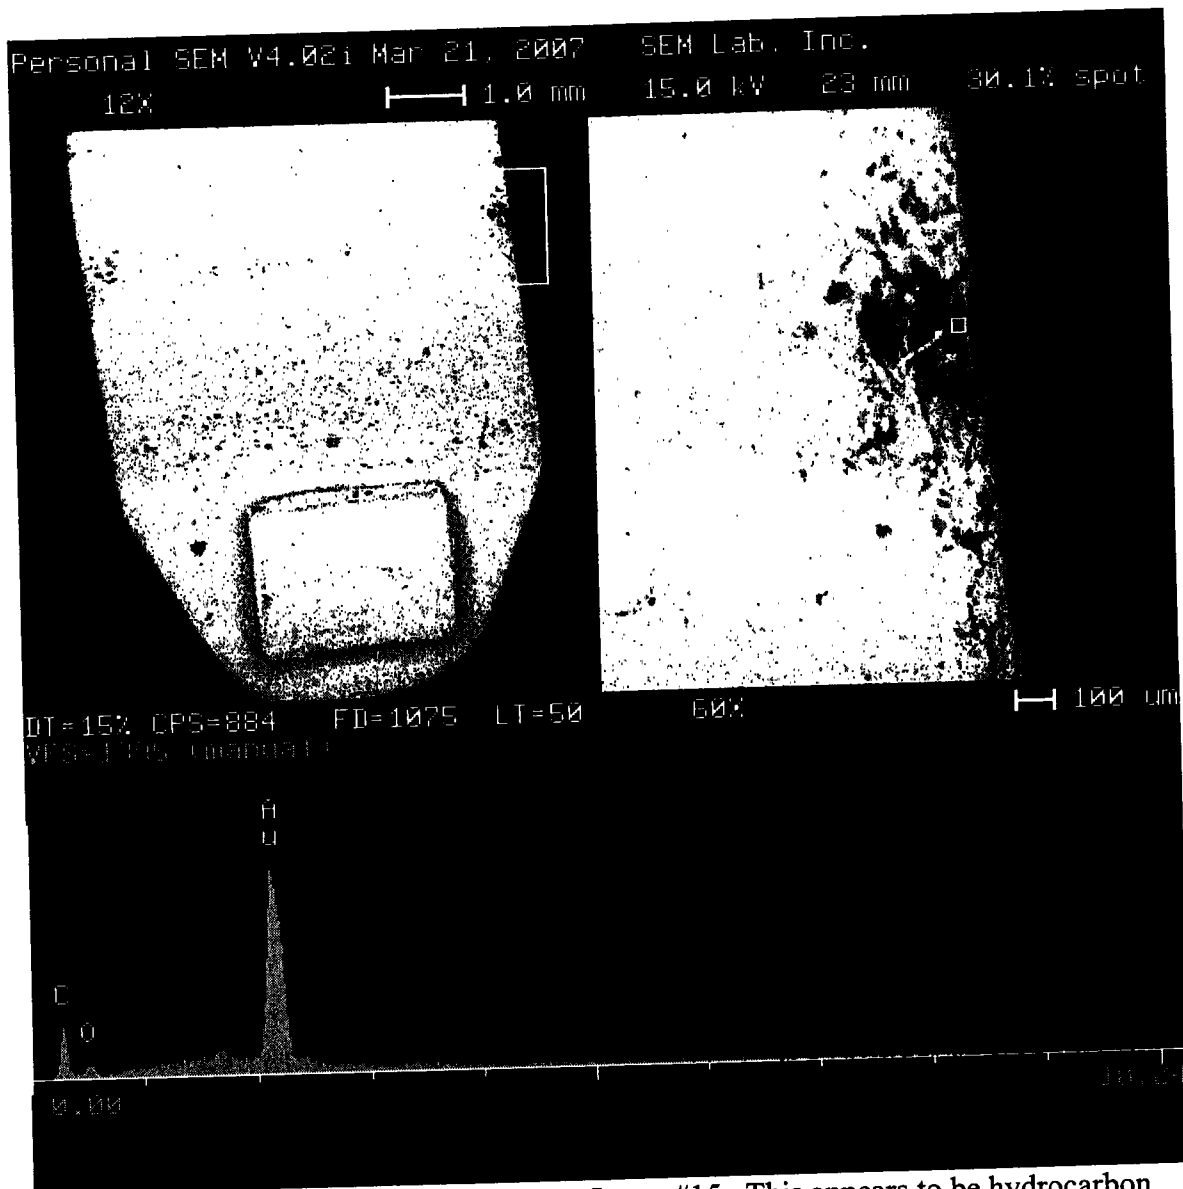
FIGURE 38: IFN 1448L\_3, Sample L – Lever #15. This appears to be hydrocarbon residue.

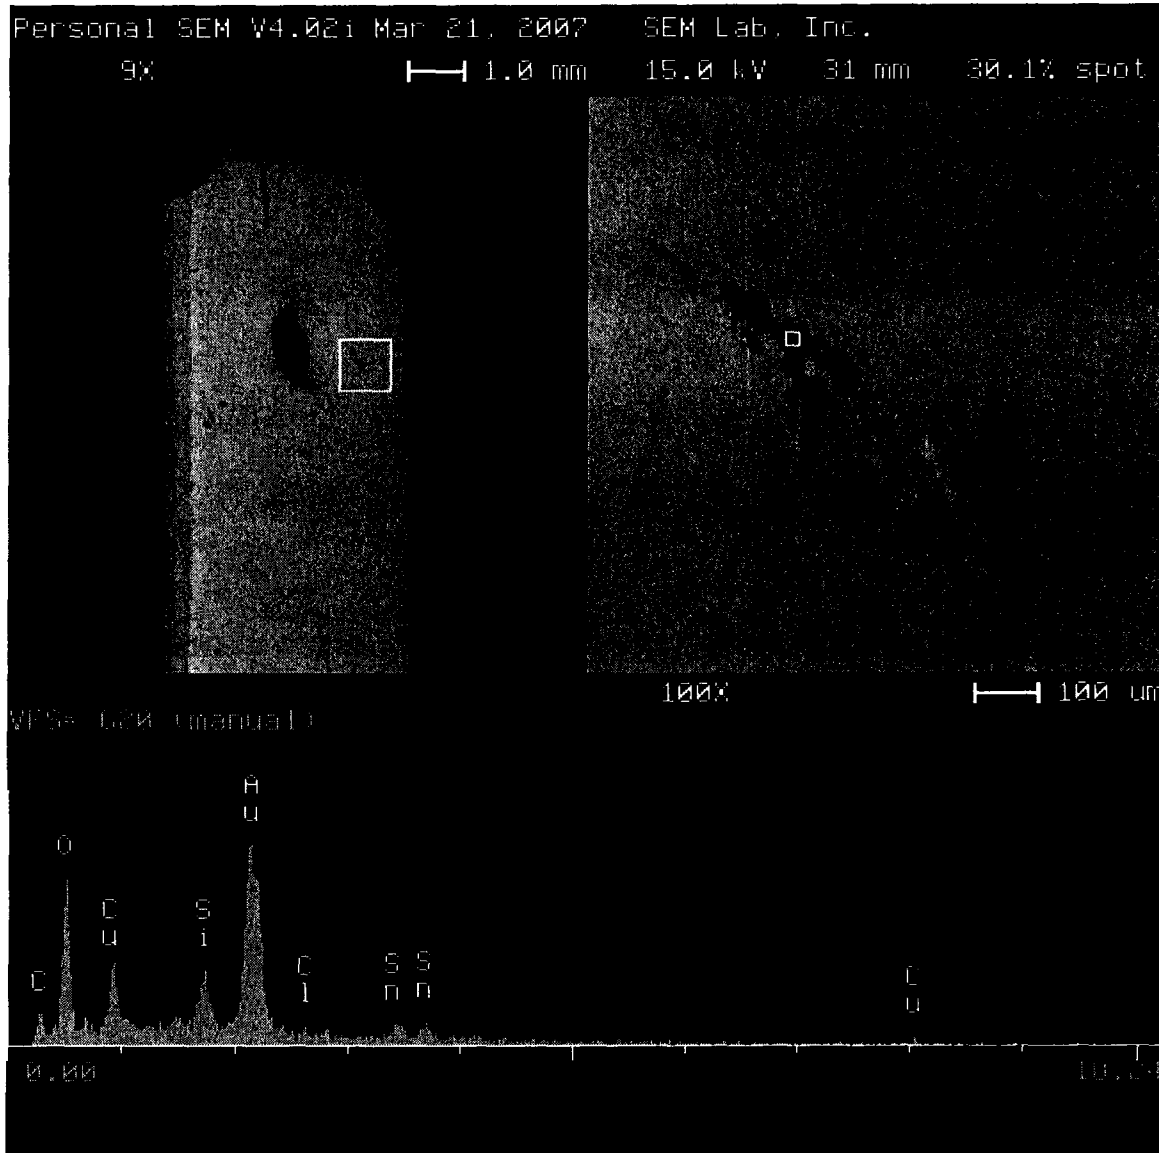
FIGURE 40: IFN 1448m\_1, Sample M – Pivot Terminal #15. This is hydrocarbon, oxidized copper, and salt.

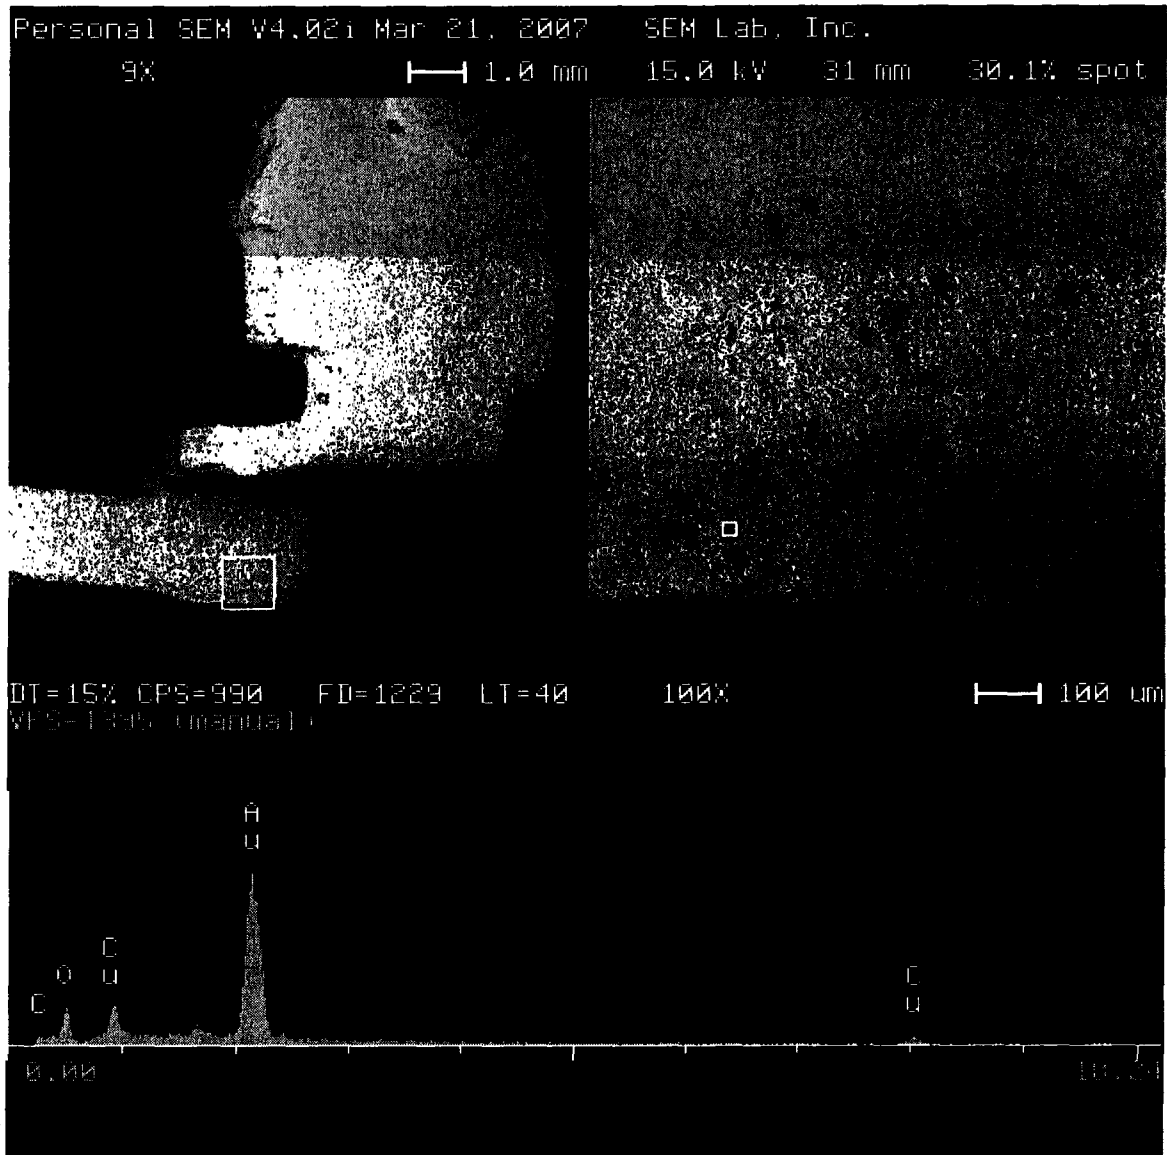
FIGURE 41: IFN 1448m\_2, Sample M – Pivot Terminal #15. There is some oxidized copper at this location.

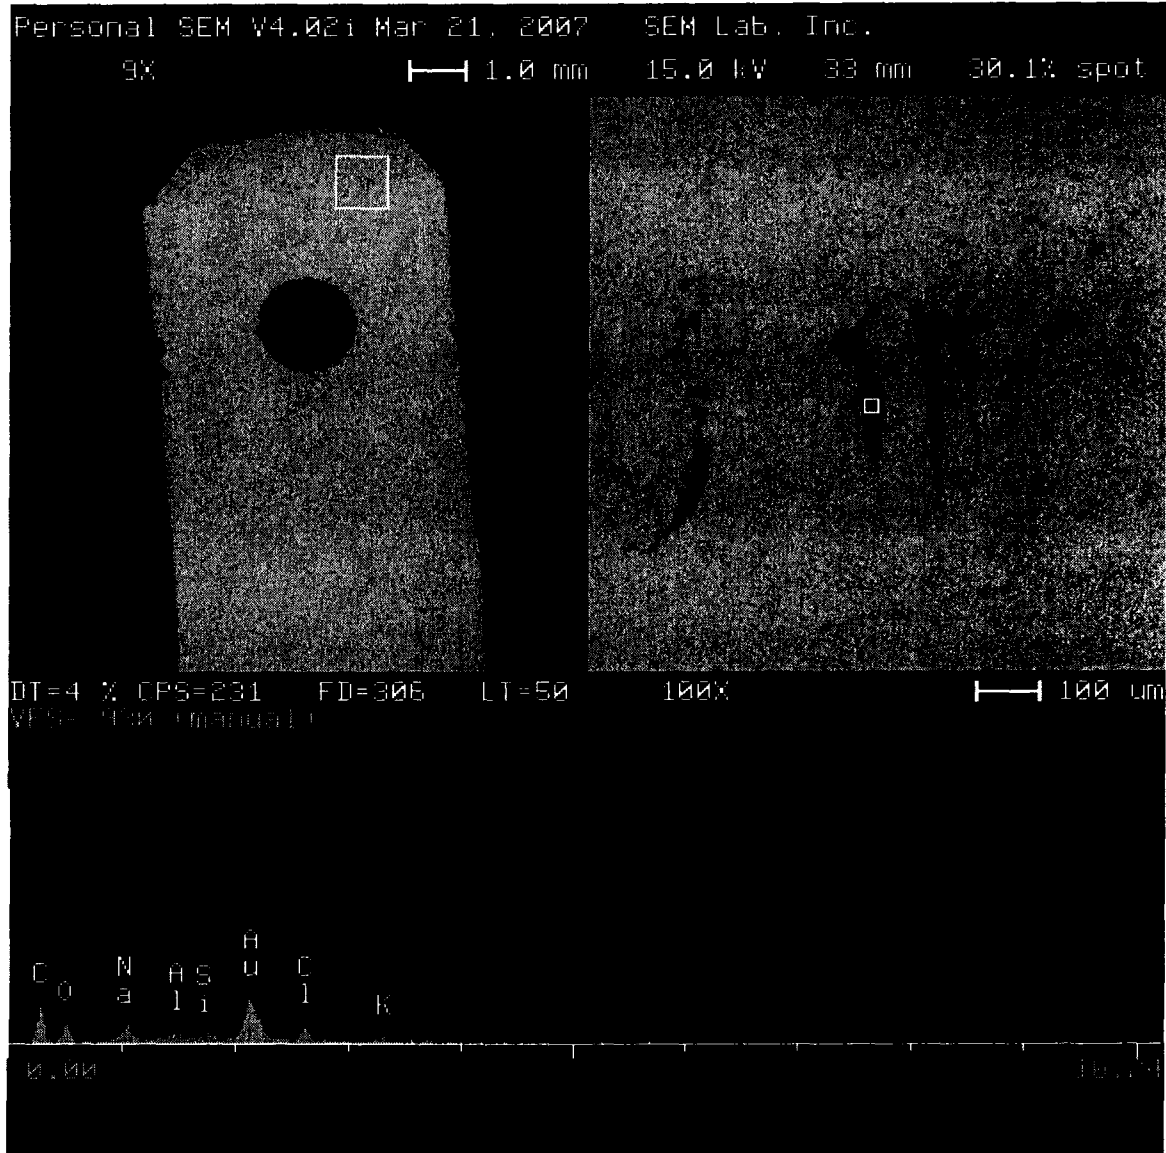
FIGURE 42: IFN 1448M\_3, Sample M – Pivot Terminal #15. This is a mix of hydrocarbon and salt.

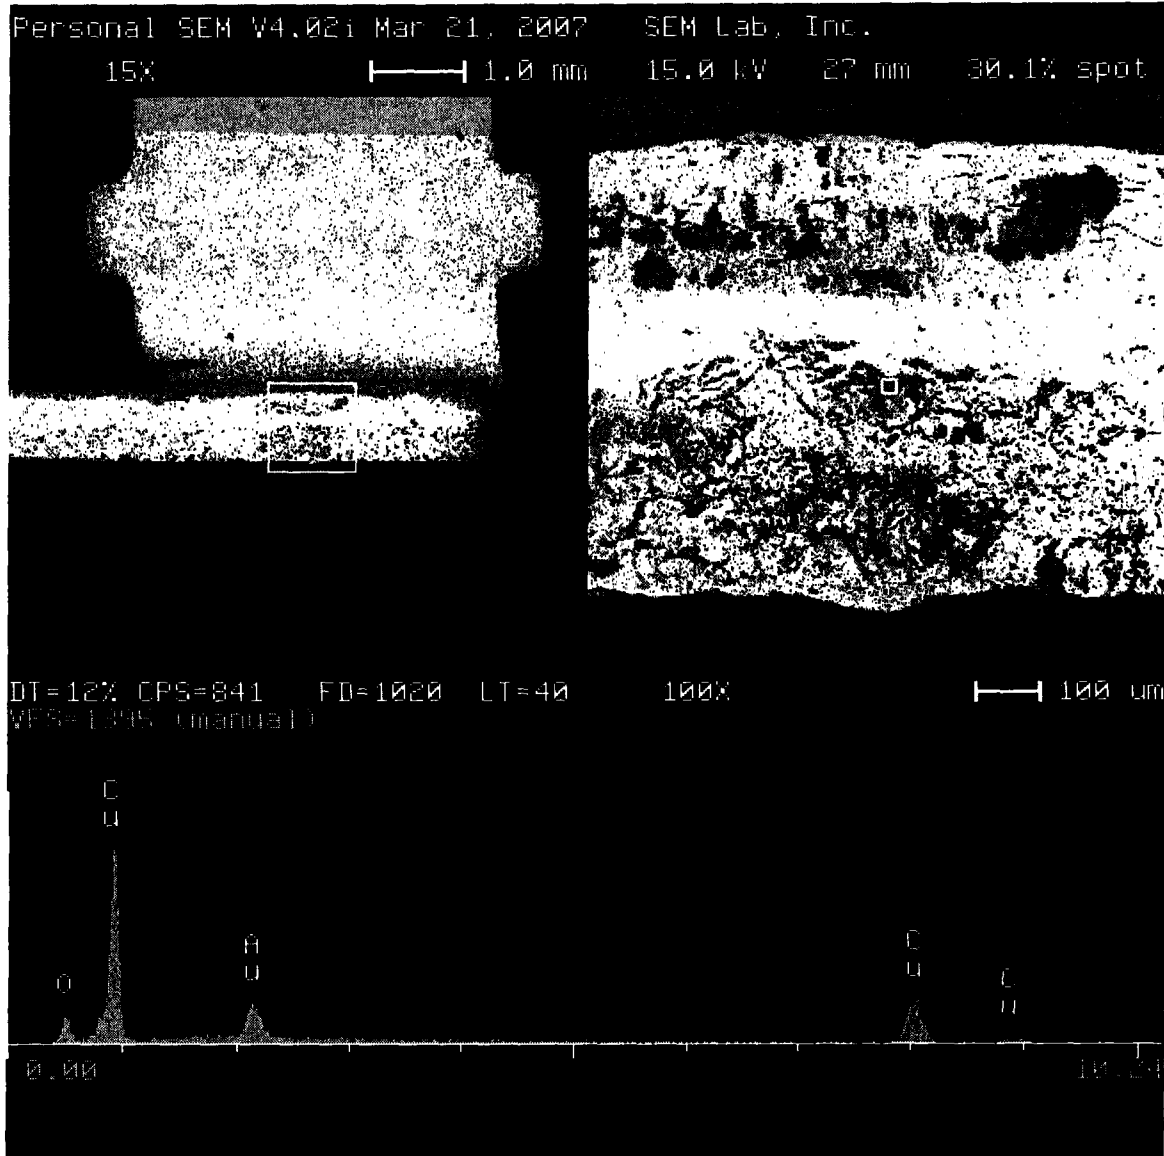
FIGURE 44: IFN 1448M\_5, Sample M – Pivot Terminal #15. This pivot contact is heavily worn.

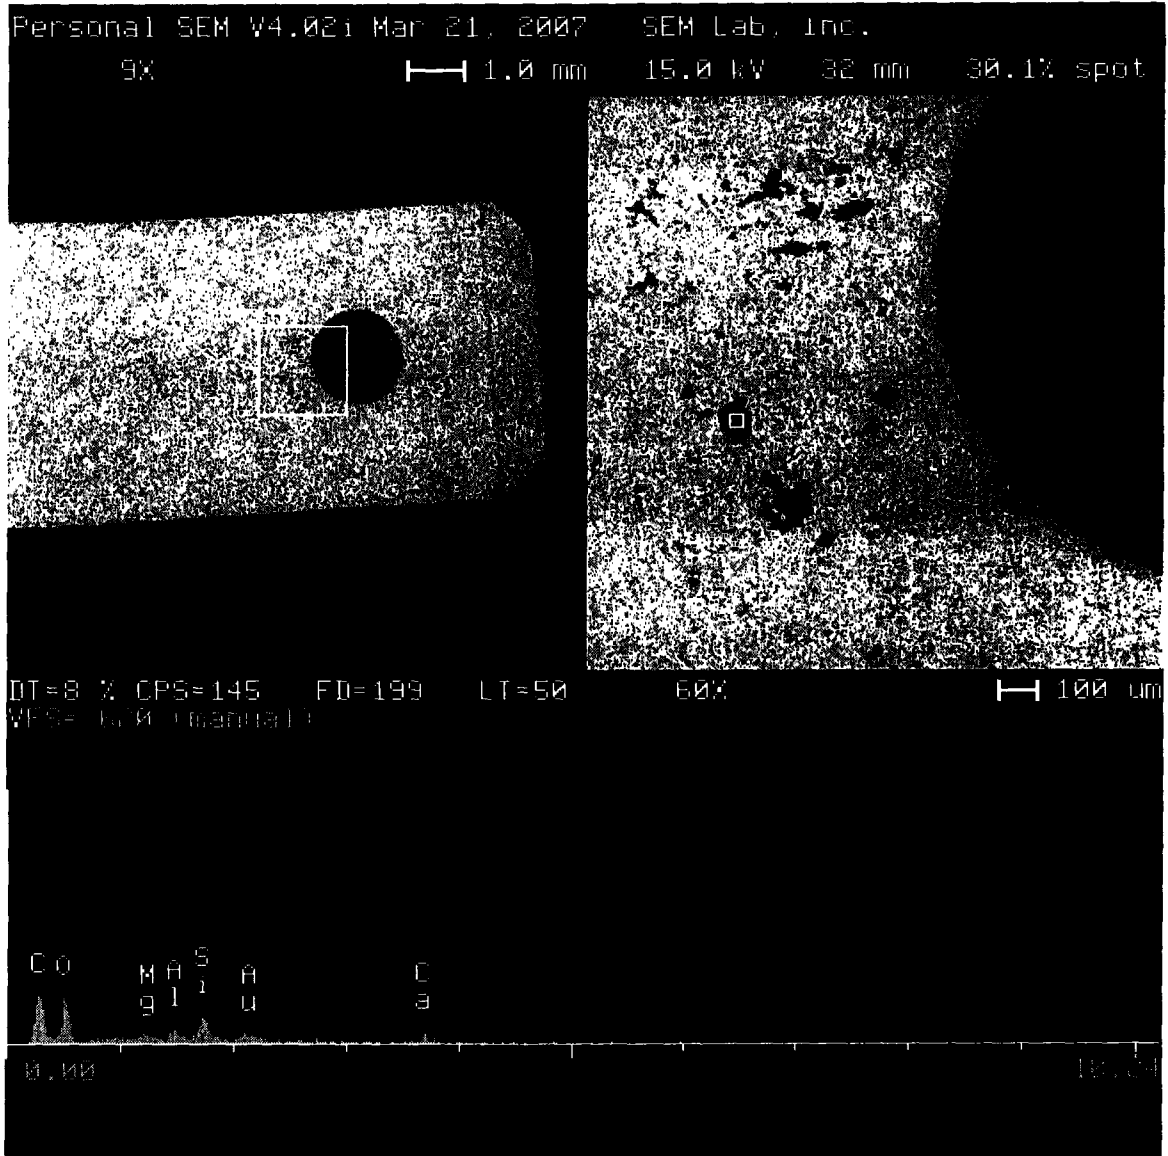
FIGURE 45: IFN 1448N\_1, Sample N – Contact Terminal #15. This appears to be a mineral or glass particle with hydrocarbon.

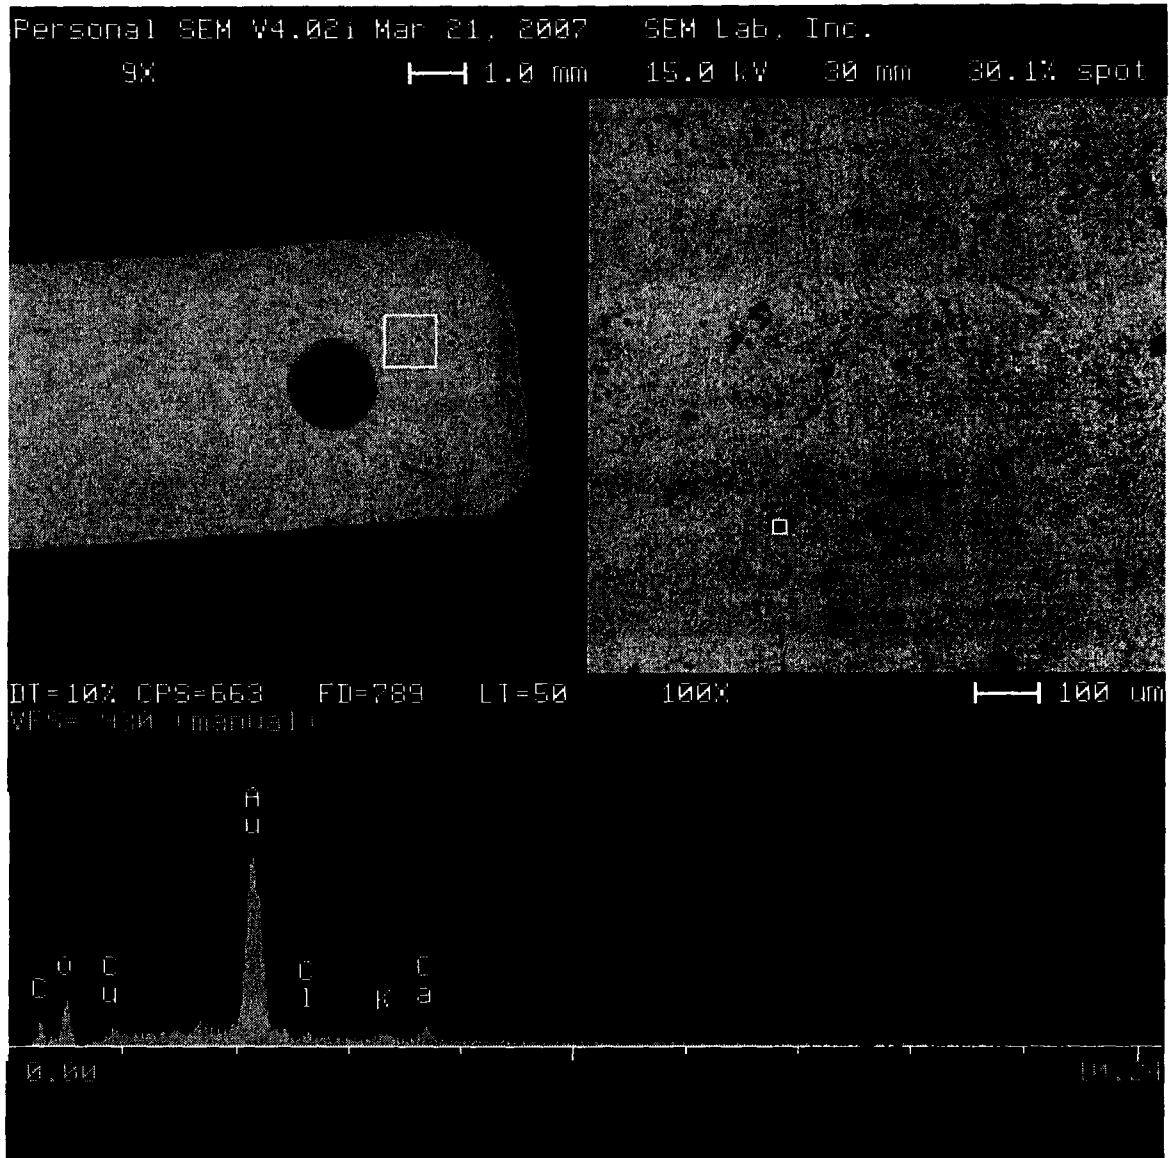
FIGURE 47: IFN 1448n\_3, Sample N – Contact Terminal #15. This blade has a thin hydrocarbon residue.
