**ORIGIN & CAUSE OF 2005 THOMAS
MVP SCHOOL BUS, CASSELMAN, ONTARIO**

Our File: 62B610
Your File: 40 332
Date of Loss: November 20, 2006
Insured: [REDACTED]

March 30, 2007

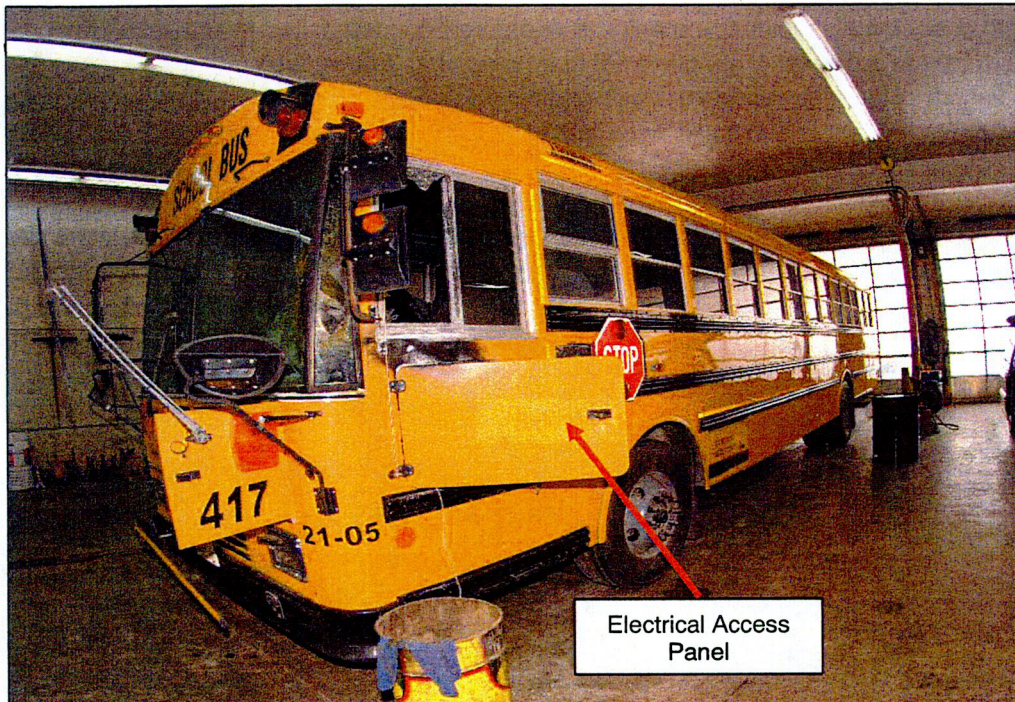
The incident vehicle was a yellow 2005 Thomas MVP School Bus (Photograph 1) and carried Ontario plate [REDACTED]. The VIN (Vehicle Identification Number) was 1T88R4E1151 [REDACTED]. This was confirmed by the data sticker attached to the overhead panel above the front windshield.

Photograph 1 – Front left wide⁴ angle view of the 2005 Thomas school bus

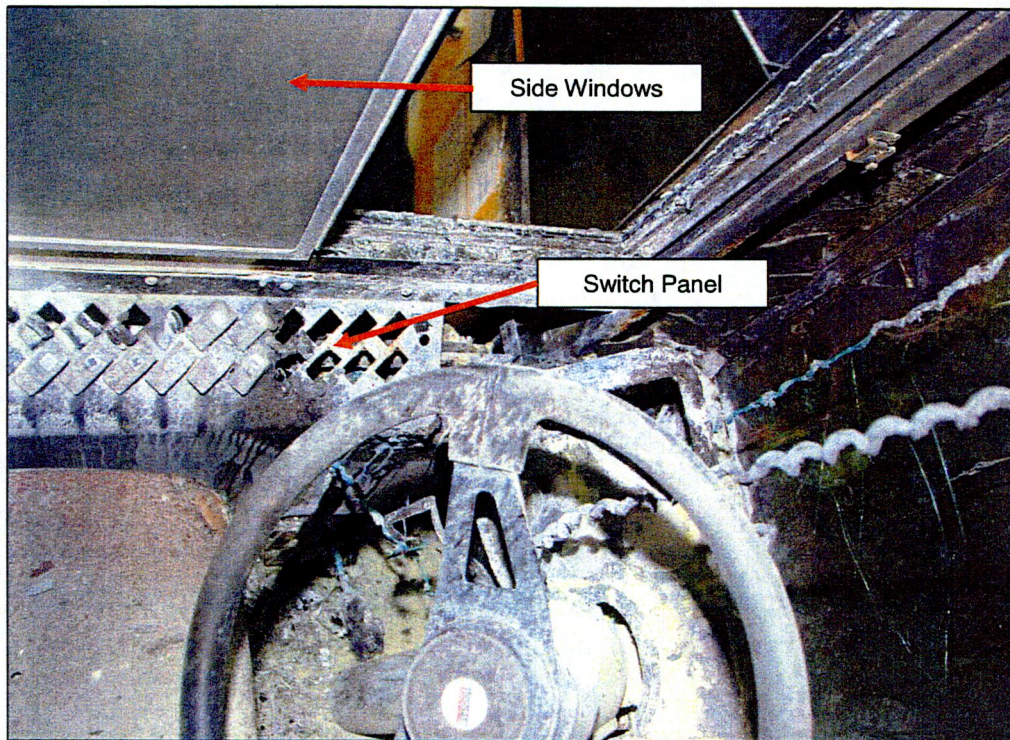
The fire propagated to the driver's compartment below the left side window frame, through the electrical switch panel (Photograph 2). There was minimal damage to the floor area below, the seat beside, or to several of the switches towards the rear of the panel which further supported that entry location. The fire also propagated to the left side of the dash board but was suppressed at that point, likely due to the use of the fire extinguisher.

Photograph 2 – Looking down at switch panel showing forward biased fire propagation

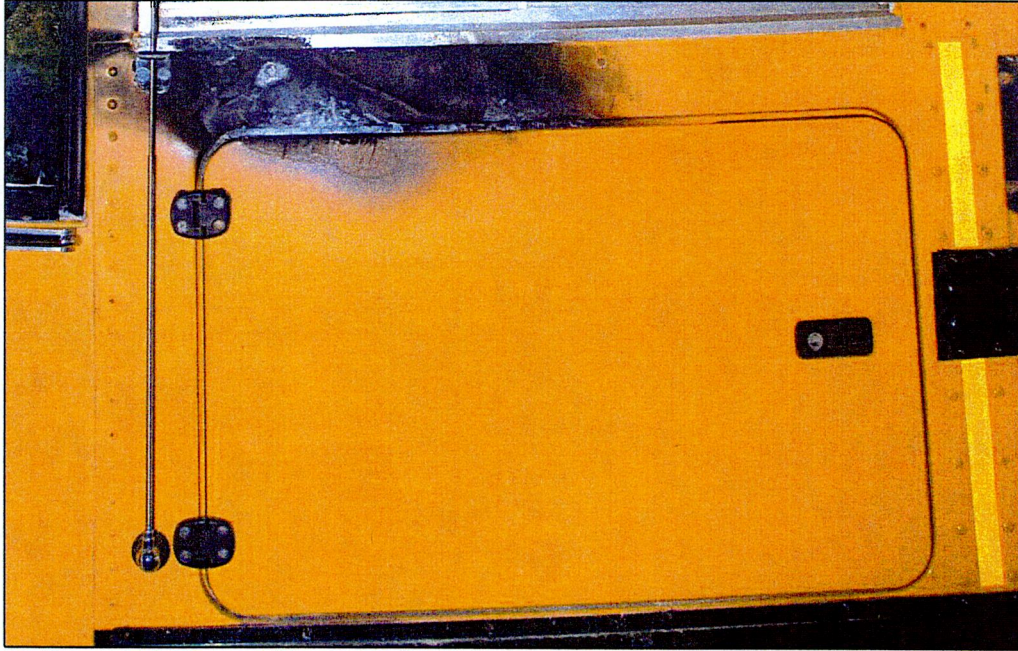
Closer examination of the fire consumption damage sustained by the Thomas Built Bus revealed that the majority of the damage was contained within the front left electrical panel cavity. There was also evident fire and heat impingement displayed on the external body panels (Photograph 3 and 4).

Photograph 3 – View of the left top corner of the access panel (closed)

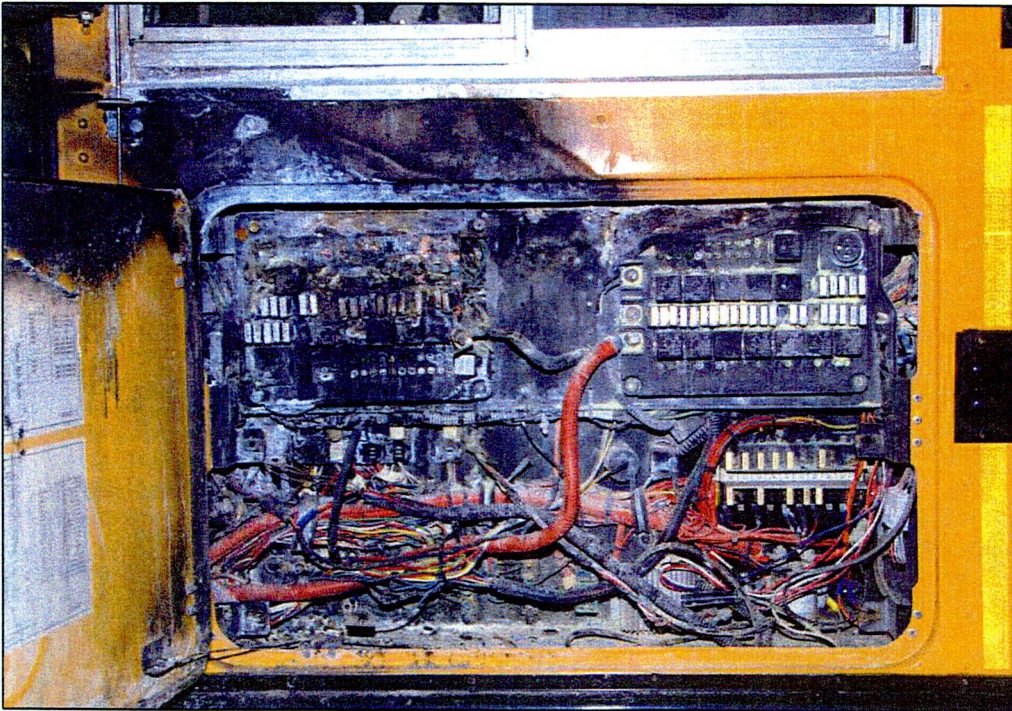
Photograph 4 – View of the left top corner of the access panel (opened)

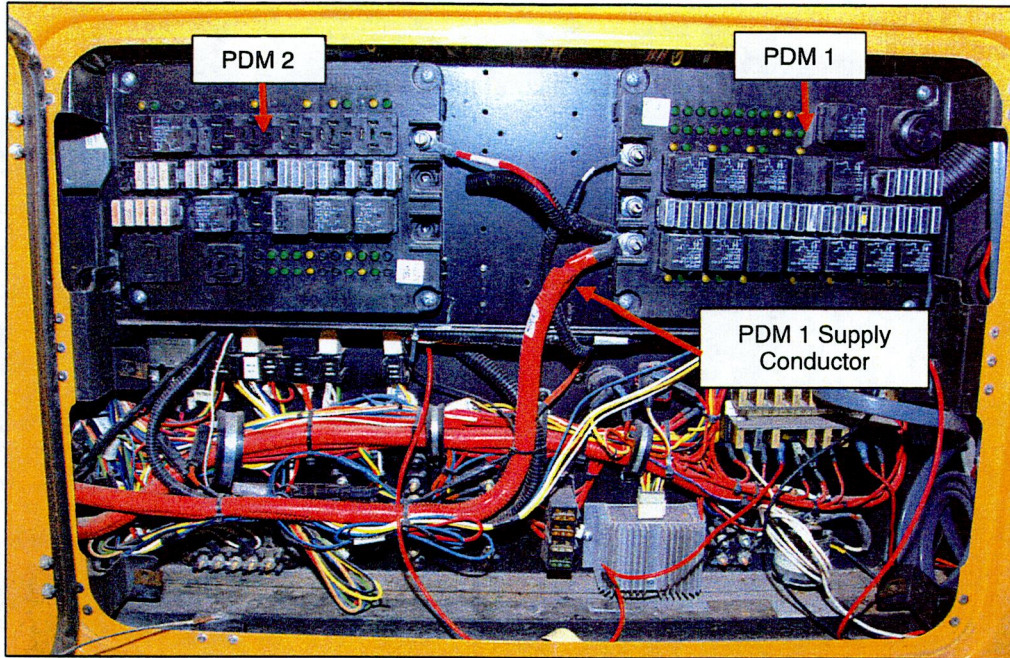
Contained within the electrical access panel were Power Distribution Modules (PDMs). PDM 1 was located at the rear and PDM 2 was located at the front (Photograph 5). The two PDM panels were used to distribute electrical power to the various vehicle branch circuits while at the same time providing overload protection using electrical relays, fuses, and breakers.

Photograph 5 – Exemplar view of PDM 1 and PDM 2

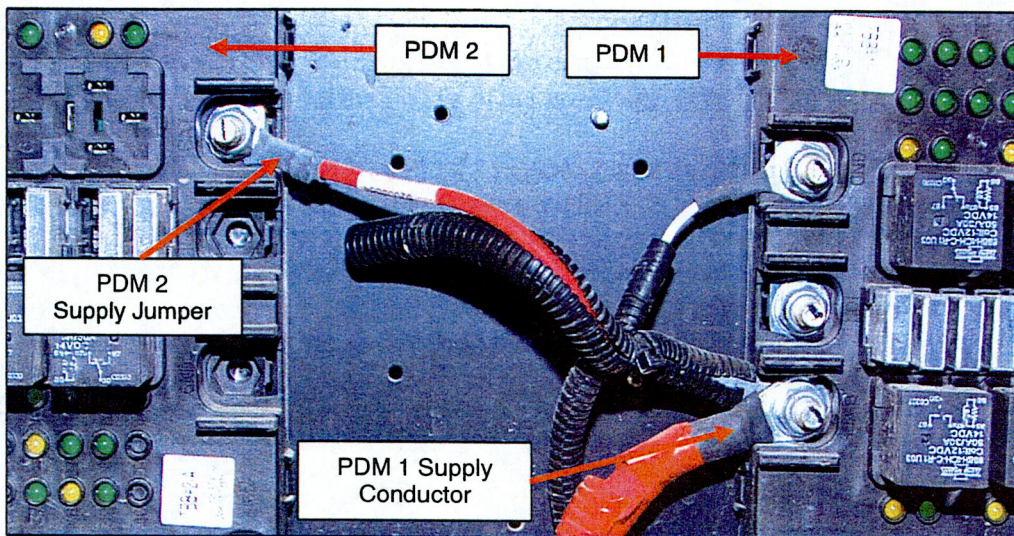
PDM 1 was energized by a heavy gauge, stranded conductor routed from the main electrical distribution panel at the front of the vehicle. The heavy gauge supply conductor was protected by a 150 amp circuit breaker mounted on the chassis circuit breaker block, located on the main electrical panel. PDM 2 was energized by a lighter gauge electrical jumper routed from the PDM 1 input terminal post (Photograph 6).

Photograph 6 – Exemplar view of jumper wire powering PDM 2 from PDM 1

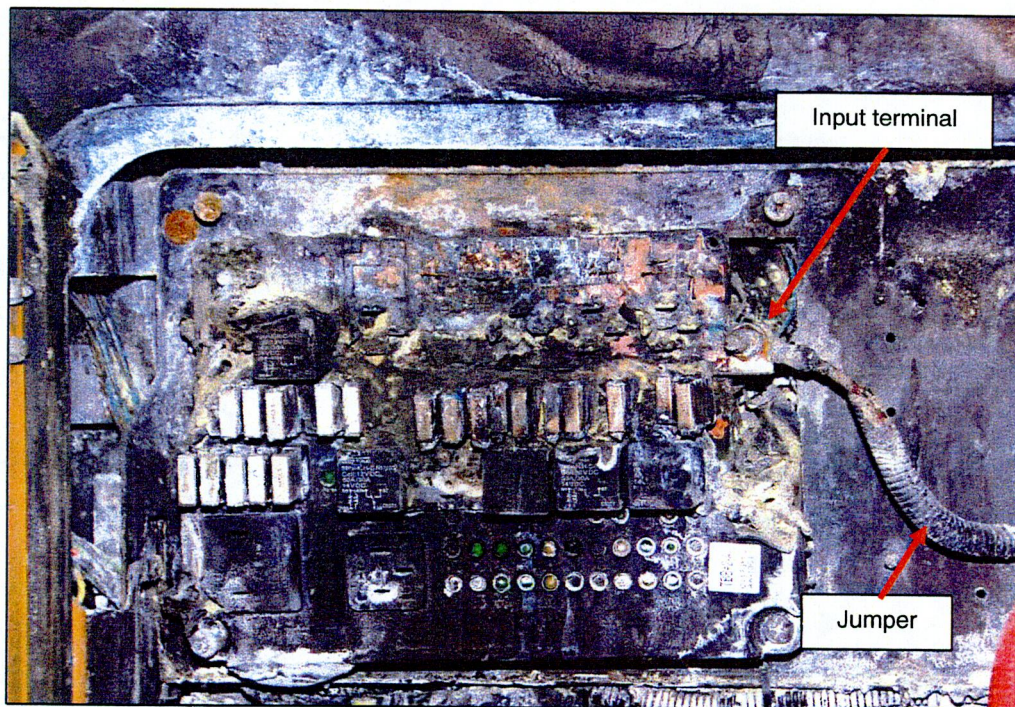
There was greater damage to PDM 2 than PDM 1 with the damage originating in the area of the electrical input terminal on PDM 2 (Photograph 7). There was an evident fire pattern that extended from the input terminal area on PDM 2 upwards into the cavity space above the board.

Photograph 7 – Looking at PDM 2 showing fire patterns rising from circuit board

There was evidence of prolonged burning above PDM 2 as witnessed by the oxidation of the metal in that area. Further, the plastic used to cover the panel had suffered fire consumption damage from the middle of the board upwards.

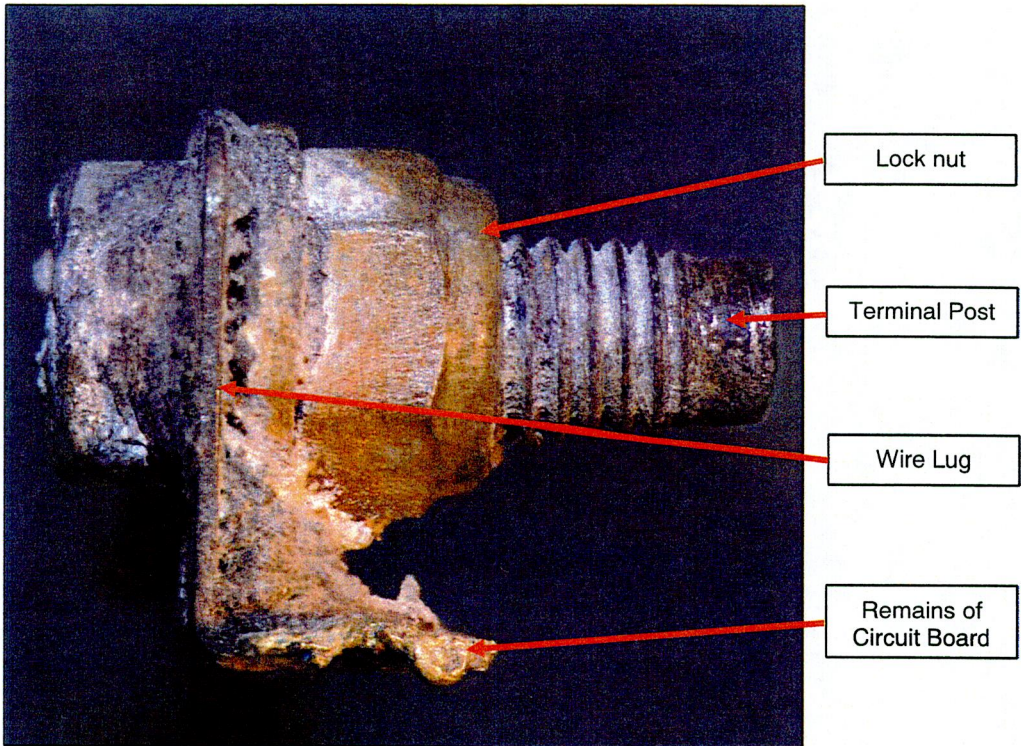
The electrical jumper cable from PDM 1 to PDM 2 was detached at the PDM 2 end. The terminal post, normally mounted to the medial side of PDM 2, had broken free of the board and was still secured to the lug at the end of the conductor. The copper conductor trace⁸ from PDM 2 was still attached to the terminal post and exhibited signs of overheating and separation (Photograph 8). In addition, the copper circuit on the PDM 2 board exhibited similar characteristics (Photograph 9).

Photograph 8 – Close-up view of the PDM 2 terminal connector with melted copper trace

In our opinion, the cause of the fire was electrical in nature due to the overheating of the Body Power Distribution Module Number 2 (PDM 2) due to the thinness of the copper input circuit on the board. The PDM 2 input power connector likely partially separated from the board creating a high resistance connection thereby heating the surrounding components to the point of ignition. The physical observations found at the end of the terminal connector and the circuit board were indicative of an overheating situation.

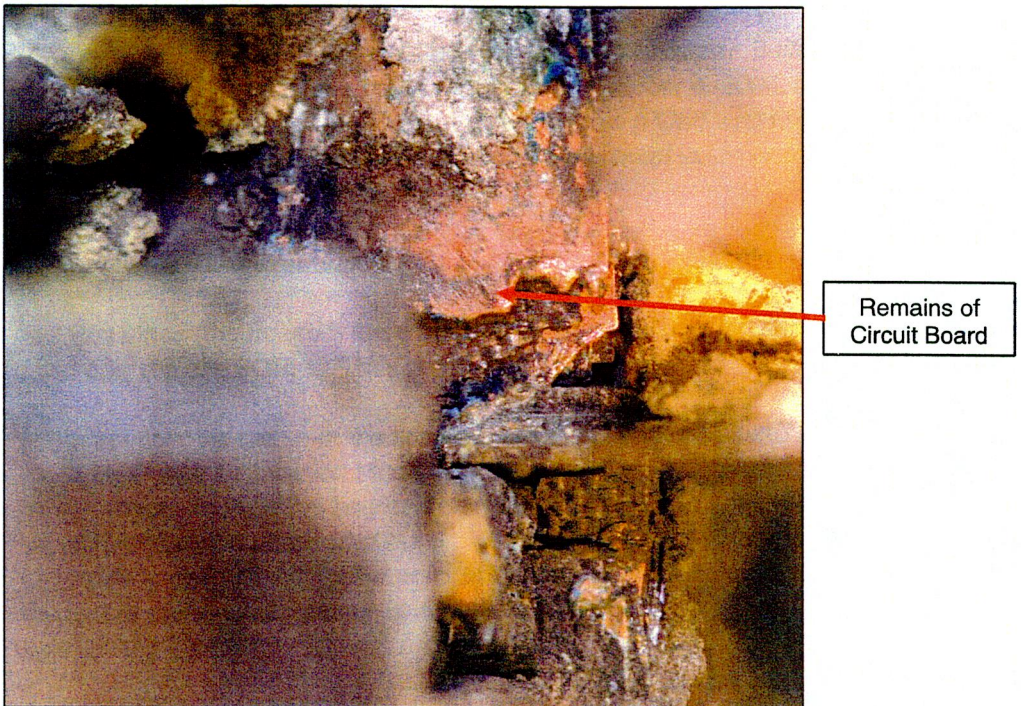
Photograph 9 – Close-up view of the PDM 2 circuit board showing melted copper trace
