PE07-029

RE: Model FS-65 Recall - Electrical Boards

(Fire in 2004 Freightliner Custom Chassis FS65
model K000042S/Thomas Built 69-passenger
school bus while the vehicle was being driven.)

Our Project No. 07-5742-FV

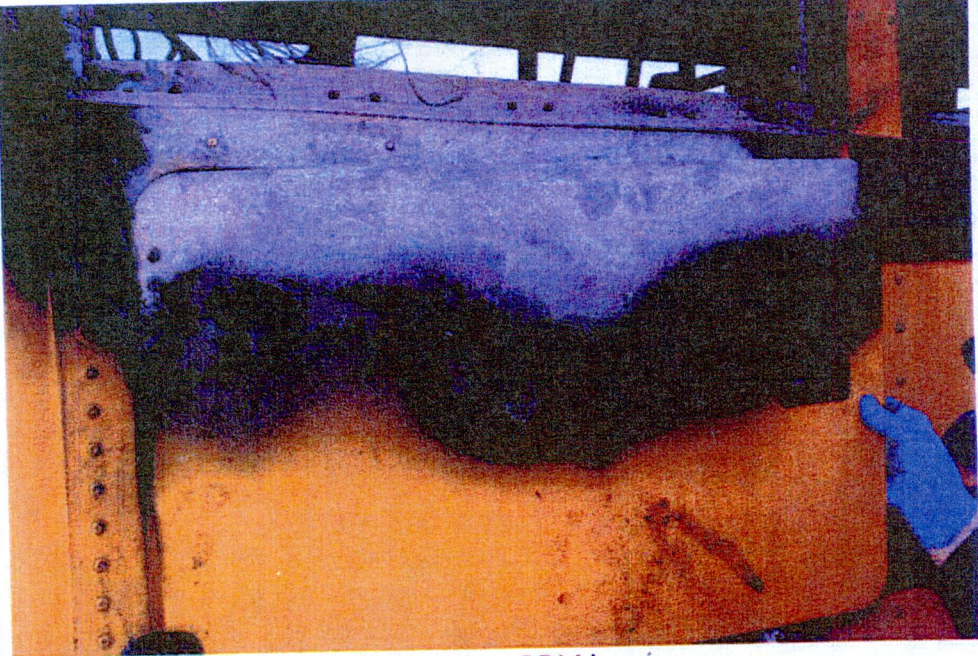
Photo No.	Description
1

<p>This photo shows cover panel in place over PDM location.</p>
2

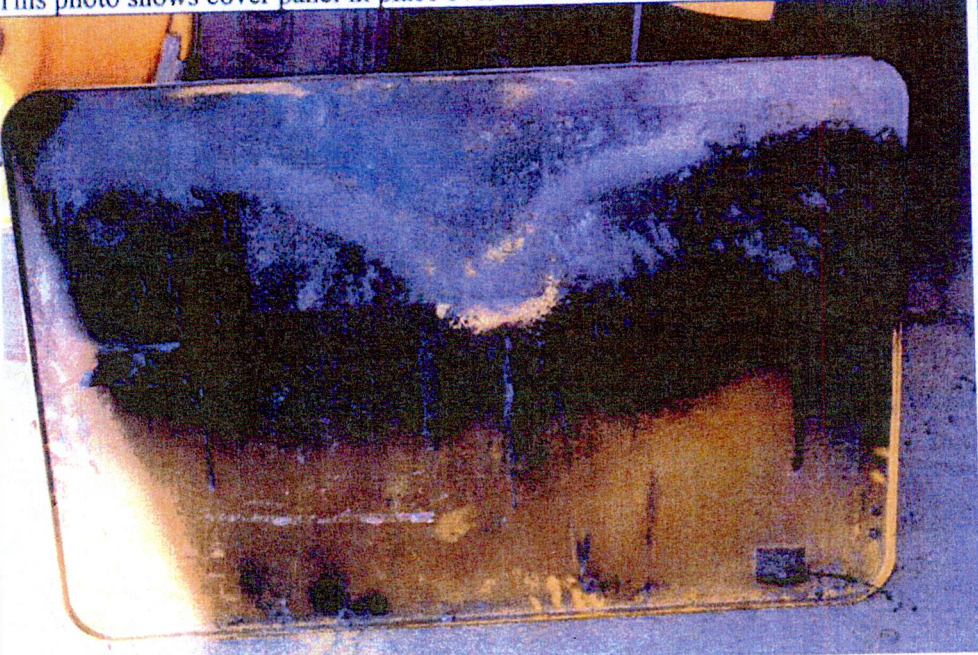
<p>This photo shows inside of PDM cover panel.</p>

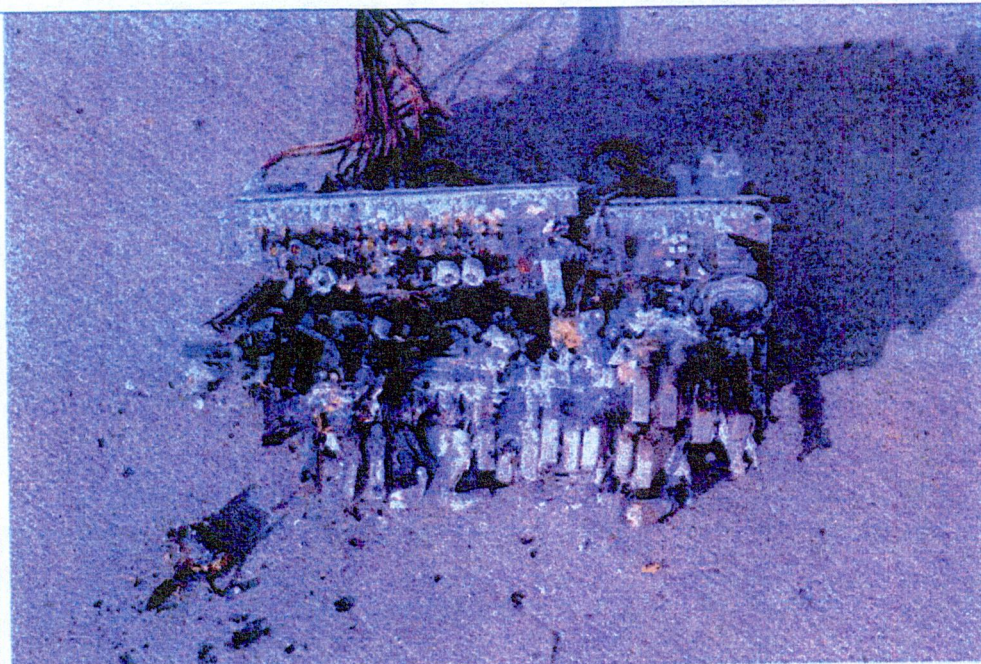
5

This photo shows removed PDM on concrete parking surface by bus.

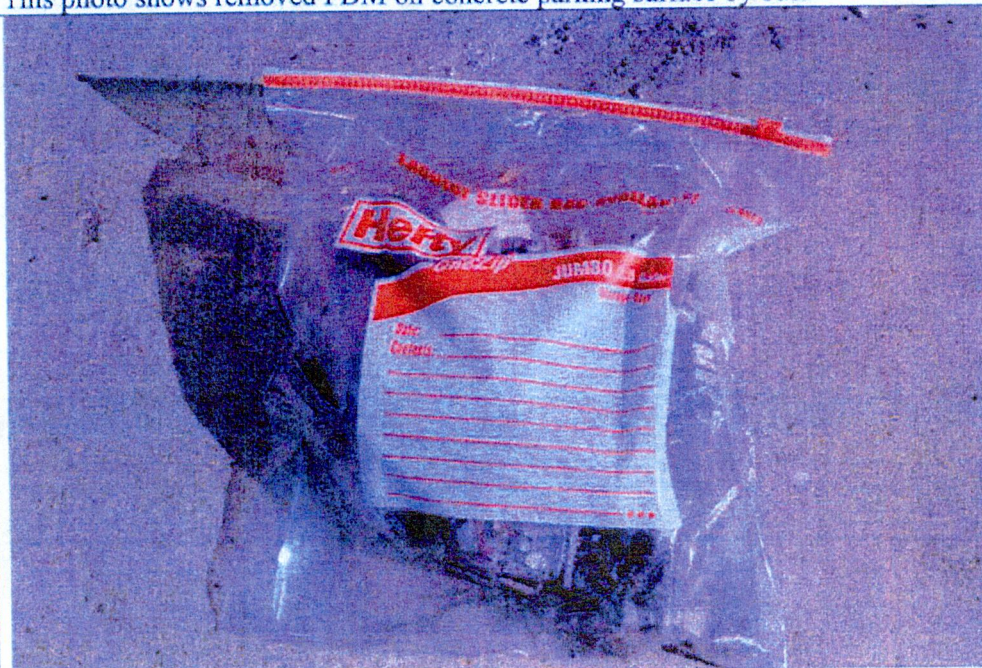
6

This photo shows PDM in evidence bag.

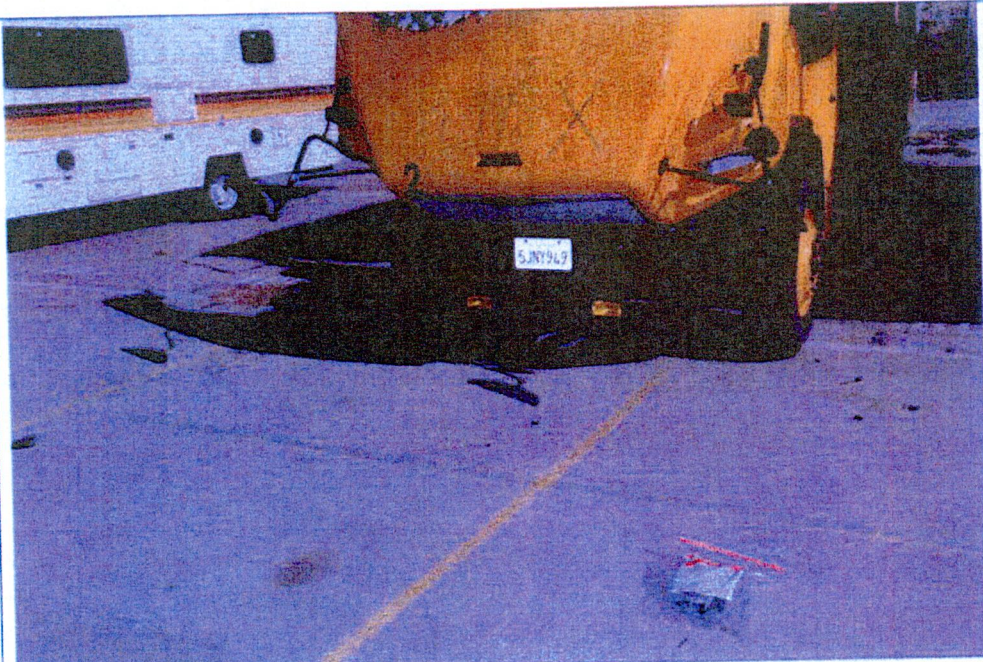
7

This photo shows evidence bag location relative to the bus.

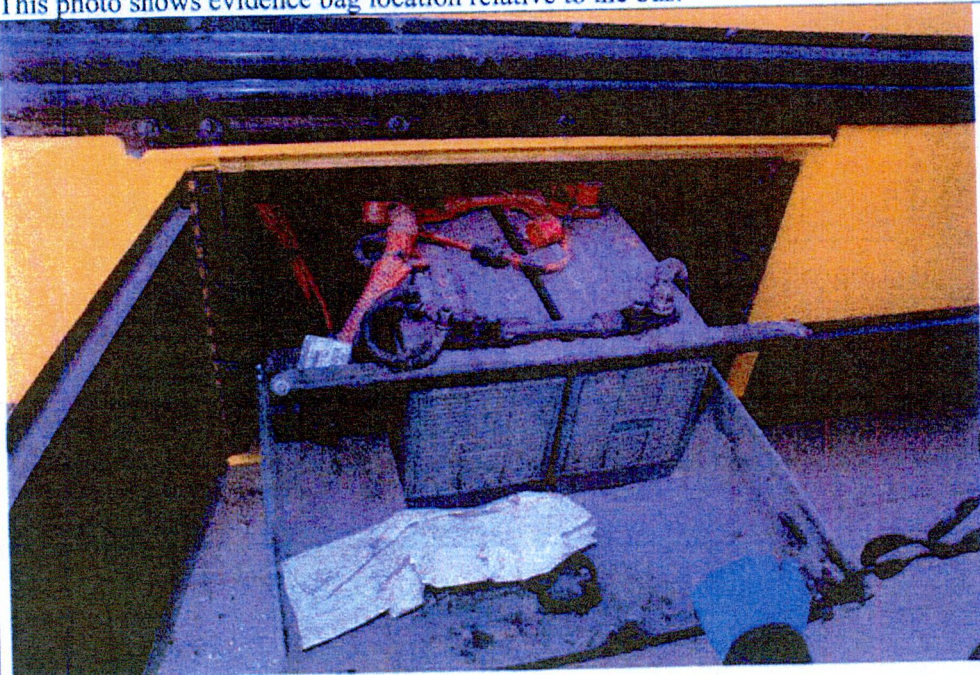
8

This photo shows bus batteries, still connected.

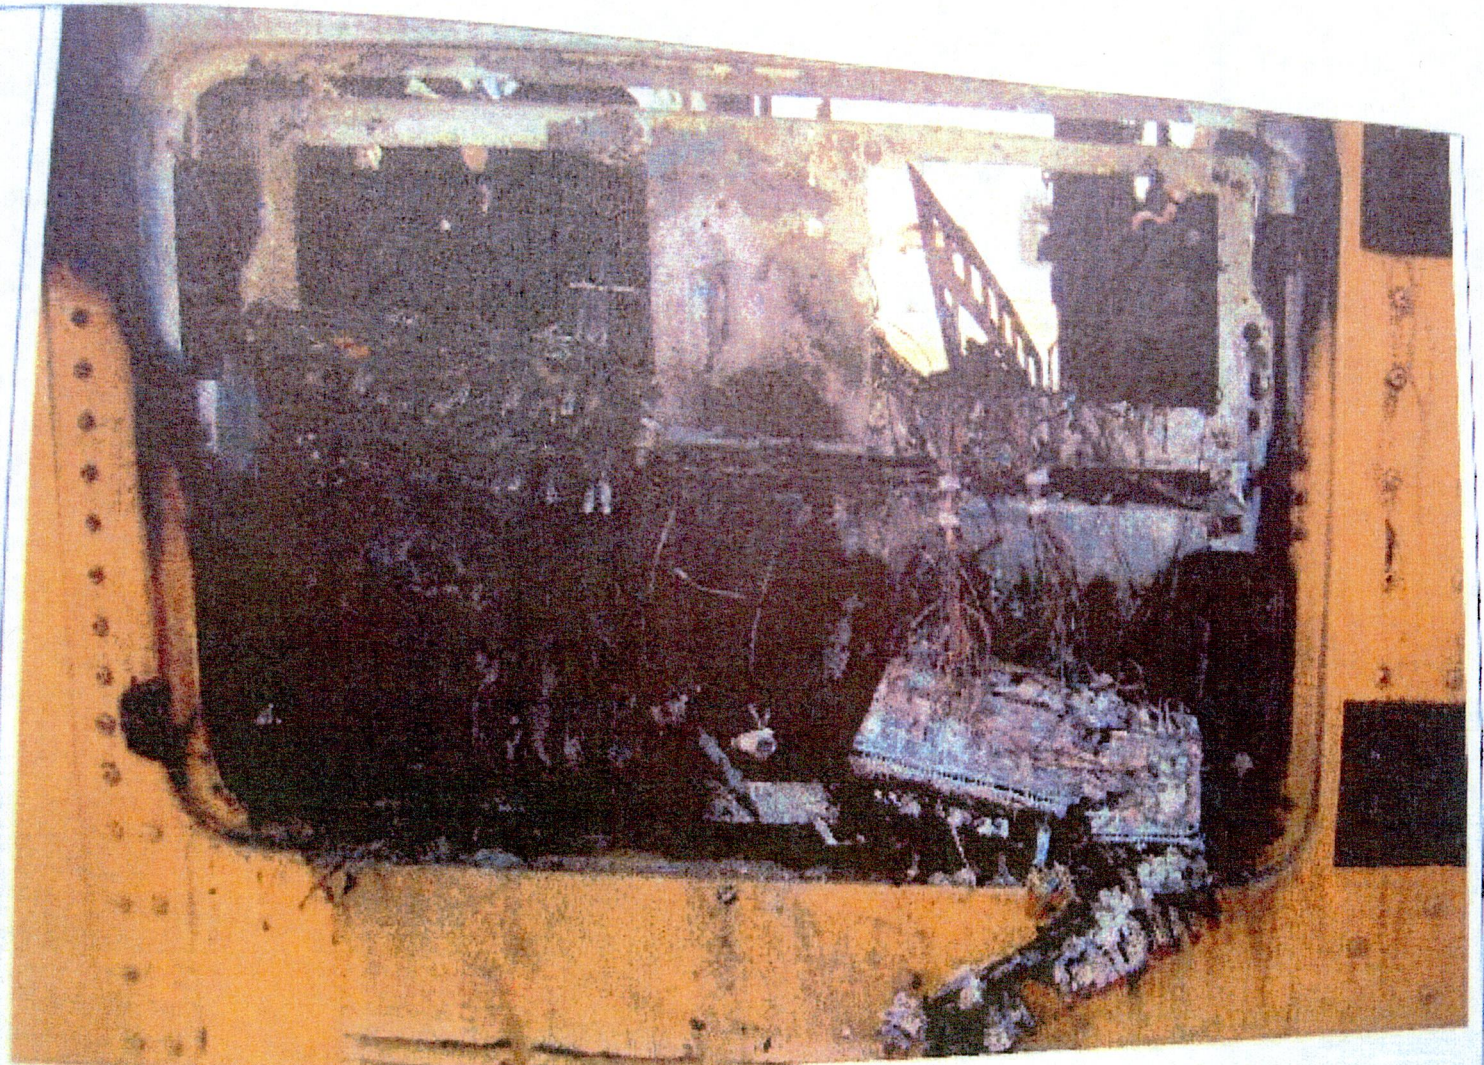
This photo shows photo of PDM as found on bus.

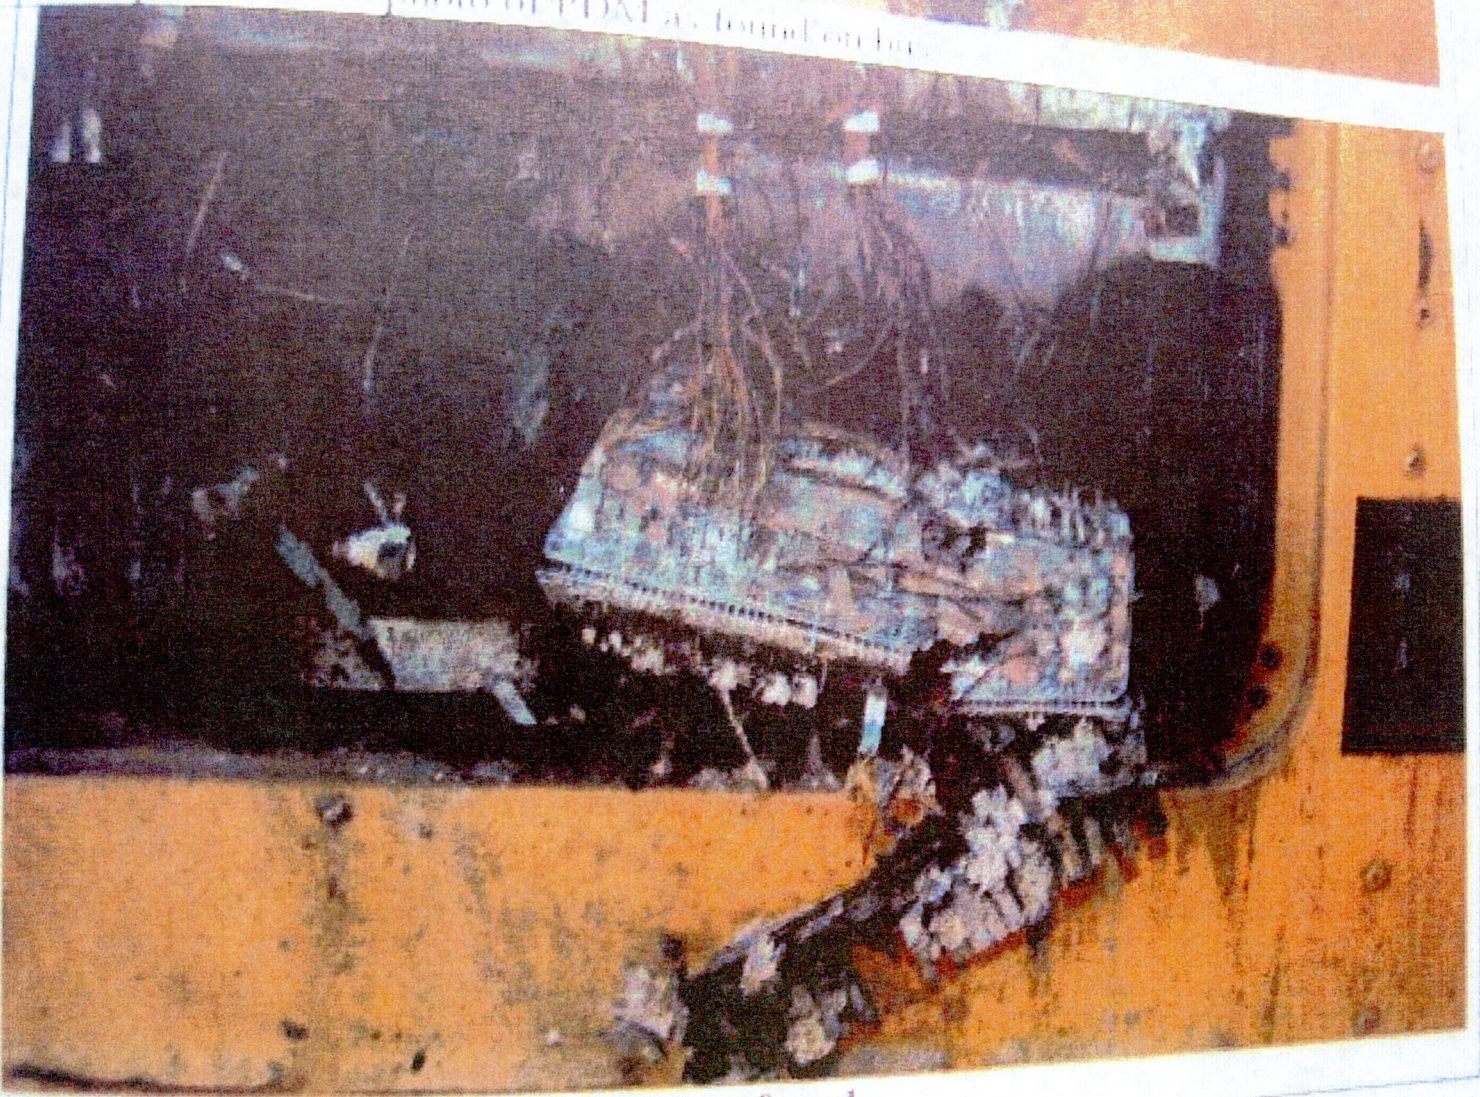
This photo shows close up of PDM as found.

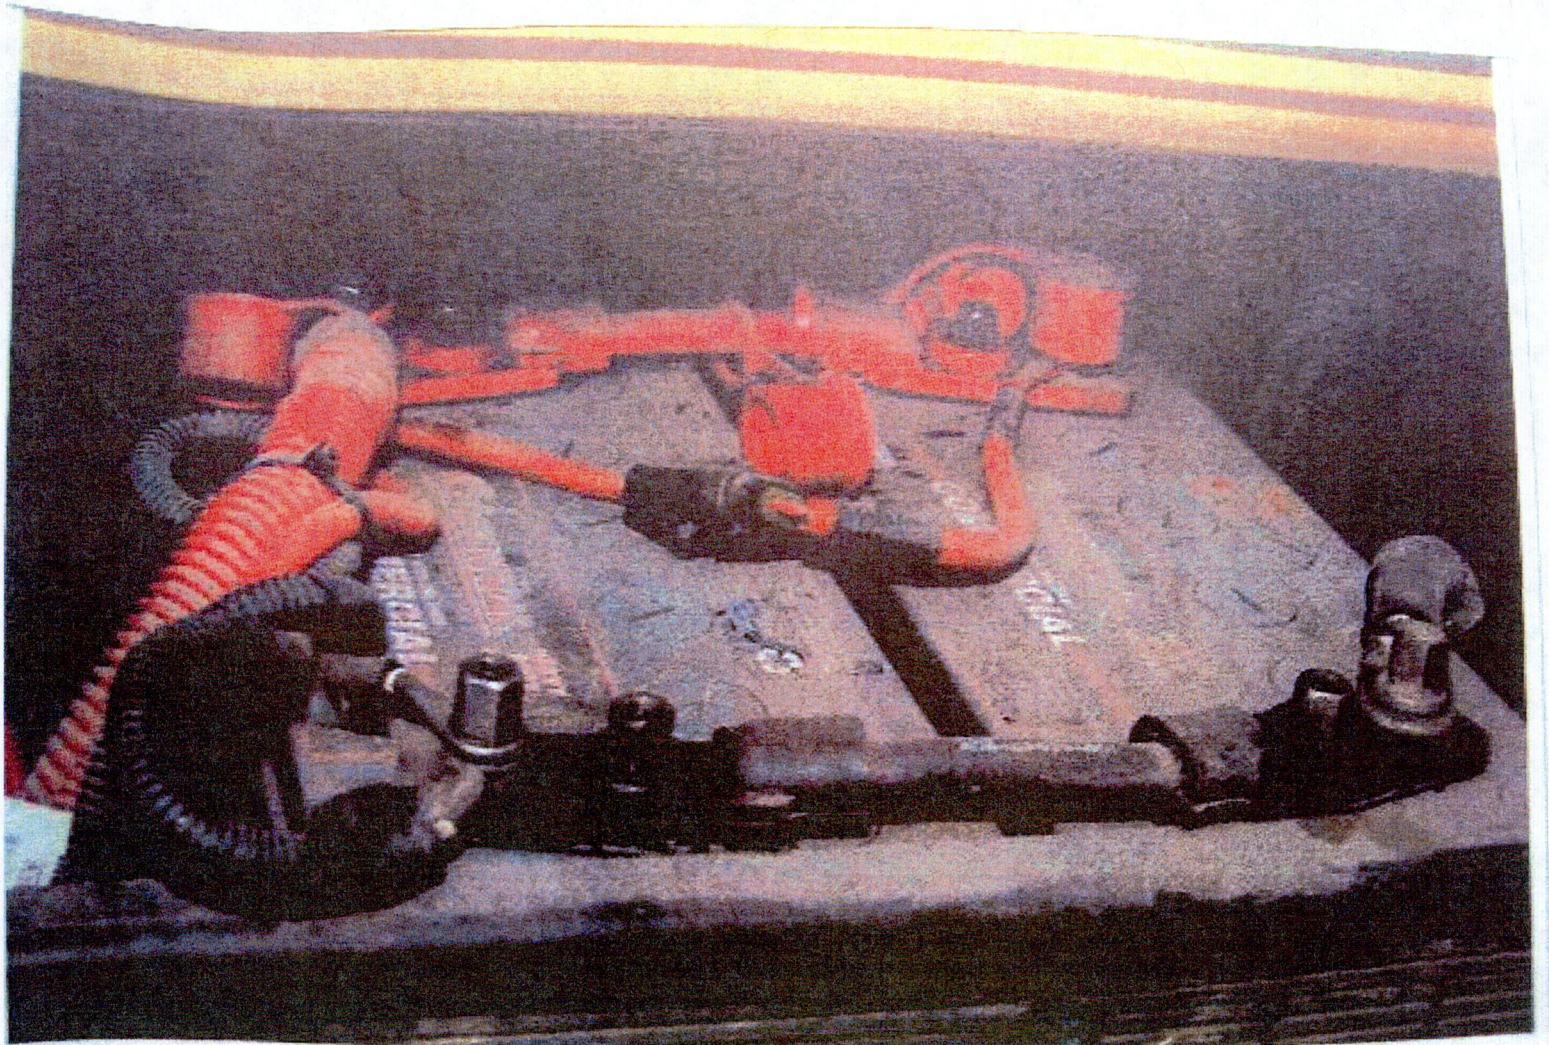
This photo shows close up of bus battery terminal connections.

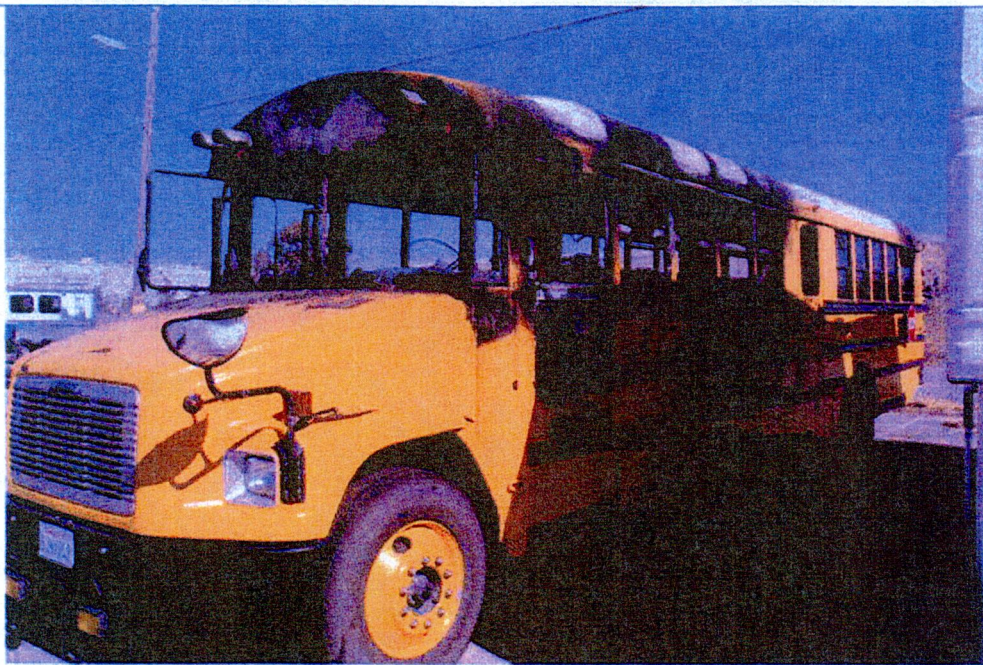
5

This photo shows damage at LF coach area.

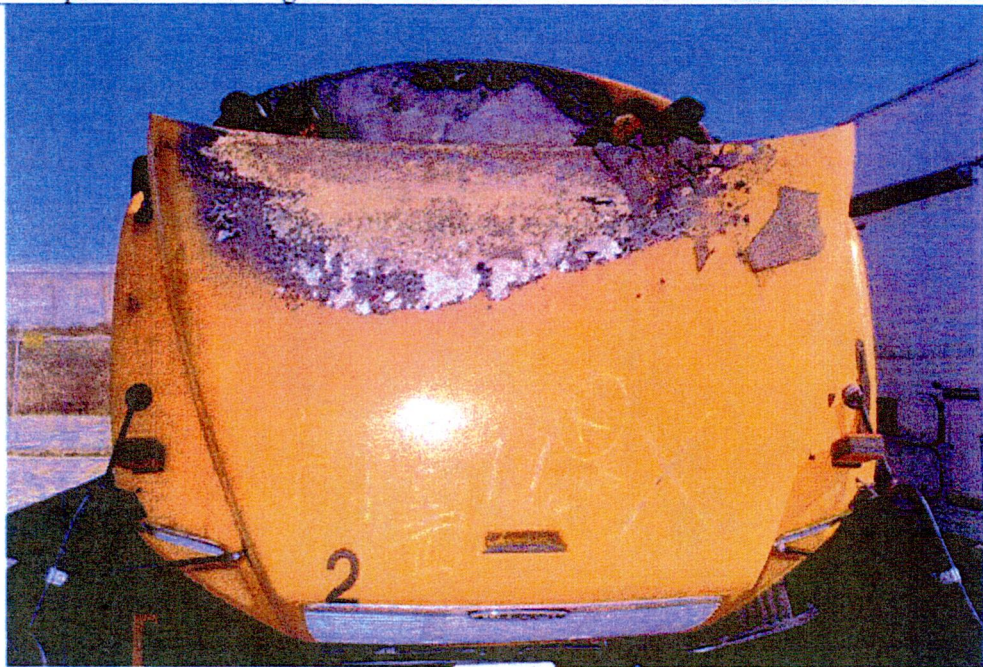
6

This photo shows burn damage to top of engine hood.

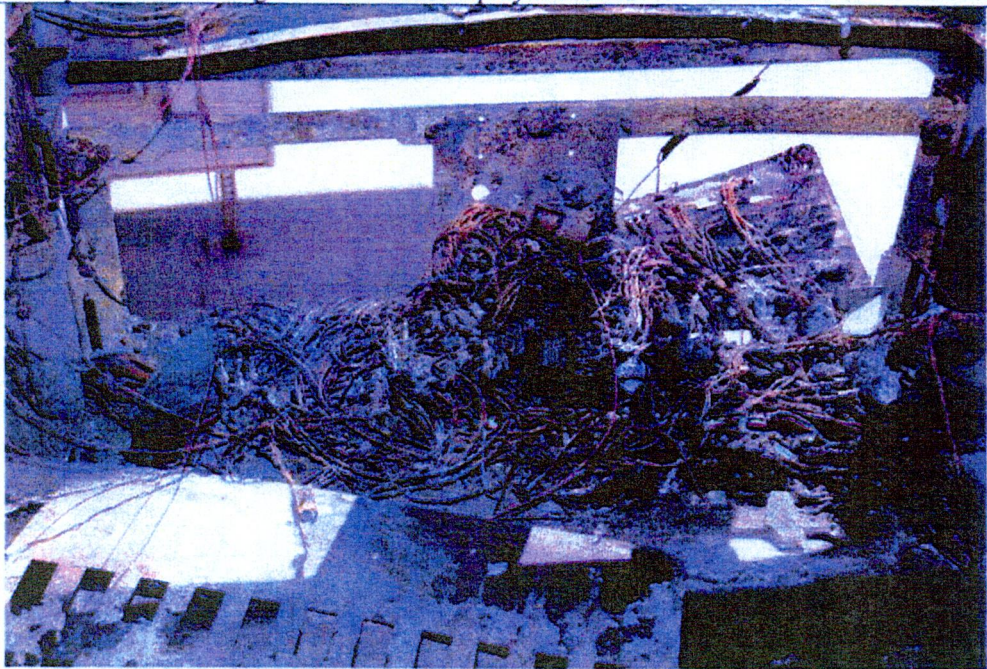
16

This photo shows electrical control box remains to left of driver.

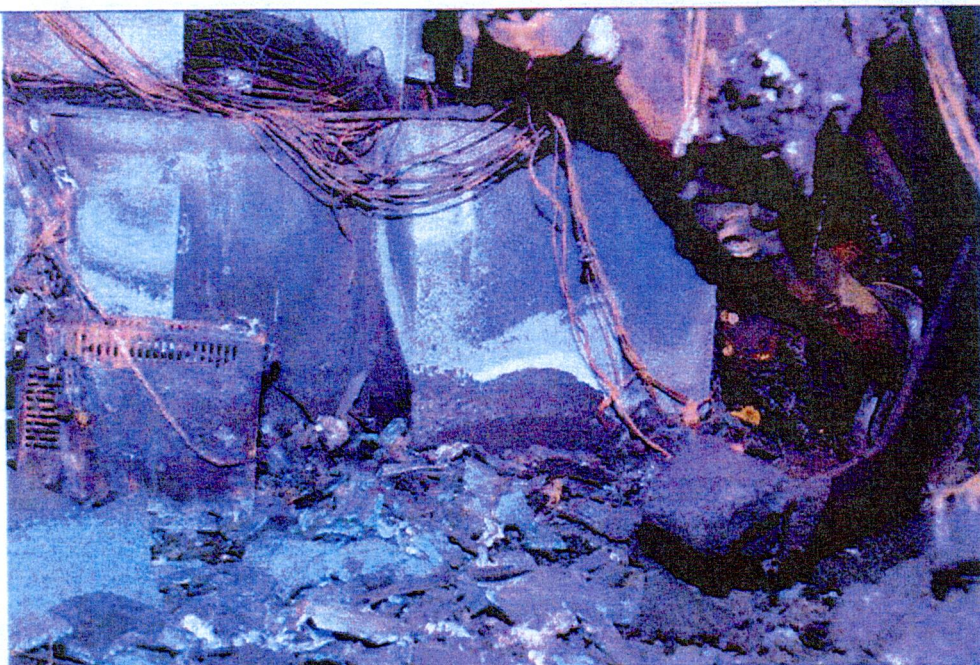
17

This photo shows burn pattern to left of brake pedal.

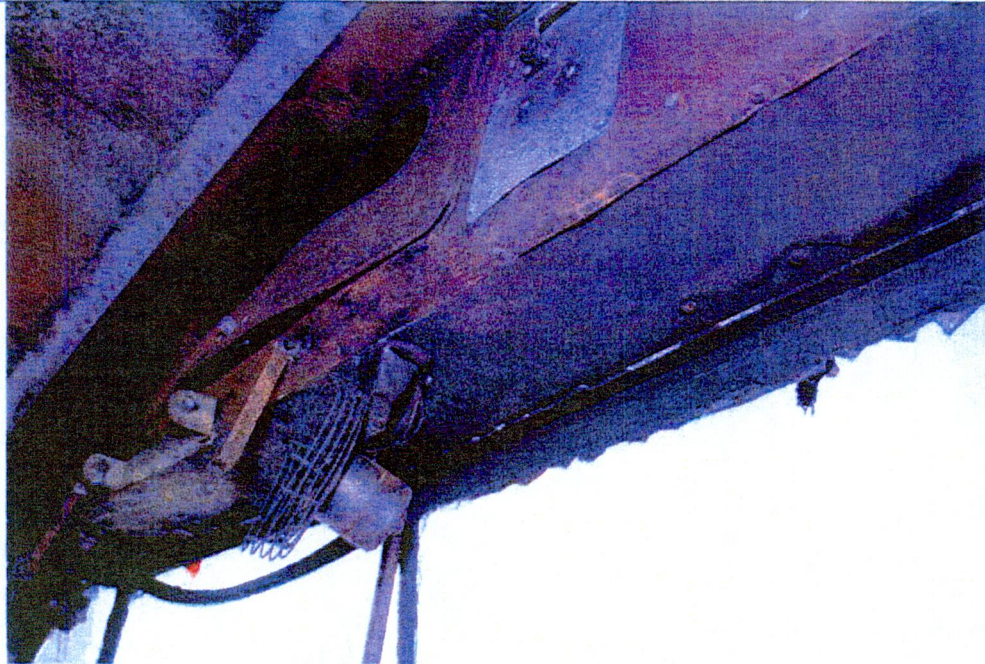
20

This photo shows inside damage above windshield.

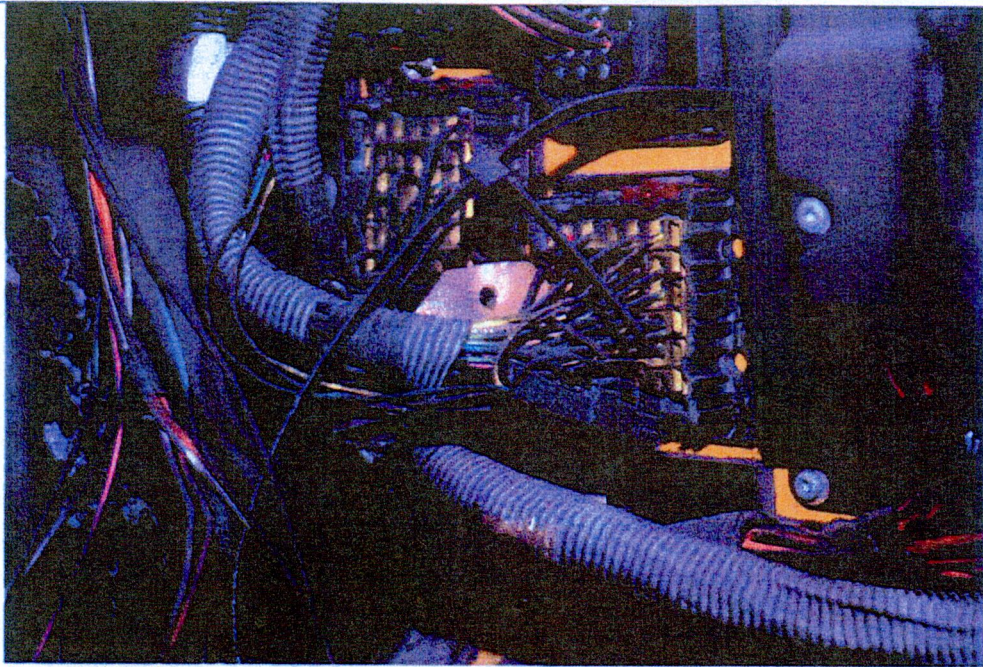
27

This photo shows close up of wiring, heat damage only.

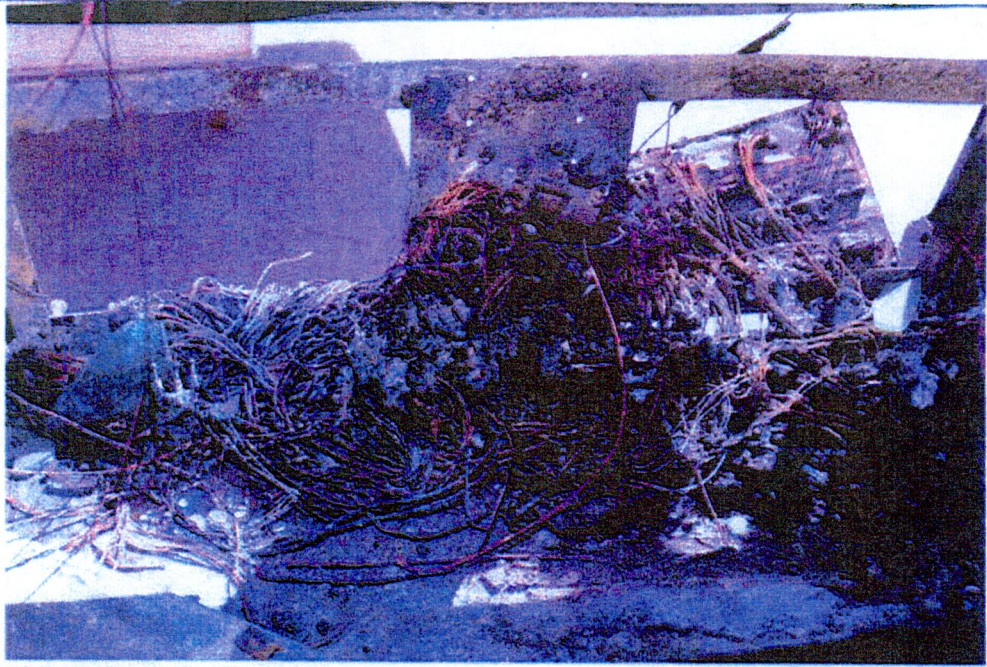
29

This photo shows fire damaged wiring to left of drivers seat.

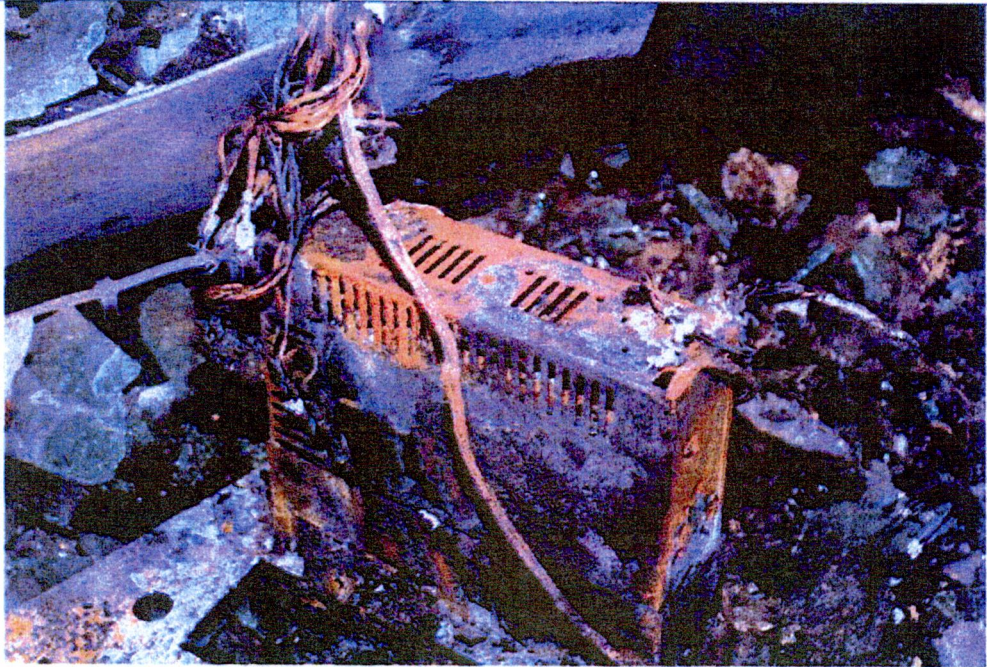
30

This photo shows electrical component found to left of drivers seat on floor.

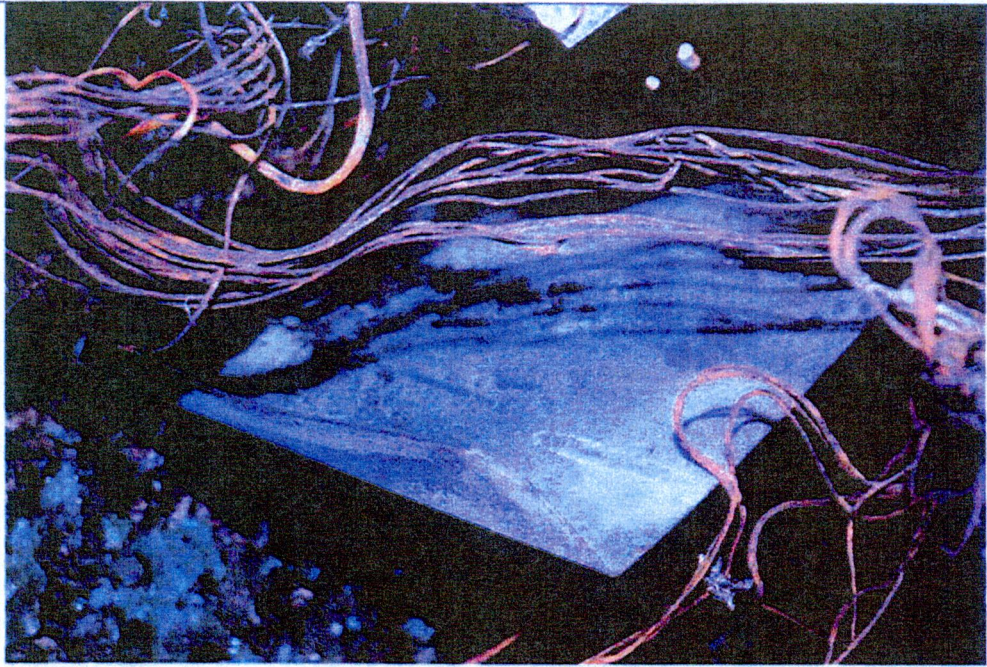
31

This photo shows burn pattern behind panel to left of brake pedal.

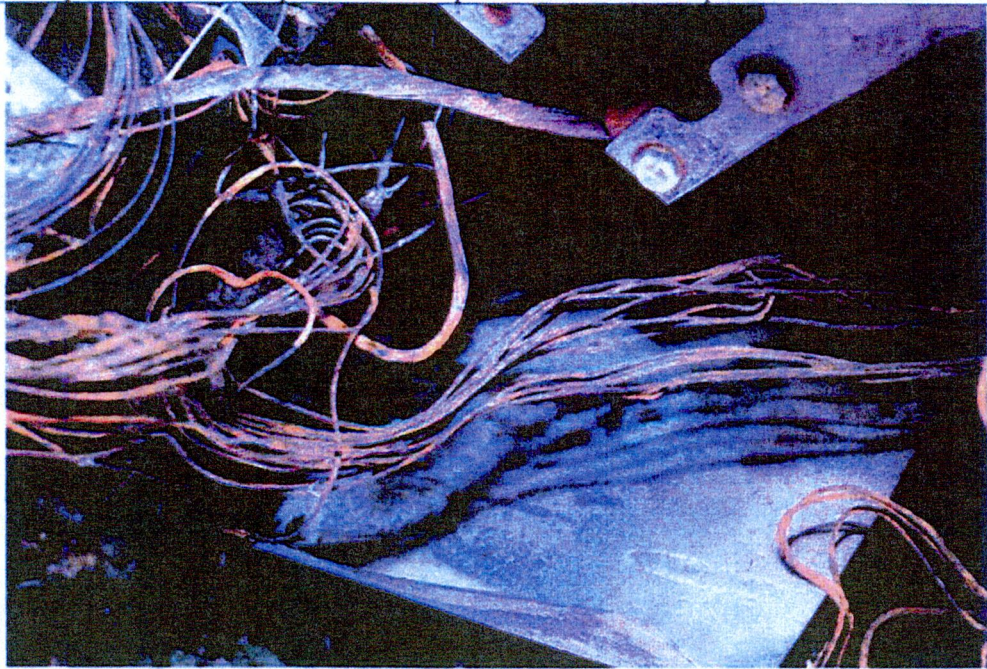
32

This photo shows close up of metal panel burn pattern.

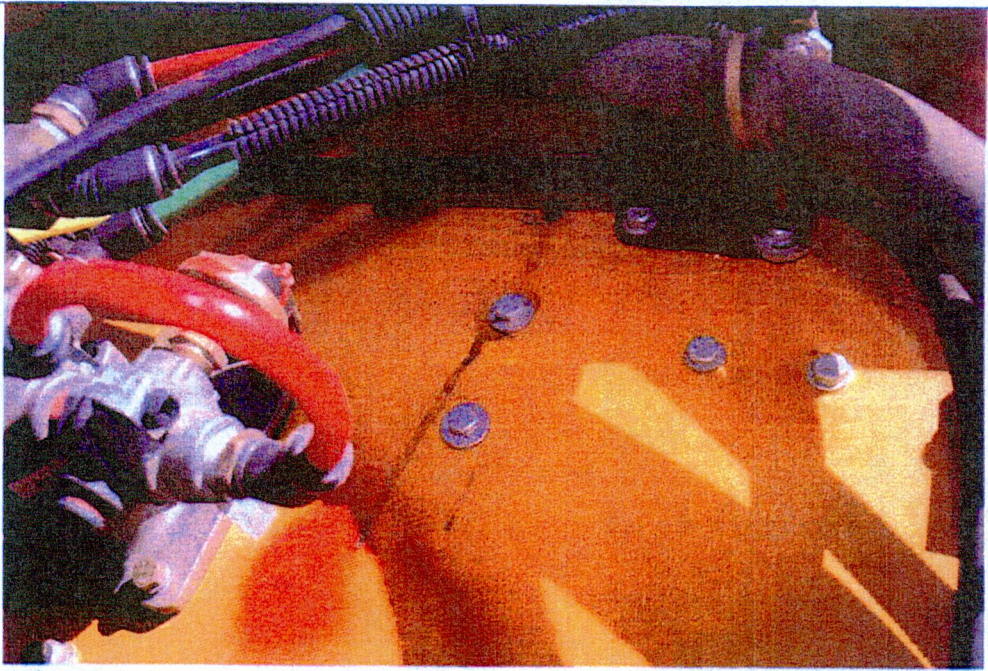
36

This photo shows black smoke stain coming from motor side hole in firewall.

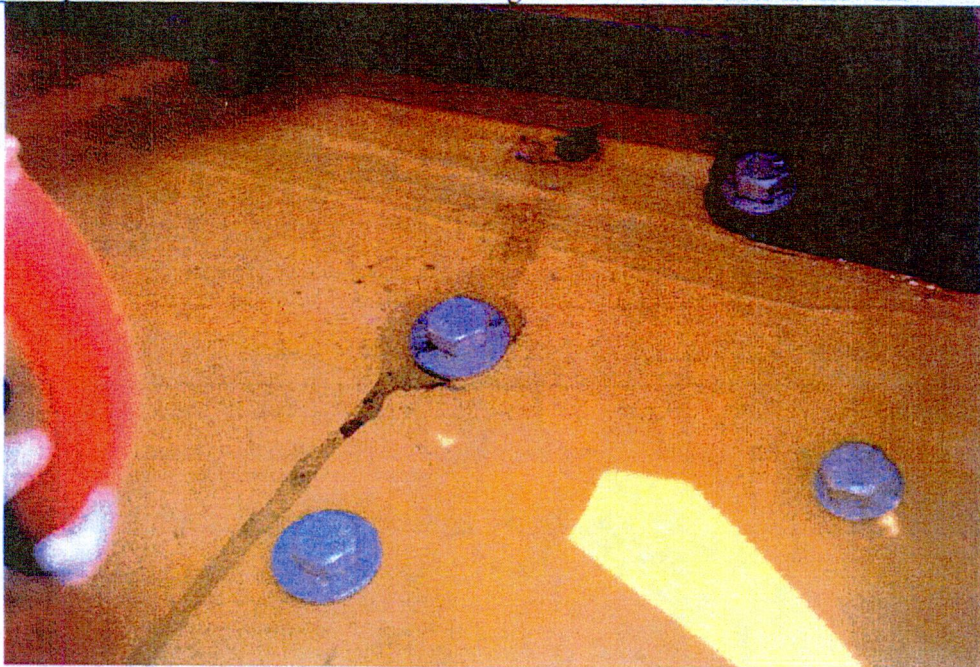
37

This photo shows hole in firewall above bolt head.

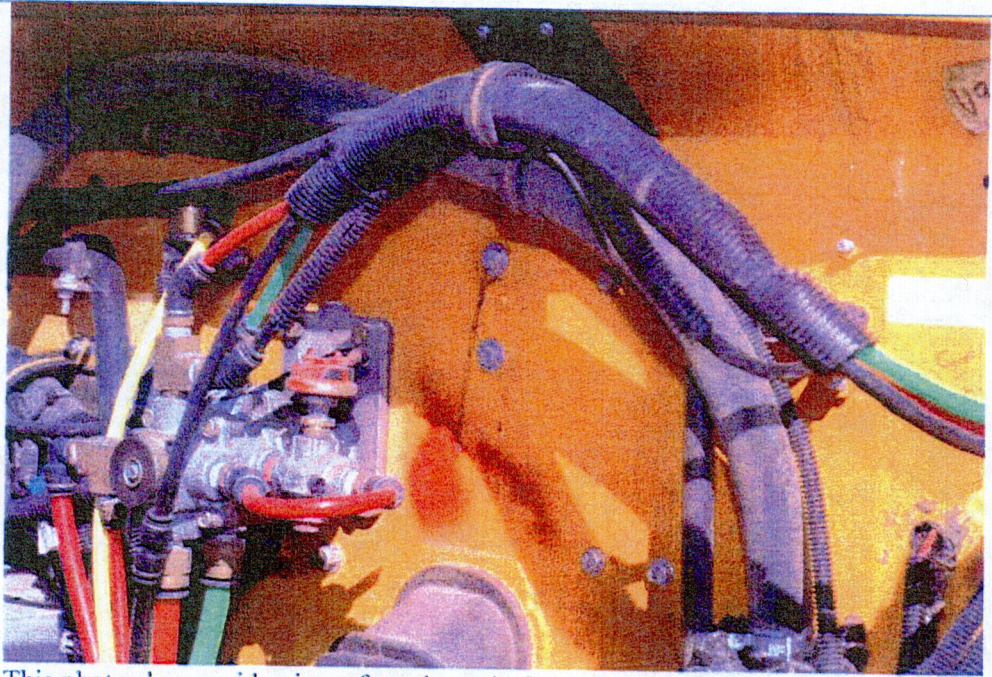
38

This photo shows wide view of smoke stain from LF of engine area.

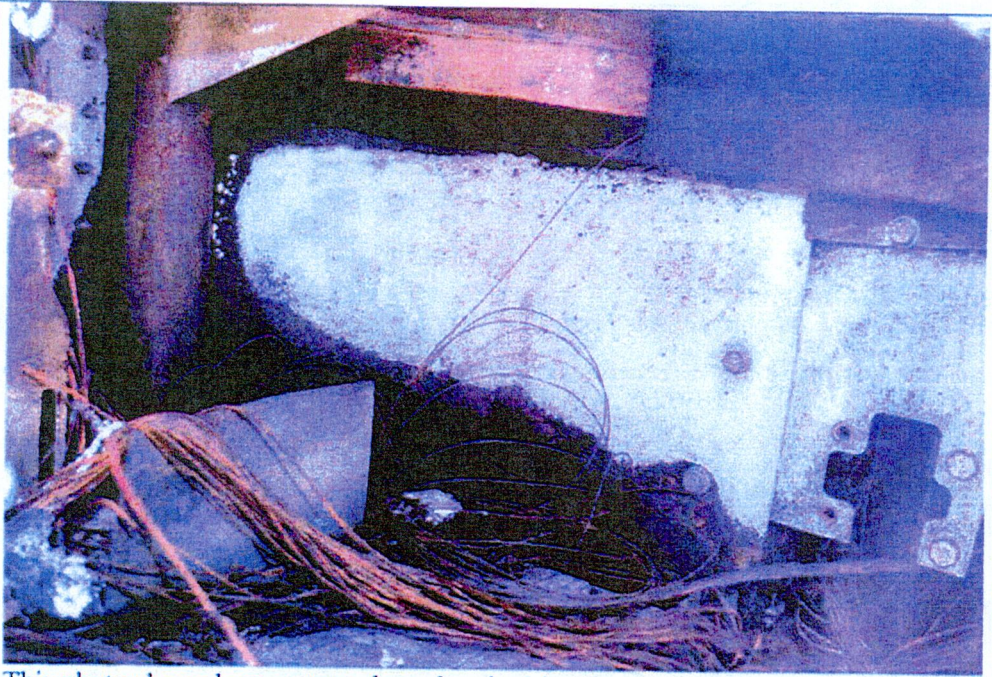
40

This photo shows burn pattern down low in driver's area.

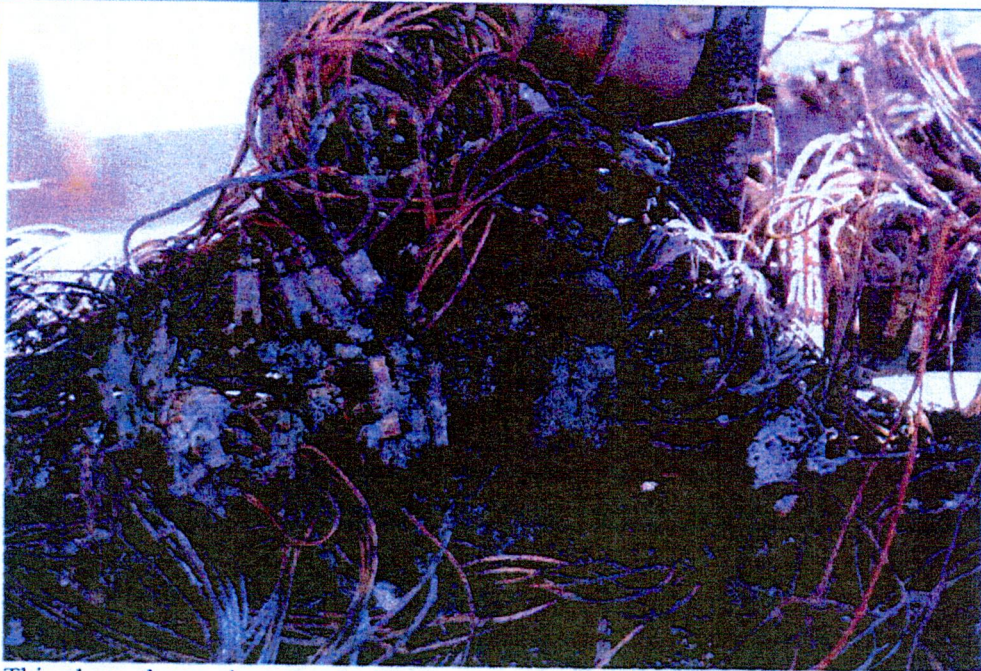
41

This photo shows close up of wiring remains in electrical control box on drv left.

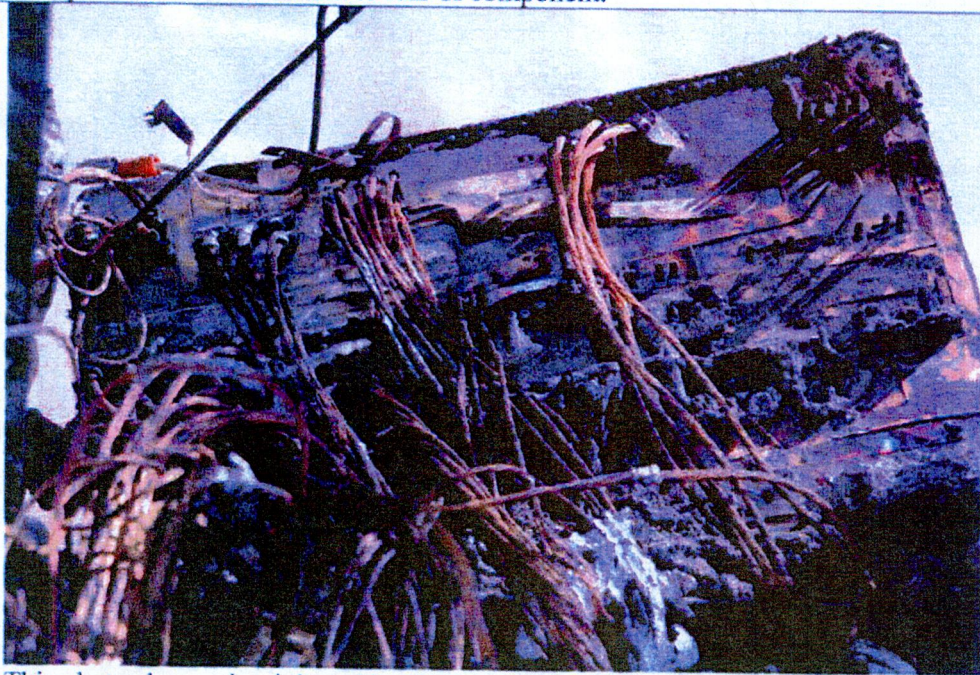
50

This photo shows circuit board hanging out broken window on driver's side.

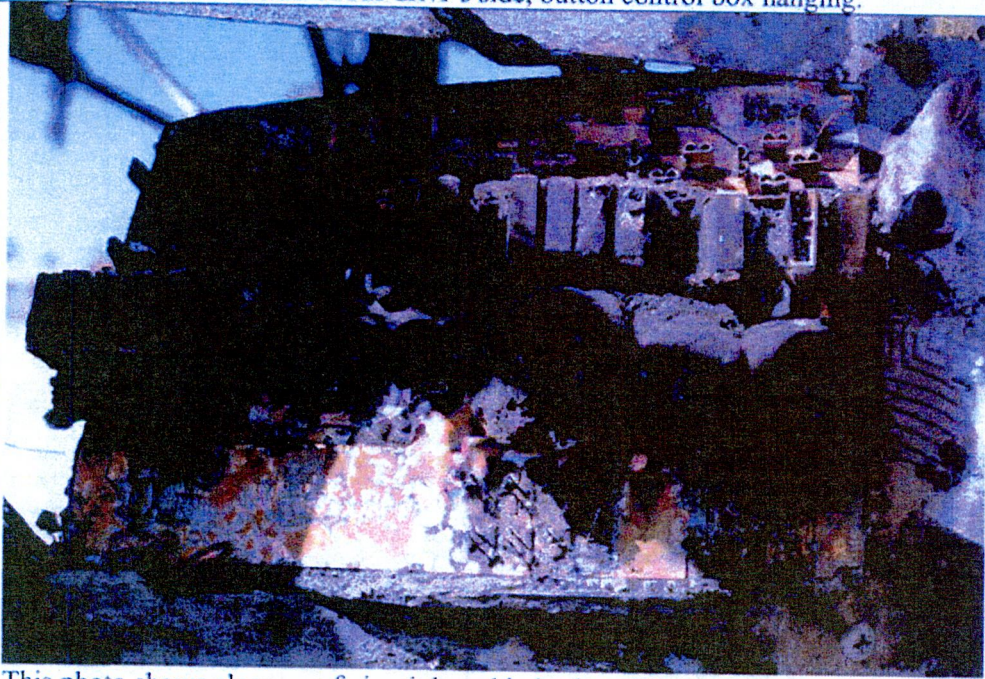
52

This photo shows close up of circuit board in broken driver's window.
