From: Kerry Legg
Sent: Wednesday, July 11, 2007 10:32 AM
To: Alan Farrant; Bernard Hejda; Scott Halbesma
Cc: Cliff Murray
Subject: New York - Roof top Evaporator Fires

Recently, a problem was reported with the interior dome light connectors on the 2000 New Flyer Articulated buses. Water was entering the roof hatch and seeping into the fluorescent light ballasts, contaminating the Molex connector of the pig tail harness. This condition **was** also found in the evaporator drain hose area. If the fluorescent light is burnt out, the high voltage at the connector plus the water from the hatch can result in a thermal event as seen in Figure #1 below. **This** wiring configuration is on 1997 (1000-1069), 1998 (1070-1109), and 2000 (5250-5509) New Flyer Articulated buses. Therefore, in order to eliminate this **concern**, the high voltage **wire** in this specified dome light **connector** must be separated from **the remaining two wires**, (see Figure #2 for the affected dome light locations). Additionally, the roadside forward evaporator drain hose, in the rear section of the bus, must be rerouted to avoid any evaporator drain hose/ballast contact concern. Constant chaffing of the drai

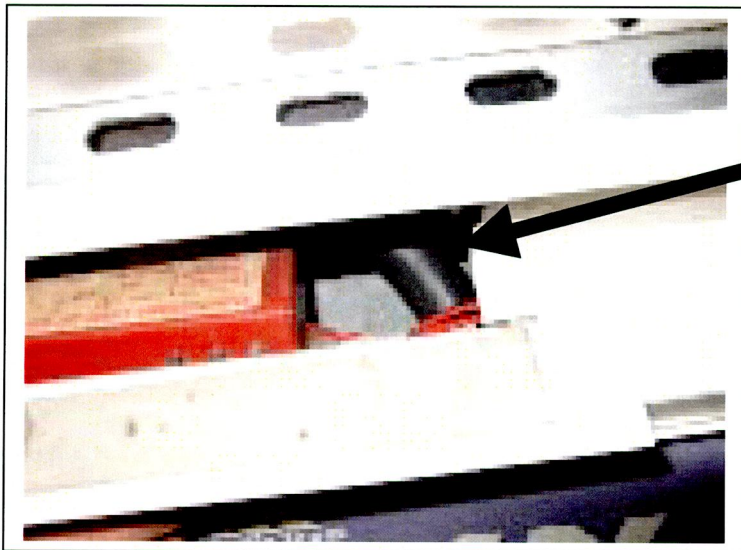
Figure # 16: Evaporator drain hose in now relocated and no longer contacting the dome light ballast and/or ballast plug.
