# Maintenance Directive

**Subject:** Interior Dome Lights and Evaporator hose on New Flyer 1997, 1998, 2000 and 2003 Articulated Buses

**Subject: Rooftop Evaporator Drains – New York City Transit**

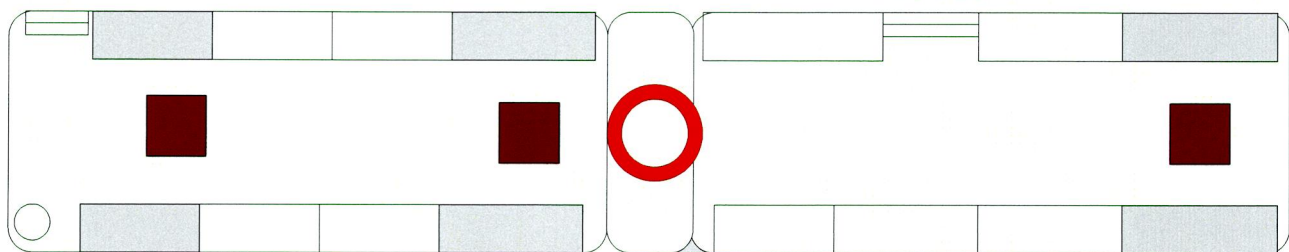
LH light #5 and  
Evaporator drain hose area

FIGURE # 10 reroute the evaporator drain hose

14. When performing the connector upgrade in the LH #5 light panel, locate the evaporator drain hose. Remove the hose and plastic fitting at the top of the evaporator assembly. See Figure #10, 11 and 12.

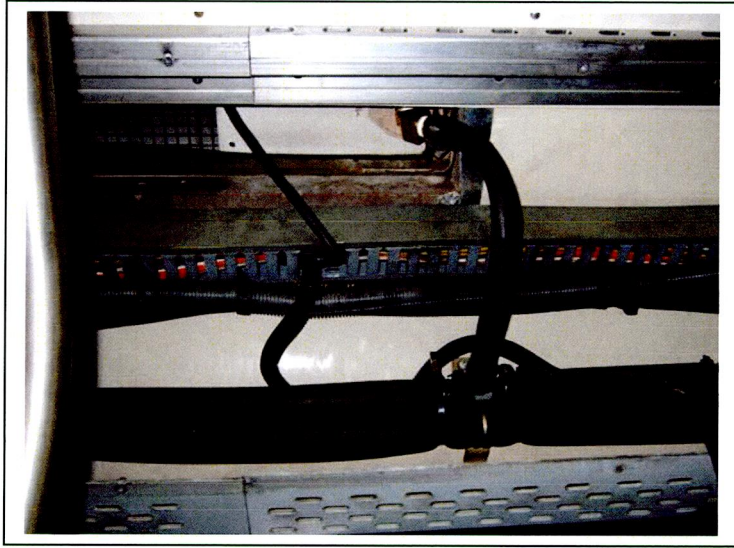
Figure #15: Install the hose back onto the hose barb fitting and secure.

16. Attach the evaporator hose back onto the new hose barb fitting (if hose is damaged or chaffed replace with TA # 79-22-0271). Secure with the original hose clamp. See Figure #15.

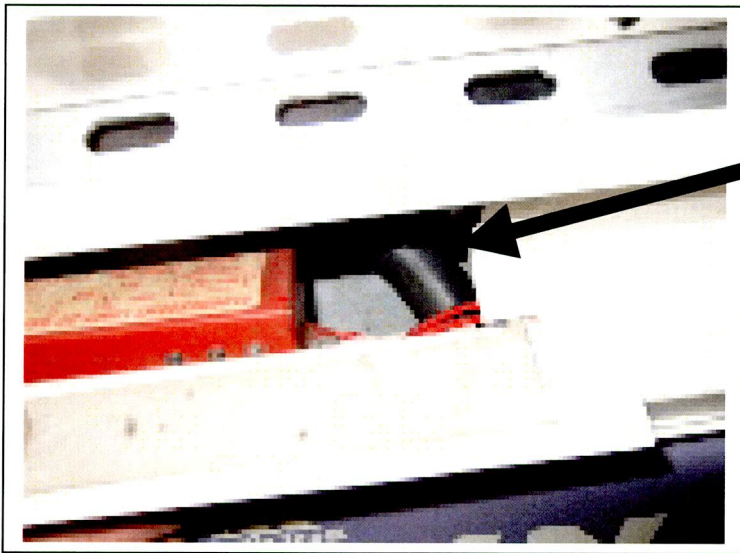
Figure # 16: Evaporator drain hose in now relocated and no longer contacting the dome light ballast and/or ballast connector.

Note: Secure/repair/replace, surrounding wires/hoses/harnesses as needed.

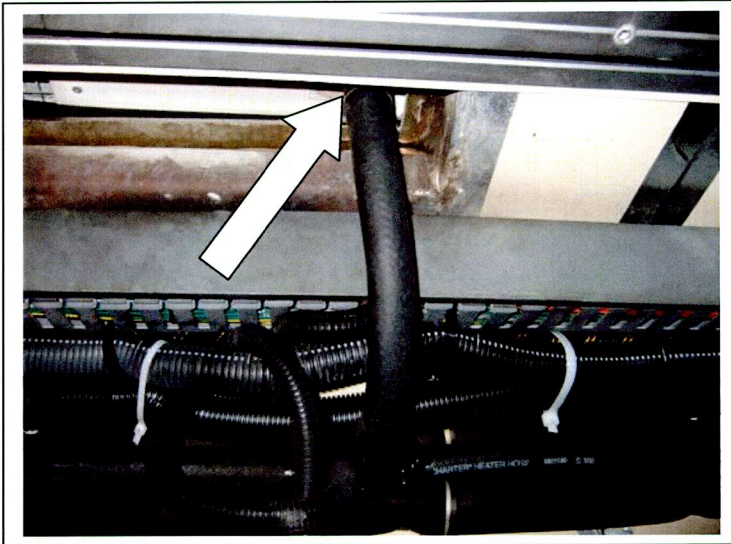
Figure #11: Loosen the hose clamp and remove evaporator drain hose at the top.

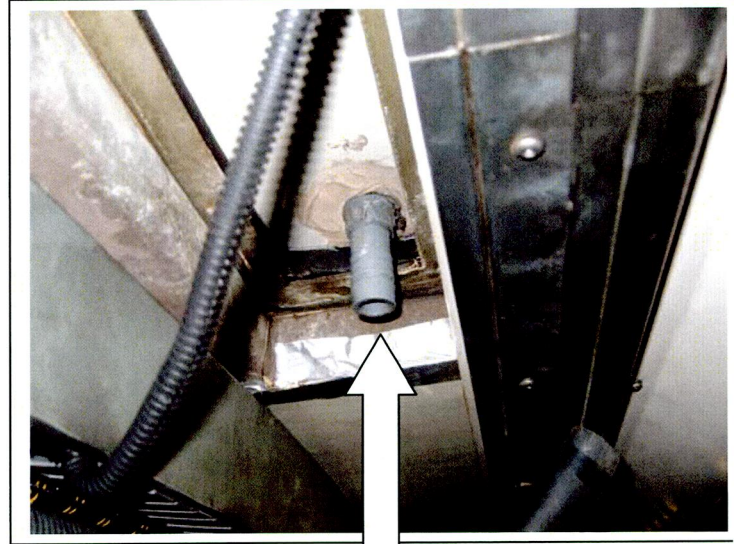
Figure #12: Remove and discard the OEM plastic fitting

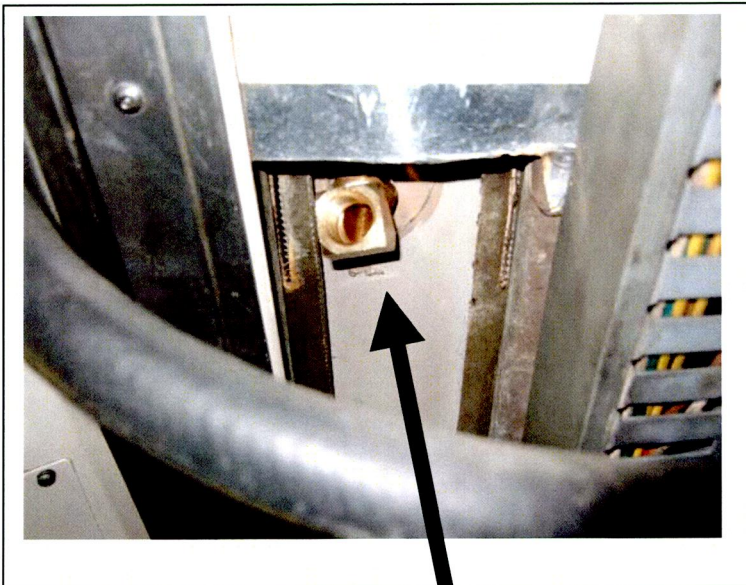
Figure #13: Install/secure the 45-degree elbow with reducer fitting attached. Elbow must face towards front of bus as shown.

15. Install the 45 degree Elbow and the hose barb fitting from fitting kit TA # 92-83-2007. The fitting should face the front of the bus as shown in the Figure #13 and 14.

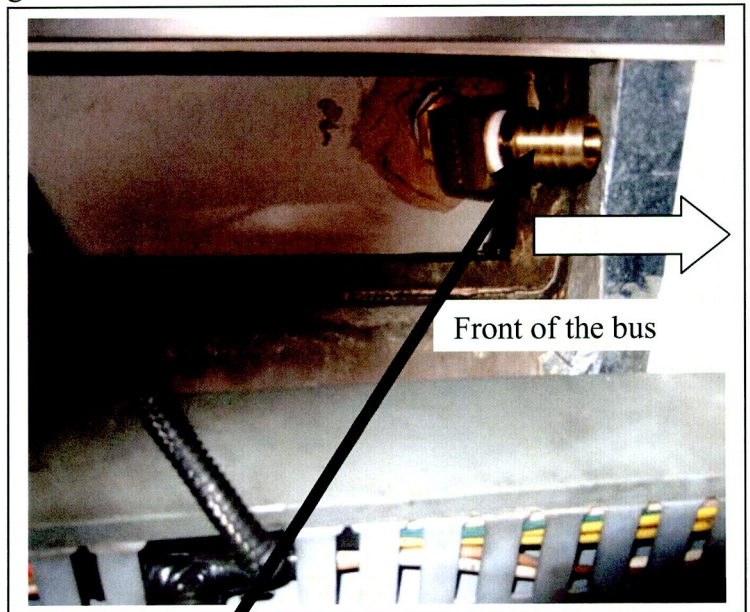
Figure #14: Now install/secure the hose barb fitting into the 45-degree fitting as shown above.

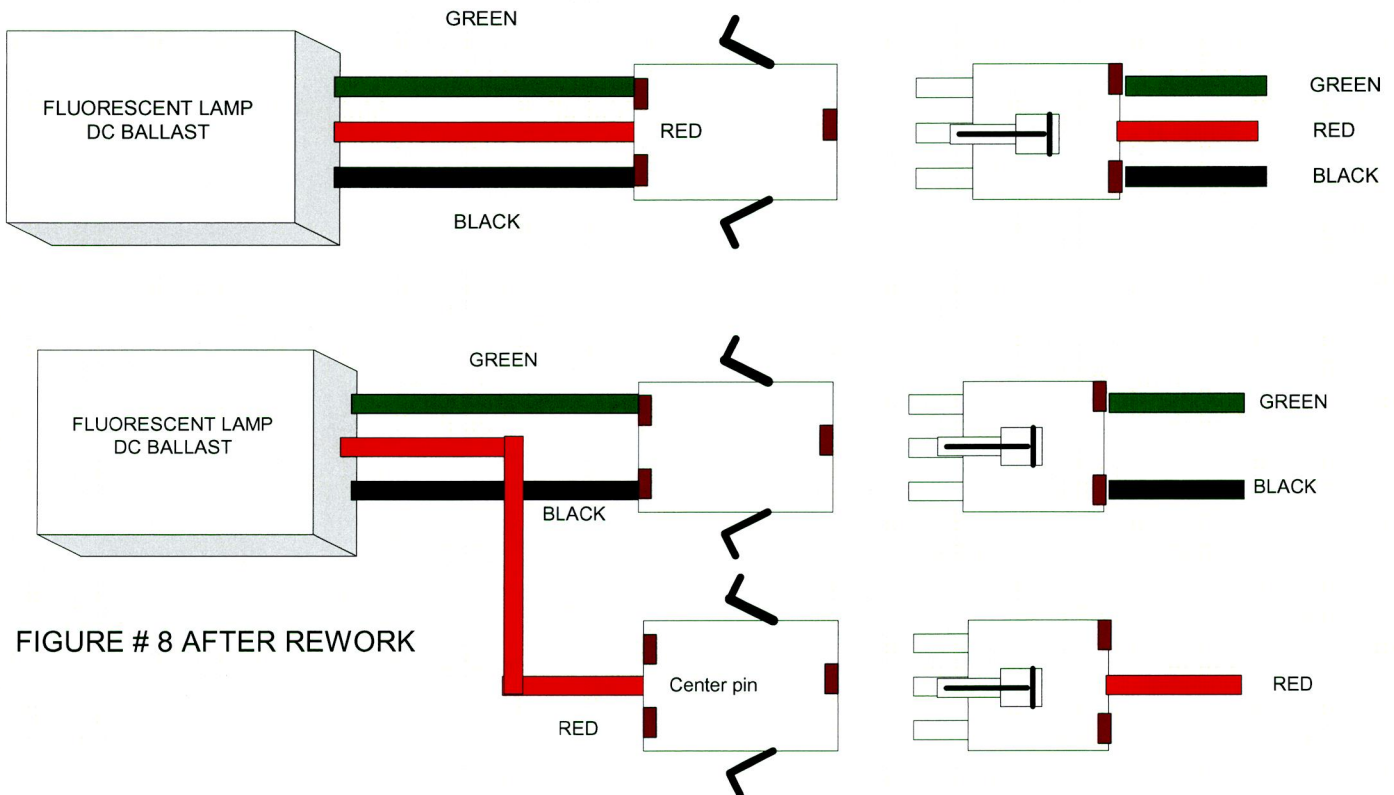
FIGURE # 7: BEFORE REWORK

FIGURE # 8 AFTER REWORK

8. For the RH # 4, # 7 and LH # 4, #5 and # 8 dome lights, disconnect the Molex connector. Use the extraction tool (TA # 42-69-0080) to remove the Red wire from the plug (female) and from the receptacle (male) connectors (see Figure # 7).
9. Use the extraction tool to slightly open the male and female terminal locking tabs. Then, insert the terminals into the new connectors at the center (middle) slot as shown in Figure # 8.
