Re: PE07-021 – Front Suspension Coil Springs on 1996-1999 Model Year Mercedes-Benz E-Class Vehicles

This letter is submitted on behalf of DaimlerChrysler AG and Mercedes-Benz USA, LLC (collectively “Mercedes-Benz”) to the National Highway Traffic Safety Administration (“NHTSA” or “Agency”) in response to the Office of Defects Investigation’s April 24, 2007 request for information relating to the Agency’s preliminary evaluation of the front coil spring suspension of 1996-1999 model year Mercedes E-Class vehicles.

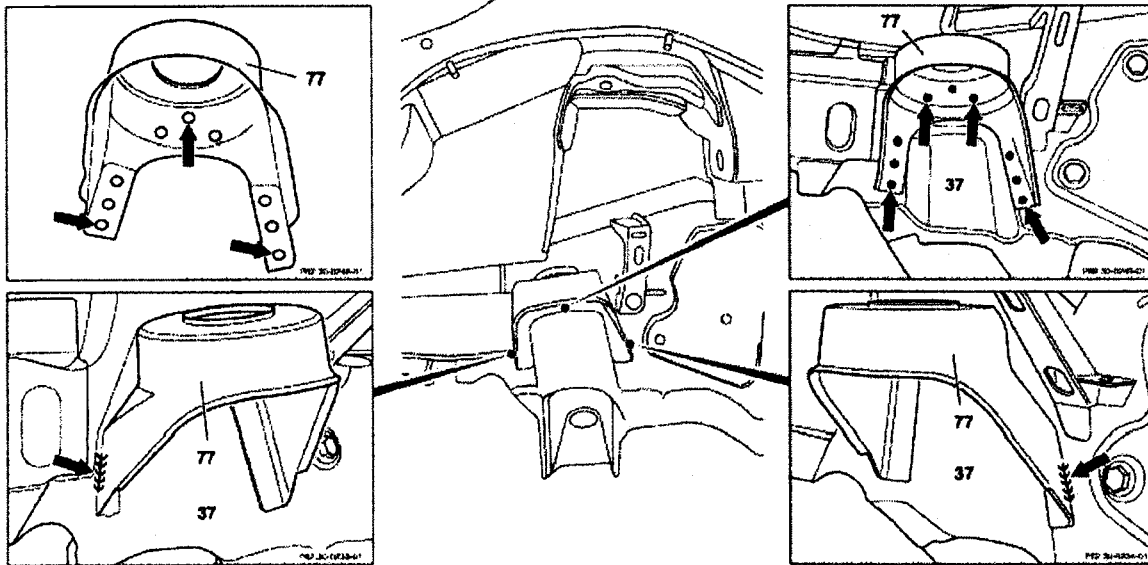
Design Drawings of Springs and Spring Mounting for Subject vehicles

Failure Mechanism: As discussed in more detail below, the potential for rust on the welded connection between the spring retention cap and the inside of the front fenders of the subject vehicles was identified in 2001. Certain aggressive salts and road deicing compounds used in certain regions have the potential to weaken or partially dissolve the poly-vinyl chloride (PVC) sealant used to cover the weld seam and keep water out of the joint between the spring

cap and fender well. Small breaches in the seal can allow water to intrude and collect in the weld connection area, leading to corrosion over time. In severe cases, the welded cap flanges could weaken enough to bend upward under the pressure of the spring. In more severe cases, one of the cap flanges could crack and break which would cause further expansion of the spring. In the most severe cases, after additional corrosion occurs, both the front and rear cap flanges could fail, which would allow the top end of the spring to become loose within the fender well. Although the potential for accelerated corrosion does exist in these vehicles, the overall warranty and goodwill claims rate for the subject vehicles is only 0.41%, and the warranty rate for loss of springs from such vehicles is only 0.02%. 1/
