**VOLKSWAGEN of America, Inc.**

Subject: PE07-024 NVS-212lhs

Attached is our response to your letter dated May 11, 2007 requesting information concerning the failure, malfunction, or otherwise unsatisfactory performance of the subject components which may potentially lead to vehicle fires: a) in the underhood or instrument panel/console areas of the subject vehicles, and b) in the vehicle undercarriage area in proximity to the catalytic converter on certain 2000-2003 Volkswagen Passat vehicles.

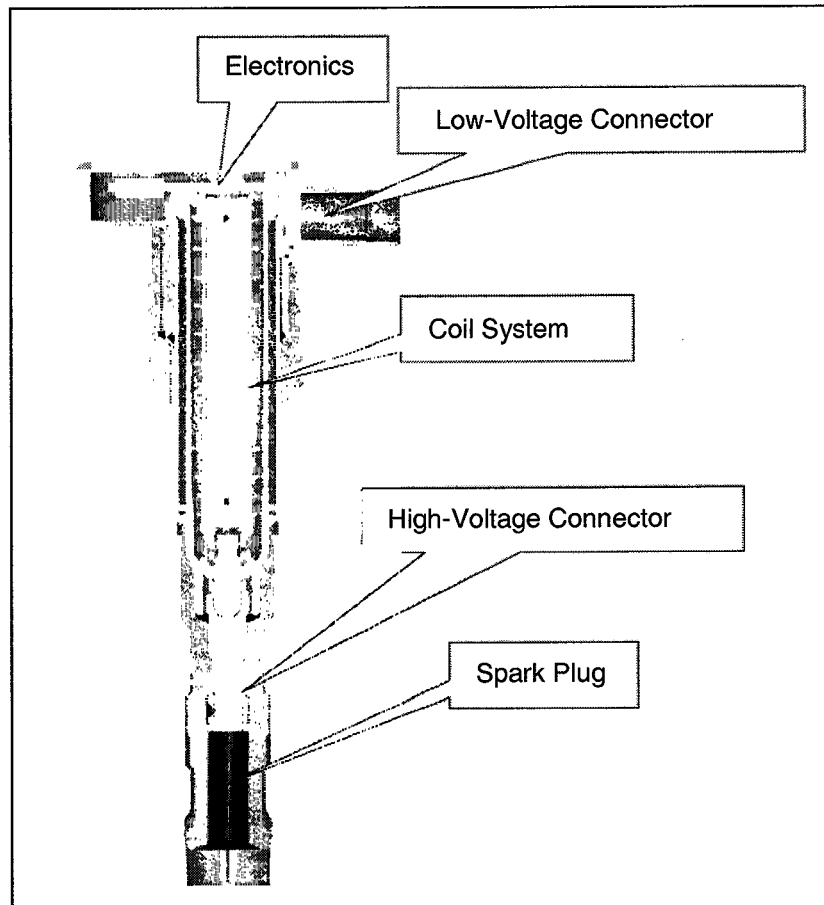
#### **1.8T pencil coils (engine codes AUG, AWM, ATW)**

The ignition circuit consists of one pencil coil and spark plug per cylinder. No high voltage ignition wiring is used. In this case the voltage transforming primary and secondary coils are placed directly above the spark plug in the cylinder head shaft. The pencil coil is directly connected to the spark plug with an SAE contact and no additional (high voltage) wiring.

The pencil coil itself consists of the electronics with low voltage connector, the coil system for generating high voltage and the SAE connector. Upon on-board voltage application from the engine control module the electronics apply voltage to the primary

coil inducing the high voltage pulse for ignition. The coil generates high voltage for the ignition directly at the spark plug without transferring the high voltage via electrical wiring.
