Jeffrey L. Quandt, Chief
Vehicle Control Division
Office of Defects Investigation
National Highway Traffic Safety Administration
1200 New Jersey Ave., S. E., Room W48-307
Washington, D.C. 20590

NVS-213kmb
PE07-051

This letter is General Motors (GM) response to your information request (IR) dated November 2, 2007, regarding alleged failure of engine throttle valve in returning to a closed (idle) position for 2004 through 2005 Model Year (MY) Chevrolet Aveo vehicles.

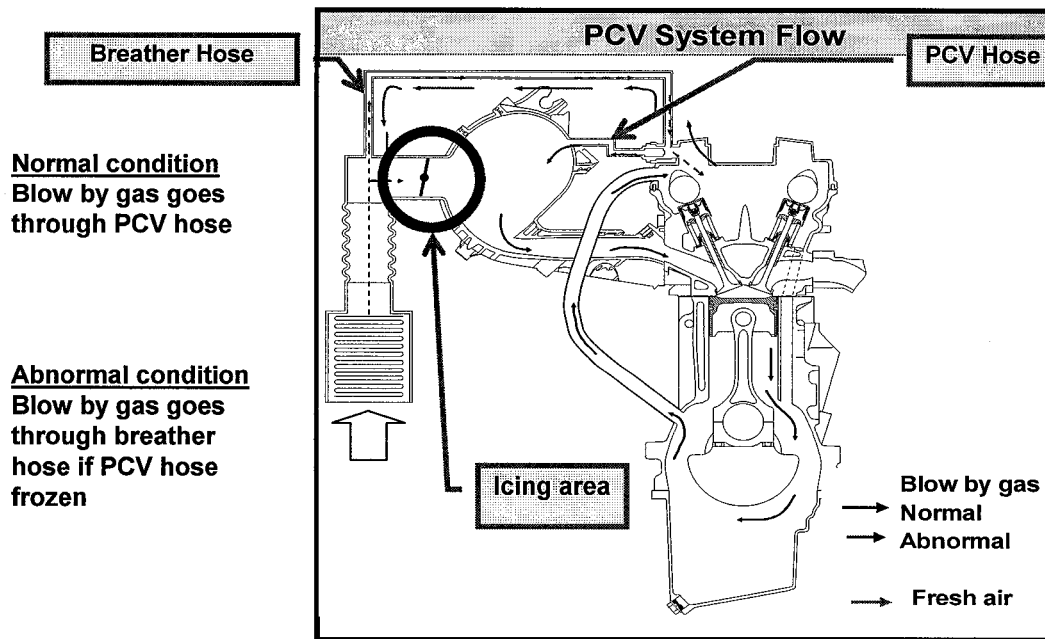
Figure 11-1

Moisture is naturally created by the combustion of fuels and oxygen. Small amounts of products of combustion, which contain moisture, pass by the piston rings after each combustion event, a condition common in internal combustion engines. During normal operation of the vehicle, the Positive Crankcase Ventilation (PCV) system is designed such that the blow-by gas, which includes moisture from the engine, goes through the PCV system:

- When the engine is cold, the moisture in the products of combustion condense into the engine crankcase.
- Uncondensed moisture and other constituents of the products of combustion are transferred to the PCV system, which directs the moisture and gasses to the induction system.

- When the crankcase warms, the accumulated moisture vaporizes, adding to the moisture content in the gas that is passed through the PCV system.
- Progressively colder ambient temperatures below freezing increases the potential for ice accumulation when the moisture in the PCV gas mixes with the inlet air.

- Higher ambient humidity levels slow the rate that this moisture/ice is evaporated.
- Extended driving in sub-freezing ambients can lower the internal temperatures in the PCV distribution hoses. Ice accumulation in the PCV hoses can restrict the air flow. Flow restriction in the PCV distribution system can result in increased moisture upstream of the throttle body, (refer to "abnormal" flow path in figure 11-1).

- Higher than expected moisture introduction upstream of the throttle in sub-freezing ambients increases the potential of ice, frost or snow in the induction system.

- Ice, frost, or snow accumulation in front of the throttle can dislodge, affecting the air flow and throttle valve movement.
