Subject: FINAL REPORT: VRTC-DCD-8127 "Evaluation of Power
Sliding Door Opening Without Command 2005 – 2007 General
Motors U Body Van"

MEMORANDUM REPORT VRTC-DCD-8127
EA07-019
Evaluation of Power Sliding Door Opening Without Command
2005 – 2007 General Motors U Body Van

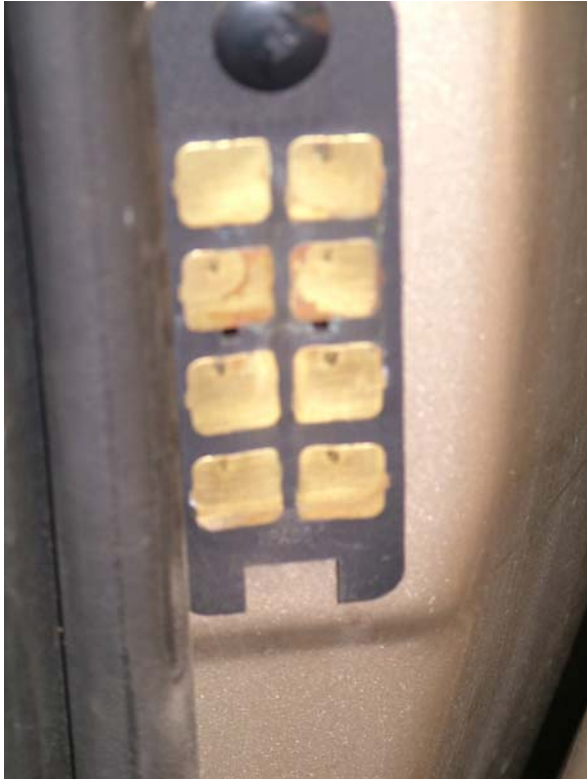
- The complaint vehicle was equipped with seven electrical contacts between the door and the B-pillar. An exemplar vehicle with non-powered doors only has five such contacts.

Electrical Contacts on B-Pillar for Right PSD

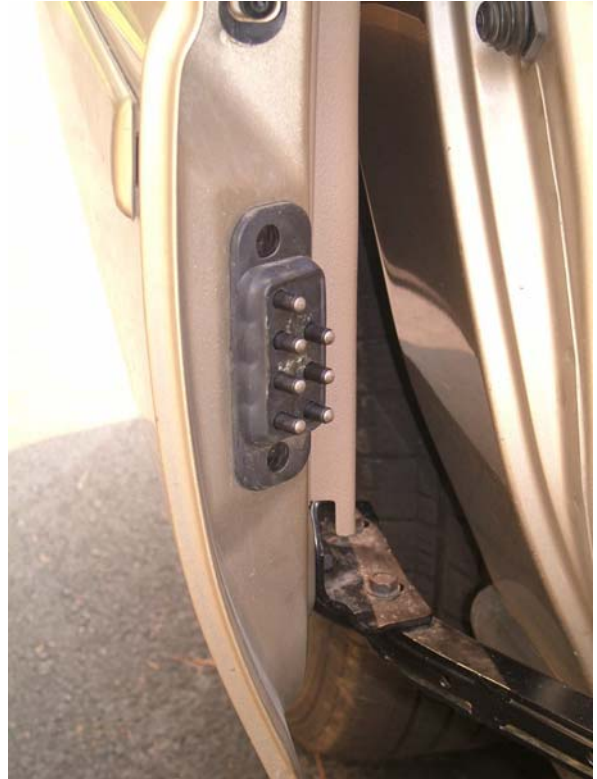
Electrical Contacts on Front of Right PSD

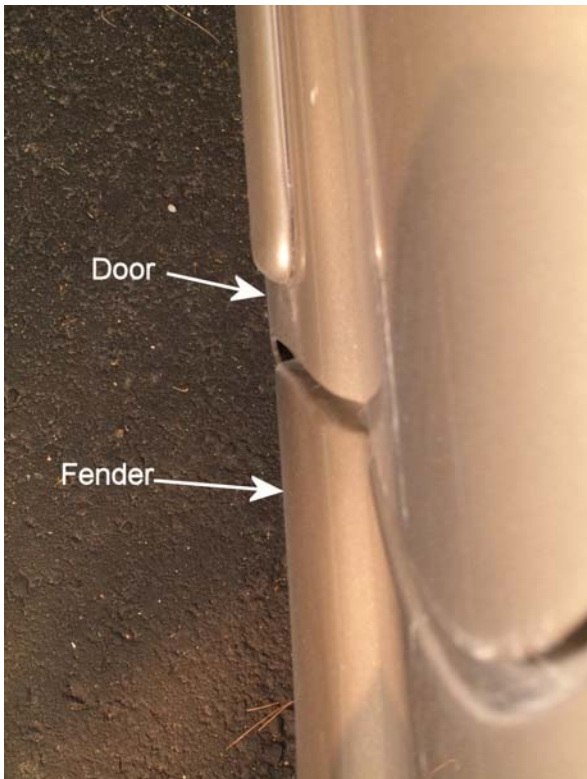
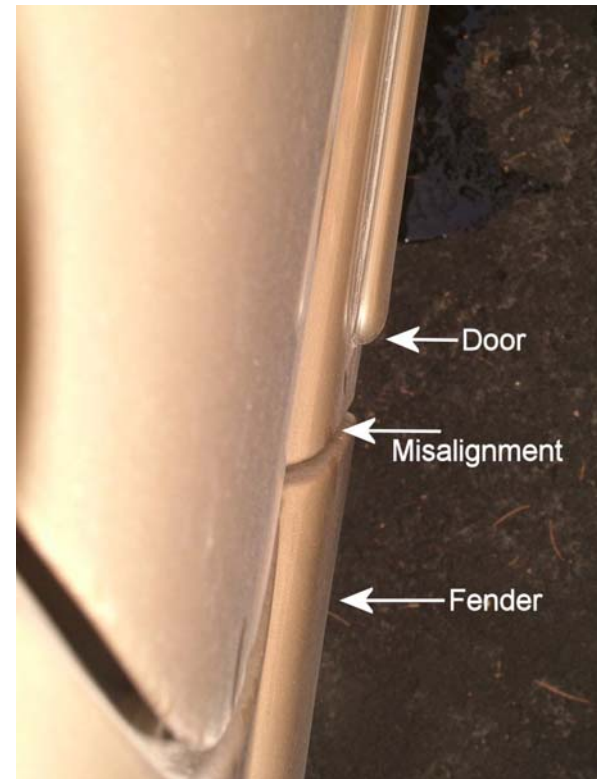
- When the right door is closed and latched, it appears to pull in toward the body of the van a bit more than does the left door. When the latch is operated to open the door, the door seems to spring outward more in the initial movement than does the left door.

Vertical View of Proper Transverse Alignment
Vertical View of Transverse Misalignment

of Left PSD

of Right PSD

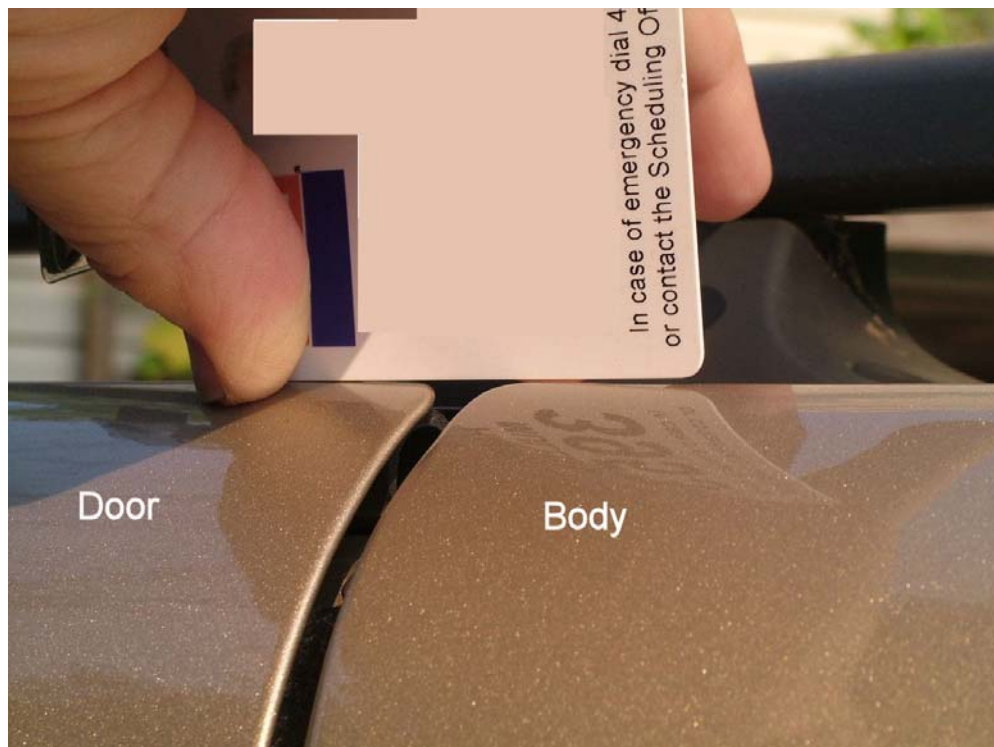
Proper Vertical Alignment Top Rear of Left PSD with Roof

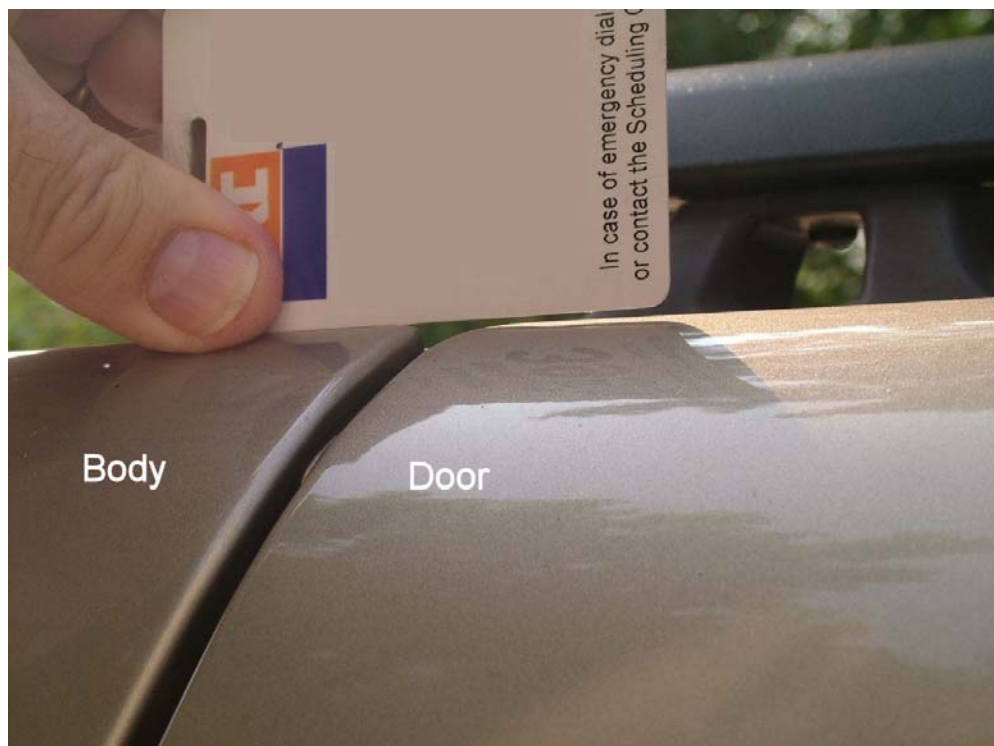
- When the doors are closed and latched, the top rear corner of the right door is slightly below the adjacent body panel, whereas the top rear corner of the left door is virtually even with the adjacent roof panel.

Vertical Misalignment of Top Rear of Right PSD with Roof

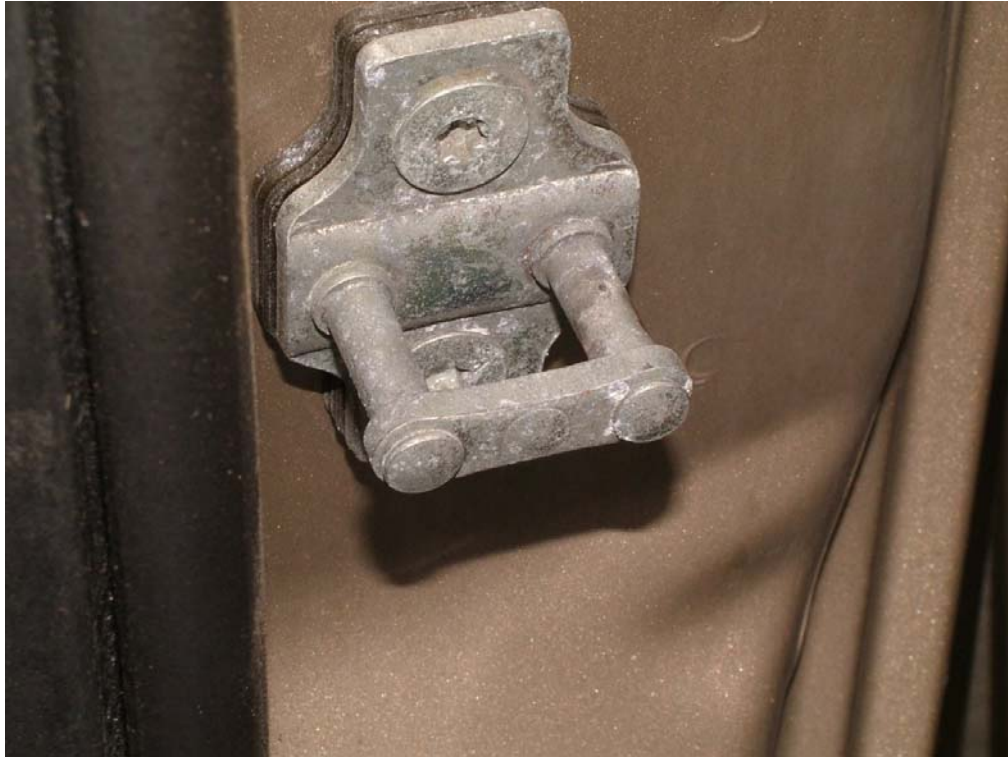
- There is a latch and striker on both the front and rear of the sliding doors. This vehicle exhibits different wear patterns between the left and right strikers.

Striker on Body at Rear of Left PSD

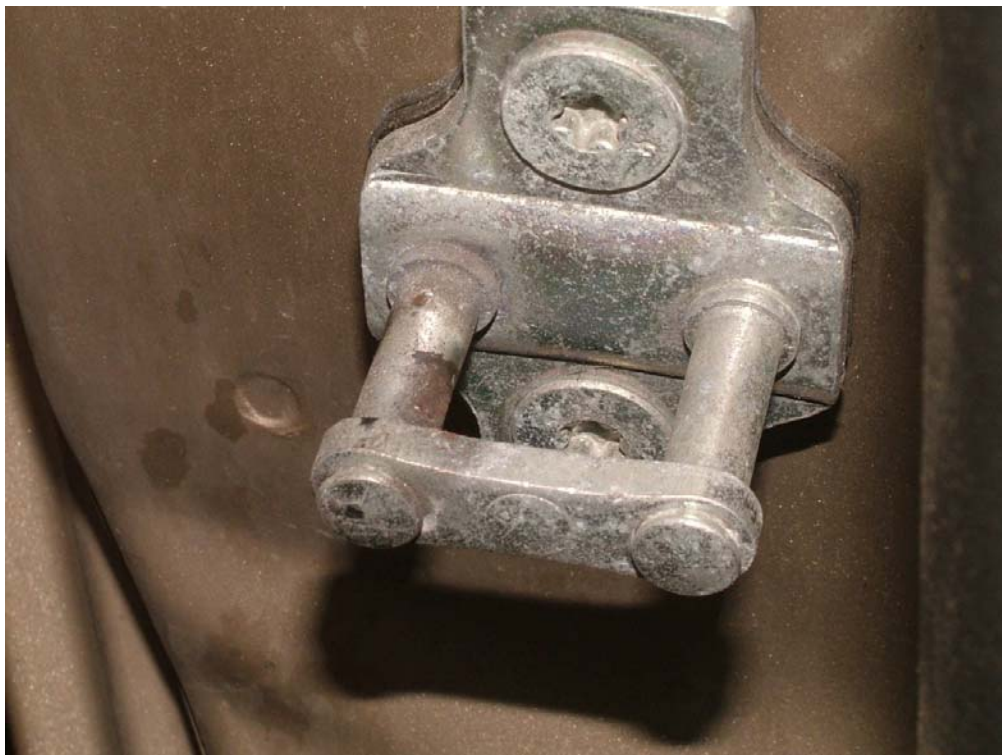
Striker on Body at Rear of Right PSD

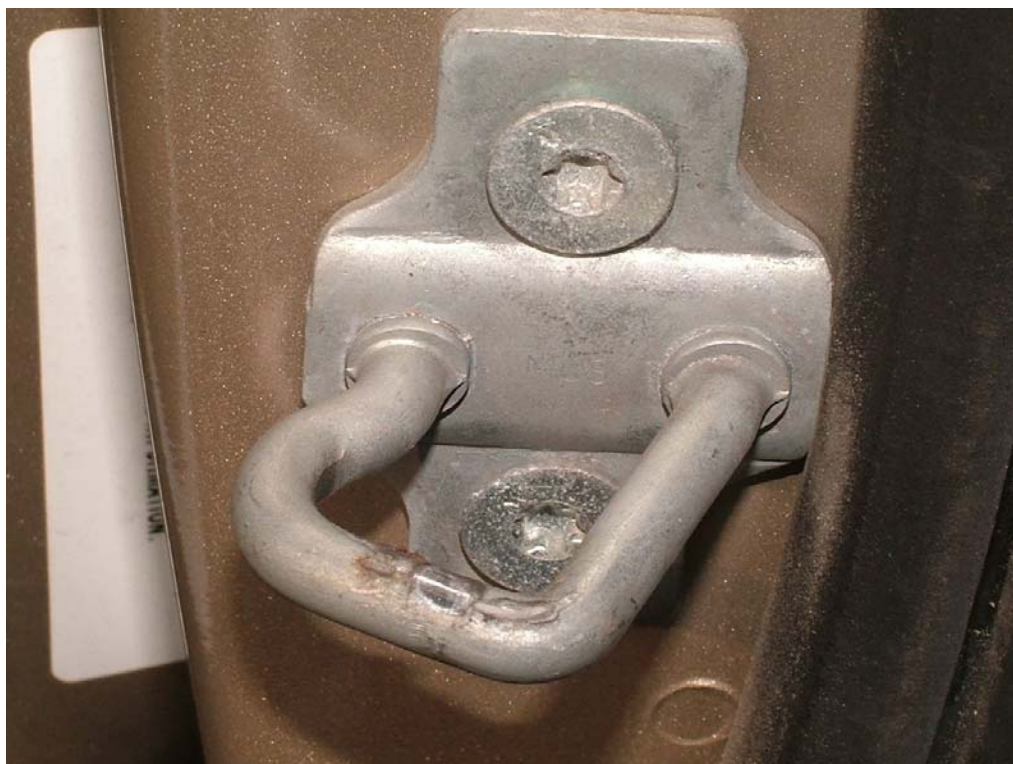
Striker on Body at Front of Left PSD

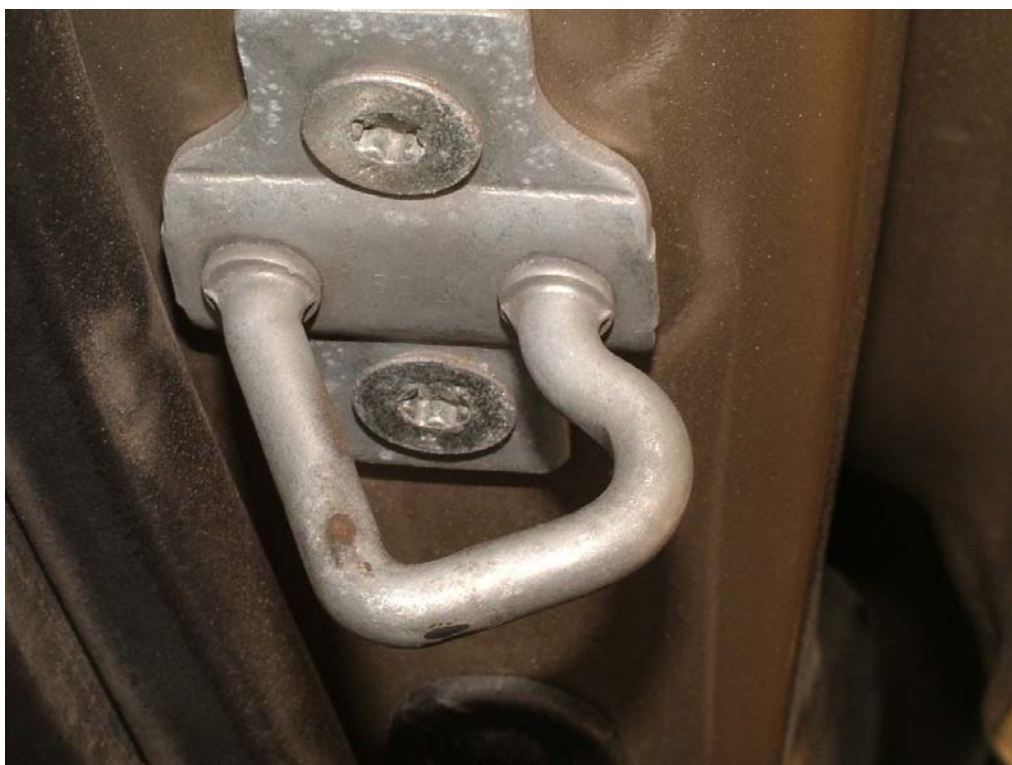
Striker on Body at Front of Right PSD

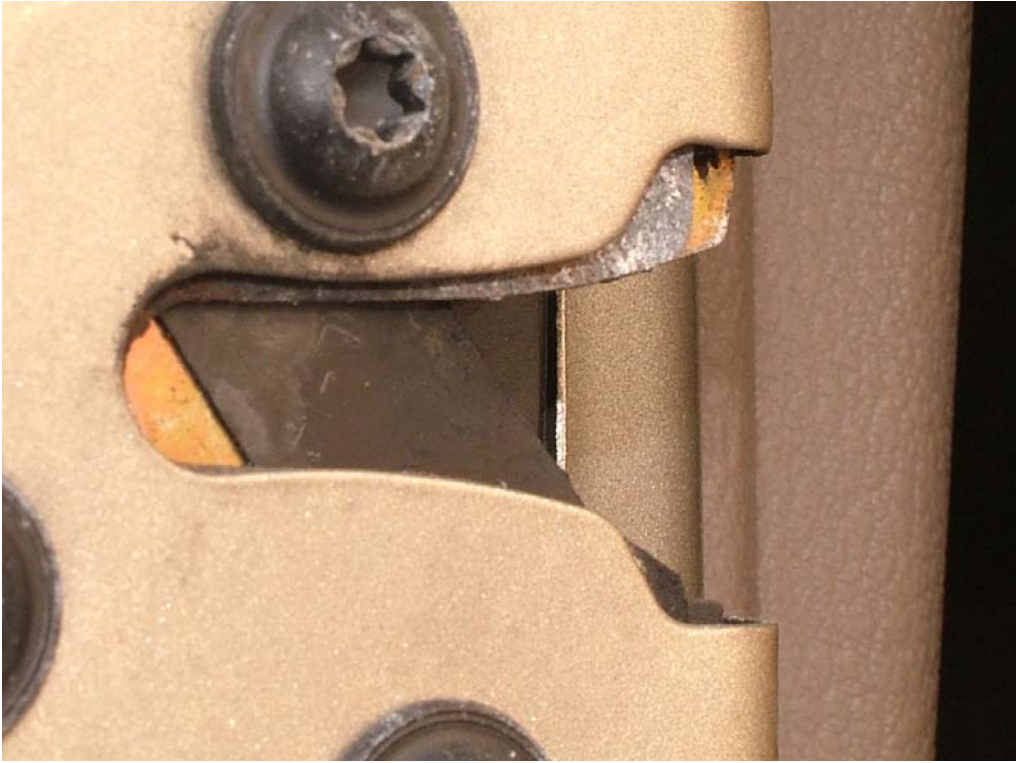
Latch Mechanism at Front of Left PSD

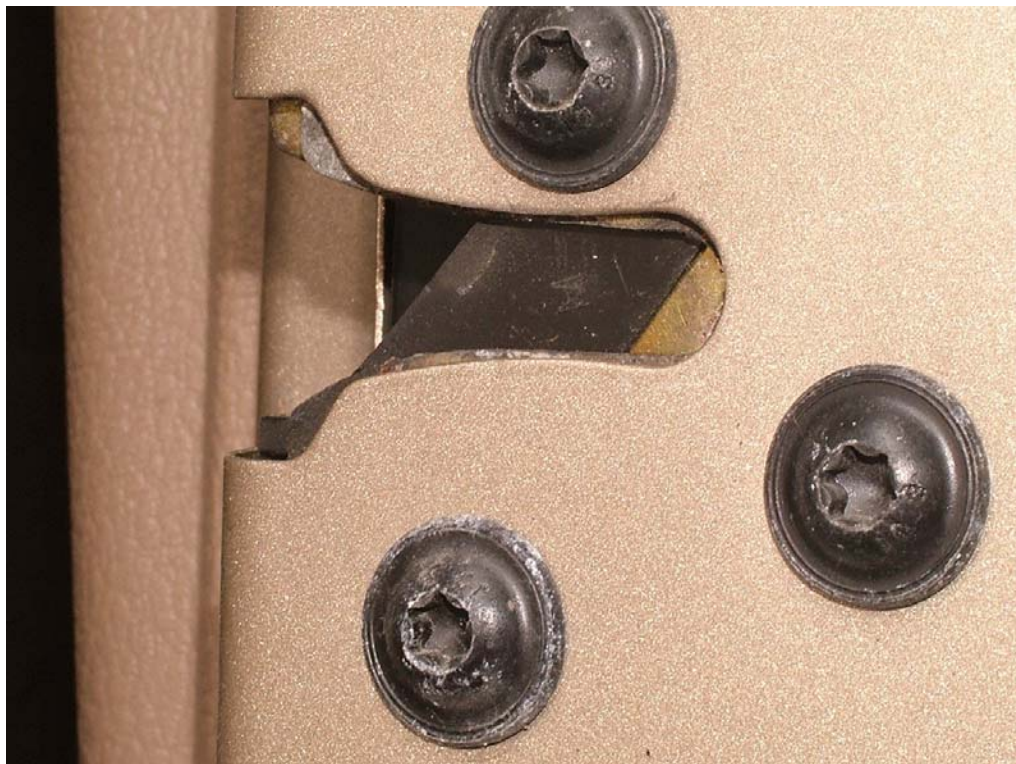
- When viewing the rear of the sliding doors in the open position, the latch mechanism on the right door is adjusted slightly higher in the latch slot of the door than is the mechanism in the left door.

Latch Mechanism at Front of Right PSD

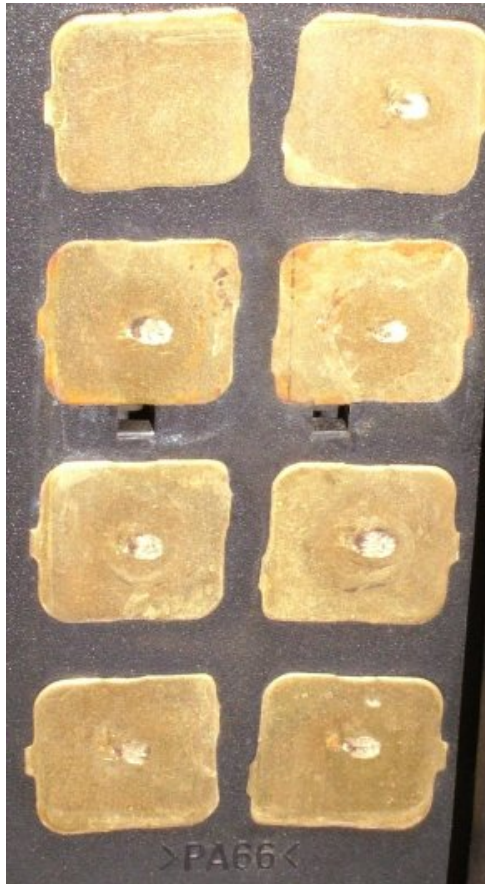
- The vehicle is equipped with seven electrical contacts between the door and the B-pillar. The pads on both B-pillars exhibit evidence of contact with the mating buttons on the door. The pads on the right door show that the buttons make marginal contact with the pads, near the top edge of the pads, whereas the pads on the left door show that the button contact point is almost perfectly centered.

Electrical Contact Pads on Left PSD

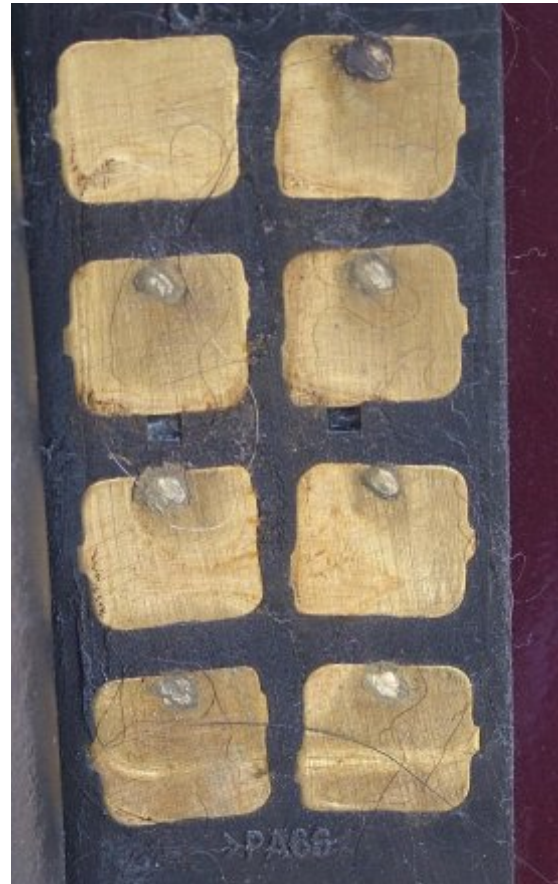
Electrical Contact Pads on Right PSD

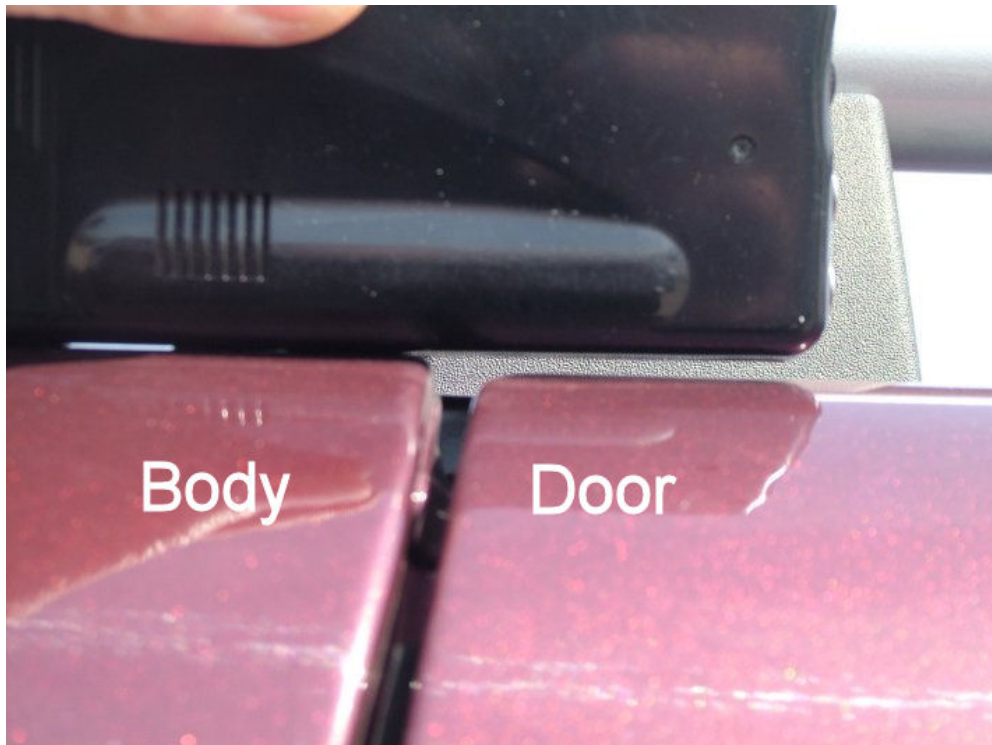
- The door was operated approximately ten times during the inspection and did not exhibit any inappropriate operation.
- The rear of the right door is misaligned vertically. When the doors are closed and latched, the top rear corner of the right door is slightly below the adjacent roof panel, whereas the top rear corner of the left door is even with the adjacent roof panel.

Vertical Misalignment of Top Rear of Right PSD with Roof

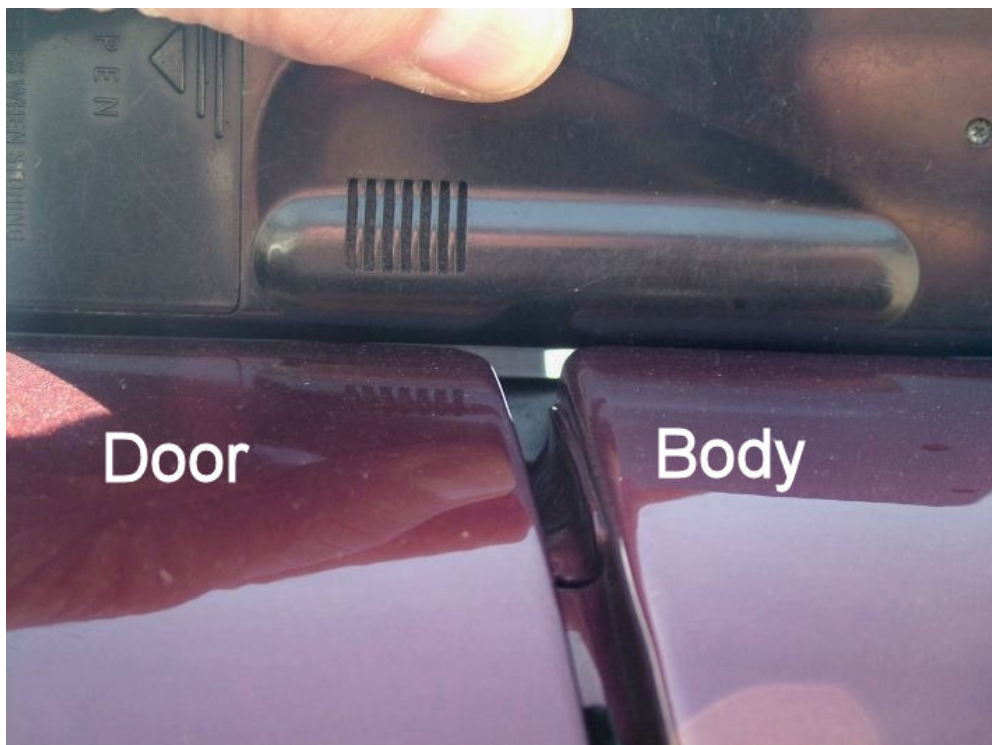
Proper Vertical Alignment of Top Rear of Left PSD with Roof

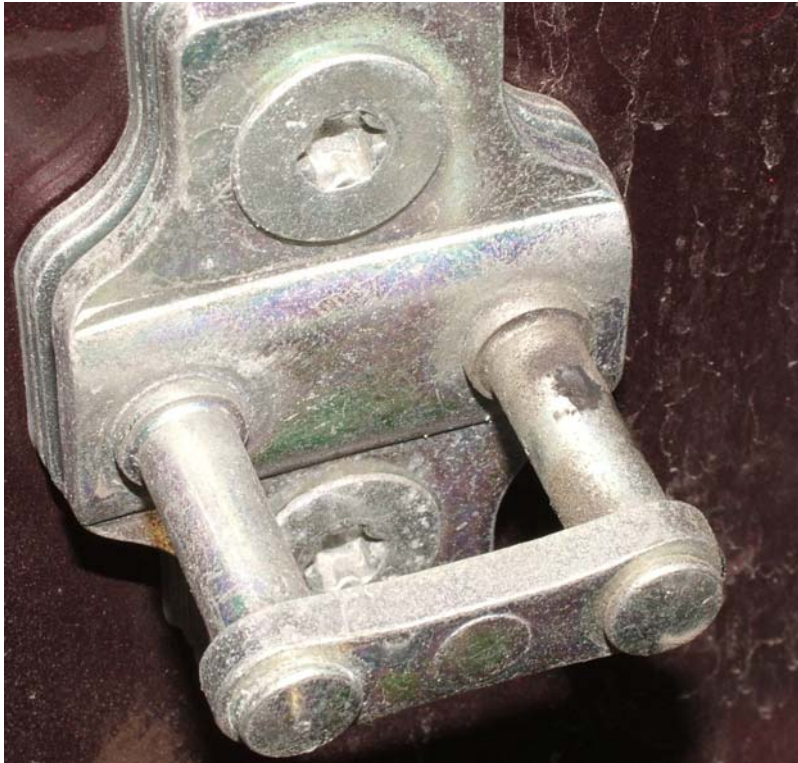
- The striker on the body on the right side exhibits less wear than does the striker on the left side.
- There is a latch and striker on both the front and rear of the sliding doors. This vehicle exhibits different wear patterns between the left and right strikers.

Striker on Body at Rear of Left PSD

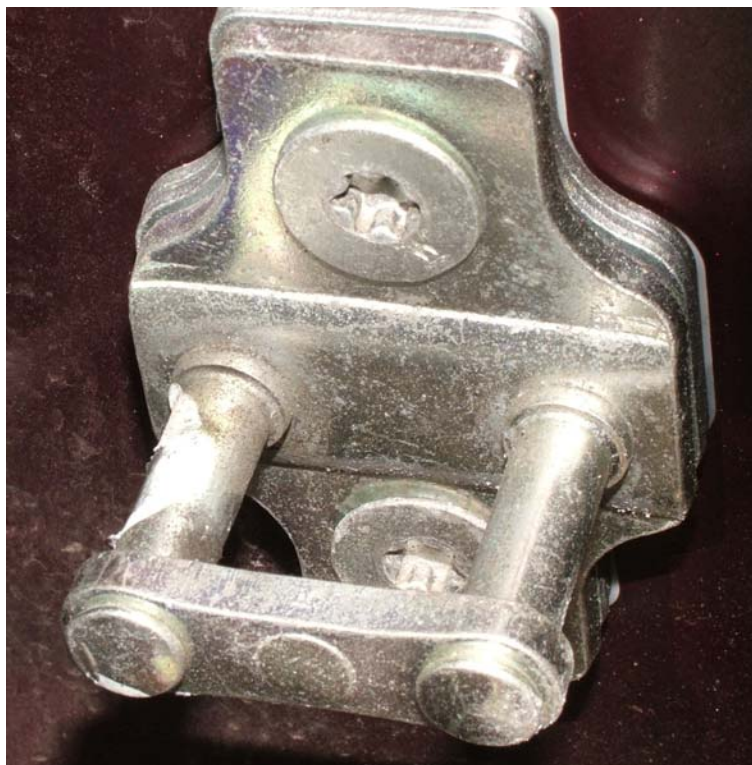
Striker on Body at Rear of Right PSD

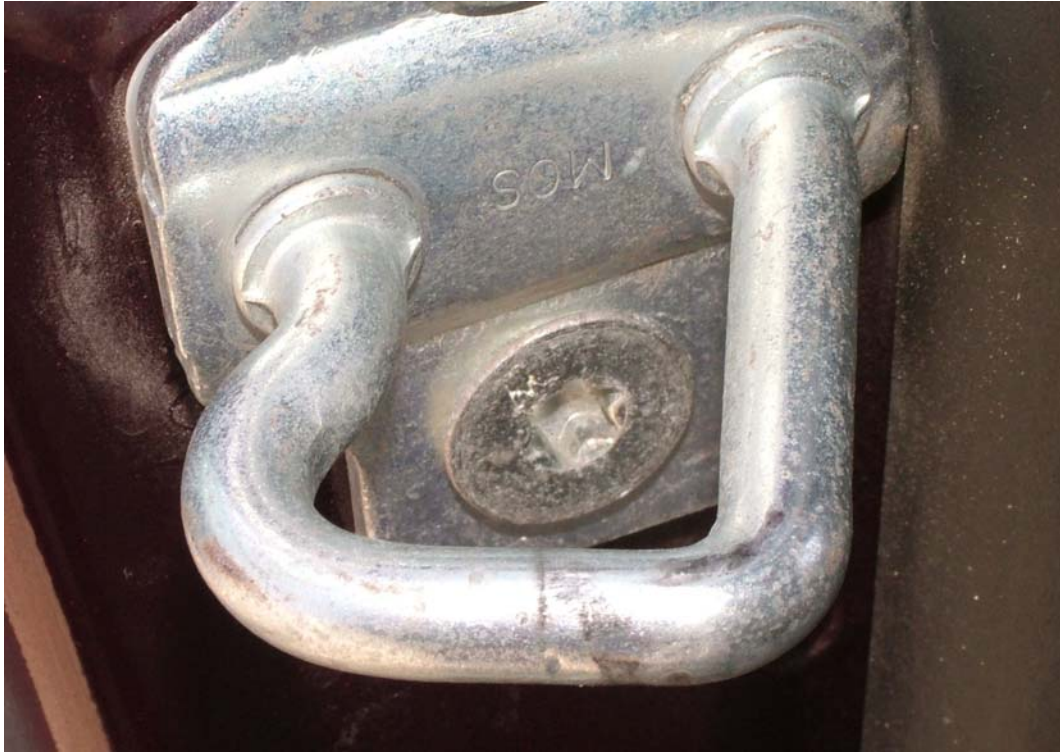
Striker on Body at Front of Left PSD

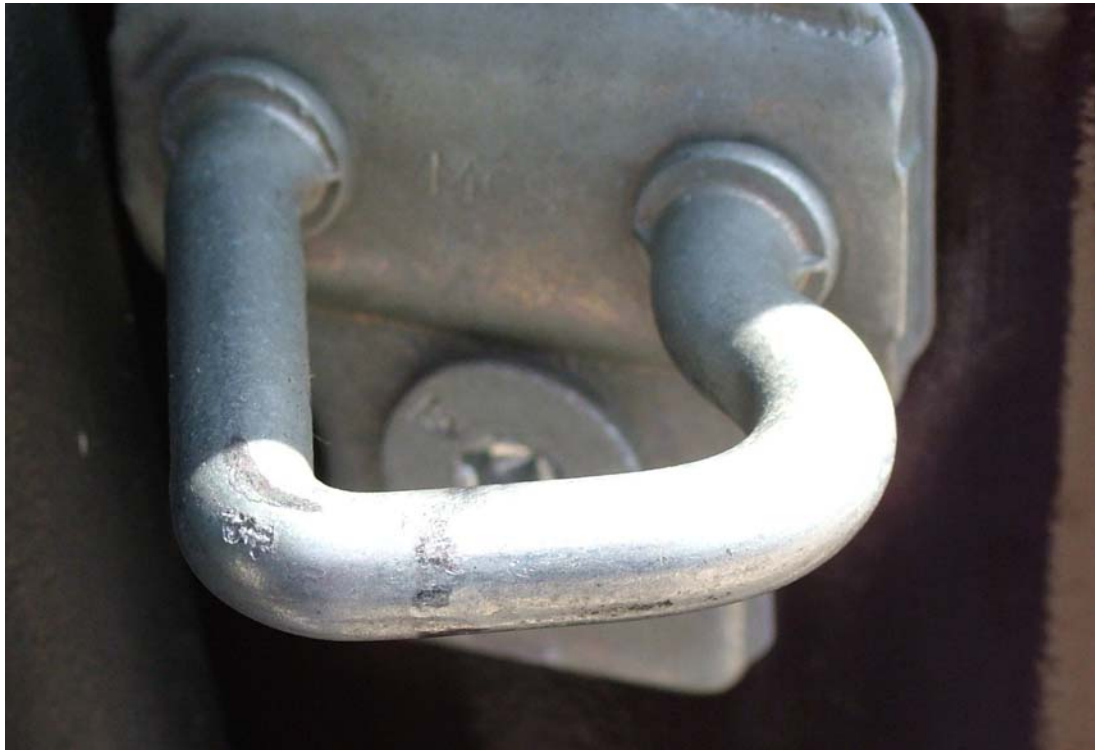
Striker on Body at Front of Right PSD
