Service Bulletin

Bulletin No.: 07-08-64-007D

Subject: General Power Sliding Side Door Diagnosis/Repair Procedures

Models: 2005-2007 Buick Terraza
 2005-2009 Chevrolet Uplander (Includes Canada and Mexico)
 2005-2009 Pontiac Montana SV6 (Includes Canada and Mexico)
 2005-2007 Saturn Relay

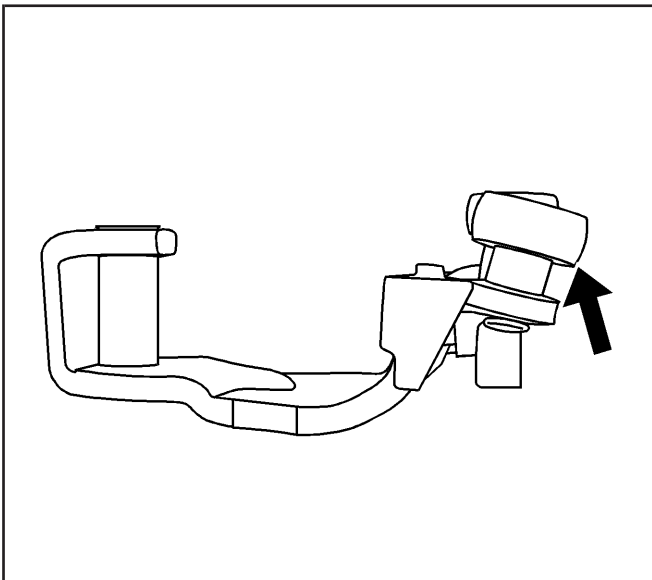
2035273

The power sliding side door motor continues to run for up to three seconds after the door has fully closed or the customer may describe this as a grinding noise (Overcinch).

1. A center roller bracket may be bent or have loose rollers. Refer to the illustration above.
2. The power sliding side door may not have the latest programming.

3. The door is closing too quickly. It needs to see two detente signals 450 milliseconds apart. The latest program calibration for the PSD, in combination with the door to body adjustment and the proper seal flange adjustment at the rear latch, slows the sliding door into the latch, allowing the system to appropriately determine the secondary and primary latch position. This minimizes overcinching.

1. Remove and inspect the center roller bracket. If the rollers are loose to the bracket or bent, replace the bracket.
2. After replacing the center roller bracket, check for a properly tensioned door. Refer to Rear Side Door Actuator Cable Tension Adjustment.
3. Upload the new programming. Latest PSD Software calibration can be found on the Service Programming System (SPS) using "TIS2WEB". Input of the VIN will find the latest software calibration program to upload to the PSDM controllers in the vehicle. If the overcinching is still present, go to step 4.

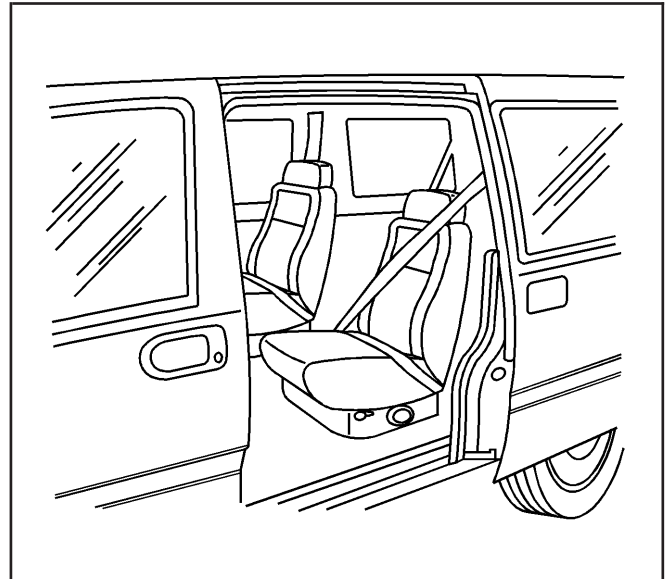
1891770

1. Inspect the door opening and tracks for obstructions. Refer to the illustration above.

1. Eliminate any obstructions in the tracks.

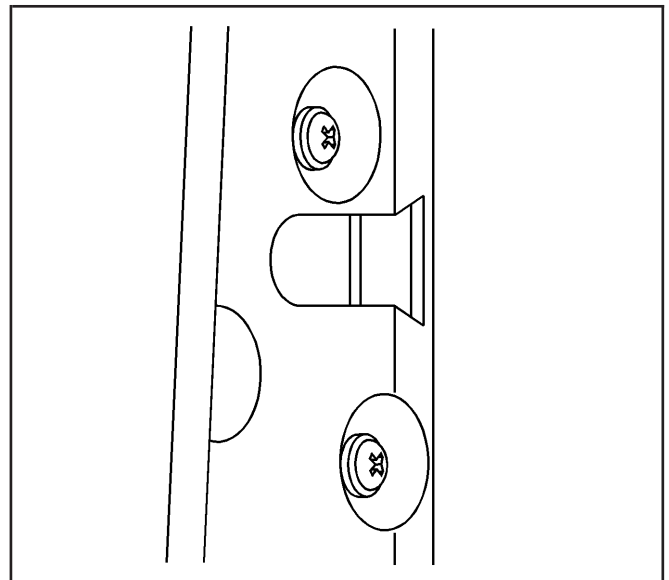
1891774

2. Inspect the C-Pillar striker alignment. Refer to the illustration above. Look for witness marks on the top and bottom of the latch. Turn the system off and close the door. Open the door slowly and look to see if the door jumps up, or falls off the striker.

The striker should line up with the center of the latch. Its purpose is to hold the door shut and adjust in or out, not up and down. Up or down adjustments should be made at the center roller bracket.

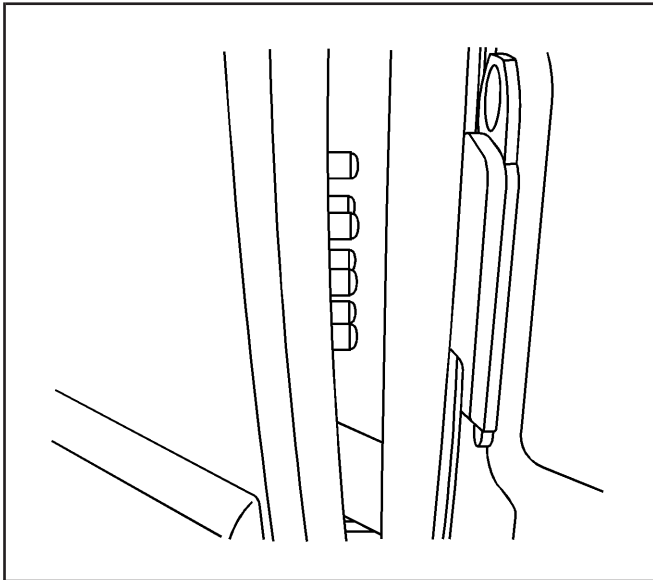
1891776

- 3. Inspect the pad and plunger alignment. Refer to the illustration above.

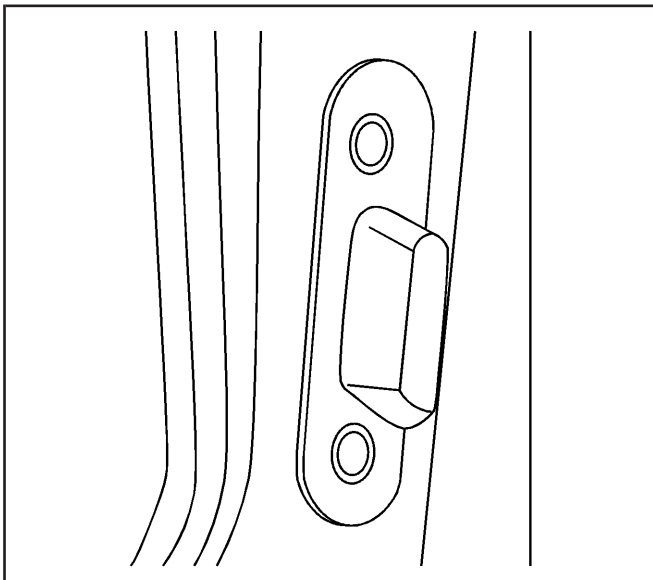
1891777

- 4. Inspect the pin and pocket alignment. Refer to the illustration above. Coating the pin with white lithium grease will leave visible witness marks on the pocket.

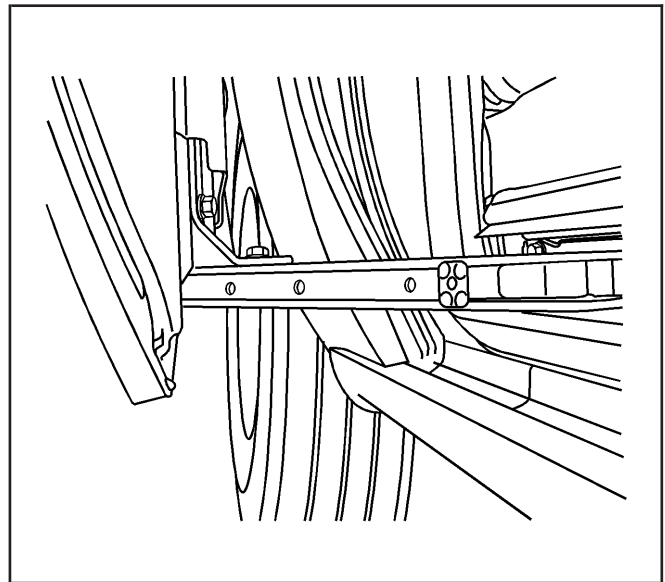
1891781

- 5. Inspect the lower hinge arm clearance to the primary seal. Refer to the illustration above. If there are witness marks on the lower weatherstrip towards the front, the lower roller bracket will need to be adjusted.

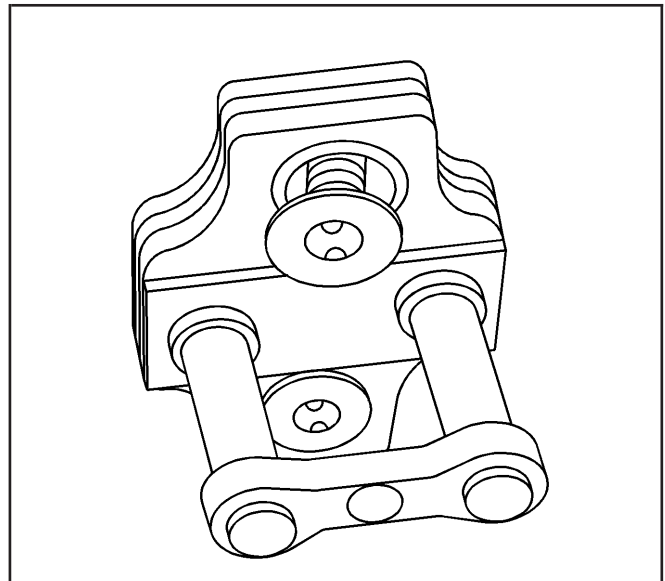
1891782

- 6. Inspect all door hardware for alignment and to make sure it is properly seated. Refer to the illustration above.

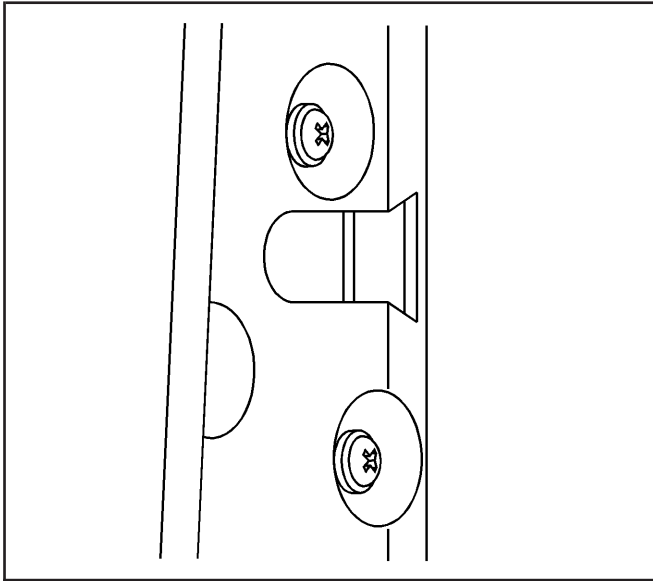
1891793

The power sliding side door starts to close then reopens.

1. Inspect the "C" pillar for proper alignment. Refer to the illustration above.

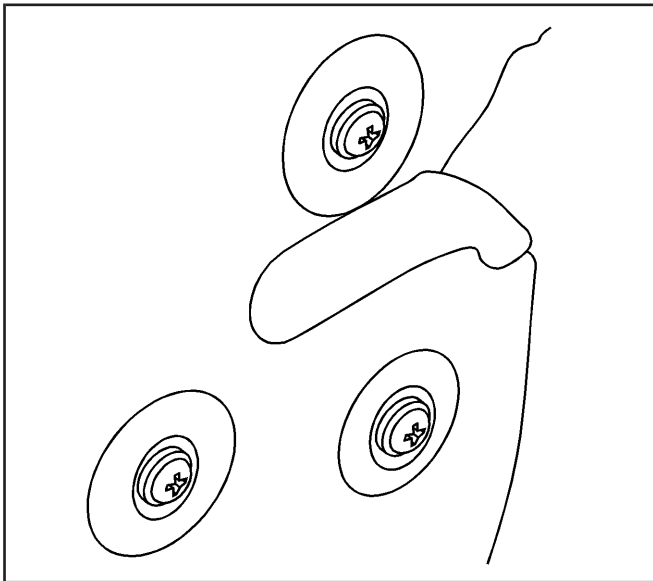
1891796

2. Inspect the "C" pillar for latch wear. Refer to the illustration above.
3. Inspect the "C" pillar for a bent striker.

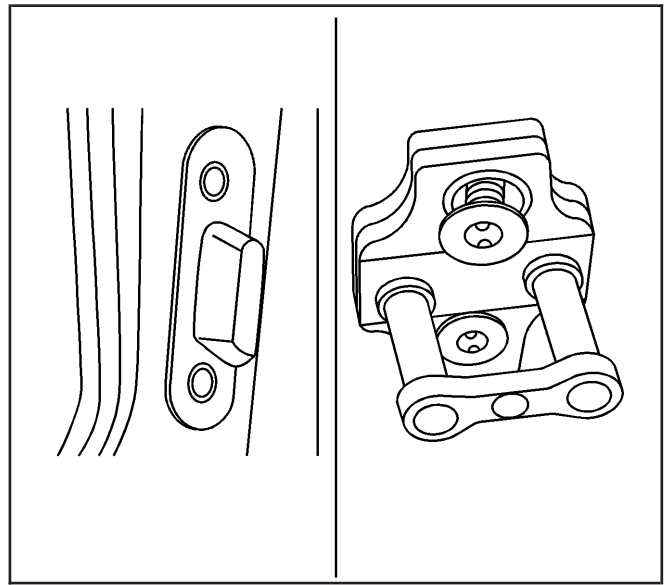
1891798

4. Inspect all door hardware for alignment and make sure it is properly seated. Refer to the illustration above.
