# ODI RESUME

Investigation: EA08-006  
Date Opened: 02/21/2008  
Principal Investigator: Cynthia Glass  
Subject: Engine Compartment Fire  
Date Closed: 04/15/2009

Manufacturer: Chrysler LLC  
Products: 2007 Chrysler Pacifica with 4.0L Engine  
Population: 51,590

Problem Description: A fire occurred in the engine compartment.

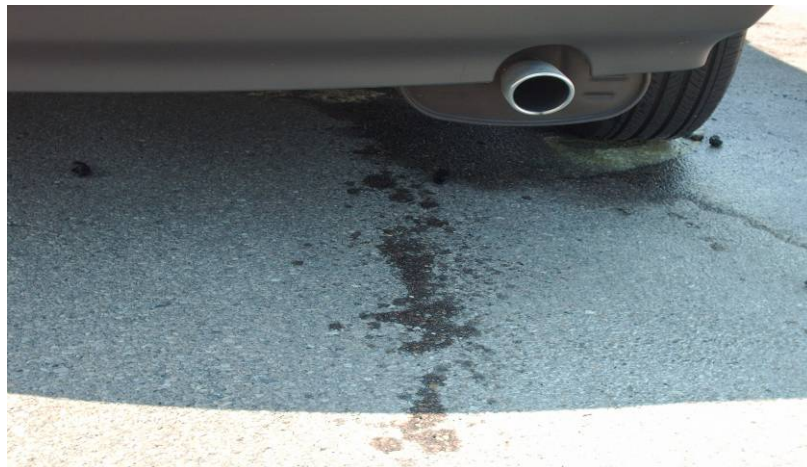
The alleged defect is fire in the engine compartment. Consumers allege that while driving, a fire started on the driver's side, near the front of the vehicle. Some consumers report observing a puddle of power steering fluid on the ground under the vehicle prior to the alleged fire. Other complaints report a power steering fluid leak but no fire, (Figure 1).

*Figure 1: Example of a power steering fluid leak*

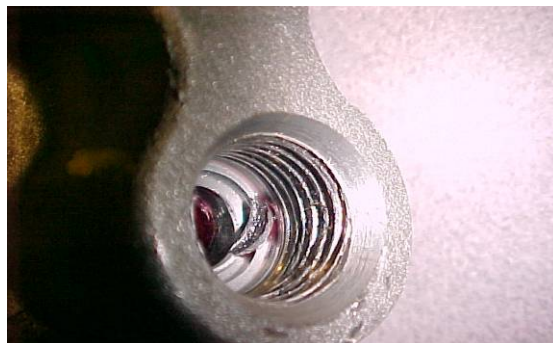
A fire may result when power steering fluid contacts a hot engine component, particularly the exhaust system. Chrysler has indicated that leaks occurred at the connection between the high pressure hose and the power steering gear. Chrysler discovered that the tube nut on the high pressure power steering hose could be cross-threaded during the assembly process. The cross-threading connection prevents the o-ring from properly sealing the steering gear (Figure 2). An improperly seated o-ring may allow power steering fluid to leak onto a hot exhaust system and cause a fire.

*Figure 2: Damaged threads in the tube nut*

Cross-threading of the tube nut occurs when an operator does not properly align the tube nut, (i.e. the threads on the nut do not align with the threads in the hole), and then turns the nut until it is tight. In a cross-threaded condition, the resisting tightening (turning) torque is produced by the interference between the threads on the nut and the threaded hole. As a result, the nut may not properly turn to the bottom of the threaded hole and the o-ring will not seal even though the nut may feel tight to the operator. When the line is pressurized, power steering fluid may leak out.

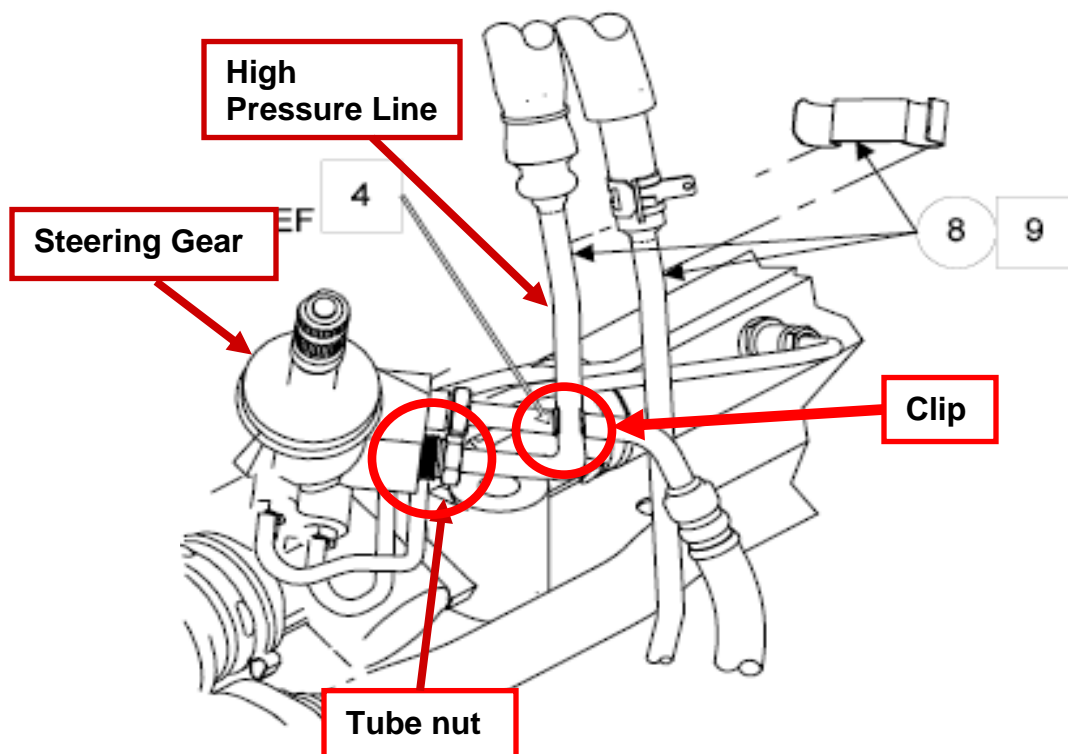
Process Change A: On May 12, 2006, Chrysler revised the assembly process to require an operator to install a clip that attaches the power steering high pressure line to the steering gear assembly in the 4.0L engine, (Figure 3). The purpose of the clip was to hold the power

steering high pressure line stationary while the operator secured the high pressure hose to the steering gear with a tube nut. Chrysler later found that the clip may have created a mis-alignment of the tube nut with the threaded hole in the steering gear, creating a risk that the operator may cross-thread the tube nut.

*Figure 3: Sketch of the 4.0L engine with the clip and tube nut attachments*

Process Change C: On May 12, 2007, Chrysler revised the assembly process for a single operator to “first hand start the tube nut prior to attaching the clip.” Chrysler found that hand starting the tube nut BEFORE stabilizing the power steering high pressure line with a clip, reduced the potential for cross-threading.

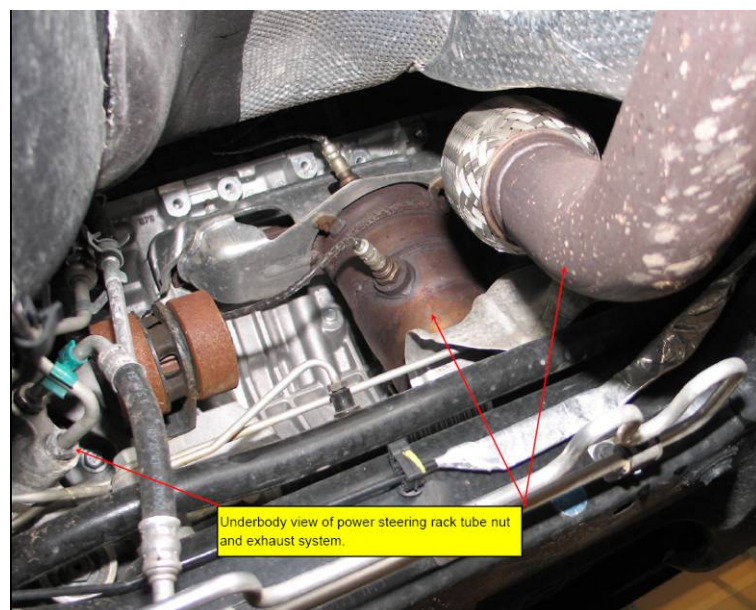
The high pressure connection at the steering gear is in close proximity to components of the exhaust system that get very hot during vehicle operation. Power steering fluid is combustible under high temperatures. When power steering fluid comes into contact with a hot surface, such as the exhaust system, it can ignite, resulting in an engine fire. In the subject vehicles, there is no dispute that the root cause of the low-mileage fires is the cross-threaded connection permitting power steering fluid to leak onto components of the exhaust system, which then may result in a fire. Figure 6 shows the proximity of the high pressure connection to the exhaust system.

**Figure 6: Underbody view of the tube nut and exhaust system**
