ODI RESUME

Investigation: EA 08-007
 Prompted By: VOQ & EWR Field Reports
 Date Opened: 03/14/2008 Date Closed: 03/31/2009
 Principal Investigator: Bruce York
 Subject: Violent Front End Oscillation

Manufacturer: Ford Motor Company
 Products: 2005-2007 F-250 & F-350 Super Duty 4X4 Vehicles
 Population: 520,909

ENGINEERING ANALYSIS CLOSING REPORT

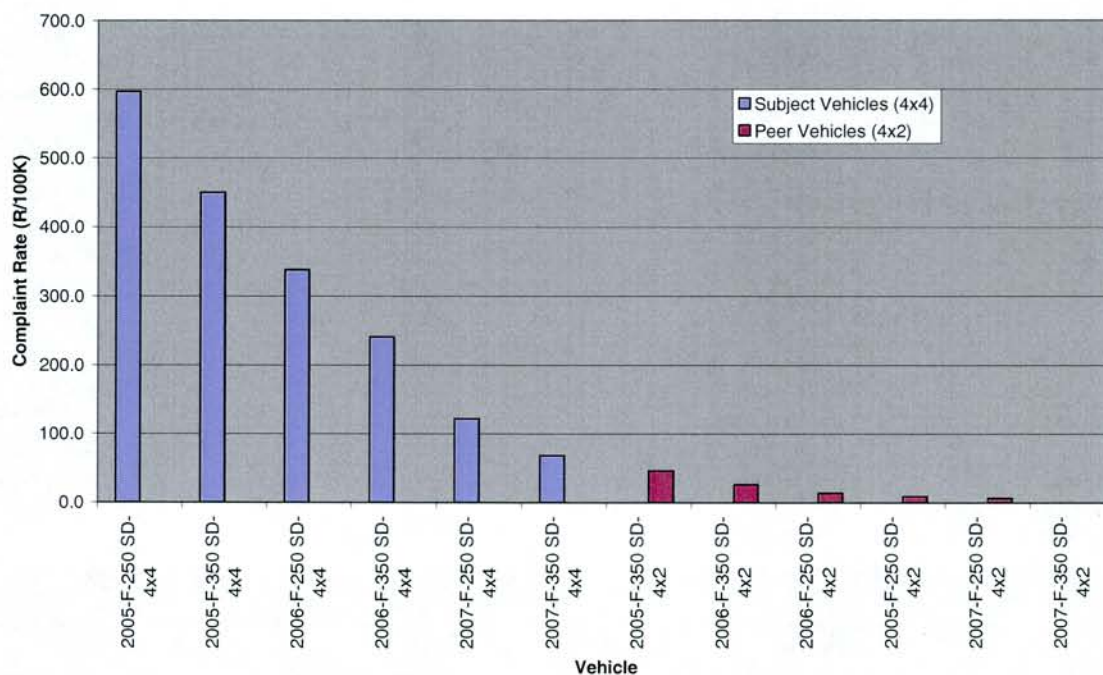
Chart 1. Complaint Rate Analysis

Chart 1. shows that the subject vehicles have a higher complaint rate than similar sized 4x2 vehicles. These 4x2 vehicles do not have a solid front axle and therefore forces generated on one

wheel are not transferred to the other wheel as occurs on the subject vehicles. Chart 2. shows the subject vehicles complaint rates compared to 2004 Ford Super Duty vehicles built with a leaf spring style suspension and peer vehicles manufactured by GM. The GM vehicles are manufactured with a torsion bar (4x4) or a coil spring (4x2) suspension. This chart shows that the subject vehicles with the lowest complaint rate have a rate over three times that of the 2004 Super Duty vehicles and over 15 times that of the GM vehicle with the highest complaint rate (the MY 2005 through 2007 Chevy Silverado 2500 4X4).

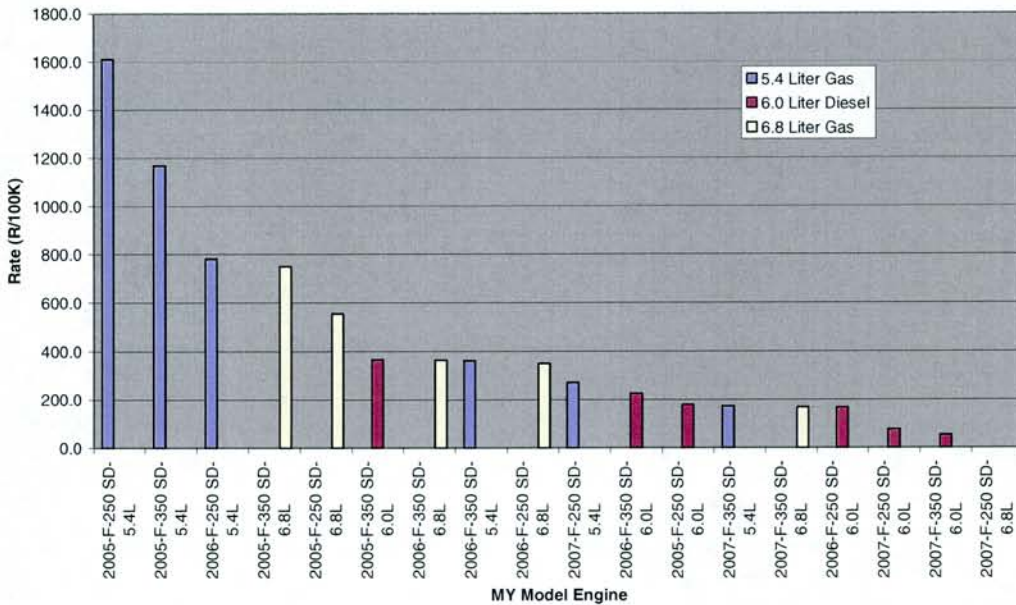
Chart 3. Complaint Rate Analysis

Chart 3. shows that the subject vehicles with gasoline engines have a higher complaint rate than subject vehicles with diesel engines.
