# ODI RESUME

**Investigation:** EA 08-015  
**Prompted by:** PE08-026  
**Date Opened:** 08/08/2008 **Date Closed:** 04/12/2010  
**Principal Investigator:** Michael Lee  
**Subject:** Unexpected Closing of Power Liftgate

**Manufacturer:** HONDA (AMERICAN HONDA MOTOR CO.)  
**Products:** 2005 Honda Odyssey Touring  
**Population:** 25,230

## **EA08-015: Honda Odyssey Power Liftgates**

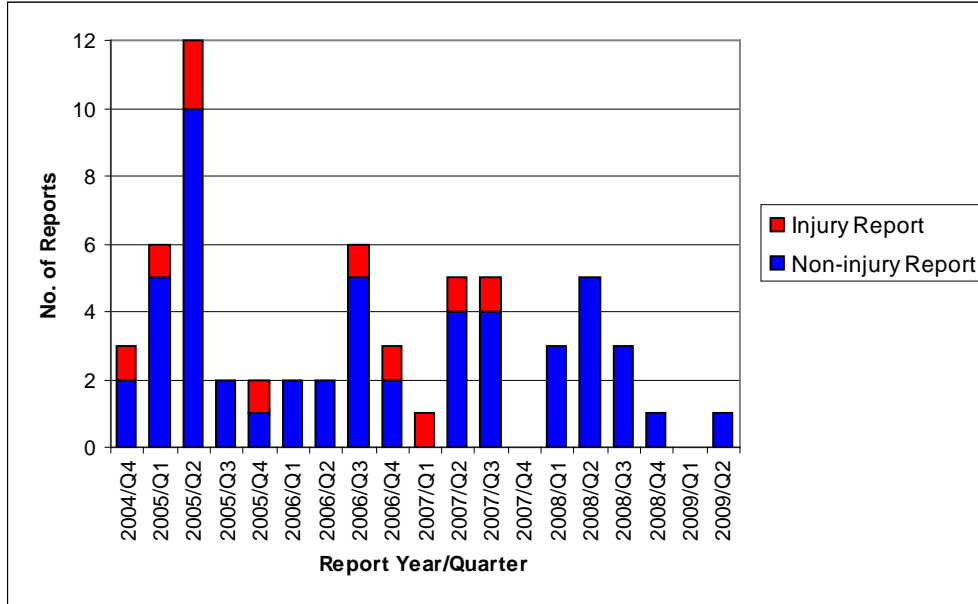
**Figure 1. Complaints by Report Year/Quarter**

Figure 1 shows an overall steady trend of complaints on the subject vehicles over time.

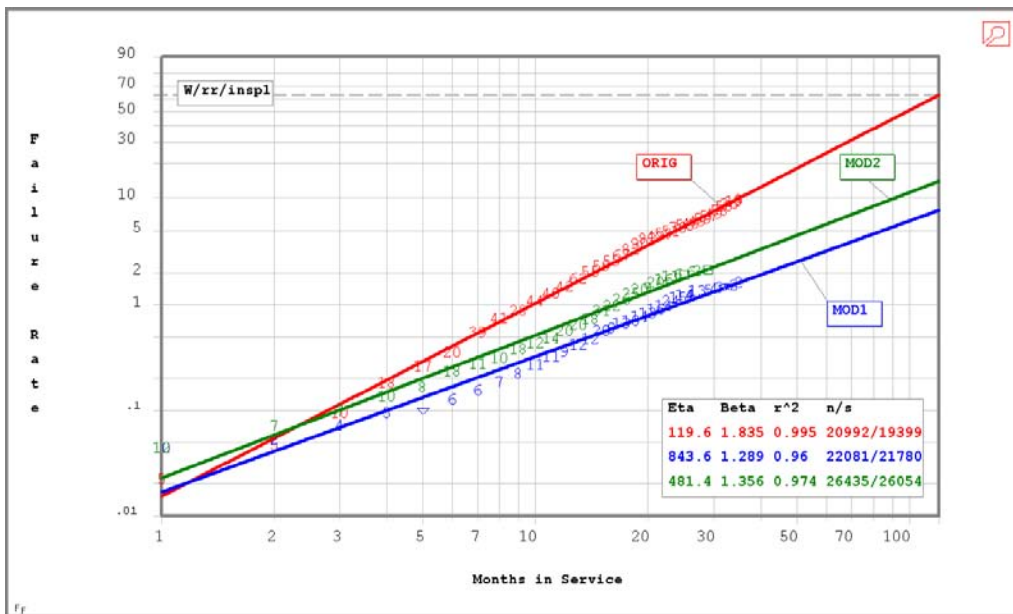
**Figure 3. Weibull Analysis of Warranty Claims**

is about 1.8 for the ORIG strut design and it is about 1.3 for MOD1 and MOD2 strut designs.<sup>6</sup> The Weibull analysis indicates an increasing failure trend for the ORIG strut design used in the subject vehicles. The Eta value is called the characteristic life and represents the time in service when 63 percent of the population is expected to fail: the Eta is about 120 months for the ORIG strut design which is much shorter than that of MOD1 and MOD2 strut designs, about 844 and 481 months, respectively.
