ENGINEERING ANALYSIS CLOSING REPORT

SUBJECT: Intermediate Steering Shaft Binding

EA No.: EA08-017

SUBJECT VEHICLES: Model Year (MY) 2002 through 2004 Kia Sedona minivans sold or registered in salt-belt states.¹

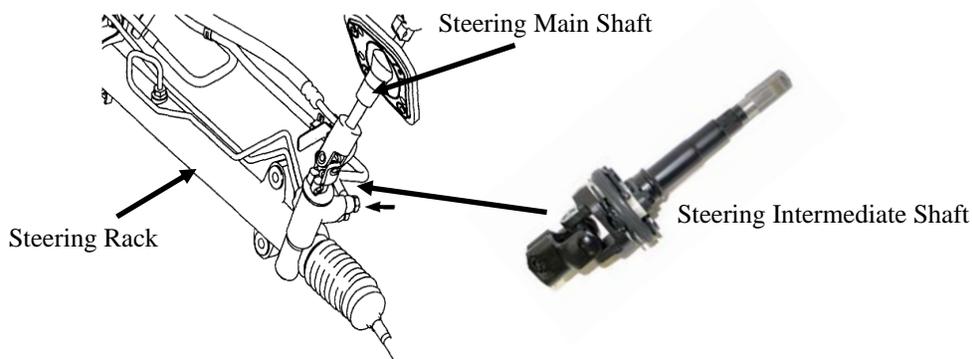
COMPONENT DESCRIPTION: The steering intermediate shaft (SIS) allows for connection of the primary steering column/shaft and the power steering rack input shaft. Because of the change in angle required, the SIS is equipped with a universal joint (Figures 2). This universal joint allows for off-axis rotation and allows steering wheel hand forces to smoothly apply torque to the steering rack input shaft.

Figure 2. Component detail – Steering Intermediate Shaft.

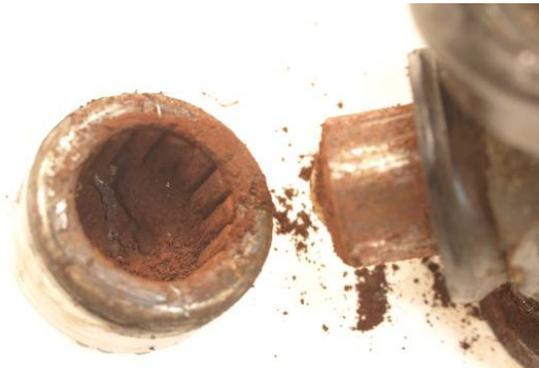
ALLEGED DEFECT: The steering intermediate shaft universal joint bearings may corrode over time (Figure 3), which can result in increased steering effort – particularly during initial steering maneuvers after the vehicle has been parked over night or longer.

Figure 3. Corroded SIS universal bearing.

FAILURE MECHANISM / CONTRIBUTING FACTORS: The primary contributing factor to the alleged defect is the loss of lubrication due to failure of the SIS universal bearing cap seals. Failure of the seals allows water to intrude into the bearings which then corrode and over time will lead to increased steering effort. Exposure to de-icing materials (road salt) will cause the bearings to degrade faster.

TECHNICAL SERVICE BULLTIN: Kia issued technical service bulletin TSB-CHA-019, “Sedona (GQ) Increased Steering Effort,” in October 2008, to provide dealers with instructions for diagnosing and repairing the alleged defect condition in the subject vehicles. The bulletin states that in areas where road salt is used, if a customer complains of increased steering effort or noise while steering the steering intermediate shaft should be checked and or replaced to address the concern.

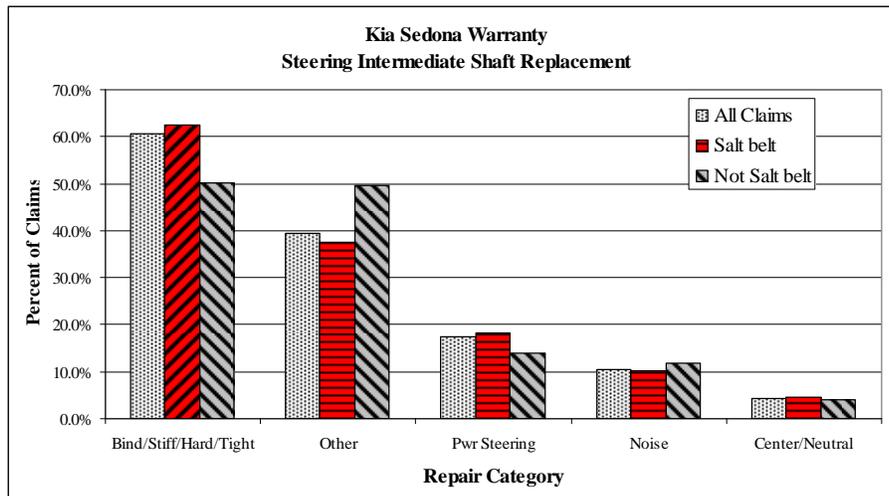
ODI’s analysis of the 1,231 claims that included owner comments found that the most frequent complaint was for hard or stiff steering (Figure 4). Approximately 18% of these claims were related to some other power steering problem, like “steering rack replacement” or “leaking fluid”. Note also that the sum of categories are greater than 100 percent, since many claims are counted in more than one category (e.g., claims for binding, stiff or hard steering also claim noise or “Other” comments)².

Figure 4. Sedona warranty by complaint category.
