# ODI RESUME

Investigation: PE 08-009  
Date Opened: 02/01/2008  
Principal Investigator: Bruce York  
Subject: Power Steering Pump Failures  
Date Closed: 07/03/2008

Manufacturer: Freightliner LLC  
Products: 2004 thru 2005 MY Freightliner Century and X-Line Models  
Population: 47,115

## PRELIMINARY EVALUATION CLOSING REPORT

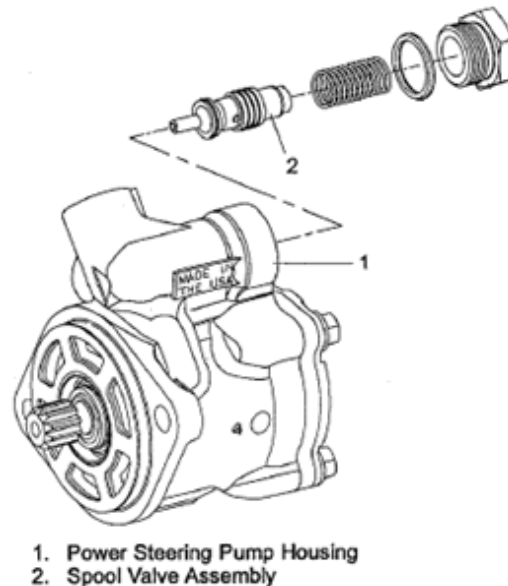
Figure 1. Power Steering Pump

**FAILURE MODES:** Field Service Bulletin FSB 46-38 released by Freightliner provides repair procedures to be followed by service technicians when a driver or owner reports an increase in steering effort on a subject vehicle equipped with a TRW power steering pump. This FSB instructs that the spool valve or the entire pump should be replaced if the pump fails to pass a diagnostic test. TRW has described the specific failure mode as a gradual reduction in the “speed of steer” in a hydraulic powered steering system caused by the progressive wearing of the power steering pump flow control valve spool. TRW further explained:

*This valve maintains a relatively constant oil flow rate to the steering gear regardless of the engine speed. The “speed of steer” is the speed at which the steering wheel can be rotated with power assist. The speed of steer is limited by the oil flow rate from the power steering pump. The oil flow rate to the steering gear may be reduced if the flow control valve begins to wear. The vehicle still has power assist but the maximum rotational speed of the steering wheel gradually slows as the flow control valve spool wears over time. This gradual loss of speed of steer is evidenced by a noticeable degrading of assist during parking maneuvers when drivers experience much higher rates of steering wheel rotation than they do at highway speeds.*

**SERVICE BULLETINS:** A Field Service Bulletin (FSB) FSB 46-38 released by Freightliner in November 2005 describes how the subject vehicles may experience reduced power assist as a result of a failed power steering pump. If the power steering pump fails a diagnostic procedure, the FSB instructs the repair technician to either install a new spool valve or replace the entire pump depending on the date of pump manufacture. This FSB was later updated in June 2006 with a corrected diagnostic procedure and revised title.
