U.S. Department  
of Transportation  
**National Highway  
Traffic Safety  
Administration**

## ODI RESUME

Investigation: PE 08-053  
Date Opened: 09/12/2008  
Principal Investigator: Peter Kivett  
Subject: Drag Link Failure

Problem Description: Drag-link failure resulting in a loss of steering control.

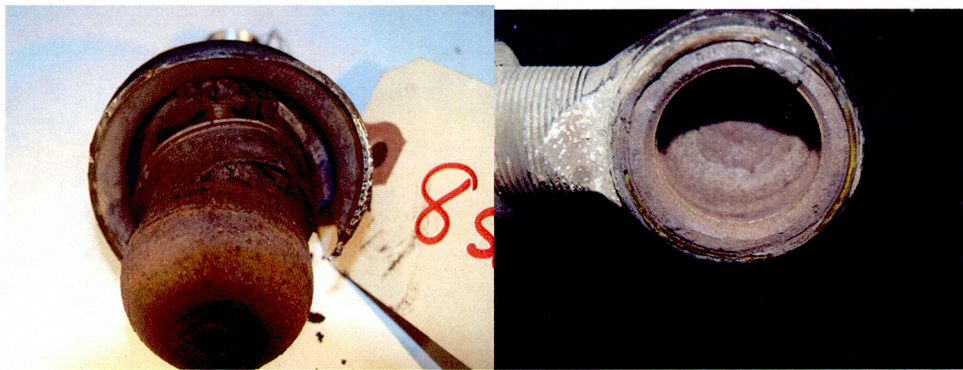
ODI theorizes that moisture can penetrate into the ball and socket assembly of the drag link ball joint (Figure 1), which at some point will compromise the joint integrity.

Figure 1: Drag link steering ends recovered from the field with extensive corrosion

Since there is no "zerk" fitting (Figure 2) to flush the ball joint free of foreign contaminants, ODI theorizes that ultimately corrosion causes the ball and socket to wear. Eventually, due to the heavy loads and constant road vibration, this wear causes the ball to detach from the socket resulting in a catastrophic failure of the drag link.

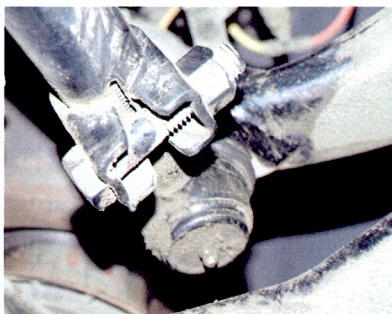
Figure 2: Photo of a peer vehicle that uses a "zerk" fitting
