ODI RESUME

Investigation: EA08-009
 Prompted By: PE08-002
 Date Opened: 04/28/2008 Date Closed: 12/16/2009
 Principal Investigator: Chris Lash
 Subject: Brake line chafe

ENGINEERING ANALYSIS CLOSING REPORT

SUBJECT: Brake Line Chafe

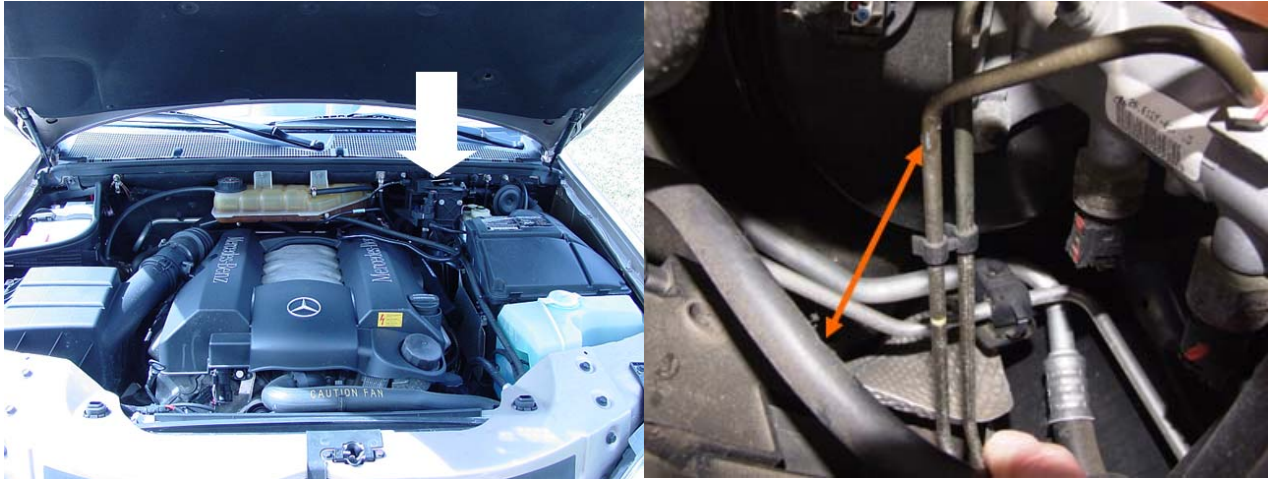
ALLEGED DEFECT: The brake line from the master cylinder to the ABS pump may leak due to chafing with the fuel supply line (Figure 2).

DESCRIPTION OF THE SUBJECT COMPONENT: The line bundle is attached to the vehicle frame by plastic clips at eight different attachment points. The area of potential contact with the fuel line is above the frame, in the upper portion of the left-rear corner of the engine compartment, just below the brake master cylinder (see Figure 2). The relative position of the two lines is not controlled by frame clips in the area of concern. The design specification for the line bundle includes a requirement for no contact in this area and the subject vehicles have a 100

Figure 2. Location of the area of potential contact between the subject brake line and fuel supply line.

FAILURE MODE: Contact between the fuel line and brake line first results in abrasive wear of the outer rubber sheath of the fuel line, exposing the braided stainless steel cover of the fuel line. Mercedes conducted wear simulation tests to study the rate at which the brake line would wear from contact with the fuel line. The tests indicated that the braided steel cover of the fuel line would result in failure of the softer metal brake line within 12,000 – 13,000 simulated miles.

DESIGN CHANGES: Mercedes first identified “the potential for this type of brake line and fuel line contact” as an assembly line issue after a larger V-8 engine was introduced in production in 2002. Mercedes responded by implementing changes in the installation process in May 2002 to ensure proper spacing of the fuel and brake lines. If necessary, a plastic spacer clip was added to ensure separation of approximately 0.8 in. between the fuel line and brake line. Mercedes indicated that “a similar remedy” would have been employed through the “off-line repair protocol” that was used previously for routing contact/anomalies.

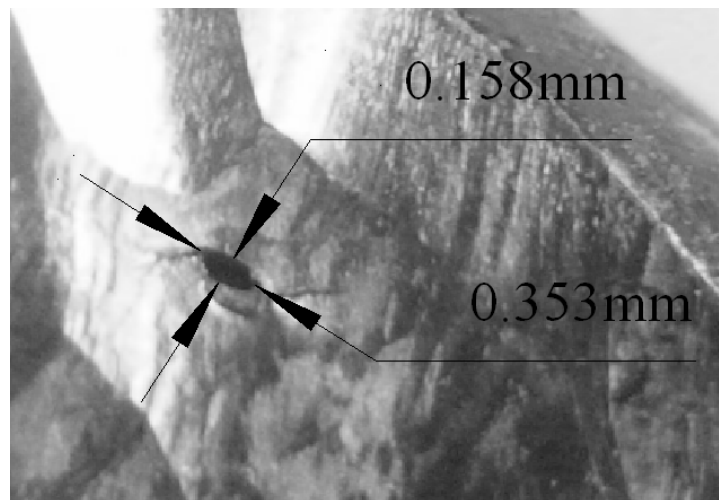
Figure 3. Field return brake with pin-hole leak.

The contact wear produces a small, pin-hole, leak that provides the drivers with some symptoms without initially resulting in reduction of brake effectiveness. Figure 3 provides a magnified view of a field return part with a pin-hole leak. The driver complained of a low pedal and diminished brake performance. When tested by NHTSA’s Vehicle Research and Test Center (VRTC) in East Liberty, Ohio, this part did not result in any notable change in brake effectiveness. The testing did note changes in brake pedal feel (e.g., low, “soft” pedal). Symptoms of line leakage may include illumination of the yellow ESP/BAS warning lamp, should the leak result in sufficient difference in brake line pressure between the affected and unaffected circuits. Statements from some incident drivers (including the driver who provided the field return part depicted in Figure 3) and testing by VRTC, indicate that the ESP/BAS lamp does not always illuminate during braking with a pin-hole leak. Drivers should notice a change in brake pedal feel with a leaking brake line, such as a low or sinking brake pedal during sustained brake application.
