ODI RESUME

Investigation: EA08-011
Prompted By: PE08-014
Date Opened: 07/01/2008
Principal Investigator: Peter Ong
Subject: Passenger Door Fire

ENGINEERING ANALYSIS CLOSING REPORT

SUBJECT COMPONENT: Window Switch Assembly

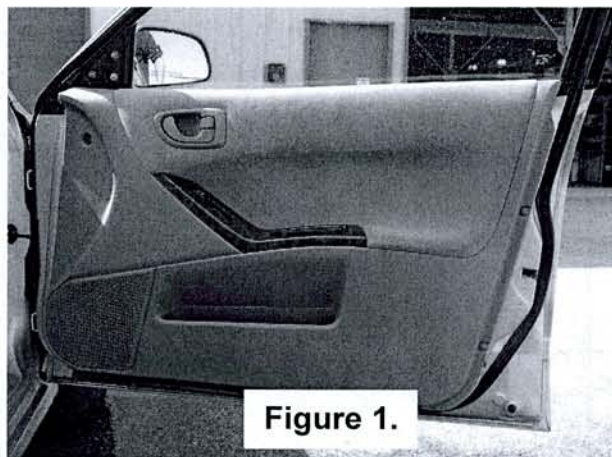
Figure 1.

Background: On July 1, 2008, NHTSA's Office of Defects Investigation (ODI) upgraded its Preliminary Evaluation (PE08-014) to an Engineering Analysis (EA08-011) to further investigate window switch failures that can lead to faulty power window operation, electrical malfunction and/or switch/door panel fires in MY 2001-2003 Mitsubishi Galant vehicles. All 292,945 MY 2001-2003 subject Galant vehicles were equipped with an electrically operated power door lock and window switch assembly. The passenger side door - shown in Figure 1- is equipped with its own power door lock and window switches mounted on the inclined surface on the door panel arm rest. As shown in Figure 2, a single housing assembly contains both the power door lock

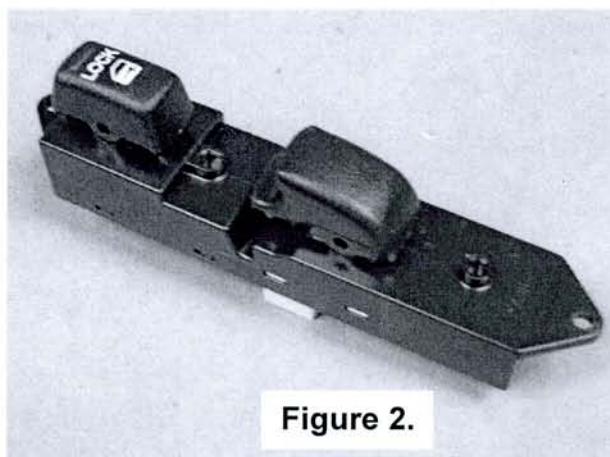
Figure 2.

The subject switch assembly (Figure 2) is used in other MY 1999-2000 Galant, MY 2004-2006 Galant, MY 2000-2005 Eclipse, MY 2001-2005 Eclipse Spider and MY 2004-2006 Endeavor vehicles totaling 654,631 peer vehicles. Unlike the subject vehicles, however, the switches on these peer vehicles are mounted differently and in different locations within the door panel and thus make them less susceptible to fluid intrusion should a spill occur.

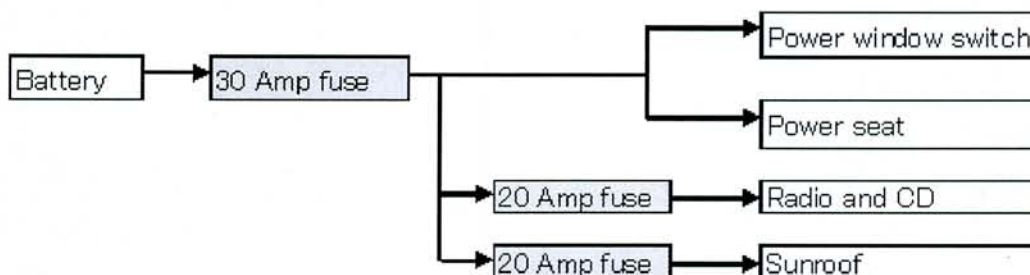
Figure 3. Power Window Switch Circuit

and power window functions. As shown in Figure 3, the vehicle's power window and power seat electrical circuits share an electrical circuit, which is protected by a 30 ampere fuse, with the Radio/CD and Sunroof circuits (each with its own 20 Ampere fuse). Normally, if the current in the power window circuit exceeds this current limit (or from a combination of the power seat, radio and/or sunroof circuits), the 30 Ampere fuse will open and prevent further operation.

The spilled liquid that seeped into the switch assembly, after being heated and carbonized, can act like a high resistance "short." The carbonized material may also lead to arcing in the switch. For example, in one evaluation conducted by VRTC, a switch was injected with a sports beverage drink and later repeatedly operated under power. After numerous cycles that created arcs, carbonized material built up to an extent that an arc/current path formed between the carbonized material and the switch contacts (even when it is not being operated). The arcing and/or the shorting condition could produce sufficient heat to damage, or potentially ignite other combustible portions of the switch without exceeding the current limit of the 30 Ampere fuse intended to protect the circuit and prevent such damage.

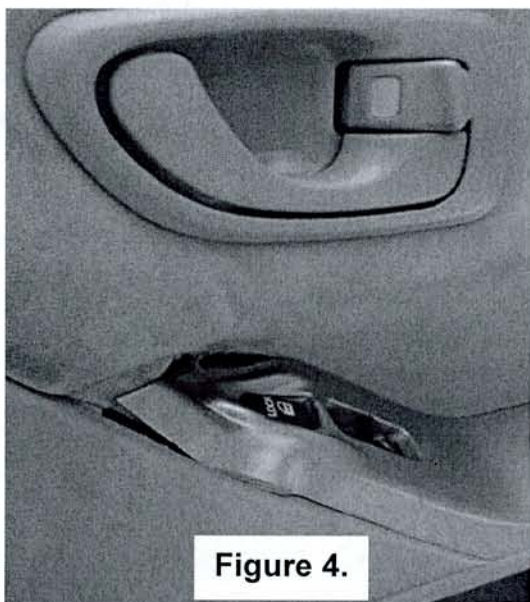
Figure 4.

Subject Vehicle Fire Incidents: As of July, 2009, ODI has identified 35 door panel fire incidents from the MY 2001-2003 Galant vehicles. Of the 35 fire incidents, no one reported a loss of vehicle control, with only three owners alleging an injury. The reported injuries are minor: a superficial fingertip burn; a minor leg burn and a sprained ankle while exiting the vehicle; and a sore right arm. Inspections of recovered door panel assemblies indicate a contained fire event within the door panel assembly with minor to moderate thermal damage to the power window switch assemblies, wiring harnesses and/or the door trim panel pieces. Figures 4 and 5 show the typical extent of the thermal damage to the passenger door panel after a

fire incident. No one reported that the fire had spread beyond the door panel to any other vehicle components such as the instrument panel or seats.

Analysis of the Cause of the Electrical, Thermal or Fire Incidents: MMNA's investigation found residue from liquids on and around the power window switch assembly and door panel arm rest region in several of the returned parts. MMNA's analysis of the liquid residue indicates the source could be liquid from sport drinks containing high sugar or electrolyte content. In fact, MMNA found carbonized substance (dried/burn sugar/salt) on the circuit board traces inside the burnt power window switch assemblies.
