## Engineering Analysis Closing Report

**SUBJECT:** Intermediate Steering Shaft Binding

**EA No.:** EA08-024

**SUBJECT VEHICLES:** Model year (MY) 2004 through 2006 Toyota Sienna minivans.

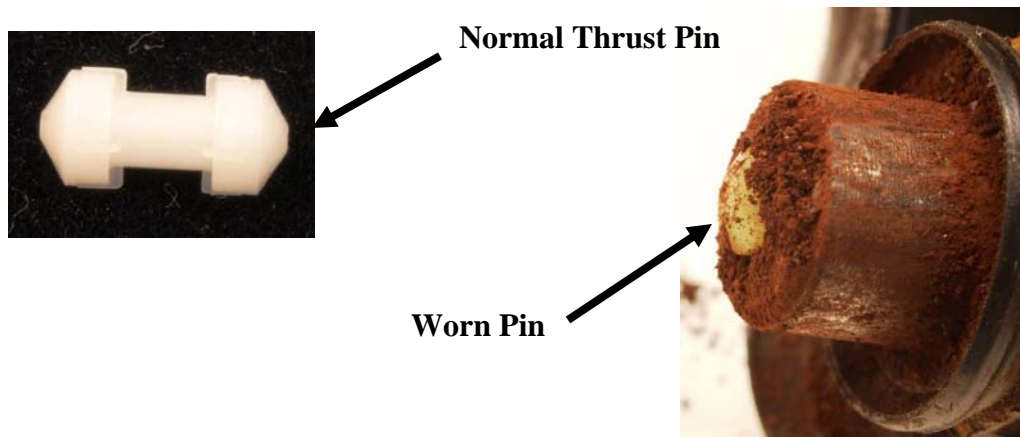
**ALLEGED DEFECT:** Failure of the SIS universal joint bearings (Figure 3), which can result in binding or resistance to vehicle steering.

**Figure 3. Corroded/worn thrust pin, SIS/ universal bearing.**

**FAILURE MECHANISM / CONTRIBUTING FACTORS:** The primary contributing factor to the alleged defect is the degradation due to thermal degradation and friction of the SIS bearing thrust pins, which leads to poor universal bearing cap seal. The failure of the seals allows water to intrude into the bearings, which then corrode, resulting in increased steering effort over time. Exposure to deicing materials (road salt) will cause the bearings to degrade faster.

**DESIGN CHANGES:** In it’s response to ODI’s information request, Toyota indicated that concerns with binding of the steering intermediate shaft were first identified and investigated in October 2005. In September 2006, Toyota implemented changes to the universal joint bearing thrust pin and seal material. The new material has a higher heat resistance which reduces the potential for deformation of the thrust pin and bearing seals.

**TECHNICAL SERVICE BULLETIN:** In February 2004, Toyota issued a technical service bulletin (TSB-ST003-004, "Steering Intermediate Shaft Noise"), providing dealers with information to diagnose and repair complaints associated with the alleged defect in the subject vehicles. In January 2007, Toyota released a second bulletin (TSB-ST001-07, "Steering Intermediate Shaft In High Road Salt Areas") with additional instructions for diagnosing and repairing the subject condition.
