# **Initial Decision Report**

**EA08-020: BMW Mini Cooper S Exhaust Pipe Tips**

U.S. Department of Transportation  
National Highway Traffic Safety Administration  
Office of Enforcement  
Office of Defects Investigation

November 2008

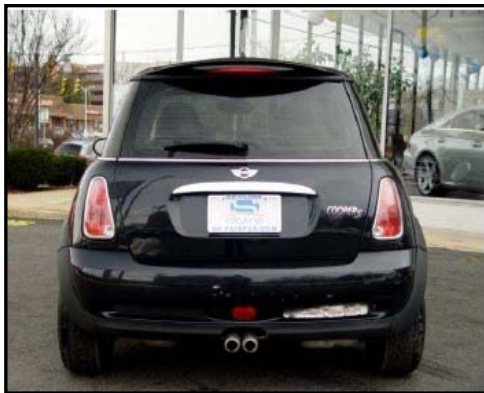
Photo 2. MY 2006 Mini Cooper S (R53)

The two exhaust pipe tips of the Cooper S exit the underside of the vehicle at the center of the vehicle and extend beyond the vertical rear plane of the rear valance (bumper cover). In the MY 2007 redesign of these vehicles, as shown in the photos 2 (MY 2006) & 3 (MY 2007) below, the exhaust pipe tips for MY 2007-2008 (R56) subject vehicles were enlarged and protrude further to the rear of the vehicles. Also note that the shape of the rear bumper cover was changed to accommodate the larger exhaust pipe tips.

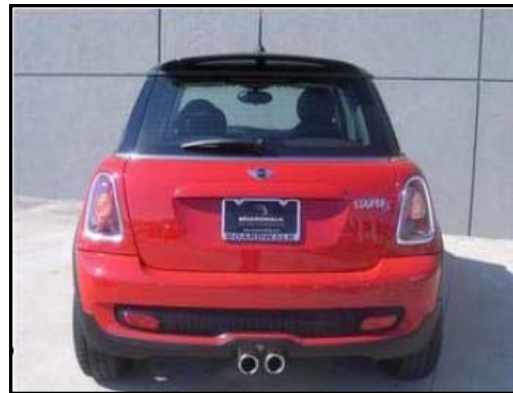
Photo 3. MY 2007 Mini Cooper S (R56)

For MY 2007, the Mini Cooper S vehicles were redesigned. As part of the redesign for MY 2007, the exhaust pipe tips were enlarged. Also, as part of the redesign, the exhaust tips extend further rearward than in previous designs. As a result of the redesign, the exhaust pipe tips extend beyond the vertical rear plane of the bumper cover to such an extent and are so situated that they burn the legs of people who are performing completely foreseeable tasks at the rear of the vehicle.

To address the issue that the larger exhaust pipe tips, and their placement in the subject vehicles, are causing burn injuries to consumers, BMW implemented a design change to the tips to recess them so as to be set back from the lower edge of the rear bumper cover. This modification was incorporated into mid-year production (July 2008) of MY 2008 subject vehicles.

Two months later, in September 2008, BMW initiated a service action to replace the production exhaust pipe tips with modified tips on all subject vehicles built before the 2008 production modification. BMW sent letters to owners<sup>1</sup> of the subject vehicles, stating: "...Mini has decided to conduct a service action on these vehicles, and we have shortened the tailpipe extension to help reduce the chances of inadvertent contact with the leg." BMW's service information bulletin (dealer notice)<sup>2</sup> states, "Due to production assembly tolerances combined with thermal expansion, the tailpipe chrome tips may extend beyond the rear bumper edge. Contacting the hot tailpipe tips may cause burns on the exposed parts of shins and/or calves."

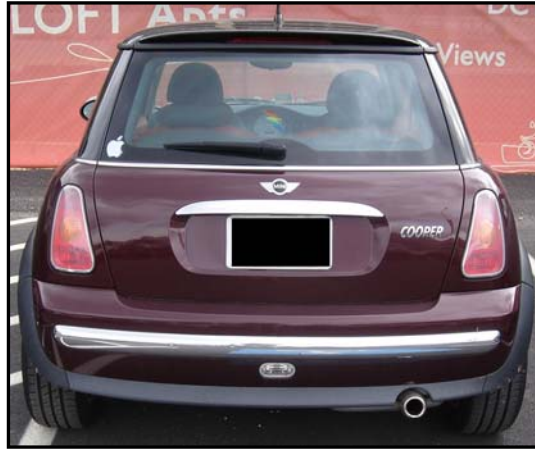
Photo 4. Mini Cooper (R 50)

As shown in photo 4 below, the Cooper, unlike the Cooper S, has a single exhaust pipe tip that exits the underside of the vehicle from the passenger's side and also extends beyond the vertical rear plane of the rear bumper cover. As shown in Table 2, Mini Cooper vehicles in MY 2002-2006 are designated with the engineering code R50.

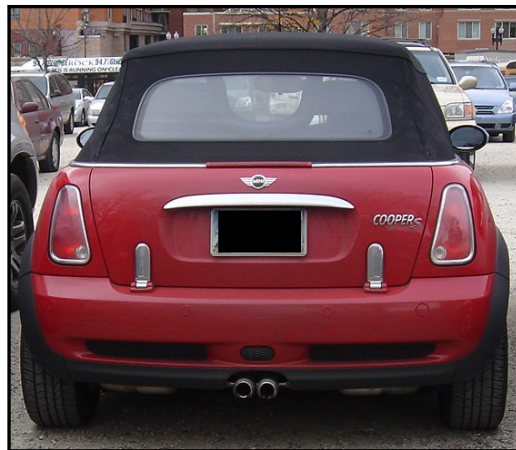
Photo 6. Mini Cooper S Conv. (R 52)

The Mini convertible, shown in photo 6 below, was introduced in MY 2005 and is also available in both the Cooper and Cooper S trims. The convertible model does not have a hatchback, as the available space is taken up when the convertible top is in the down position. The rear storage compartment (trunk) is accessed through a door that folds down and out. There are no known reports of burn injuries from the exhaust pipe tips on convertible models. As shown in Table 2, Mini Cooper and Cooper S convertible vehicles in MY 2005-2008 are designated with the engineering code R52.

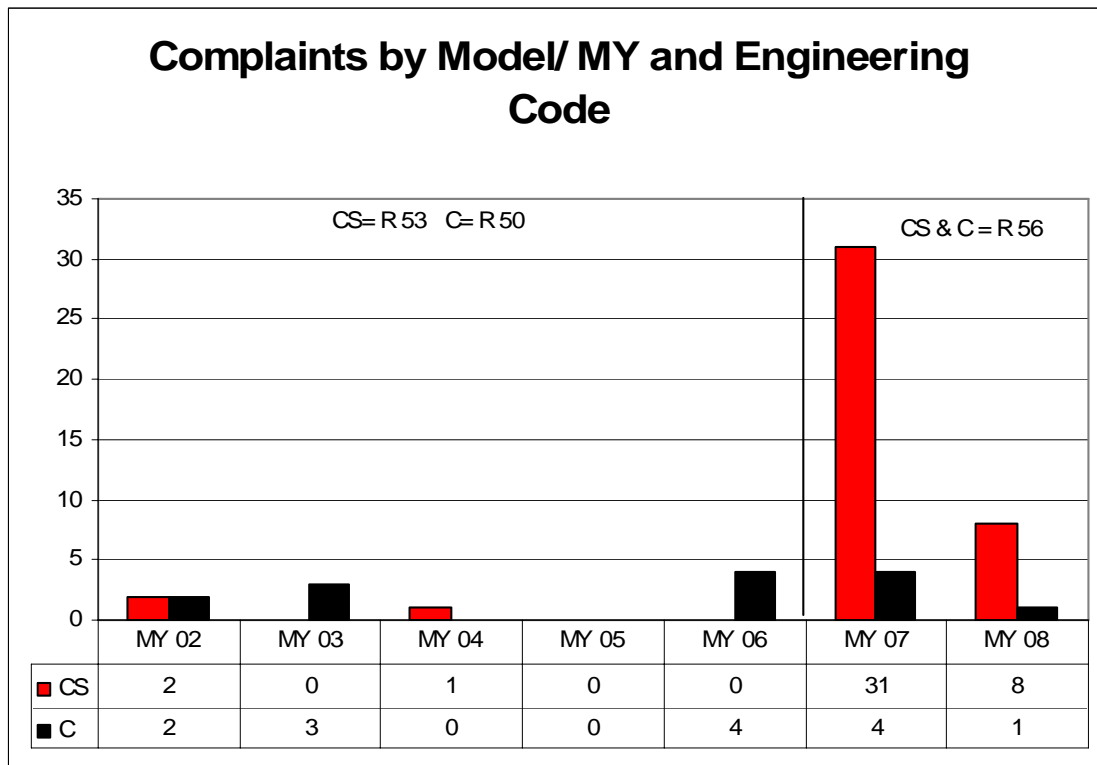
**Figure 1. Complaint Data by Model/MY and Engineering Code**

Table 4 below shows the total number and rate of complaints reported to NHTSA and BMW that relate to the alleged defect for Cooper vehicles, by model year and engineering code. When comparing Table 4 to Table 3, note that although the number of reports for MY 2002-2006 Mini Cooper (R50) is slightly higher than MY 2002-2006 Mini Cooper S (R53), there is no dramatic increase for MY 2007-2008 and the reports remain relatively low. Figure 1, below, graphs the report data from Tables 3 and 4.

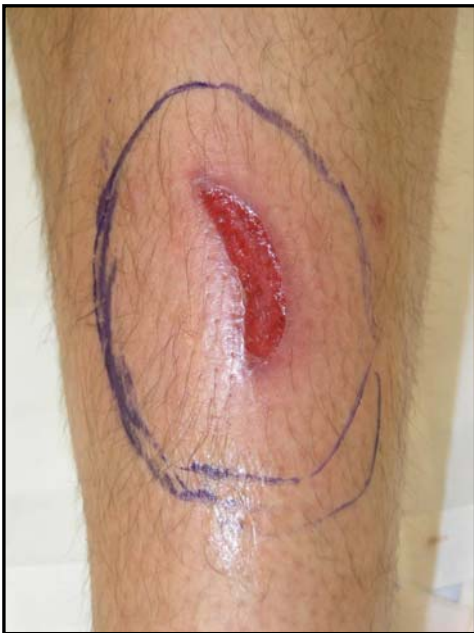
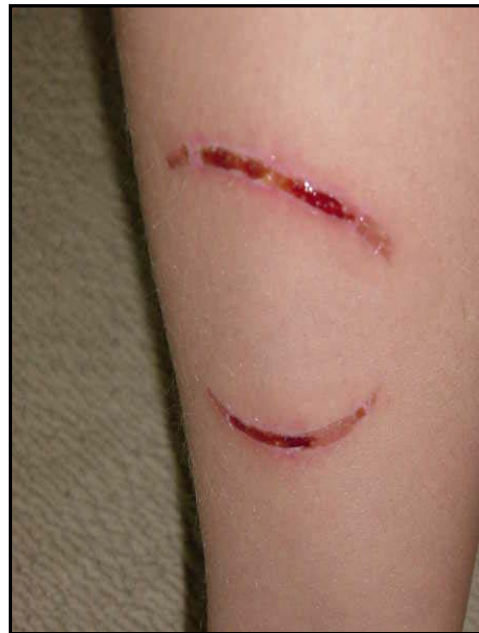
The complainants reported receiving burn injuries as they were retrieving items from the rear cargo area of their vehicles. Some of the complainants reported multiple incidents of burns, or that other persons helping to unload their vehicles were burned. Two (2) of the complainants reported that their child was burned, a seven year old and a ten year old. As noted above there are 39 (31+8) reports and these address 48 injuries. Photos 8 & 9 below are examples of the burn injuries.

Photo 8. Exhaust Tip Burn Injury

Photo 9. Exhaust Tip Burn Injury

ODI and BMW have received numerous complaints indicating that leg burns occur as people are accessing the rear cargo area shortly after the vehicle has been driven. As reflected by the complaints, people removing items from the rear cargo area naturally place their legs at the rear of the vehicle. People are burned as they inadvertently contact either of the two hot exhaust pipe tips while accessing the rear cargo area. Photographic evidence accompanying many of these complaints shows that the burn injuries are significant, causing blistered skin or scarring, and often in a half-moon shape pattern, matching the approximately 2¾-inch diameter of the exhaust pipe tips.

Many of the burns caused by the exhaust pipe tips on the MY 2007 and early MY 2008 Mini Cooper S vehicles are second degree burns. These burns are severe.
