DRAFT FINAL REPORT: VRTC-DCD9143 for EA08-018 and

PE08-041 "Evaluation of Changes in Steering Effort Resulting

MEMORANDUM REPORT for VRTC-DCD9143

Evaluation of Changes in Steering Effort Resulting from Corroded Intermediate Shafts in 2002-2004 Kia Sedonas and 2004 Toyota Siennas

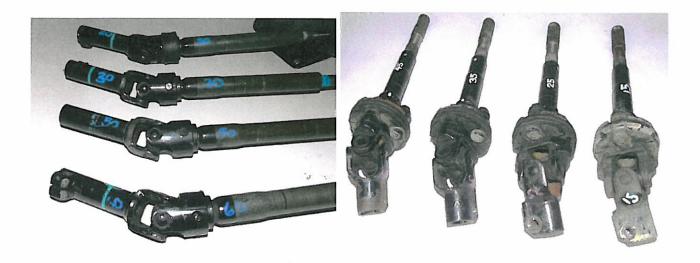
Figure 3 - Toyota Sienna Intermediate Shafts Figure 4 - Kia Sedona Intermediate Shafts

5.1 Visual Inspection – The intermediate shaft consists of two painted shafts, joined by a universal joint (Figures 3 and 4). The joint facilitates off-axis articulation and rotation. The universal joint consists of two pairs of cylindrical bearings arranged in a cross pattern. Each axis of the cross is mated to pivoting receivers that are joined to the respective ends of the shaft. The shaft can then pivot and rotate about the universal joint. The bearings are sealed to prevent the entry of contaminants. In all observed complaint

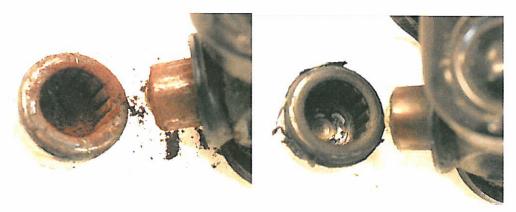
Figure 5 - Corroded Bearing (Left) and a Normally Wearing Bearing (Right)

shafts, on at least one axis of bearings the seals had been breached and corrosion of the internal needle bearings had occurred. A sample of the corroded bearing compared to a non-corroded bearing can be seen in Figures 5 and 6. The Sienna design incorporated hard plastic thrust pins inserted into each end of the joint to maintain equidistant spacing. Sienna joints that were binding exhibited worn thrust pins (Figure 7).

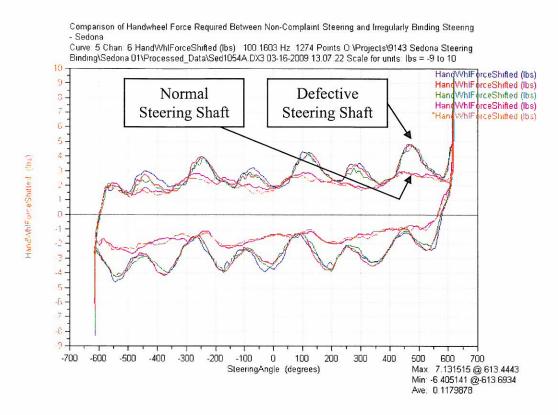
Figure 9 - Sedona Suspended Steering Test Normal versus Defective Intermediate Shaft

5.2.1 Suspended Static Steering Test – Both vehicles were instrumented with a data acquisition system that could monitor and record the following inputs: steering wheel angle, driver steering effort, vehicle yaw rate, and vehicle speed (Figure 8). It was found that the binding condition is most prevalent after the vehicle has been sitting dormant for an extended period of time. Once the wheel was rotated at least two times, the binding force was greatly reduced. Forces required to turn the steering wheel in a normally operated Sedona, measured in hand wheel pounds force, varied from one to three pounds (Figure 9). When a complaint shaft was tested, the required force varied from one to five pounds. With regard to the Sienna, a normally operating intermediate shaft required one to four pounds, while a defective intermediate shaft required one to eleven pounds (Figure 10). A sinusoidal pattern can be seen in the Toyota defective shaft as a result of only one of the two axes of the universal shaft corroding. The sinusoidal pattern is created because each axis rotates at a non-constant rate while articulated. During the highest rate of rotation, the bind becomes most evident.

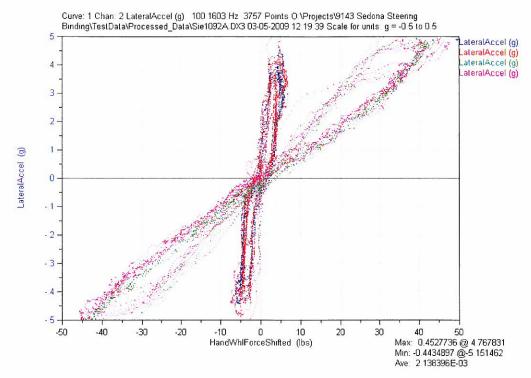
Figure 12- Sienna Steering Gain with Defective Steering Shaft

5.2.2 Dynamic Steering Gain Test – Graphical representation of the steering forces can be seen in Figures 11 through 14. Figure 11 shows two traces of steering wheel forces required to generate increasing lateral acceleration in a Toyota Sienna with a non-defective steering shaft. The first trace (the more vertical of the two) is generated while the engine is running with normal power assist. The second trace is generated with the engine turned off to remove power assist. Figure 12 is the same test with a defective shaft installed in the Toyota Sienna. Figure 13 is also the same test but with the Kia Sedona and a non-defective steering shaft. Finally, Figure 14 is the same test with the Kia Sedona but a defective steering shaft.
