Service Information

M18 01 08

Service Action: R56 Cooper S – Replacement of Tailpipe Extensions

R56 Cooper S with N14 engine produced 09/06 up to 07/08

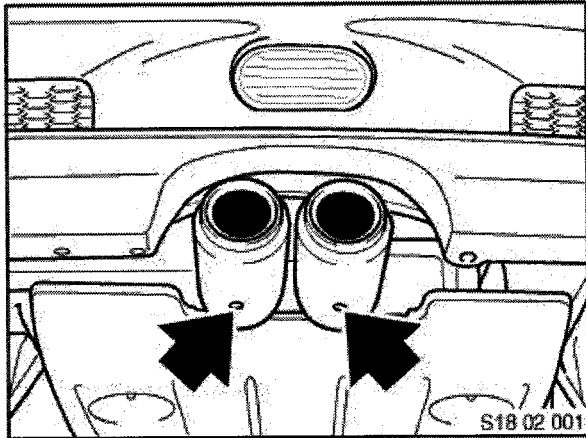
Due to production assembly tolerances combined with thermal expansion, the tailpipe chrome tips may extend beyond the rear bumper edge.

Contacting the hot tailpipe tips may cause burns on the exposed parts of shins and/or calves.

Replace the exhaust tailpipe tips with the updated parts (PN 18 30 7 595 688).

1. Loosen the tailpipe tips hold down bolts (see arrows). Remove the exhaust tips.
2. Push the replacement tailpipe chrome tips up to the stop on both tailpipes. (The tailpipe tips must bottom out on the tailpipes.)
3. Retighten the tailpipe tips hold down bolts – torque specification = 3.5Nm (2.6ft.lb).
