**ON-SITE AIR BAG NON-DEPLOYMENT/  
DRIVER FATALITY INVESTIGATION**

**CASE NO: CA03-046**

**VEHICLE: 2001 HYUNDAI ELANTRA**

**CRASH DATE: AUGUST, 2003**

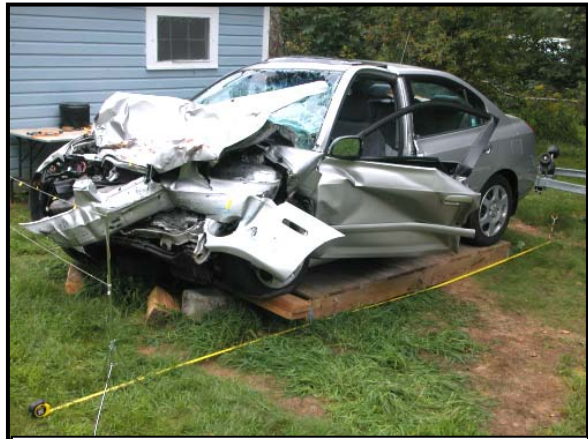
This investigation focused on the issues surrounding the driver air bag non-deployment, and the fatal injury mechanisms of a male driver of a 2001 Hyundai Elantra, **Figure 1**. The Hyundai was involved in a severe frontal impact with a 1995 Chevrolet G20 cargo van. The Hyundai Elantra was equipped with an Advanced Occupant Protection System (AOPS) that consisted of front safety belt pretensioners, redesigned frontal air bags and front right occupant detection. The Hyundai's safety belt pretensioners and frontal air bags failed to deploy as a result of the impact. The Hyundai was occupied by a 27 year old restrained male driver and was the vehicle's sole occupant. Reportedly, the Hyundai drifted left of center precipitating the crash. The Chevrolet van was equipped with a Supplemental Restraint System that consisted of a driver (only) air bag that deployed during the crash. The estimated travel speed of the Hyundai was 89 km/h (55 mph). The Coroner's report listed the Hyundai driver's immediate cause of death as a lacerated aorta and a cervical spine fracture.

**Figure 1: Left front view of the Hyundai.**

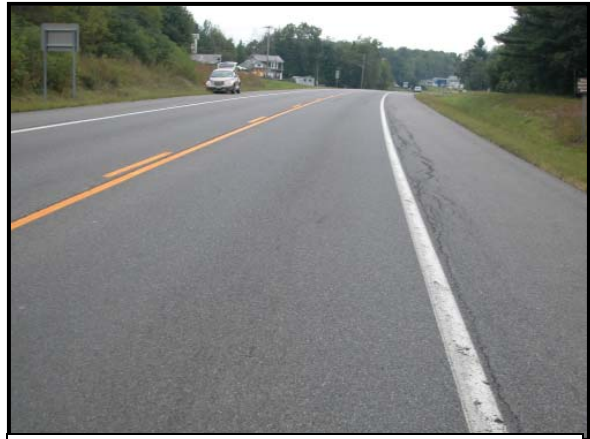
**Figure 2: Northbound trajectory view.**

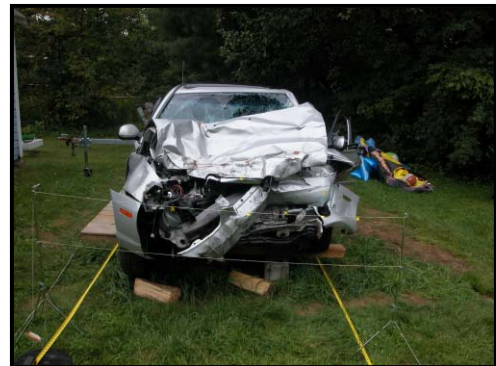
The front plane of the Hyundai sustained 142.2 cm (56.0 in) of direct contact damage that extended across the entire end width of the vehicle, **Figure 3**. The frontal damage was biased to the left indicative of the angular offset impact configuration. The crush profile documented along the front bumper was as follows: C1 = 78 cm (30.7 in), C2 = 79.0 cm (31.1 in), C3 = 84.0 cm (33.1 in), C4 = 67.0 cm (26.4 in), C5 = 58.0 cm (22.8 in), C6 = 22.0 cm (8.7 in). Maximum crush was located at the left front corner (C1).

**Figure 3: Front view of the Hyundai Elantra.**

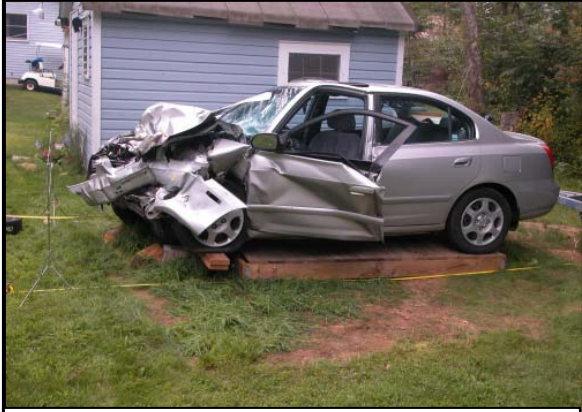
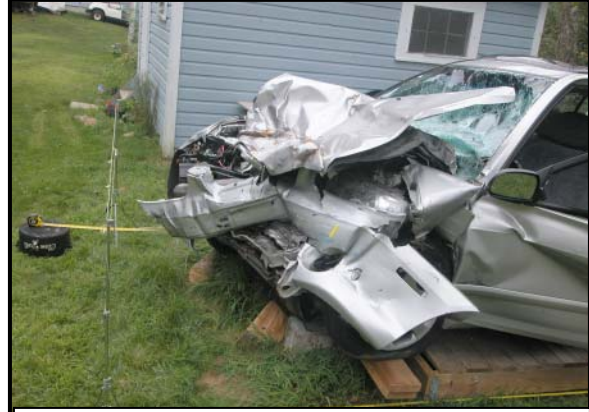
**Figures 4 and 5** are the left side and left lateral views of the vehicle. The left front fender was completely crushed. The left front wheel assembly deformed rearward into the rear aspect of the wheel opening; the tire was restricted and aired out. The left wheelbase was reduced 29.3 cm (11.5 in). The windshield fractured in multiple locations from the exterior force of the crash. The left front door was jammed shut by the deformation and opened by extrication. The left rear door was jammed and could not be opened. The right doors remained operational. The center rear aspect of the roof was buckled. The Collision Deformation Classification (CDC) was 12-FDEW-3. The damage algorithm of the WINSMASH model computed a total velocity change of 82.9 km/h (51.5 mph) for the Hyundai. The longitudinal and lateral components were -81.7 km/h (-50.8 mph) and -14.4 km/h (-8.9mph), respectively. The calculated delta V was consistent with a reconstruction analysis using the conservation of momentum.

**Figure 4: Left side view of the Hyundai.**

**Figure 5: Left lateral view.**

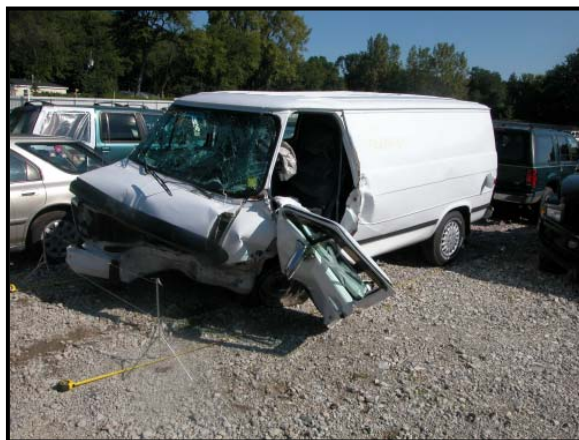
The front plane of the Chevrolet (**Figure 6**) sustained 162.6 cm (64.0 in) of combined direct and induced damage that extended across the vehicle's frontal end width. The direct damage measured 113.0 cm (44.5 in) and began 31.8 cm (12.5 in) left of center and extended to the left front corner. This frontal direct contact wrapped around the left front corner and extended 43.2 cm (17.0 in) onto the left side. The left front wheel assembly was displaced rearward into the aft aspect of the wheel opening. The left front tire deboned and was restricted. The left wheelbase was reduced 53.1 cm (20.9 in). The left front door was jammed shut by deformation and opened by extrication. The residual crush profile measured along the front bumper was as follows: C1 = 93 cm (36.6 in), C2 = 80.0 cm (31.5 in), C3 = 65.0 cm (25.6 in), C4 = 55.0 cm (21.7 in), C5 = 12.0 cm (4.7 in), C6 = 0. The maximum crush was located at the left front corner (C1). The Collision Deformation Classification (CDC) was 12-FYEW-6. The total delta V calculated by the damage algorithm of the WinSmash model was 45.5 km/h (28.3 mph). The longitudinal and lateral delta V components were -45.5 km/h (-28.3 mph) and 0, respectively.

**Figure 6: Left front view of the Chevrolet.**

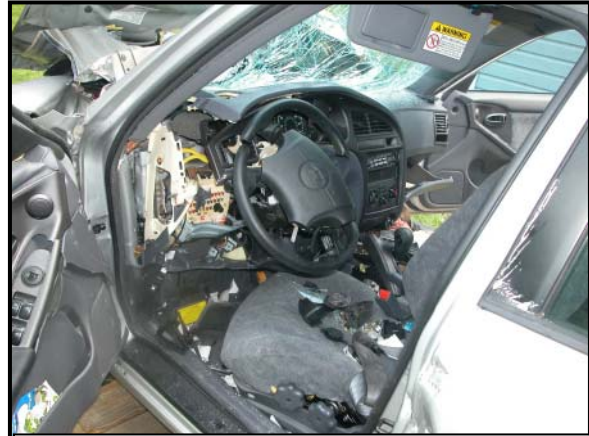
The interior of the Hyundai sustained moderate damage and intrusion as a result of the exterior crash forces. **Figure 7** is a view of the driver's interior. The intrusion at the left corner of the instrument panel measured 33.0 cm (13.0 in). The center aspect of the instrument panel intruded 12.2 cm (4.8 in). The intrusion of the driver's foot well measured 18.8 cm (7.4 in).

The driver's knee bolster exhibited two contacts from the driver's lower extremities. The right lower extremity contacted the bolster 22.9 cm (9.0 in) left of the steering wheel center line. The bolster's metal backer was deformed 5.1 cm (2.0 in) at this location. The right lower extremities contacted and penetrated the bolster 3.8 cm (1.5 in). This contact was located 17.8 cm (7.0 in) right of the steering wheel center line.

**Figure 7: Driver's interior view.**

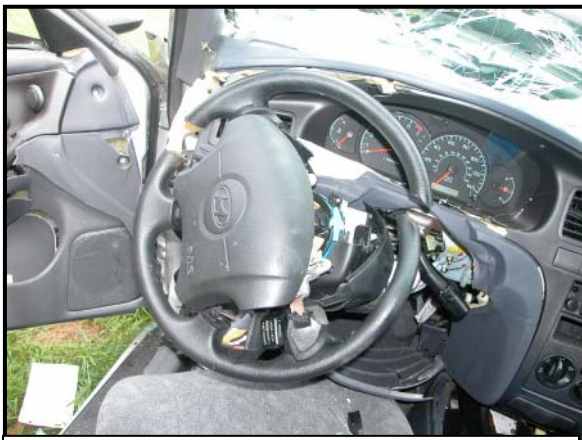
The 4-spoke steering wheel rim was rotated approximately 90 degrees clockwise at inspection. The steering column was completely separated from the shear capsules and the column had dropped. The left and right shear separation measured 5.1 cm (2.0 in) and 4.6 cm (1.8 in), respectively. The steering wheel rim support casting (fastened to the steering column end) was fractured by inertial loading from the occupant. The steering wheel rim was cut in 1 and 9 o'clock sectors during the extrication process for unknown reasons. **Figure 8** is a view of the deformed steering wheel rim. **Figure 9** is a lateral view across the steering wheel viewed from the 1 o'clock sector to the 8 o'clock sector of the fractured casting.

**Figure 8: View of the steering wheel rim.**

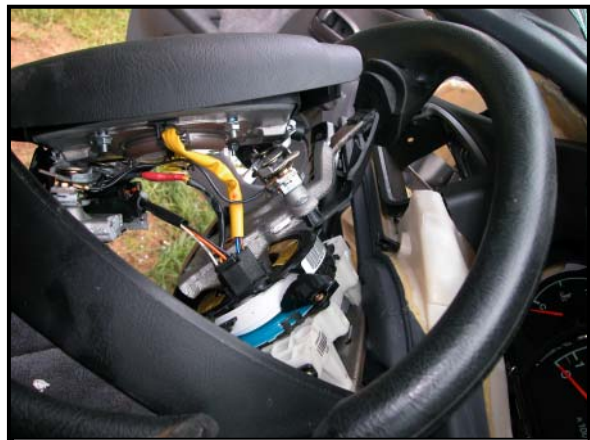
**Figure 9: Lateral view across the plane of the steering wheel from 1 to 8 o'clock.**

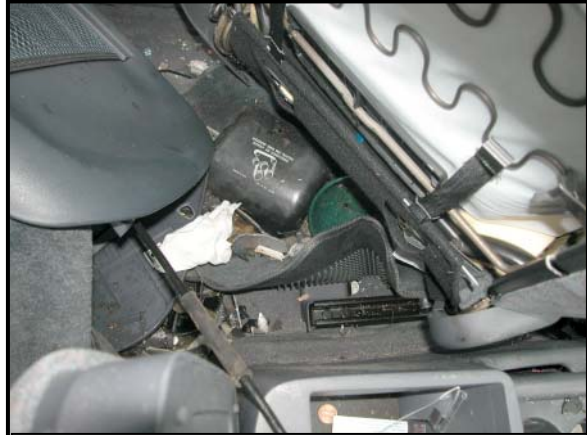
The driver's seat was adjusted in a mid-to-rear track position. The seat was jammed by floor pan deformation and could not be moved. The seat back was reclined 12 degrees aft of vertical. Upon inspection, it was noted that the driver's seat cushion was rotated approximately 30 degrees counterclockwise (refer to Figure 8 above) with respect to the vehicle's longitudinal axis. Further inspection revealed the adjustable portion of the rear inboard seat track had separated from the fixed portion of the inboard seat track, **Figure 10**. The separation occurred as a result of the driver loading the lap portion of the locked safety belt. The inboard safety belt buckle was attached to the inboard seat track and was the load path between the driver and the fixed portion of the seat track.

**Figure 10: View of the driver's separated inboard seat track.**

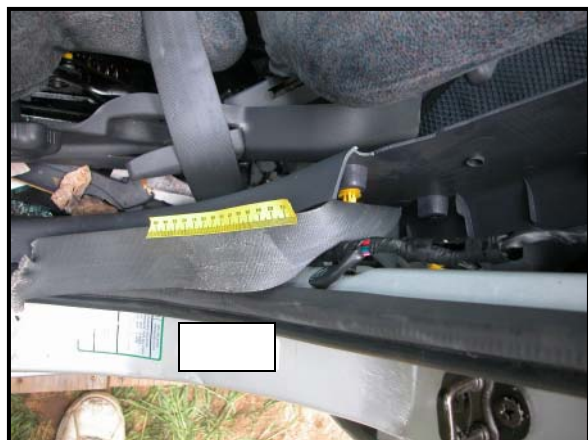
Inspection of the driver's safety belt indicated the first responders had cut the driver's safety belt during the extrication. A 140 cm (55 in) section of webbing was attached to the outboard anchor. This section of webbing had been used to tie the left front door closed during vehicle transport. The use of the belt in this manner hampered the identification of any crash related evidence on the webbing. The balance of the driver's webbing was spooled back into the retractor. The retractor was operational; the pretensioner had not fired. The webbing was extended from the retractor and an 8.9 cm (3.5 in) D-ring abrasion was identified, **Figure 11**. The abrasion began 15 cm (6 in) from the point where the webbing was cut. The driver's D-ring was adjusted in the full down position. Inspection of the friction surface of the D-ring identified a corresponding abrasion across the full width of the surface. Inspection of the latch plate revealed indications of historical use and crash related abrasions on its friction surface. The inspection of the driver's safety belt indicated that he was restrained at the time of the crash.

**Figure 11: D-ring abrasion to the driver's restraint webbing.**

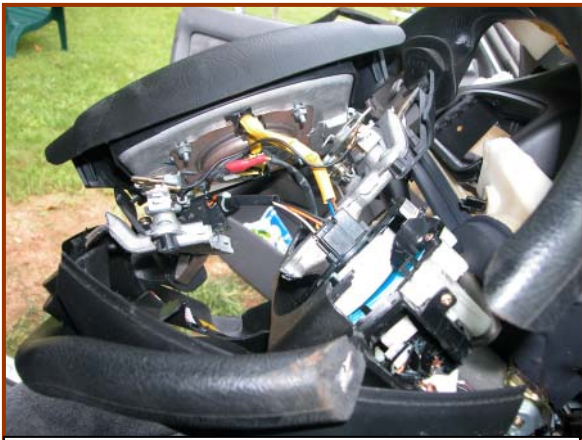
The driver bag was a located in the center hub of the steering wheel. It was not deployed. **Figure 13** is a lateral view of the driver air bag module attached to the fractured casting. **Figure 14** is a close-up view of the back side of the module and the inflator. The inflator was manufactured by Autoliv Inc. and was identified by the following: *MAF M27 1M AOH*. Inspection of the inflator determined the electrical connector was still attached to the inflator; however, the connector was crushed. The connector had impacted the casting, when the casting was fractured by driver loading. **Figure 15** is a close-up view of the casting. Yellow transfers from the connector's housing were identified on the casting indicative of the contact. It should be noted that this contact sequence occurred late in the overall crash sequence and would not have compromised the proper deployment of the driver air bag.

**Figure 13: Left lateral view of the DAB.**

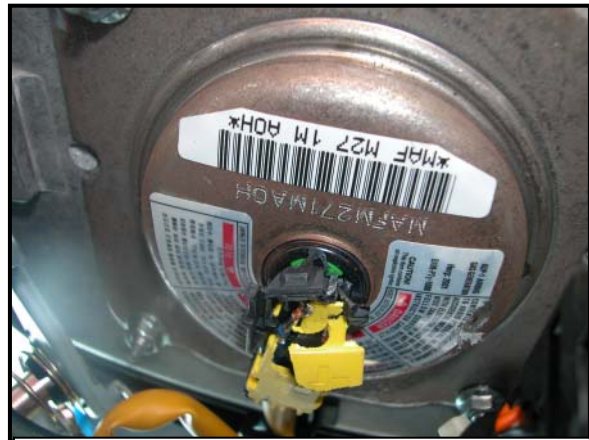
**Figure 14: View of the DAB inflator.**

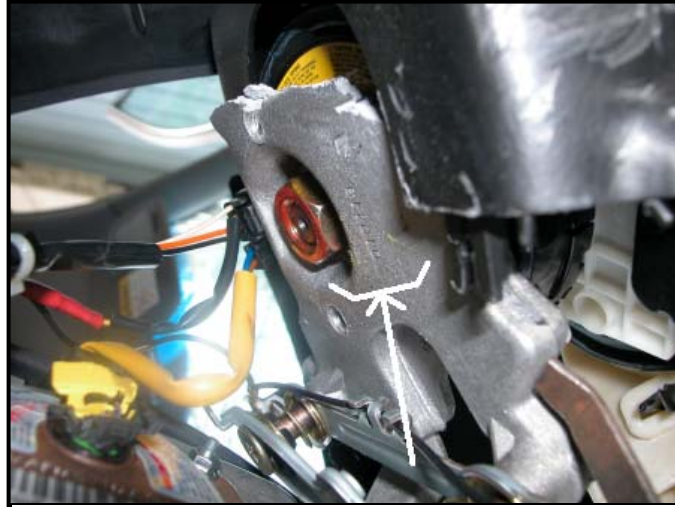
**Figure 15: View of the fractured casting and yellow transfers.**

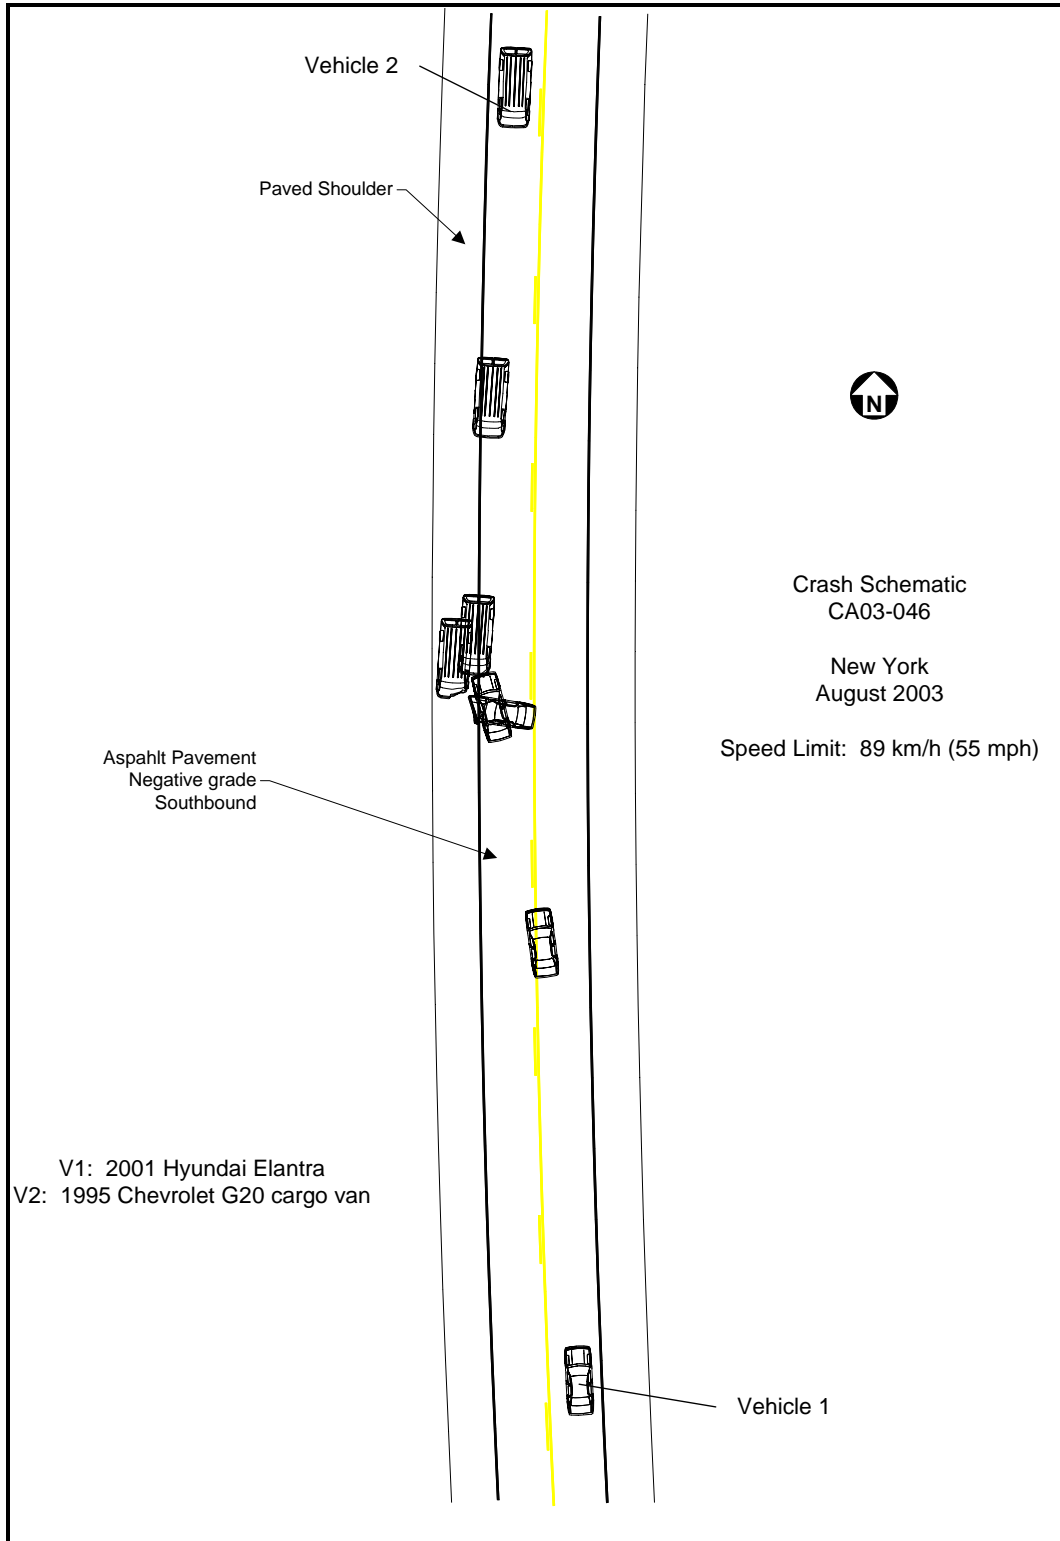
km/h (51.5 mph) and 45.5 km/h (28.3 mph), respectively. The offset impact induced a counterclockwise rotation to the Hyundai and the vehicle came to rest at the point of impact. The Hyundai rotated approximately 65 degrees counterclockwise and came to rest facing westward, blocking the southbound lane. The Chevrolet separated from the impact with a southwest trajectory and came to rest facing south, straddling the fog line, approximately 2 m (7 ft) from the point of impact. The driver air bag in the Chevrolet deployed as a result of the crash. None of the safety systems (seat belt pretensioners and frontal air bags) in the Hyundai deployed. **Figure 16**, at the end of this report, is a schematic of the crash.

**Figure 16: Crash Schematic.**
