Recall Bulletin

PRODUCT SAFETY RECALL

SUBJECT: Front Windshield Wiper Operation – Replace Module Cover

MODELS: 2003 HUMMER H2

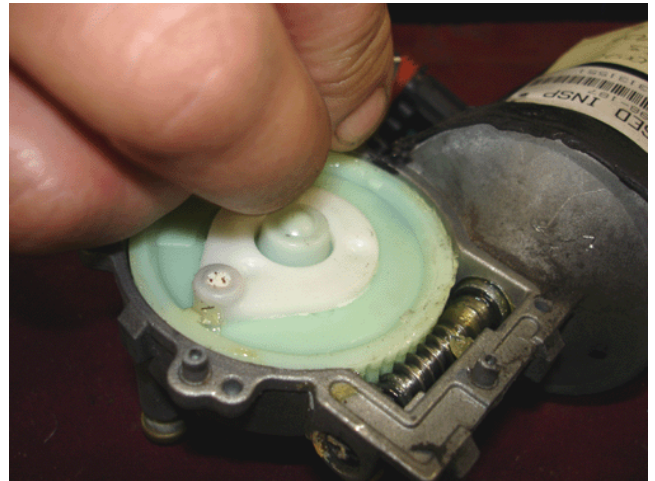
Wiper motor/module shown out of vehicle for illustration purposes only

6. Release the five retainers (1) that retain the cover/module to the motor.

7. Inspect the plastic module cover (2) and metal module (1) sealing surfaces for butyl.
 - If butyl is on either sealing surface, discard the plastic cover and replace it with a new cover. Ensure that all of the butyl is removed from the metal sealing surface **BEFORE** installing a new cover. Use a flat-blade screw driver or razor blade to remove the butyl from the metal surface.
 - If no butyl is on either sealing surface, re-install the cover. Refer to Step 8.
8. Install the wiper cover/module. Align the retainer with the tang on the motor and push down.
9. Install the electrical connectors to the cover/module.
10. Make sure wipers are operational.
11. Install the air inlet grille panel. Align the air inlet grille to the vehicle and secure by pushing downward on the four retainers. Install the push in retainer and tighten the two end screws.
