## **Report – Field service spring failures**

**Date: 31<sup>st</sup> July 2008**

**ITEC Spring Part Number 3533197-C91**

Analysis Of Two Broken Springs

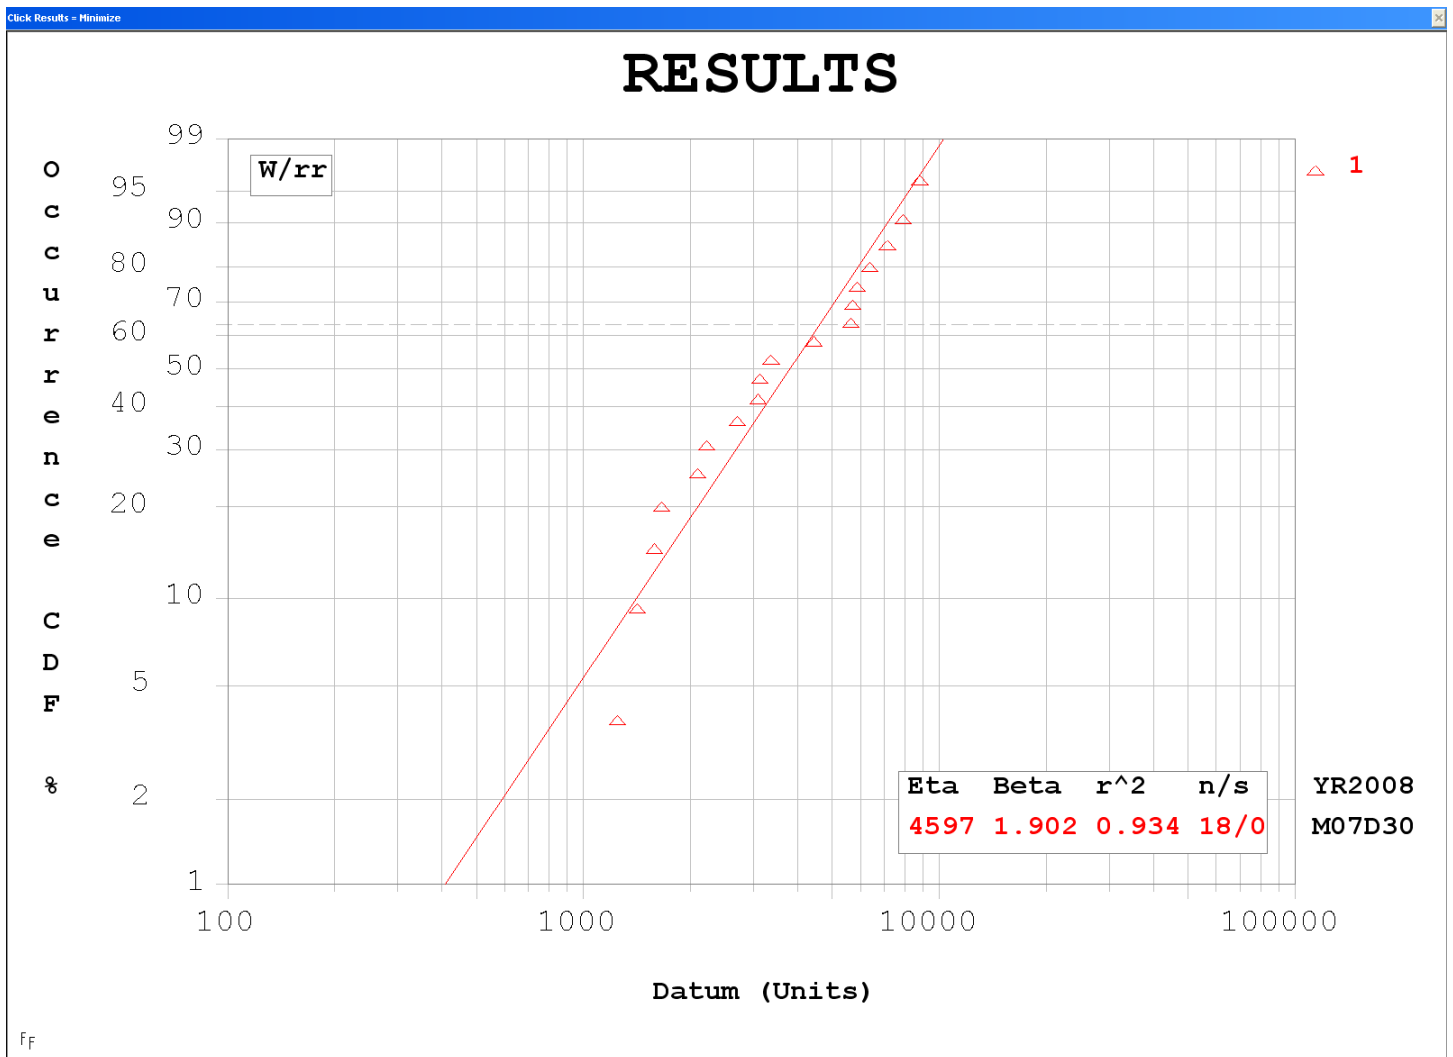
# MILEAGE

The mileage data analysis shows that 99% of parts affected by quench cracks would have failed by 10,000 service miles. Equally, 99% would have failed within approximately 220 days in service. The data would strongly suggest that, as long as the entire job was assembled on to vehicles within three months of the final shipment (28<sup>th</sup> August 2007), the problem is now behind us. The complete Weibull analyses are attached as Appendix A, together with a brief explanation of the analytical method.

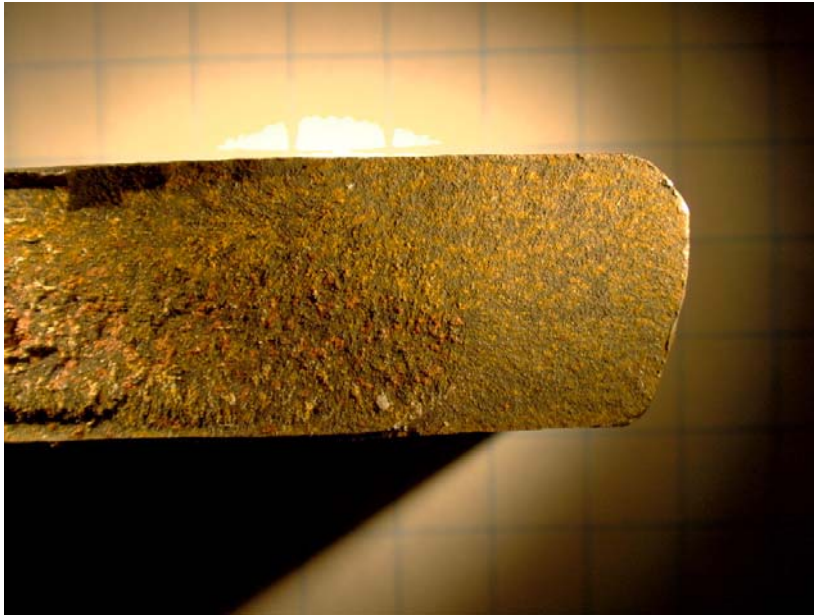
**Figure 3:**

Fracture surface. Origin is at edge of spring. Note the lack of shear lip on the compression surface. Image acquired on as received surface before cleaning at HSS.

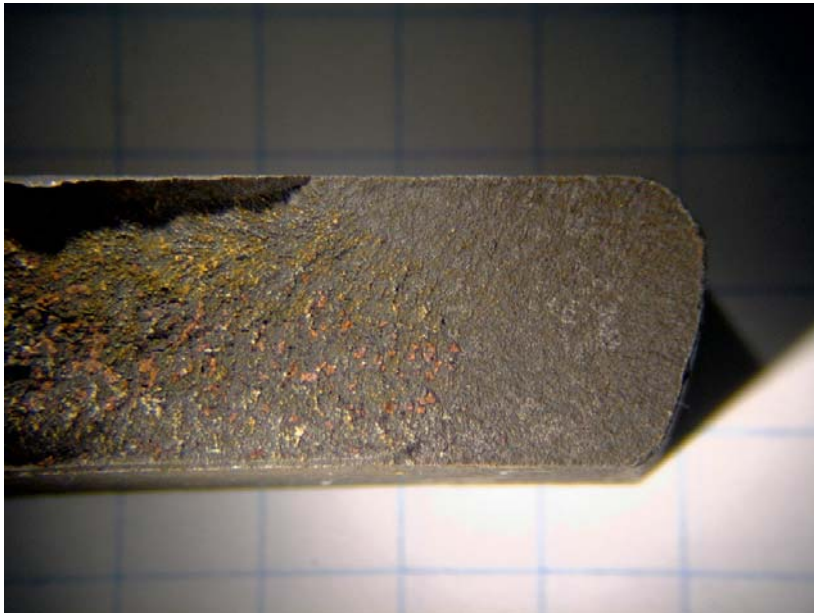
**Figure 4:**

Fracture surface. Note the lack of shear lip on the compression surface. Image acquired on surface after cleaning at HSS.

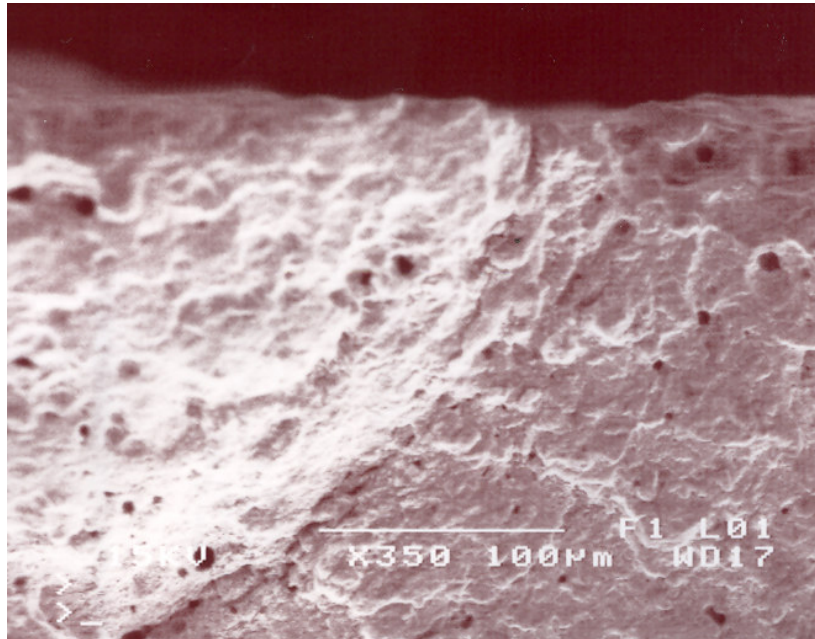
**Figure 5:**

Intersection between primary origin and shear lip on secondary origin.

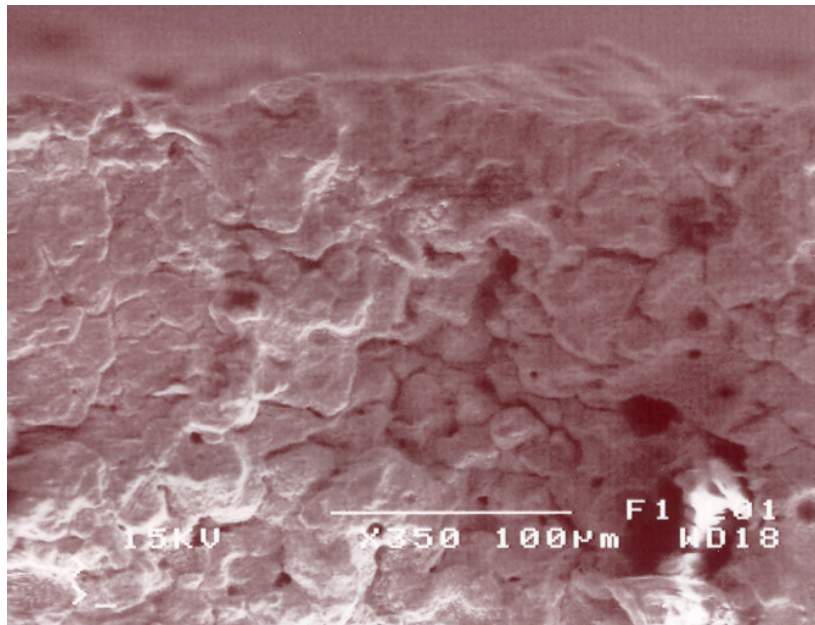
**Figure 6:**

Primary origin, intergranular facets partially obscured by corrosion.

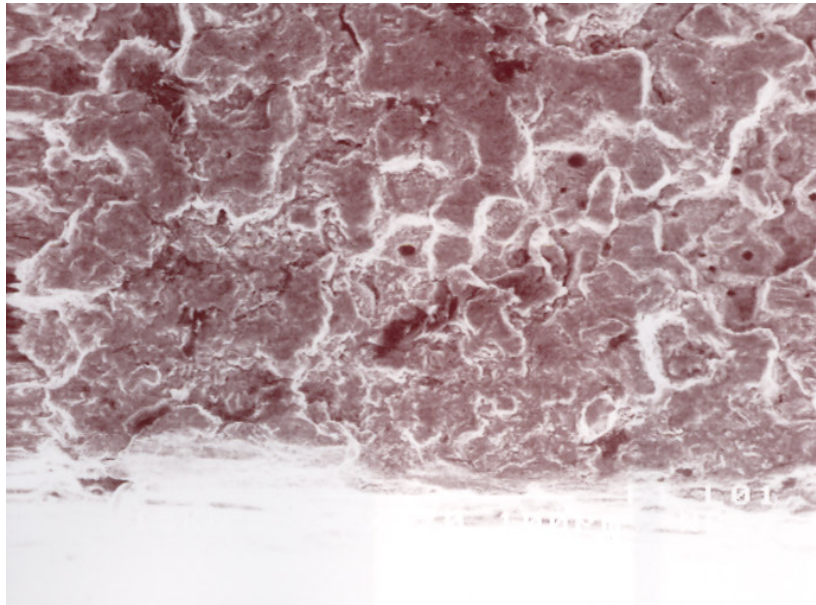
**Figure 7:**

Primary origin at compression surface. Intergranular facets are visible.

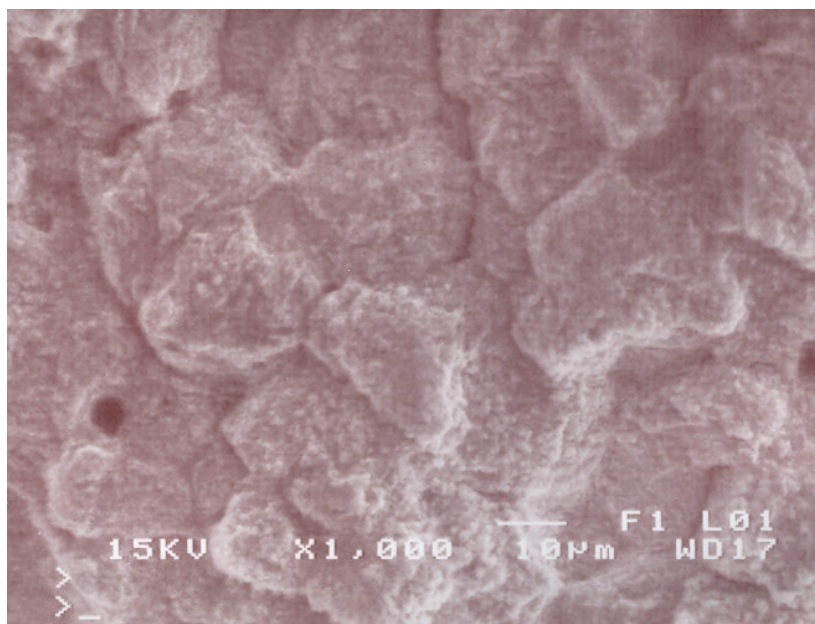
**Figure 8:**

Intergranular fracture on primary origin. Note the erosion/corrosion damage on the grain facets

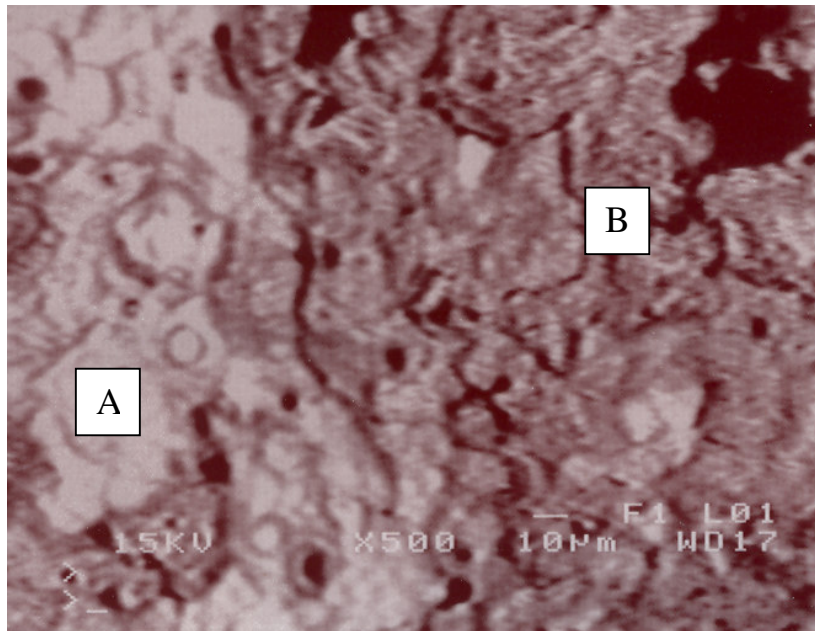
**Figure 9:**

1. The primary origin was plane and extended about half an inch from the edge of the spring, perpendicular to the length of the leaf and the upper and lower surfaces.
2. A ductile shear lip seen on the compression surface where the leaf finally separated was not in evidence at the quench crack.
3. Intergranular features were visible on the primary origins but not on the secondary fracture faces.
4. Intergranular facets were covered with a tight layer of material identified by EDS as oxidized oil.

Primary origin showing a tight non-metallic coating on the fracture surface using backscatter electron imaging. Area A is clean steel. Area B is oxidized oil.

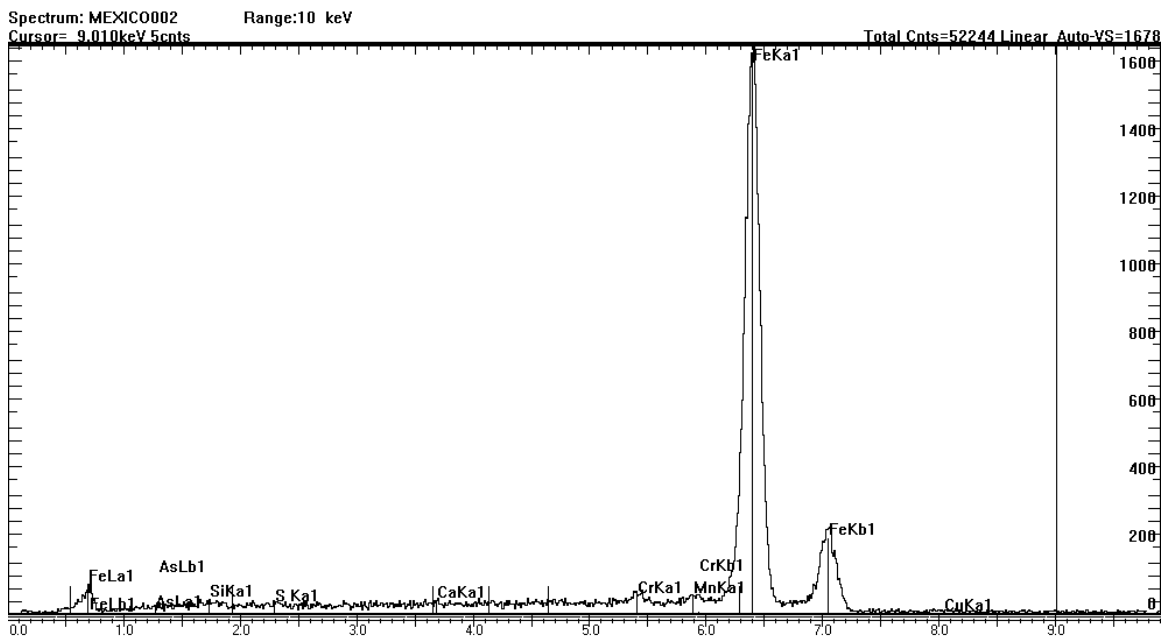
**Figure 10:**

Characteristic spectrum at Area “A” on image

Figure 9.

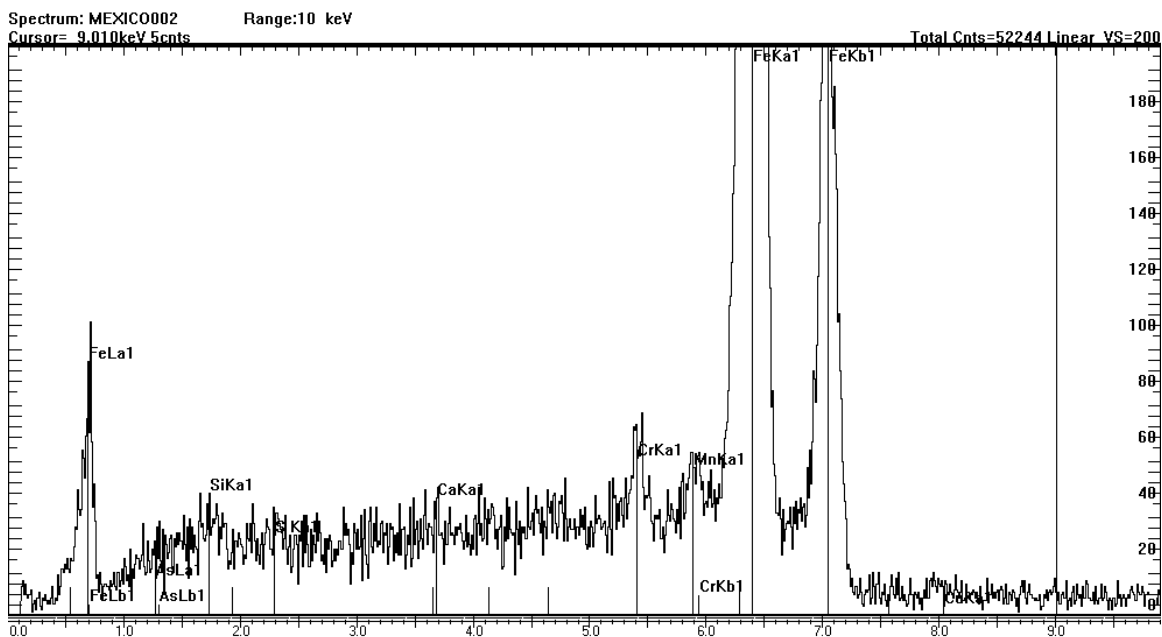
**Figure 11:**  
Characteristic spectrum at Area “A” on image

Figure 9. Range decreased to show detail.

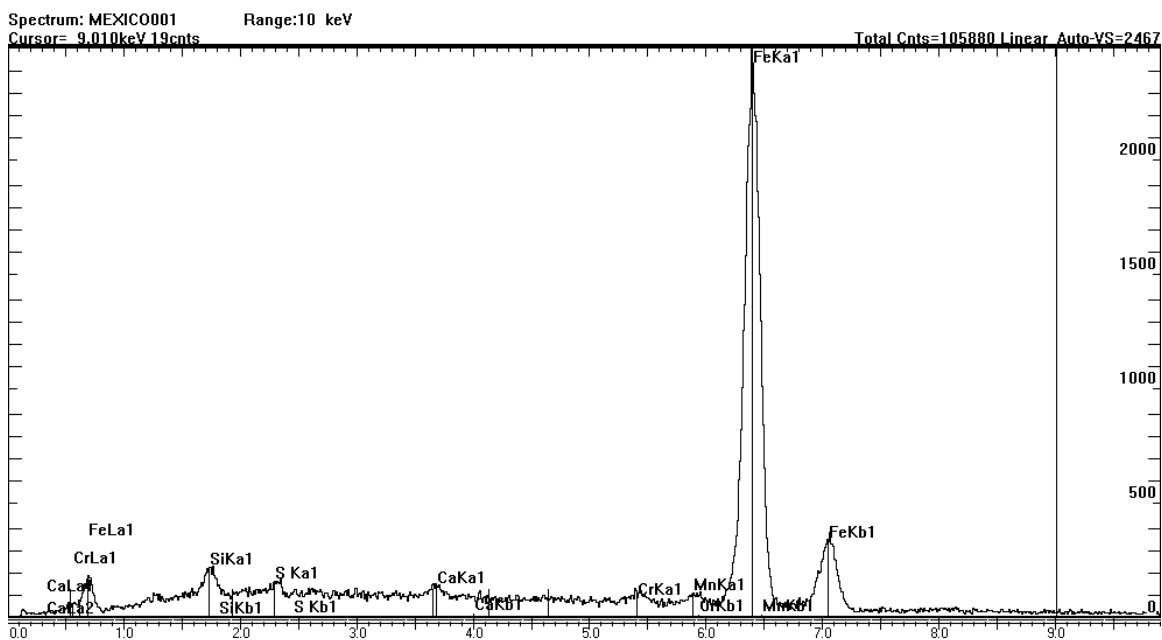
**Figure 12:**  
Characteristic spectrum at Area “B” on image

Figure 9.

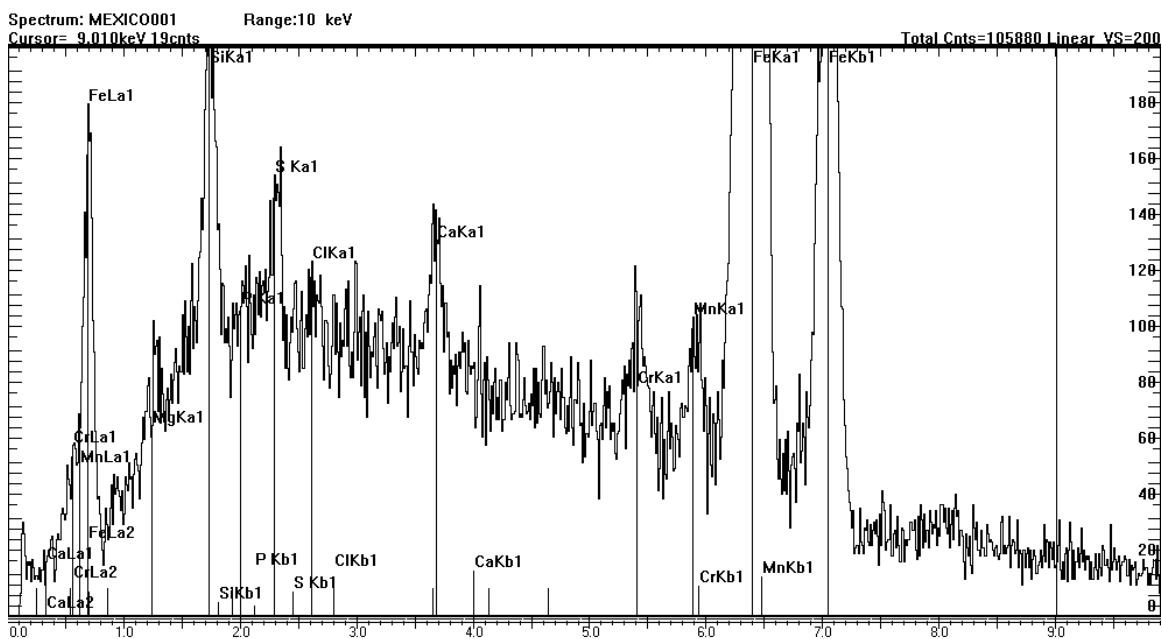
**Figure 13:**  
 Characteristic spectrum at Area “B” on image

Figure 9. Range decreased to show detail. Elements detected are representative of oxidized oil.

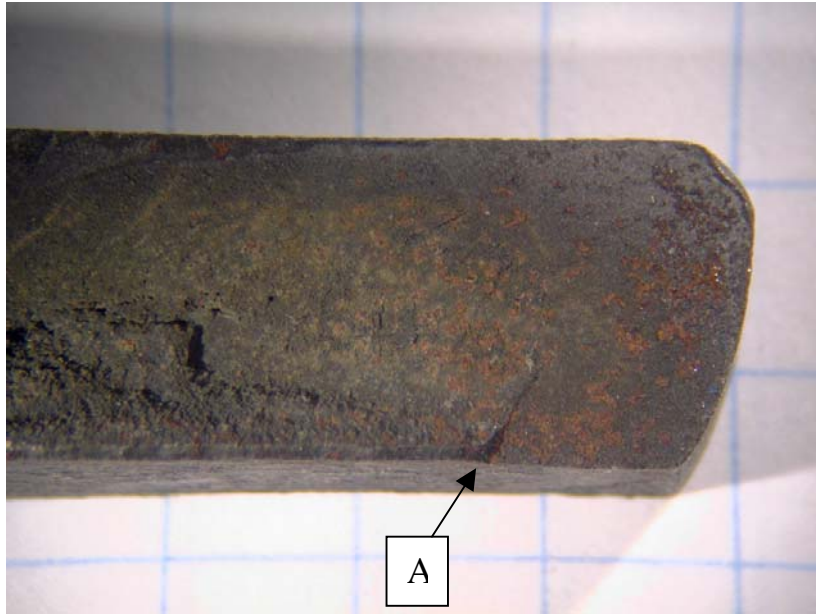
**Figure 14:**

Fracture surface at origin. Post fracture ding mark is visible on upper edge. Transition between intergranular fracture to a shear lip is visible on bottom of image at “A”.

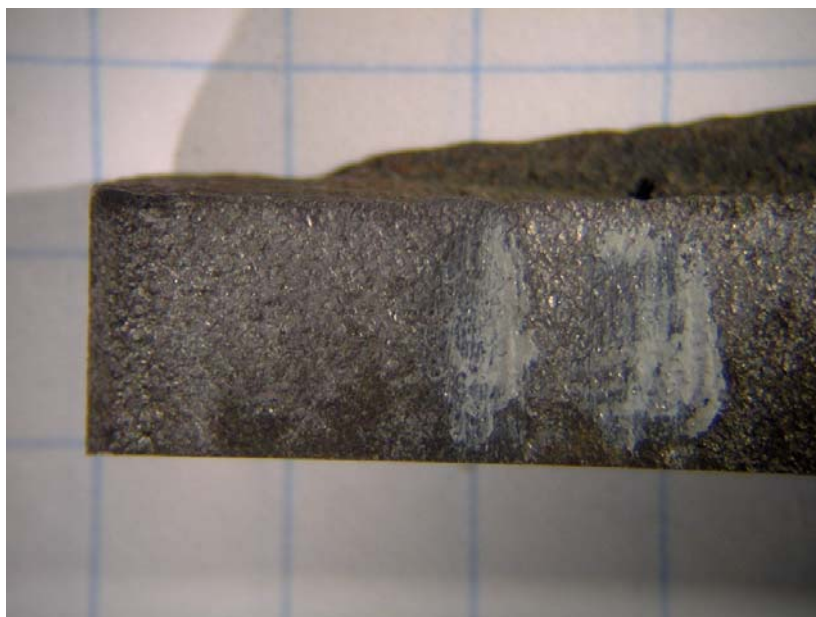
**Figure 15:**

Tension surface at primary origin.

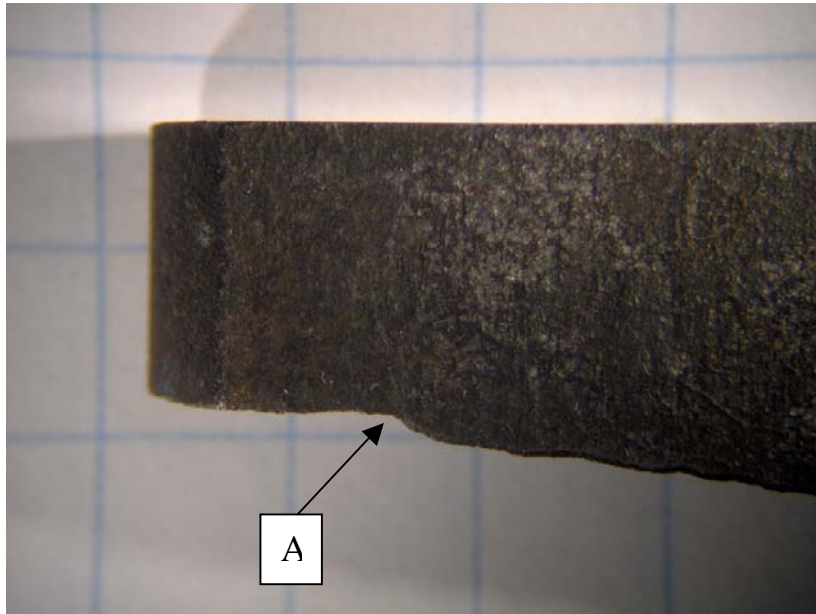
**Figure 16:**

Compression surface at origin. Area “A” from Figure 14 is indicated by arrow.

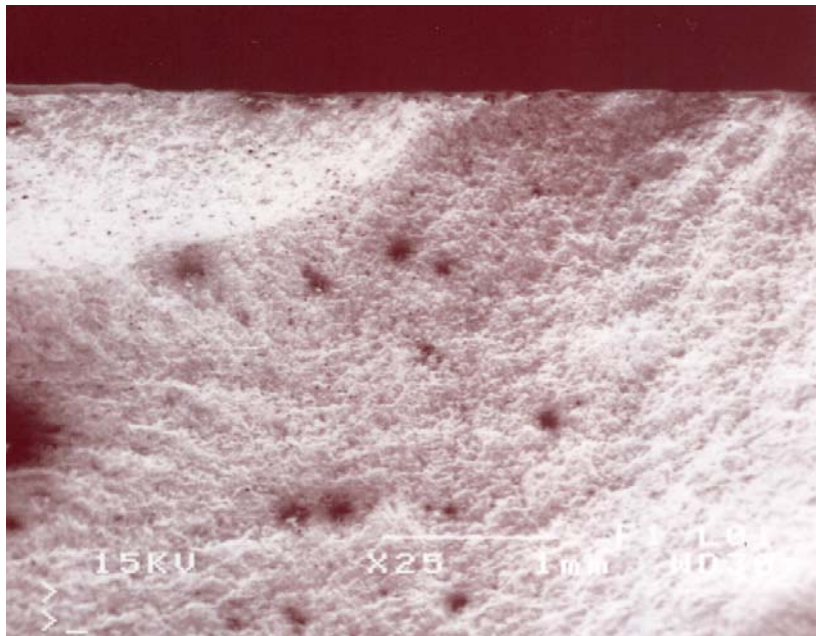
**Figure 177:**

Intersection between primary fracture and secondary fracture.

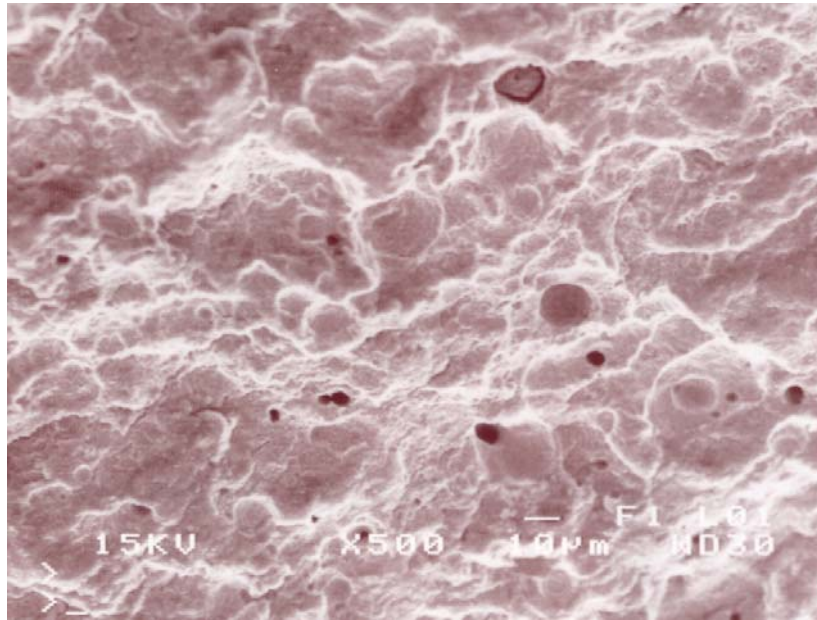
**Figure 18:**  
Erosion / corrosion damage on primary fracture face.

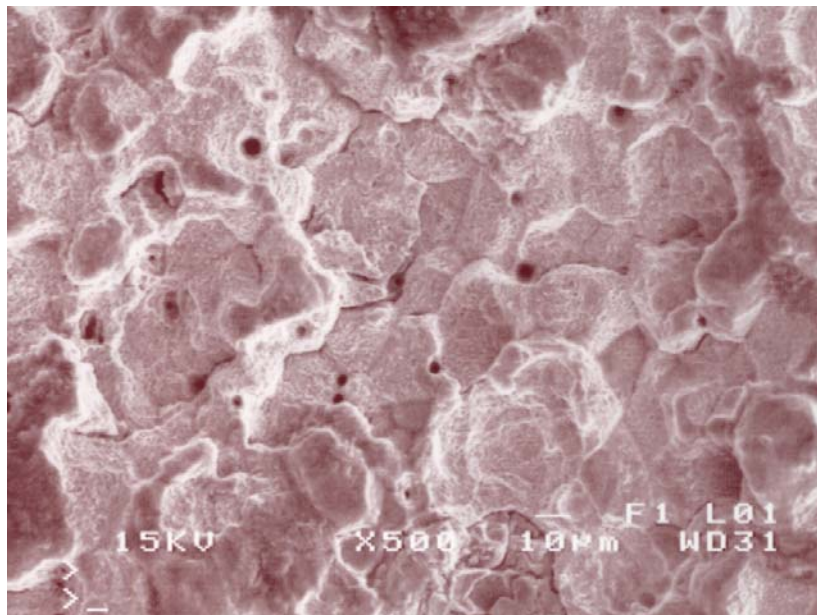
**Figure 19:**  
Intergranular fracture on primary origin.
