To: MITSUBISHI MOTORS CORPORATION

Doc.No.AQ-F080082(1/16)

PS41,ST41 PW AS SW Failure Returned Part Analysis Result Report

June 30, 2008

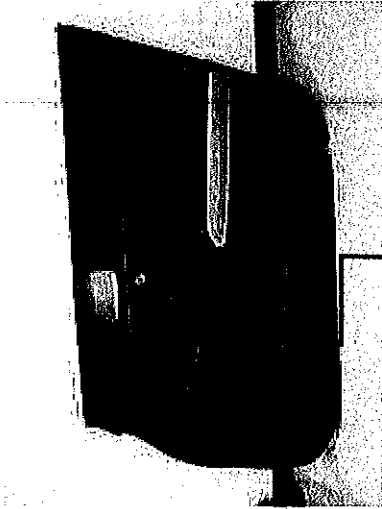
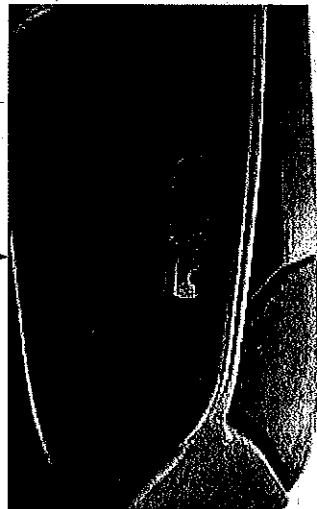
- Carbonization was confirmed in the vicinity of UP side NO contact on insert-molded base of P/W SW.
- Confirmed melting of P/W SW connector housing and the harness coating in the connector area (approx. 5cm).

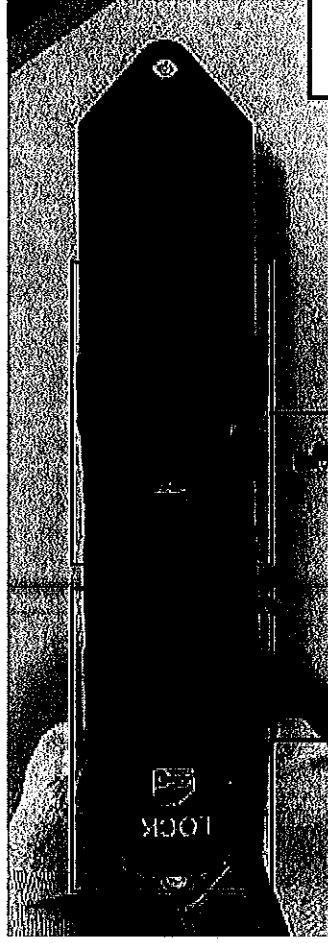
- Contamination confirmed in the vicinity of P/W SW knob and D/L SW knob.
- Confirmed melting at the upper portion of UP side NO contact on case surface.

Contamination

Knob front wall
was cut open

Melting at the upper portion of
UP side NO contact of the case.

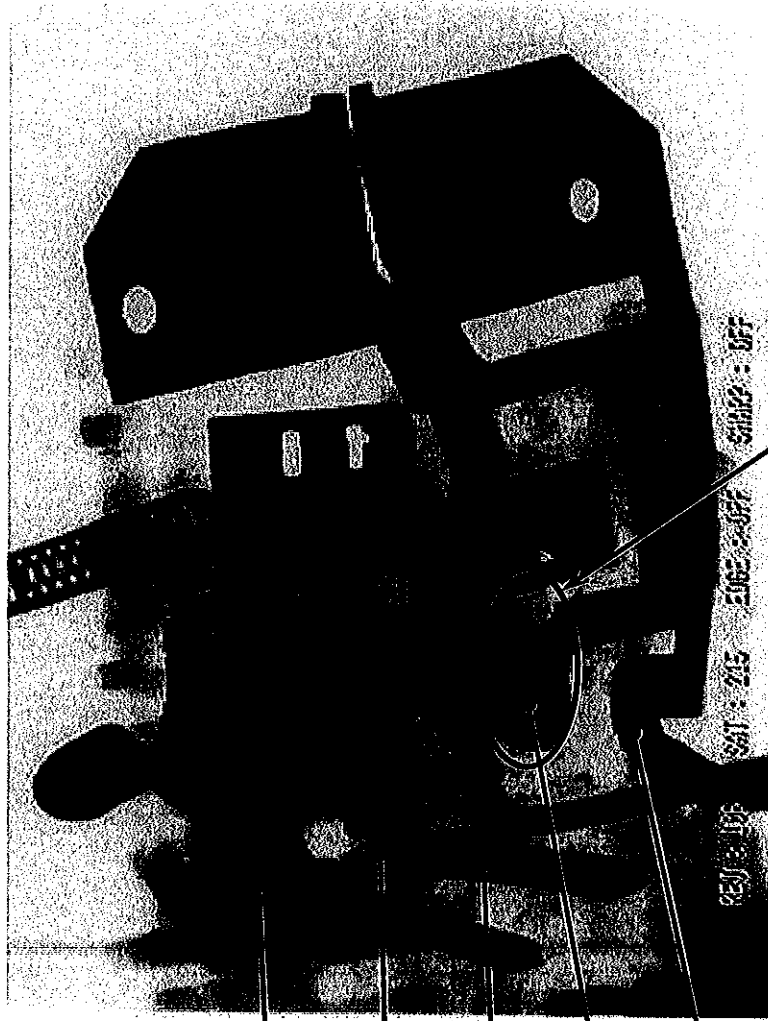
-Confirmed broken IG trace in the vicinity of Up side NO contact area.

IG copper trace is broken in the vicinity of
UP side NO contact area.

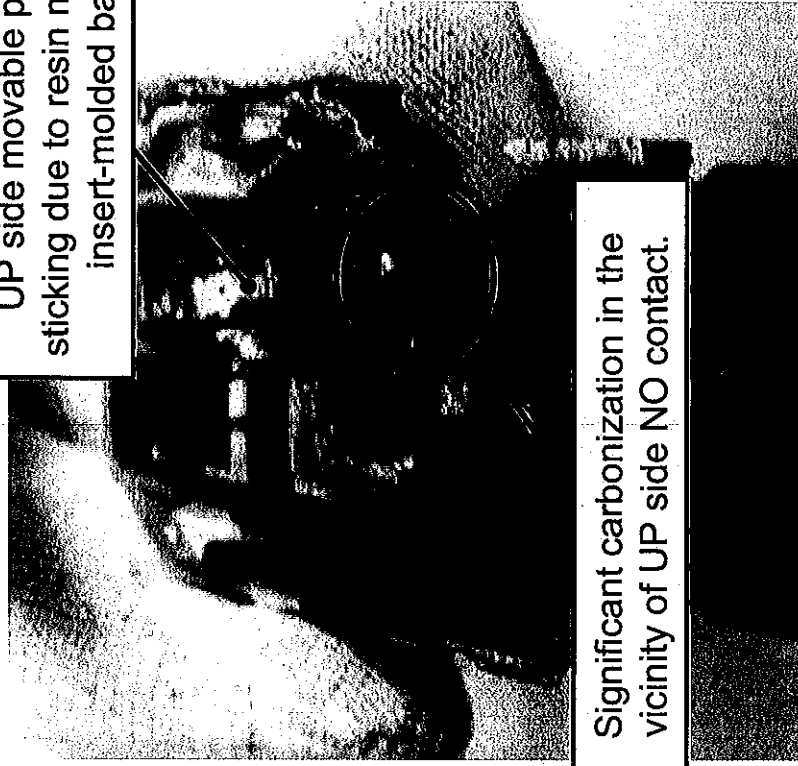
Insert-molded base, top side

- Confirmed significant carbonization in the vicinity of UP side NO contact area.
- Confirmed that movable plate in UP side is sticking due to melting of insert-molded base resin.
- Confirmed carbonization in the upper portion of UP side NO contact (between IG-MU) on the back of the case.

UP side movable plate is sticking due to resin melting of insert-molded base.

Significant carbonization in the vicinity of UP side NO contact.

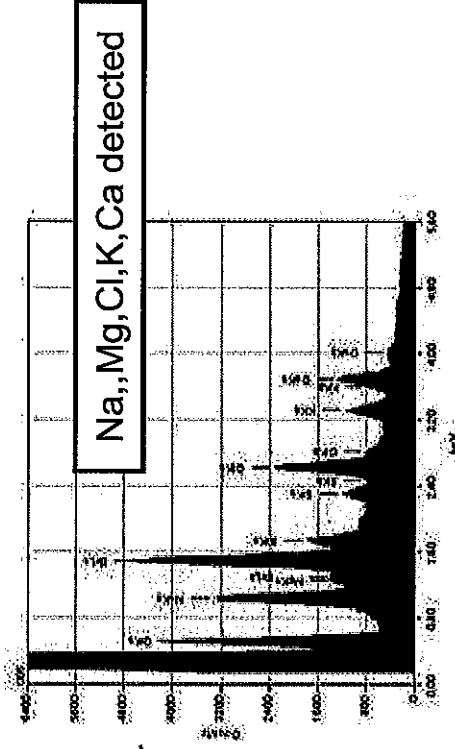
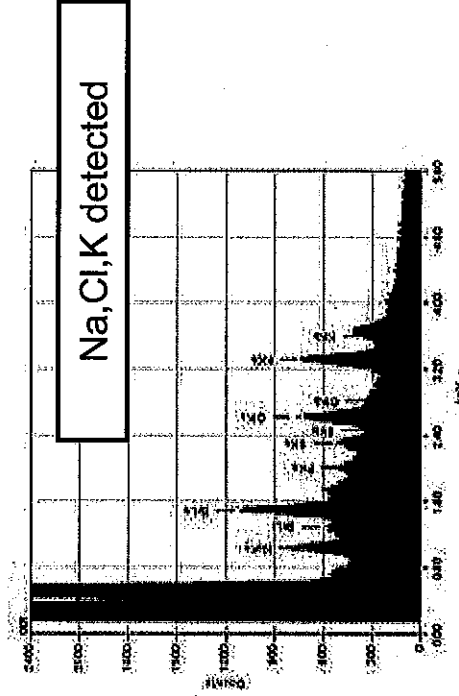
From the fact that ionic impurities (Na, Mg, Cl, K, Ca, etc.) are found under P/W SW knob, fluid intrusion inside SW is considered a high possibility.

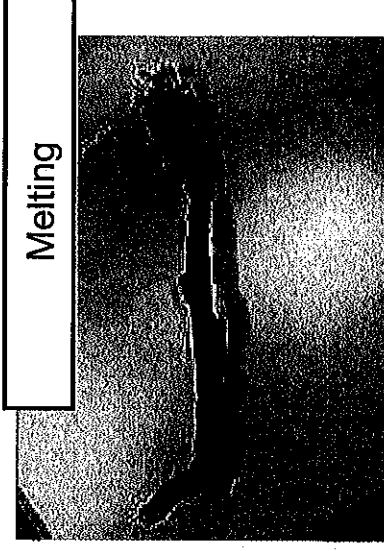
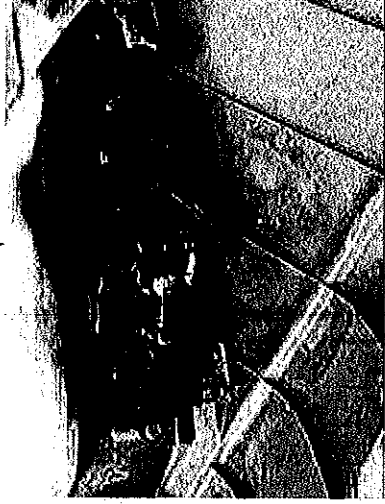
- ・Carbonization was confirmed in the vicinity of UP side NO contact on insert-molded base of P/W SW.
- ・ Confirmed melting of P/W SW connector housing and the harness coating in the connector area .

Carbonization in the vicinity of UP side NO contact of insert-molded base of P/W SW.

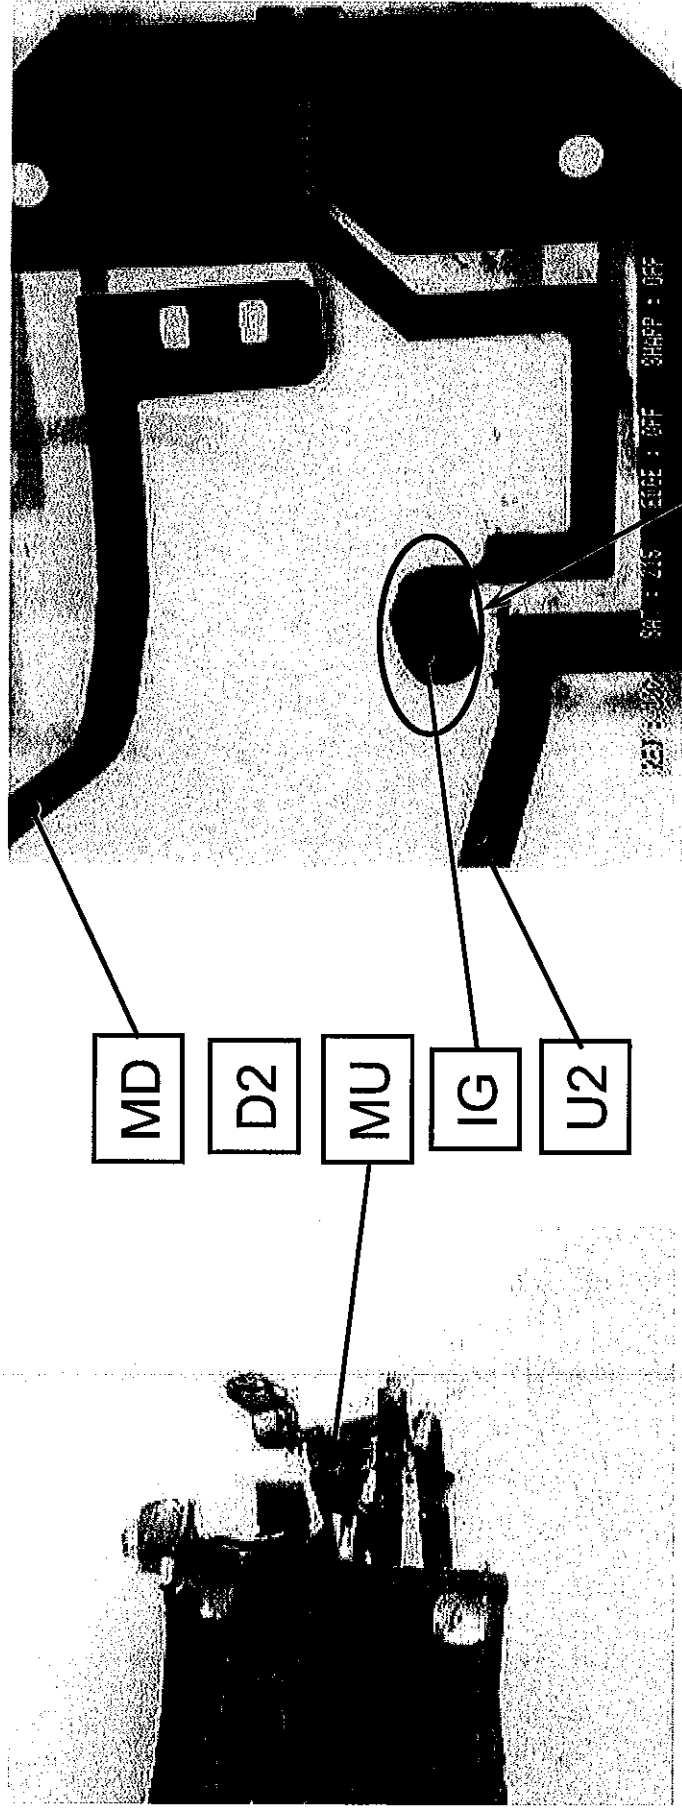
• Confirmed broken IG trace in the vicinity of Up side NO contact area.

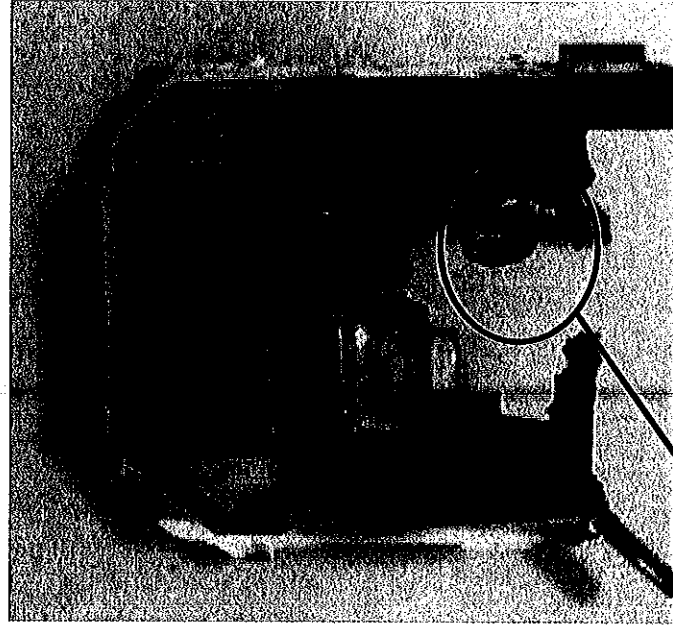
Insert-molded base, top side

- Confirmed significant carbonization in the vicinity of UP side NO contact area.
- Confirmed that movable plate in DOWN side is sticking due to melting of plunger resin.
- Confirmed carbonization in the upper portion of UP side NO contact (between IG-MU) on the back of the case.

Significant carbonization in the vicinity of UP side NO contact.

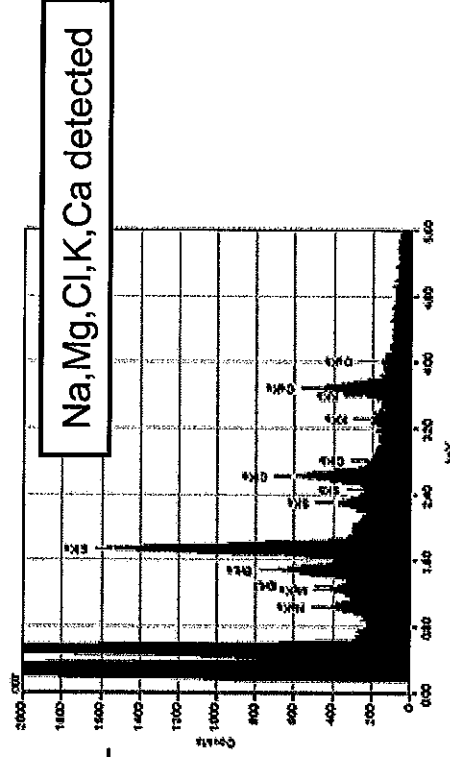
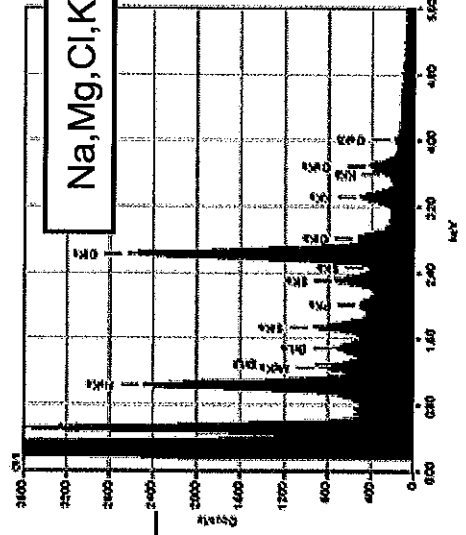
- From the fact that ionic impurities (Na, Mg, Cl, K, Ca, etc.) are found under P/W SW knob and back side of trim, fluid intrusion inside SW is considered a high possibility.
