Doc.No.AQ-F090032(1/8)

ST41 P/W AS SW Failure Returned Parts Analysis Result Report

May 11, 2009

**Omron Corporation AEC Company
Quality Assurance Division**

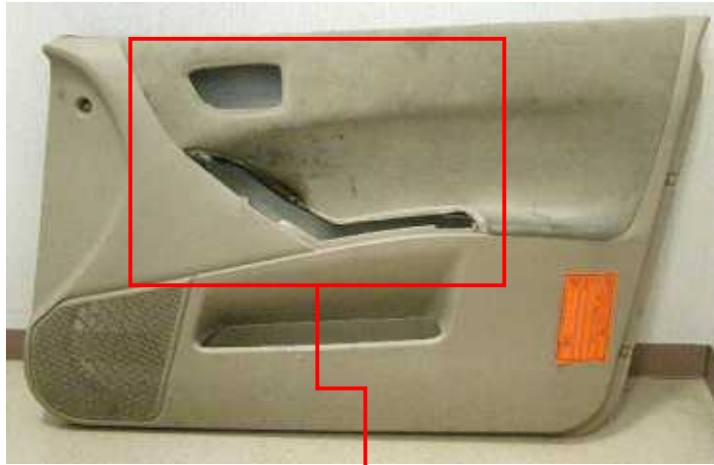
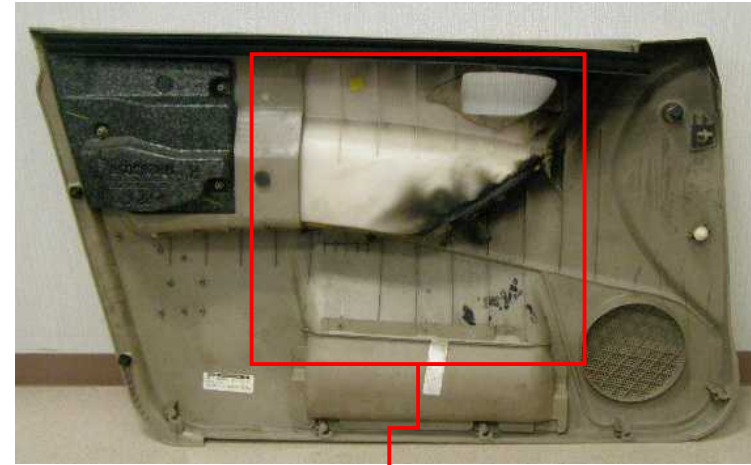
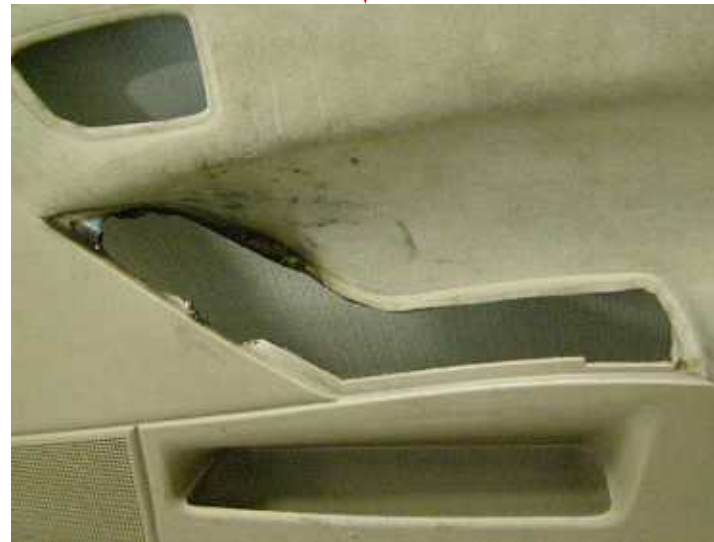
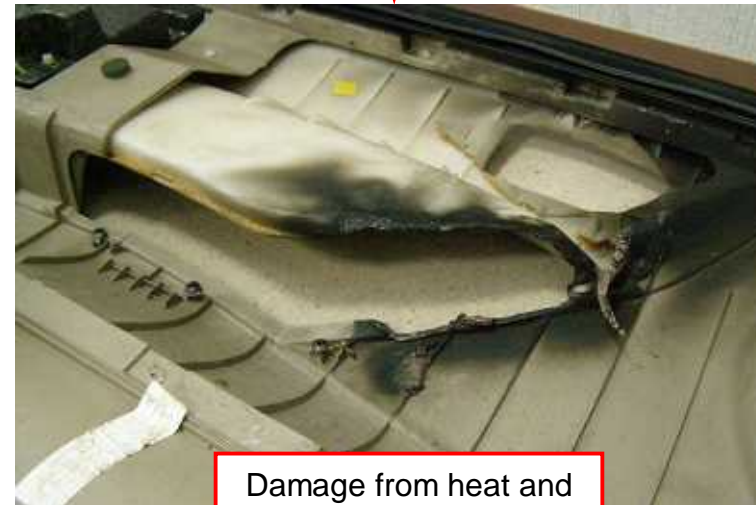
-The generation of heat and smoke was confirmed in the P/W SW area of the trim.

Damage from heat and
smoke at P/W SW

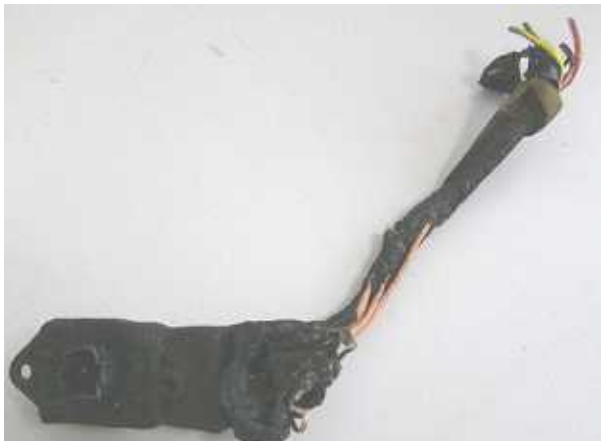
- Carbonization of the case, insert-molded base and connector of the P/W SW was confirmed.
- The copper trace (IG-MU) was lost due to generated heat and smoke.
- It was judged that the broached area between IG-MU was the source of fire as its damage was significant.

Carbonization of P/W SW case, insert-molded base, connector and harness.

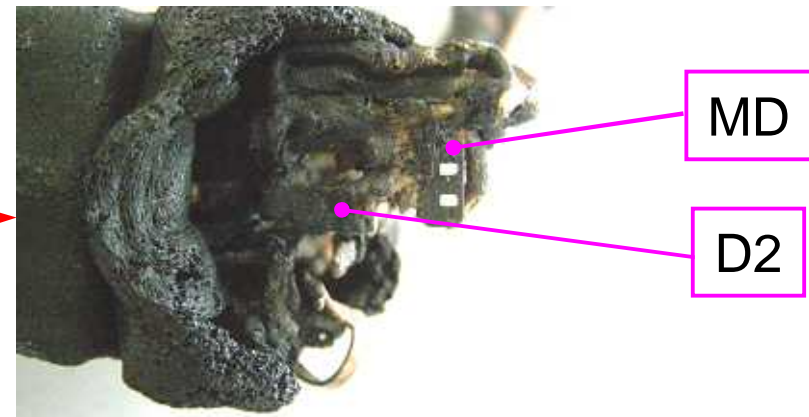
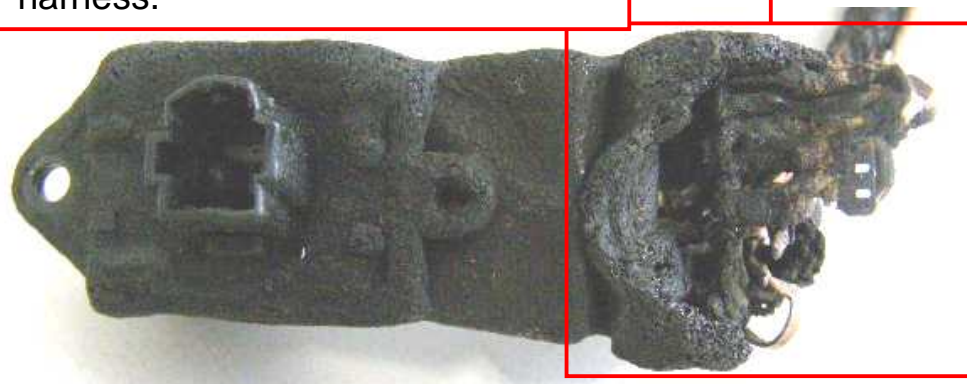
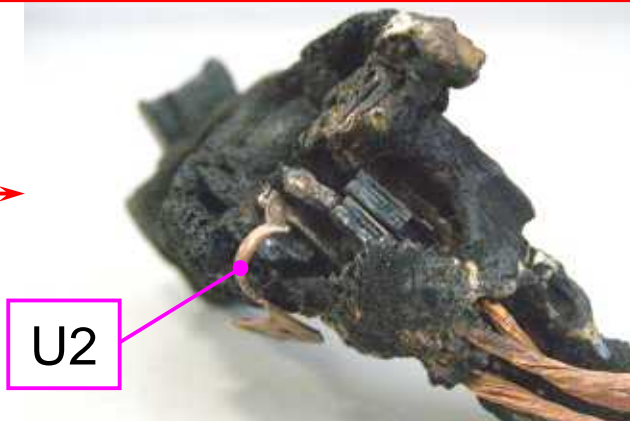
The copper trace (IG-MU) was lost due to generated heat and smoke.

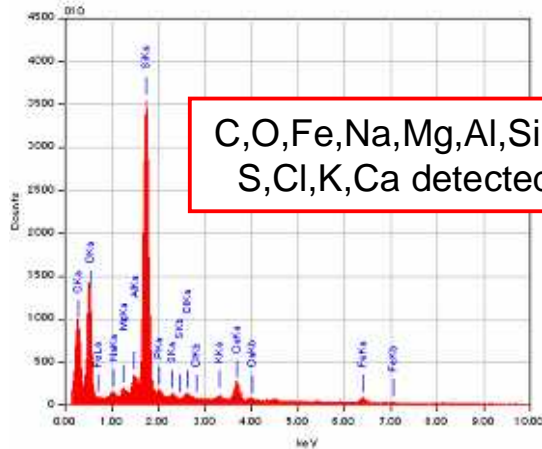
-From the fact that ionic impurities (Na,Mg,Cl,K,Ca,etc.) were found under P/W SW knob, it is considered that there is a high possibility of fluid intrusion inside SW.

C,O,Fe,Na,Mg,Al,Si,P
S,Cl,K,Ca detected

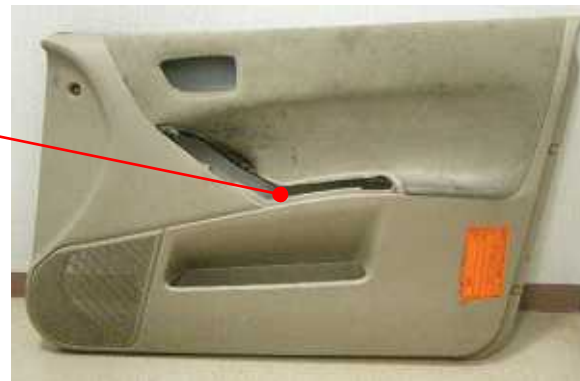
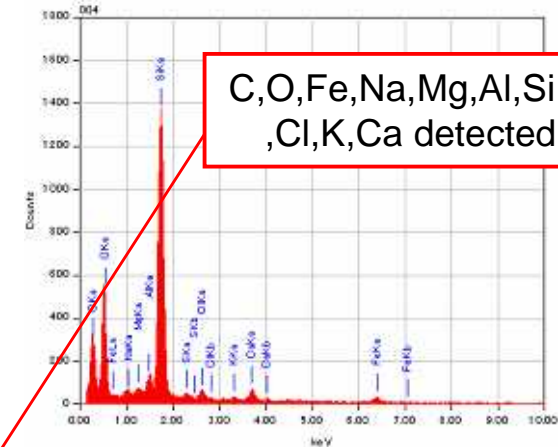
C,O,Fe,Na,Mg,Al,Si,S
,Cl,K,Ca detected

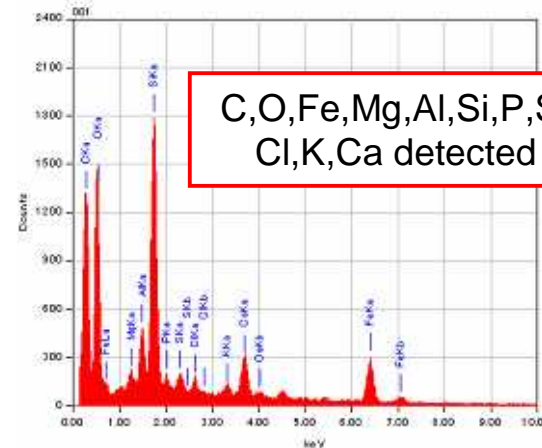
C,O,Fe,Mg,Al,Si,P,S,
Cl,K,Ca detected

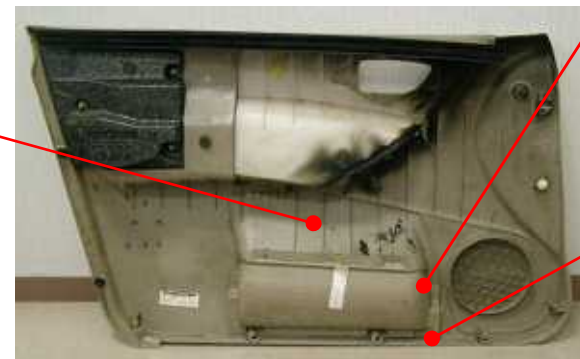
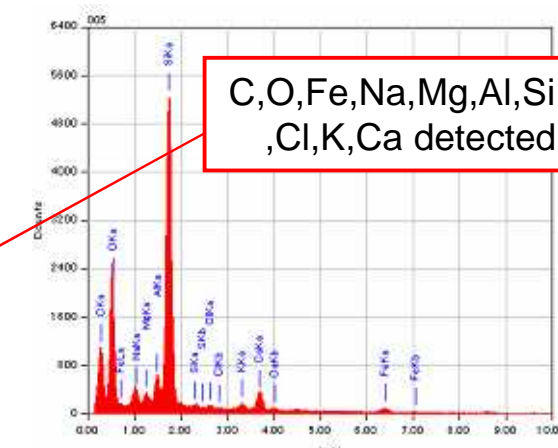
C,O,Fe,Na,Mg,Al,Si,S
,Cl,K,Ca detected
