Doc.No.AQ-F080017(1/10)

3A45 P/W AS SW Failure Returned Part Analysis Result Report

March 4, 2008
Omron Corporation AEC Company
Quality Assurance Division
Omron Dualtec Automotive Electronics Inc.
Quality Assurance

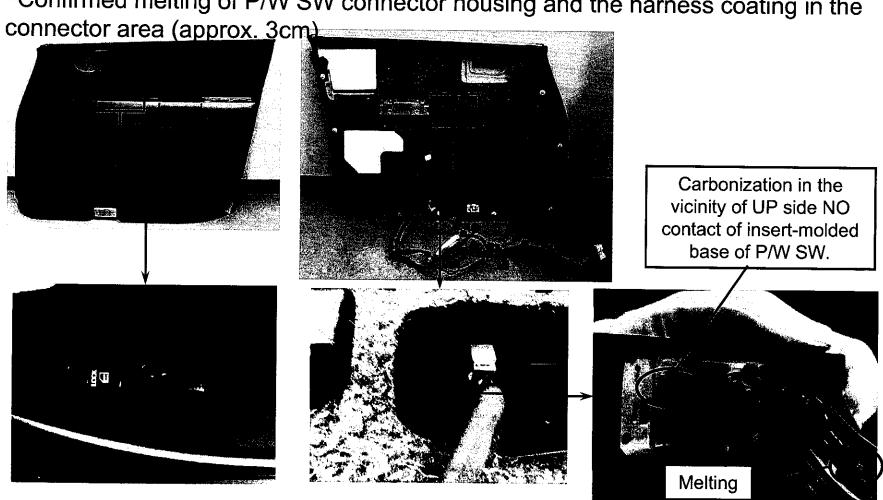
Trim appearance examination

· Carbonization was confirmed in the vicinity of UP side NO contact on insert-molded base of P/W SW.

·Confirmed melting of P/W SW connector housing and the harness coating in the

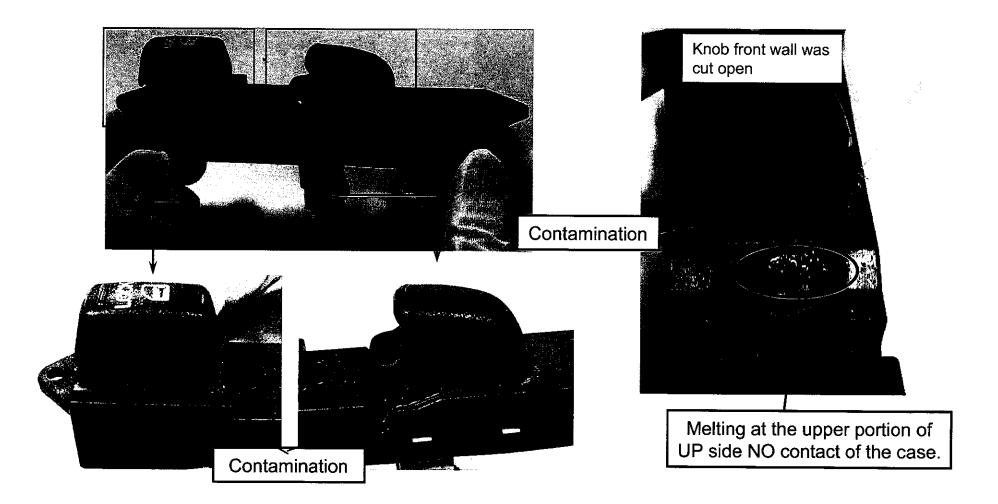
♦ SW appearance examination

- Contamination confirmed in the vicinity of P/W SW knob and D/L SW knob.
- Confirmed melting at the upper portion of UP side NO contact on case surface.

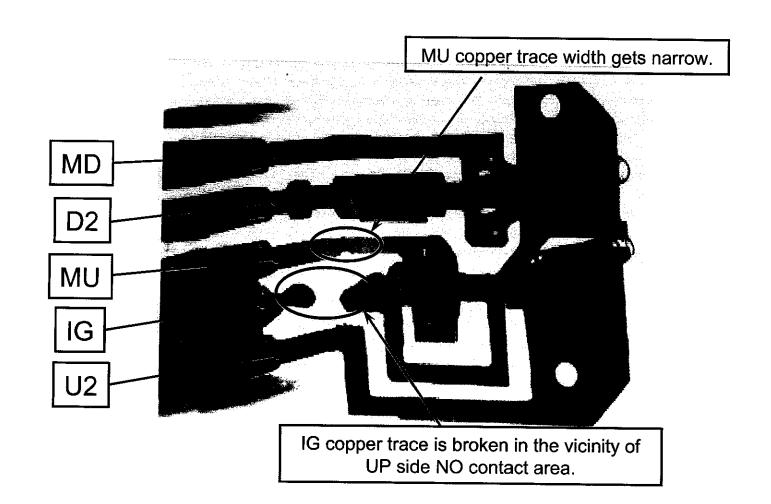
◆ X-ray internal examination

•Confirmed broken IG trace in the vicinity of Up side NO contact area (connector side) and melted MU trace with a narrowed width.

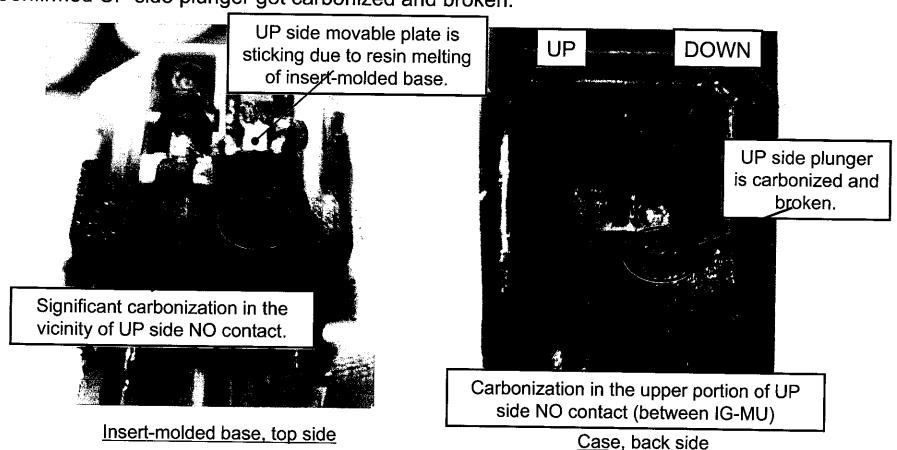
◆ P/W SW internal examination

- ·Confirmed significant carbonization in the vicinity of UP side NO contact area.
- •Confirmed that movable plate in UP side is sticking due to melting of insert-molded base resin.
- •Confirmed carbonization in the upper portion of UP side NO contact (between IG-MU) on the back of the case.
- ·Confirmed UP side plunger got carbonized and broken.

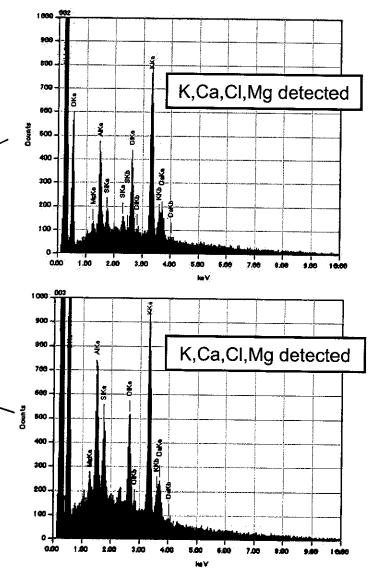
Element analysis

From the fact that ionic impurities (i.e. K,Ca,Cl,Mg,etc.) are found under P/W SW knob, fluid intrusion inside SW is considered a high possibility.
