QIS #SHJA-071012-01

QUALITY IMPROVEMENT SHEET (Q.I.S.)

05M - 07M Odyssey

PTG Open Stay problem summary

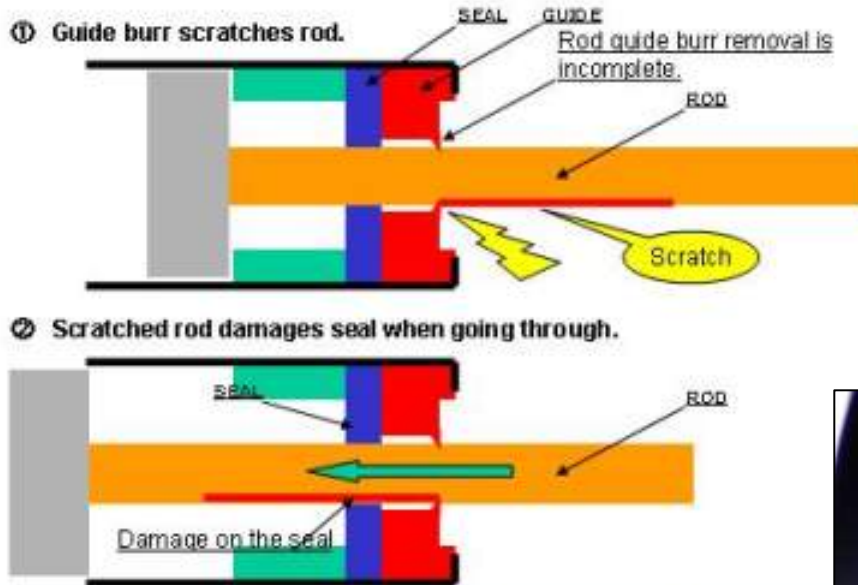
■ Cause Rod Guide Burr Defect

- Scratches on rod (due to rod guide burr and side-loading) lead to seal damage.
- Seal damage causes open stay failure.

Root cause is rod guide manufacturing defect (burr).

Increase burr removal time from 6 min to 18 min and add automated visual check

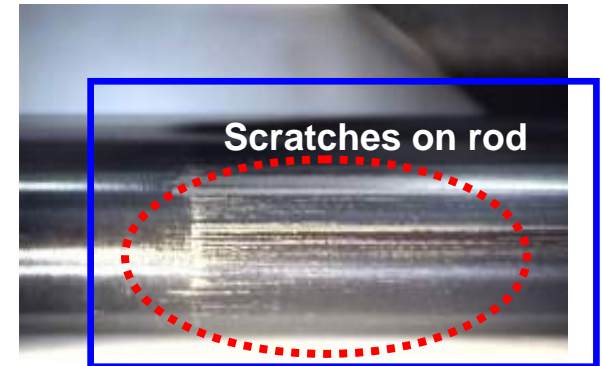
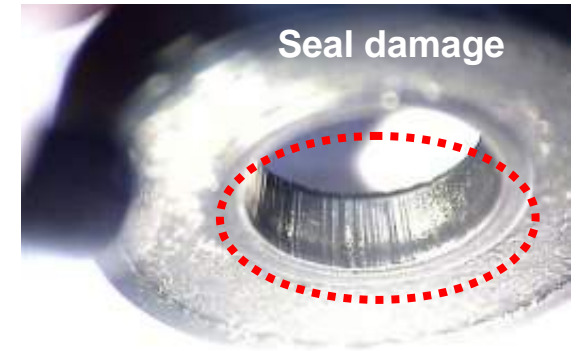
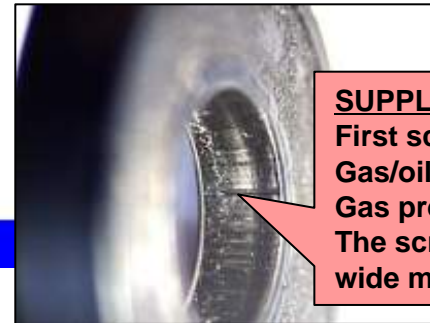
SUPPLIER RECREATION TESTING:
First scratch was found after 250 cycle.
Gas/oil leak was confirmed after 1000 cycle.
Gas pressure went down to 53%.
The scratch was 0.4 μm deep and 0.1 mm wide maximum.

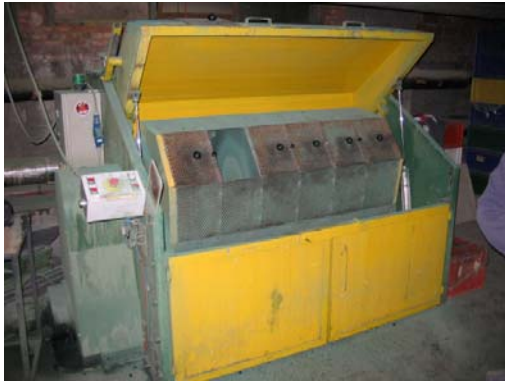
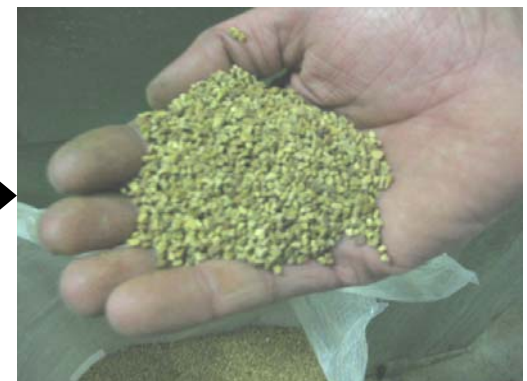
Total de-burring time
Increase from 6 to 18 min

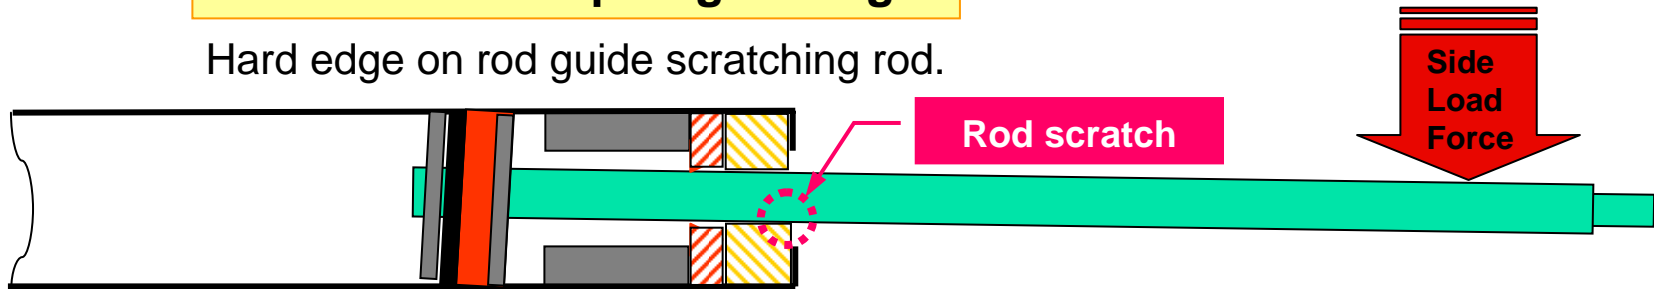
Rod Guide Sharp Edge Design

Hard edge on rod guide scratching rod.

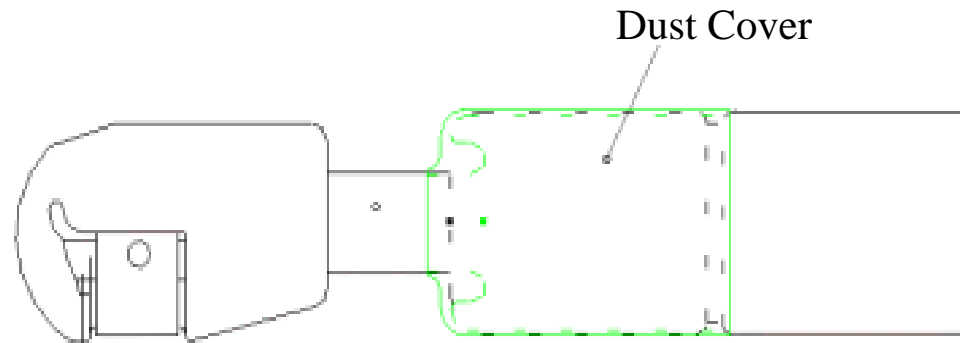
Contaminant entry into seal area

Dust cover applied (same as S0X design) by MI

But dust cover was deemed ineffective for decreasing warranty claims and was discontinued.

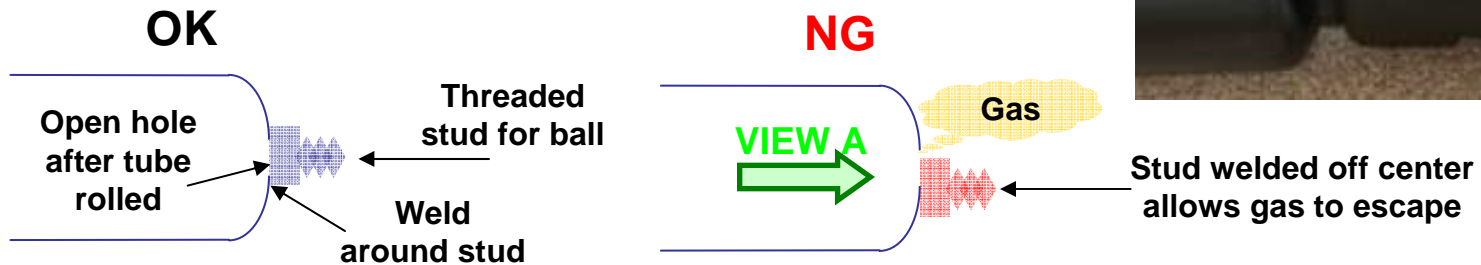
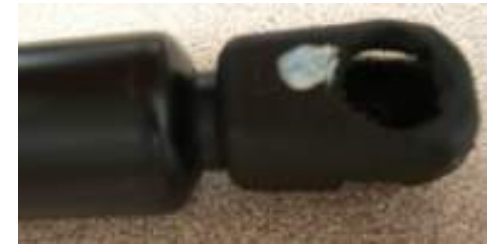
Assembly Contamination / NG Weld

For contamination issues, a polycarbonate cover was made to cover the component parts bins to prevent airborne contaminants from getting into the bins.

For offset weld, the program was adjusted and a new inspection standard was set that includes an internal visual and measurement inspection to ensure that the weld is centered. (2pieces per hour)

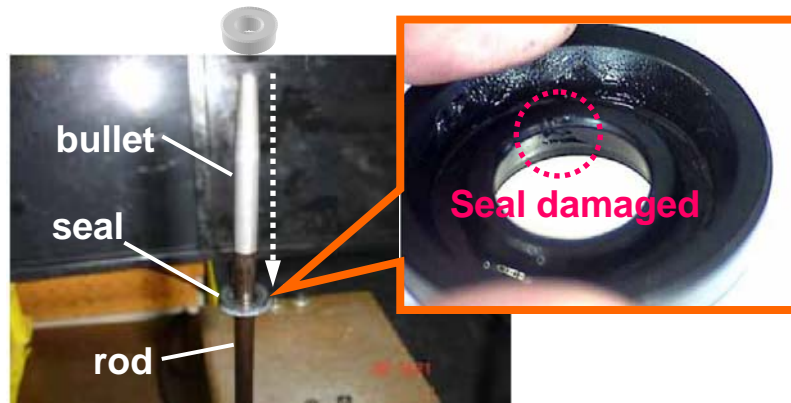
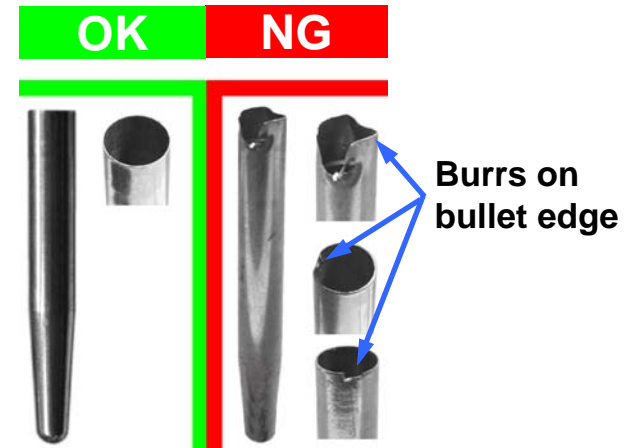
Burrs on Bullet edge causing seal damage

※Bullet is used to prevent seal damage when seal is set on the rod

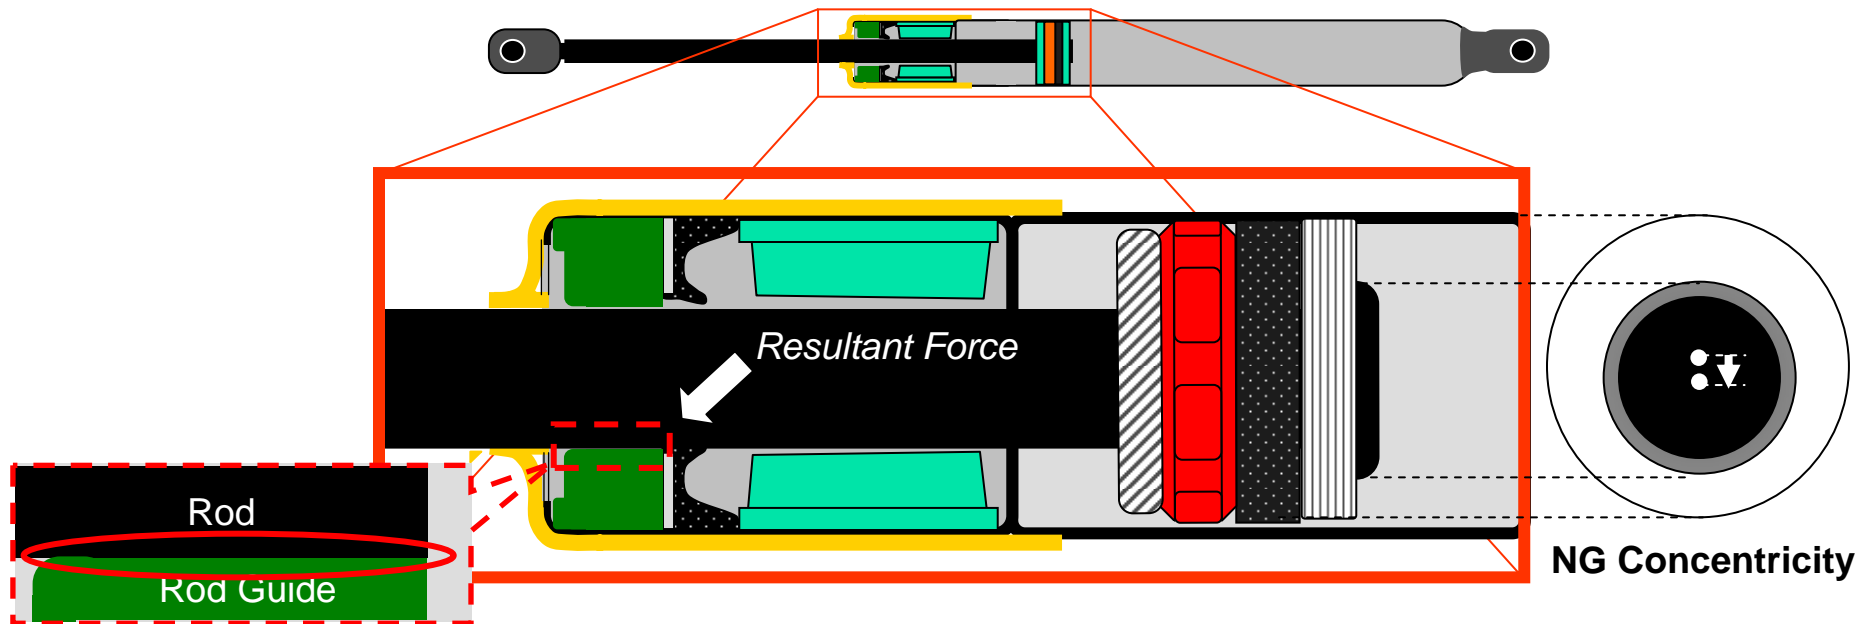
Piston package concentricity out of spec for NG set up on reveter

NG Concentricity causes heavy rod guide to rod contact.

Revetting machine design change

① Rod guide design change (Push type ⇒ Clamp type)

② Rod hold jig design change
(Hold components by nest ⇒ Hold rod by base)

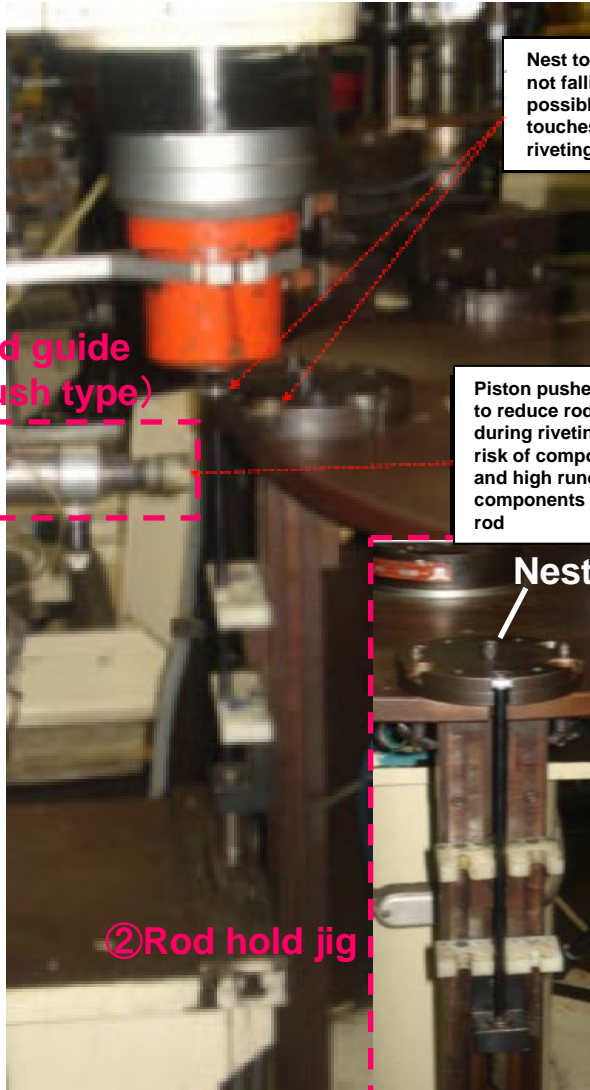
BEFORE

Orbital rod riveting system with nest to hold the components

Nest to hold the components not falling before riveting, possible damage if nest touches the components at riveting time

Piston pushes rod to help to reduce rod movement during riveting, potential risk of component damage and high runout of components attached to rod

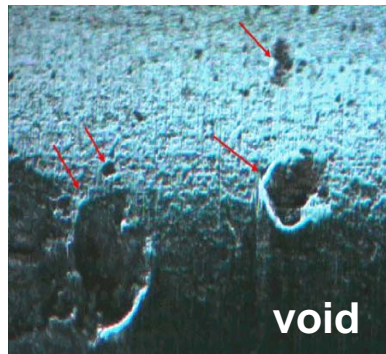
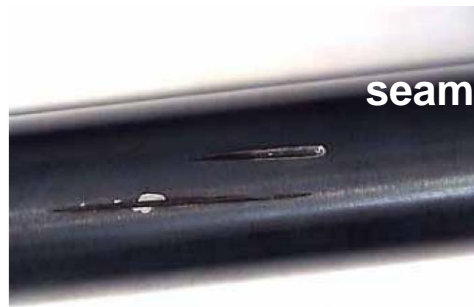
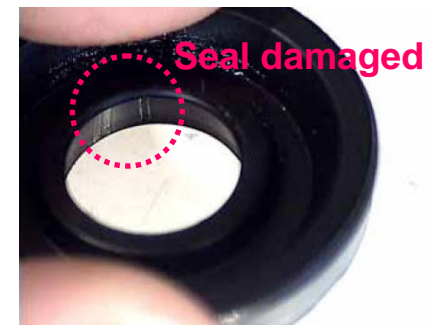
③Using rejected rod by eddy current tester

④Material defect in the rod (void and laps/seams)

③-1. Reject parts go into the locked box

③-2. Eddy current adjustment more sensitive

④Raw material supplier change

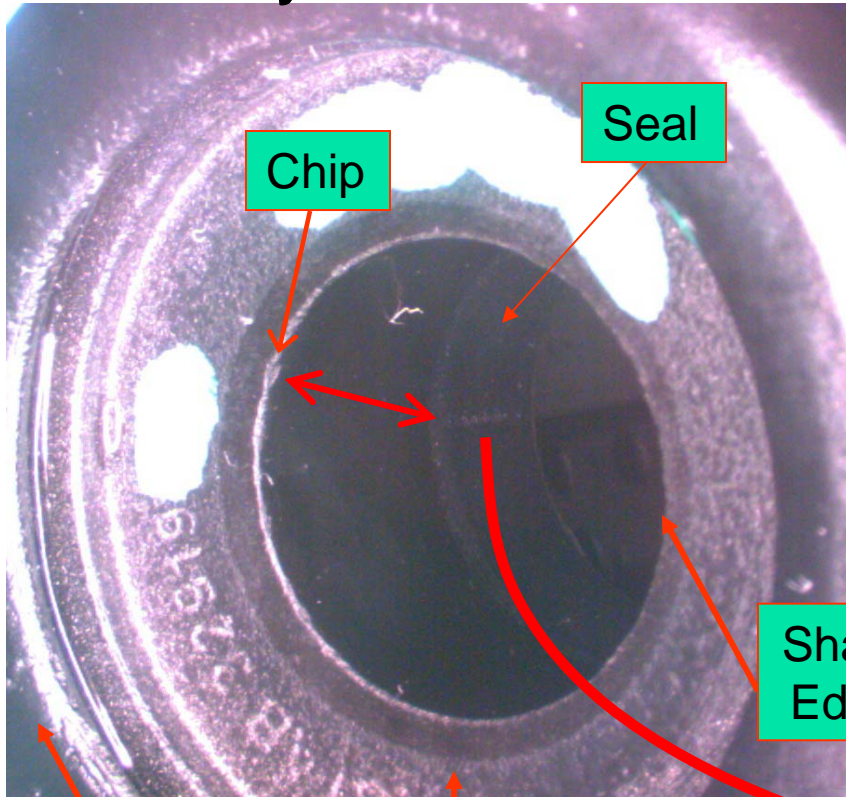
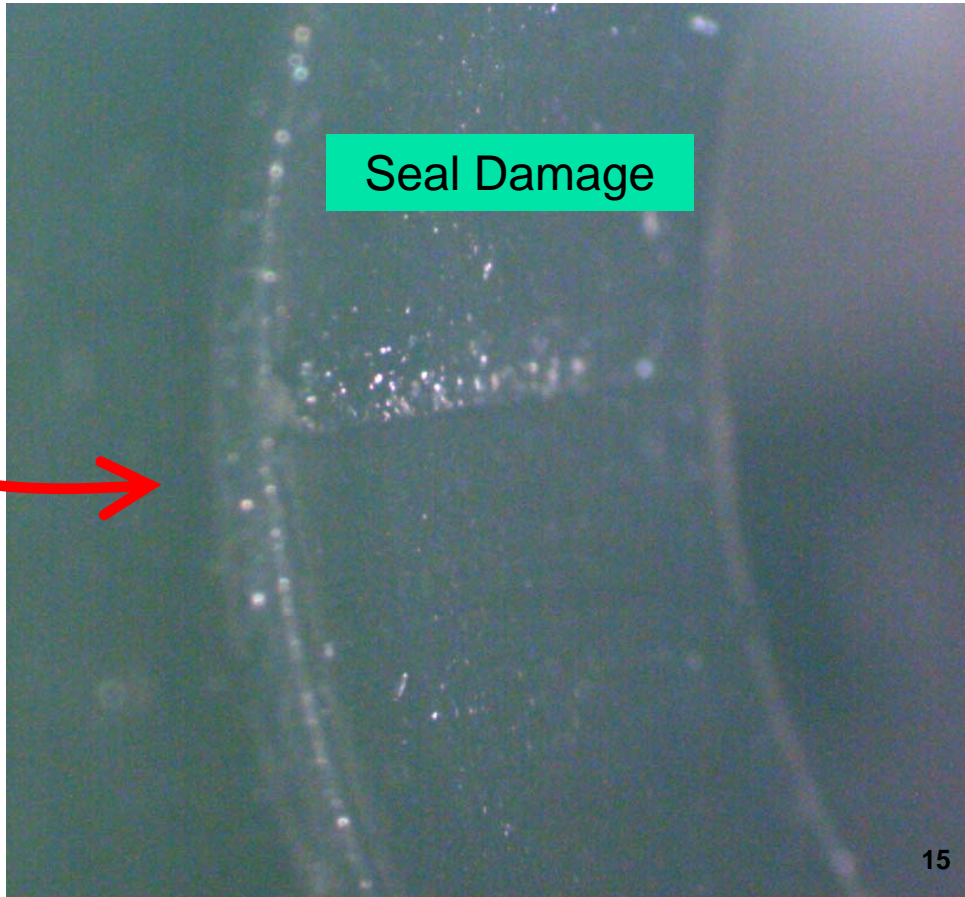
Part Analysis Claim #254293

Rod Guide Material is hard and abrasive. Under a side load pieces may break off and damage seal and rod.

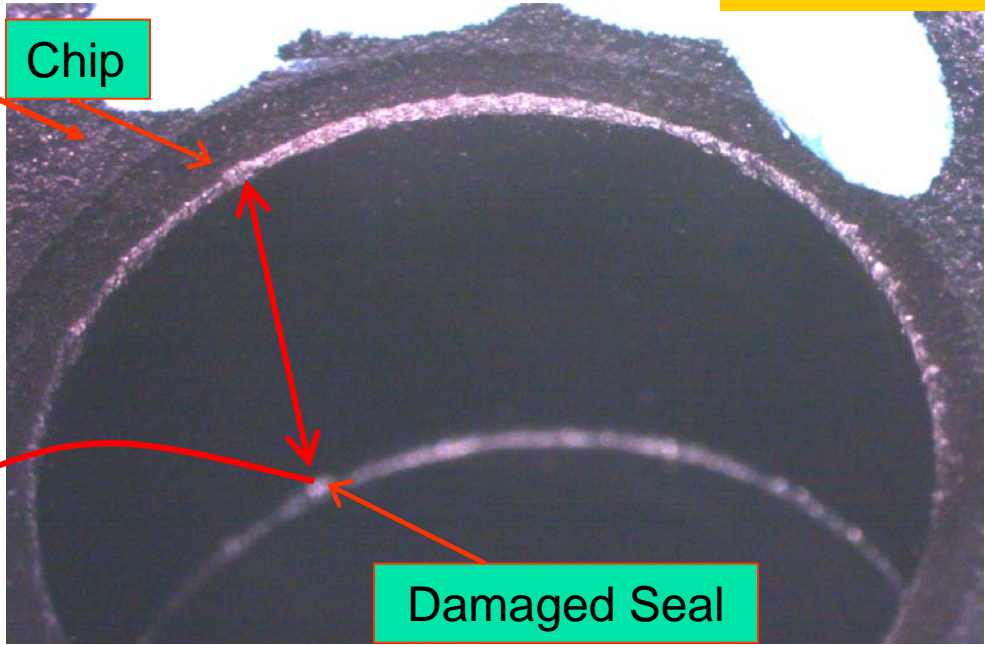
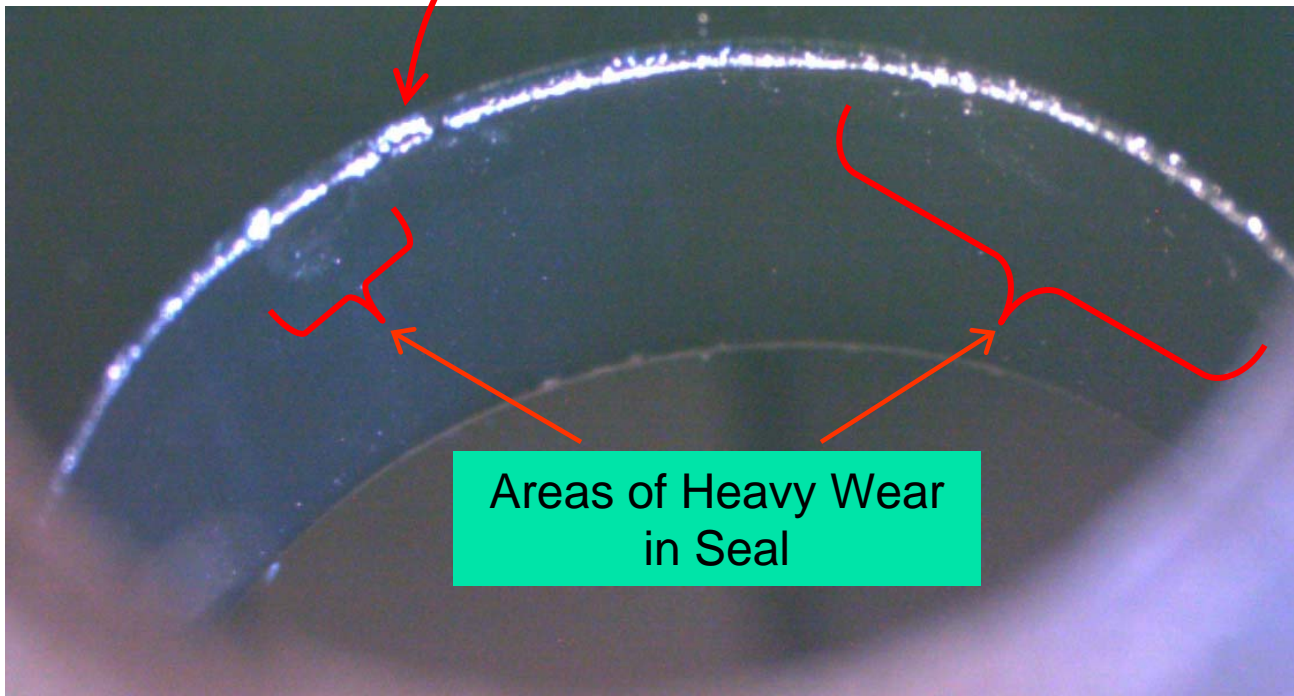
Claim #254293

Damaged Seal

Areas of Heavy Wear in Seal

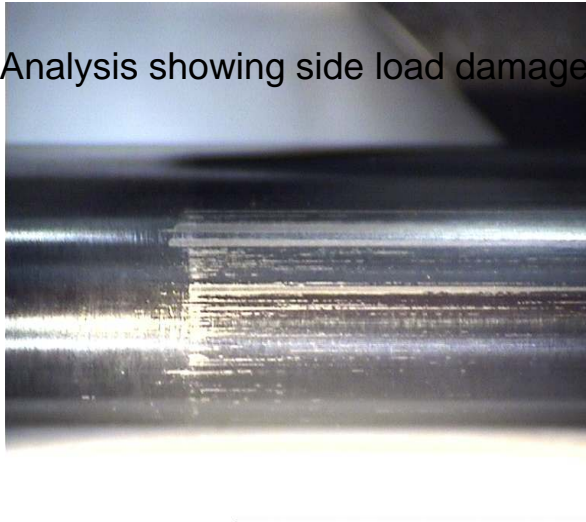
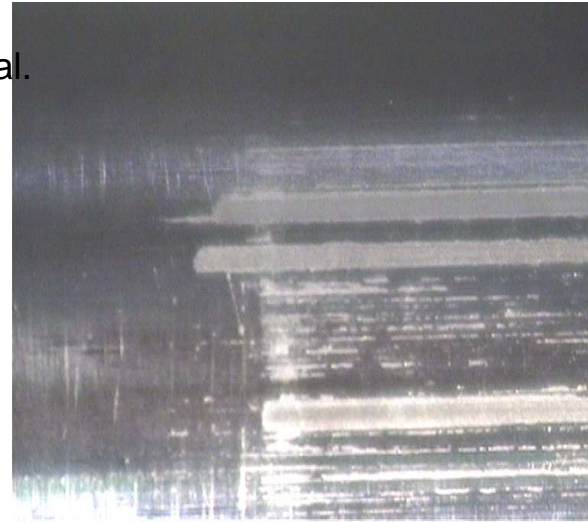
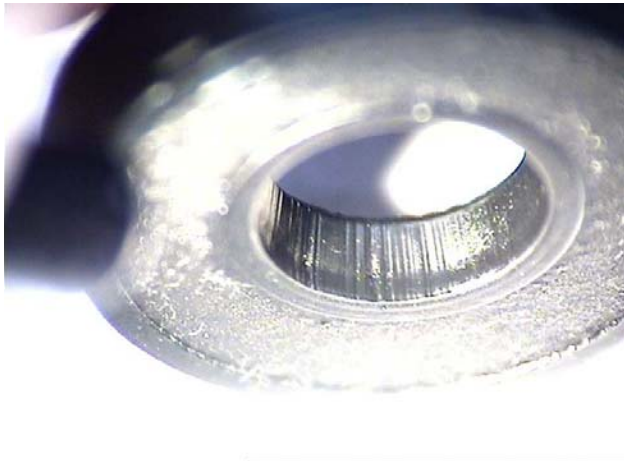
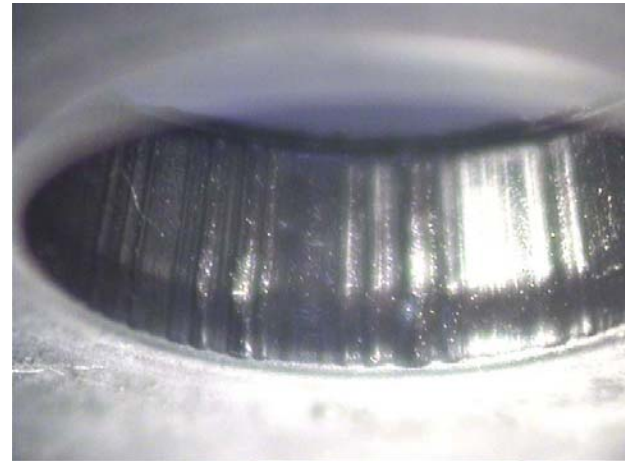
Scratches were found on 2 locations, rod and seal. The scratches show severe wear which is normally caused by high horizontal load or bend load. The rod scratches are caused by horizontal load when rod is possibly pushed against inner rod guide from one direction. This will cause inner lip damage shown on the pictures. HGT believes that conditions for installation etc. need to be confirmed.

HGT Analysis showing side load damage to rod and seal.

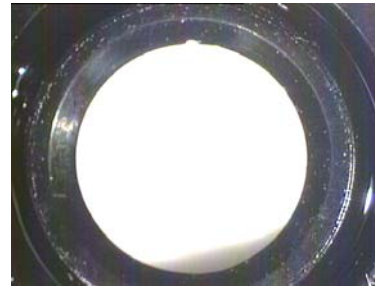
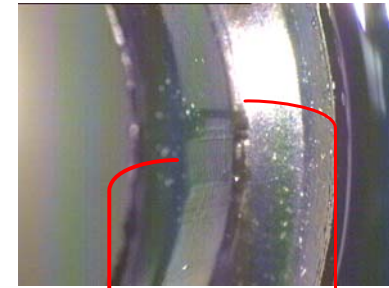
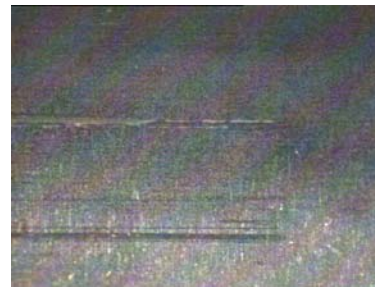
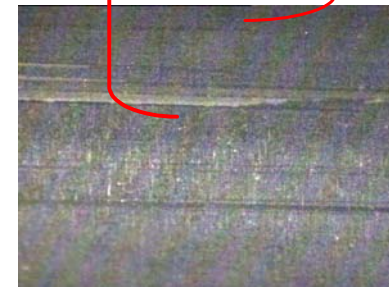
Recreation test using rod guide with no deburring

Root cause is scratch at rod

First scratch was found after 250 cycle.
Gas/oil loss was found after 1000 cycle and gas pressure went down to 53%.
Scratch depth was 0.4 μ m and width was 0.1mm at max.

Mass test show a depth of approx.4 μ m at the scratch area, scratch width up to 0,1 mm

Scratches were noticeable at the first visual check after 250 cycle, no force or oil loss at this time.

First gas and oil loss (remaining gas spring pressure at 53%) after 1000 cycle. Seal picture above shows

Chipping is cause of damage.

Cause is the burr on edge of outer guide on the 8mm OD rod.
Tiny part of burr comes off during stroke and slips in between guide and lot causing scratches on rod.
