EA08-015

This letter is in response to our meeting on January 6, 2010 to discuss the issue of gas-charged liftgate struts on certain 2005 model year Honda Odyssey vehicles equipped with power liftgates. In that meeting Honda shared technical information in response to questions posed by your staff, some of which required additional testing and follow-up.

**Honda Response to Questions Provided by NHTSA December 3, 2009, and  
Follow-up to January 6, 2010 Meeting  
January 18, 2010**

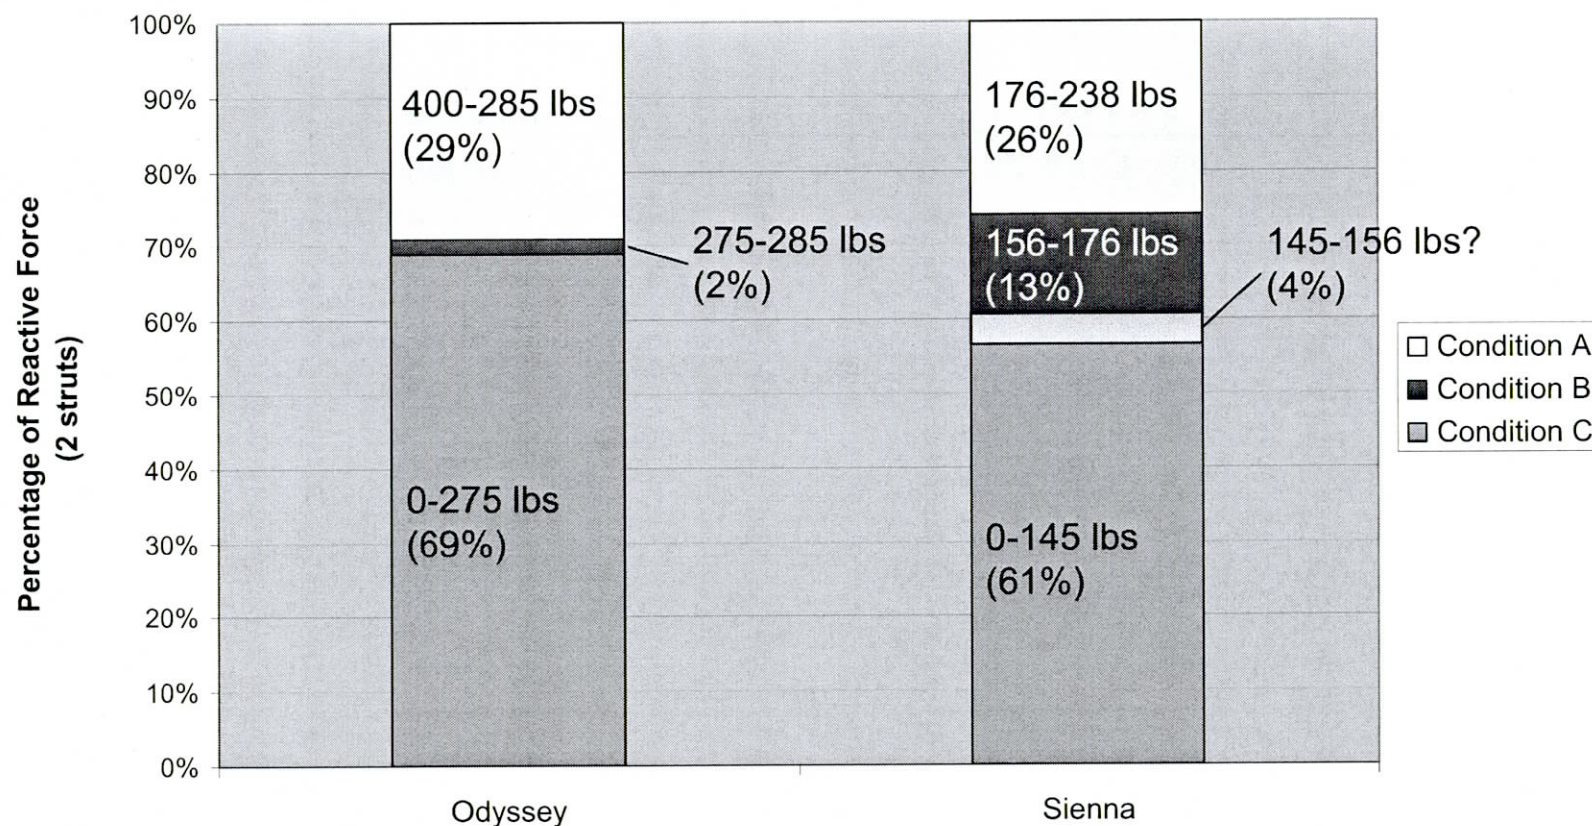
# Comparison of Strut Performance

We point out that the range of Condition B for the Odyssey, from 285-275 lbs of force, represents a range of only 2% of the gas strut as it is failing, as opposed to a much wider range of condition B for the Sienna (see Attachment Q3-1). Our comment that we anticipate period B to exist for a "shorter period in the market" was based only on the narrow range of 2%, compared to a span of 13% for the Sienna. We believe any Odyssey strut that is failing will remain in condition B for a very short time, but we have no reliable method to forecast how long (see Attachment Q3-2).

The Odyssey remains in “Condition B” for only 2% of the performance range as gas strut performance degrades, compared to a 13% range for the Sienna in Condition B.

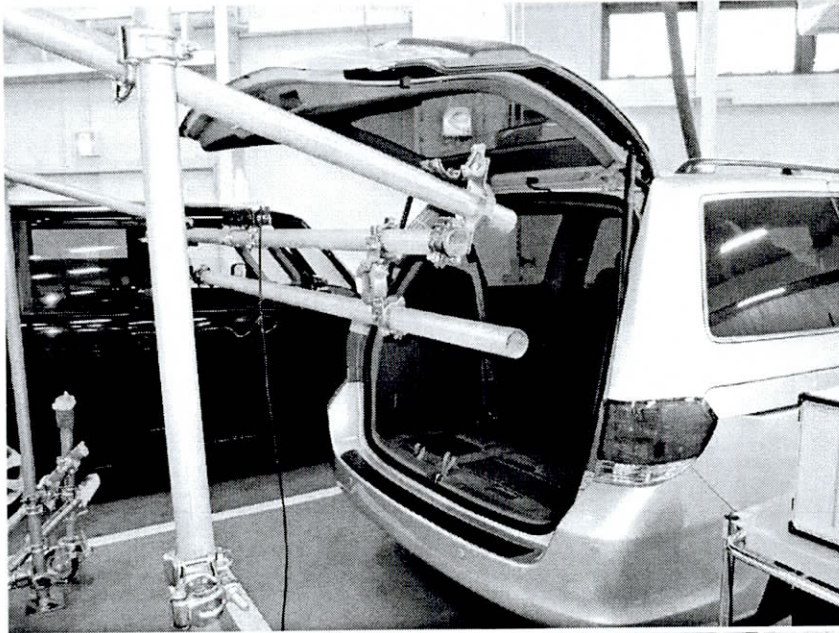
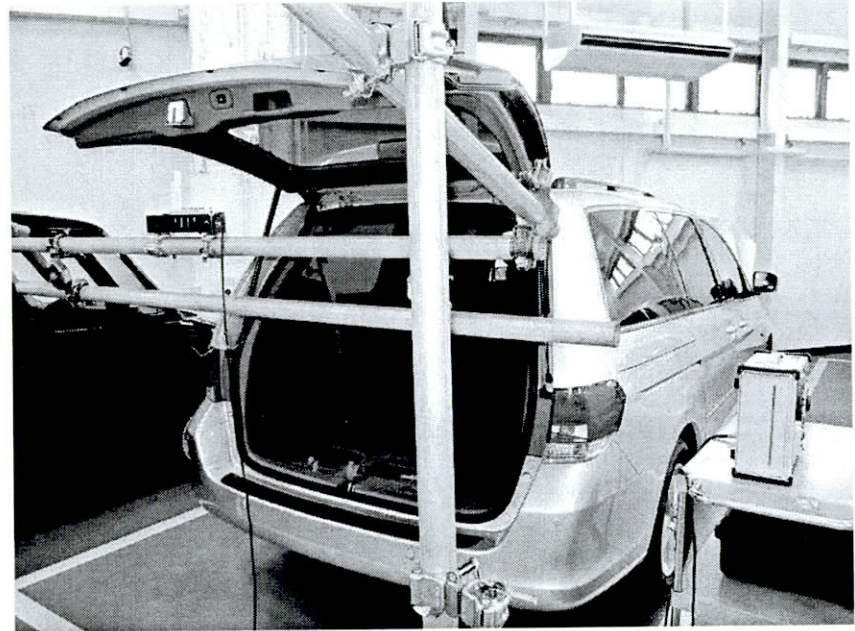
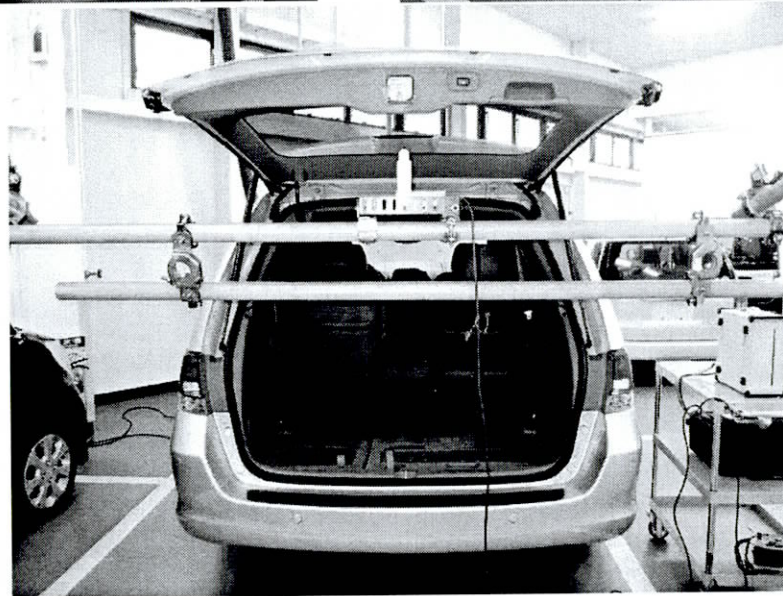
### Measurement of load

1. See attachment Q4-1 for details on the test equipment used by Honda.
2. Measurement location was latch cover, as indicated in attachment Q4-2.
3. See attachment Q4-2 for pictures of test setup and see video for the test conduction.

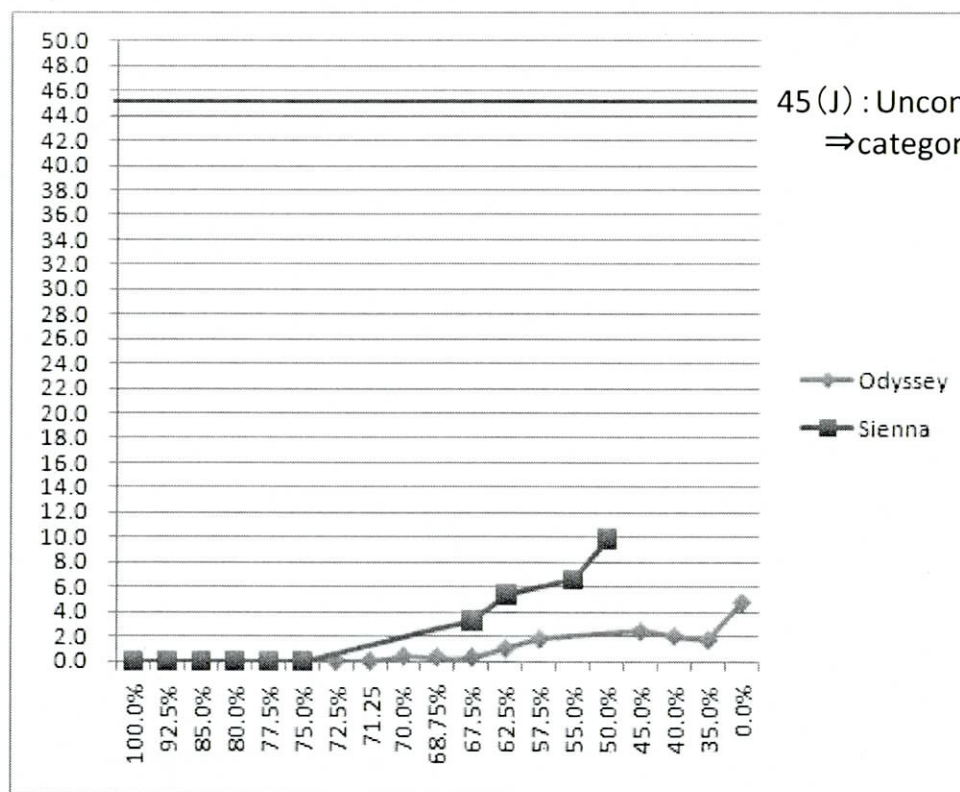
See Attachment Q5 to find calculations using the Honda our method of determining the energy, and the method used by Toyota in their technical response. By either method it is clear that the relative energy of the Odyssey liftgate falling is significantly less than the Sienna, though both yield values in the non-serious injury range.

45 (J) : Unconscious concussion

⇒ categorized as AIS-1 (minor injury) due to AIS
