**PE08029/HYUNDAI-KIA
2001 EF FIELD REPORTS**

HYUNDAI
Field Product Observation Report

**PE08029/HYUNDAI-KIA
1999 EF FIELD REPORTS**

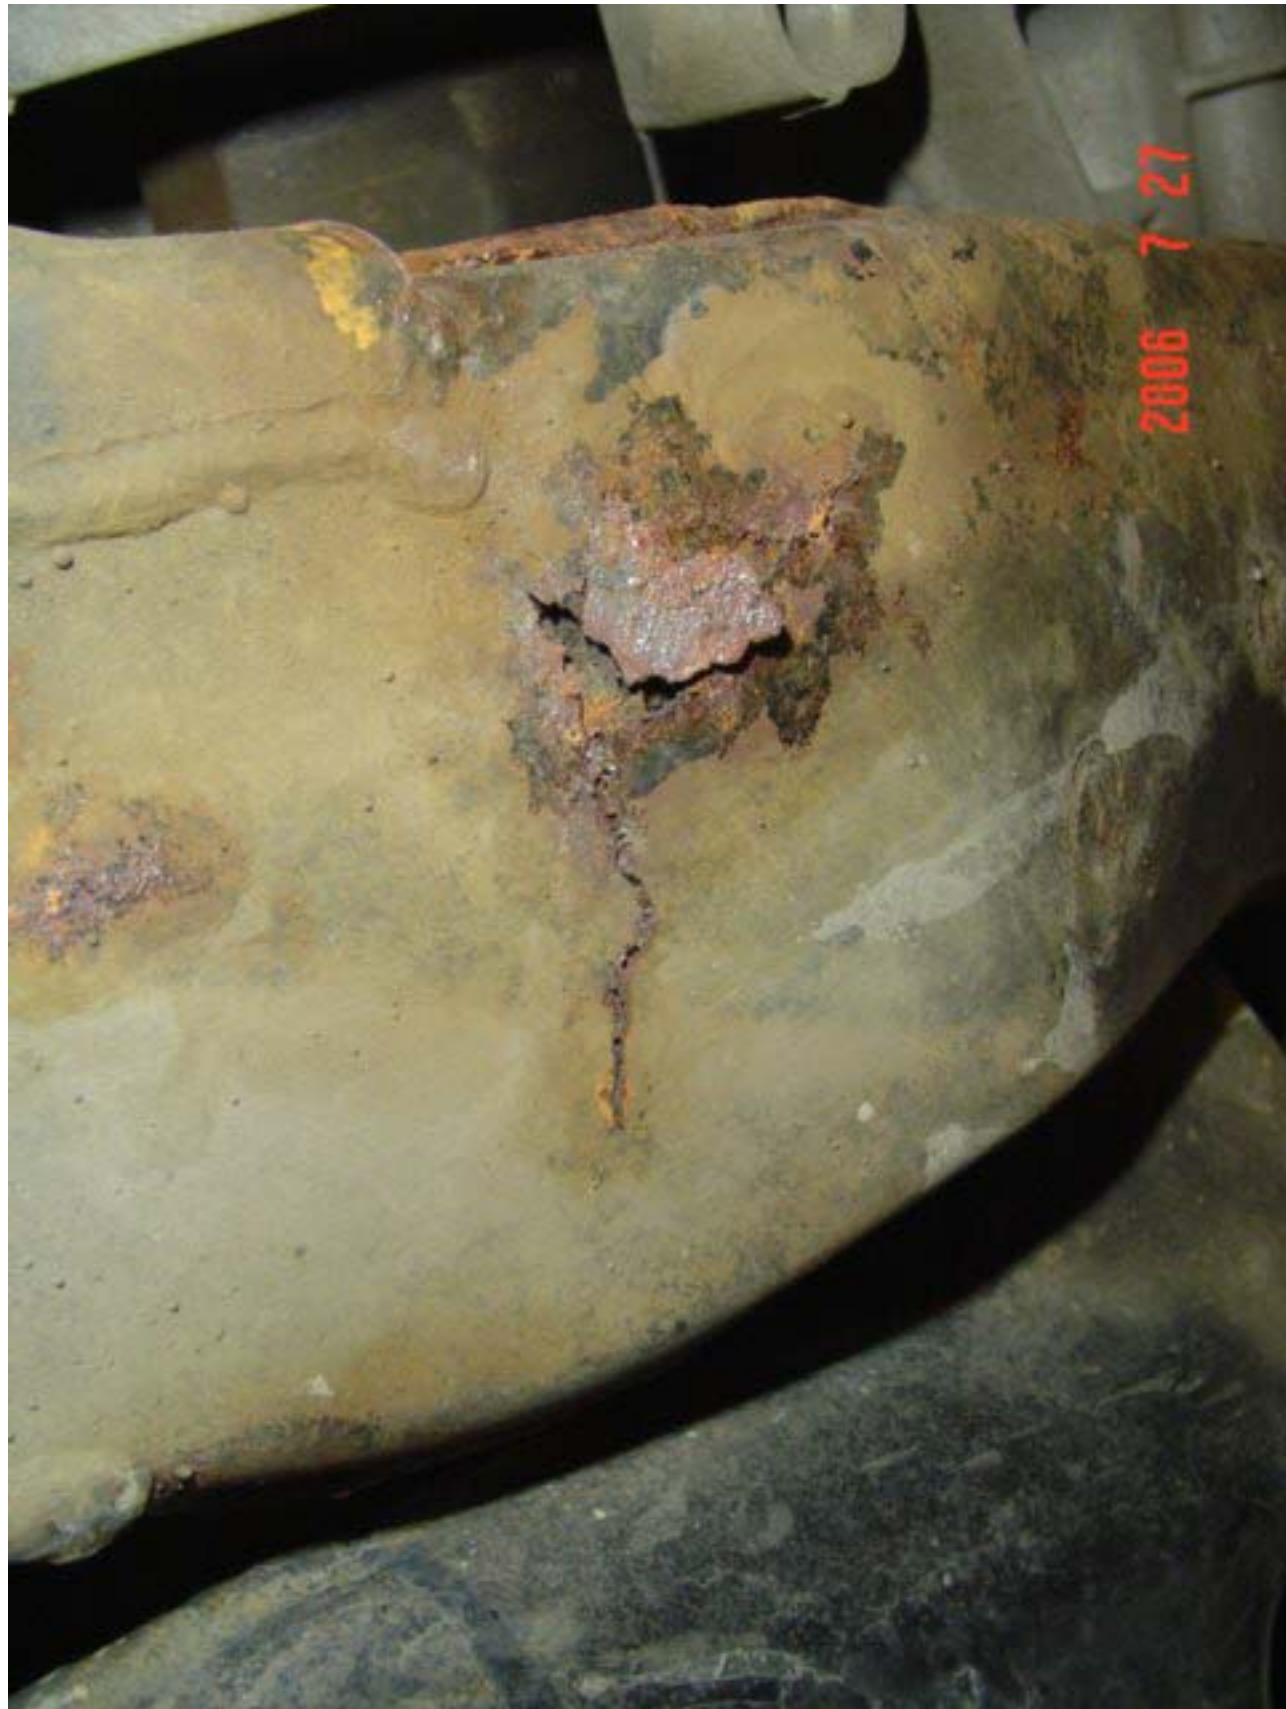
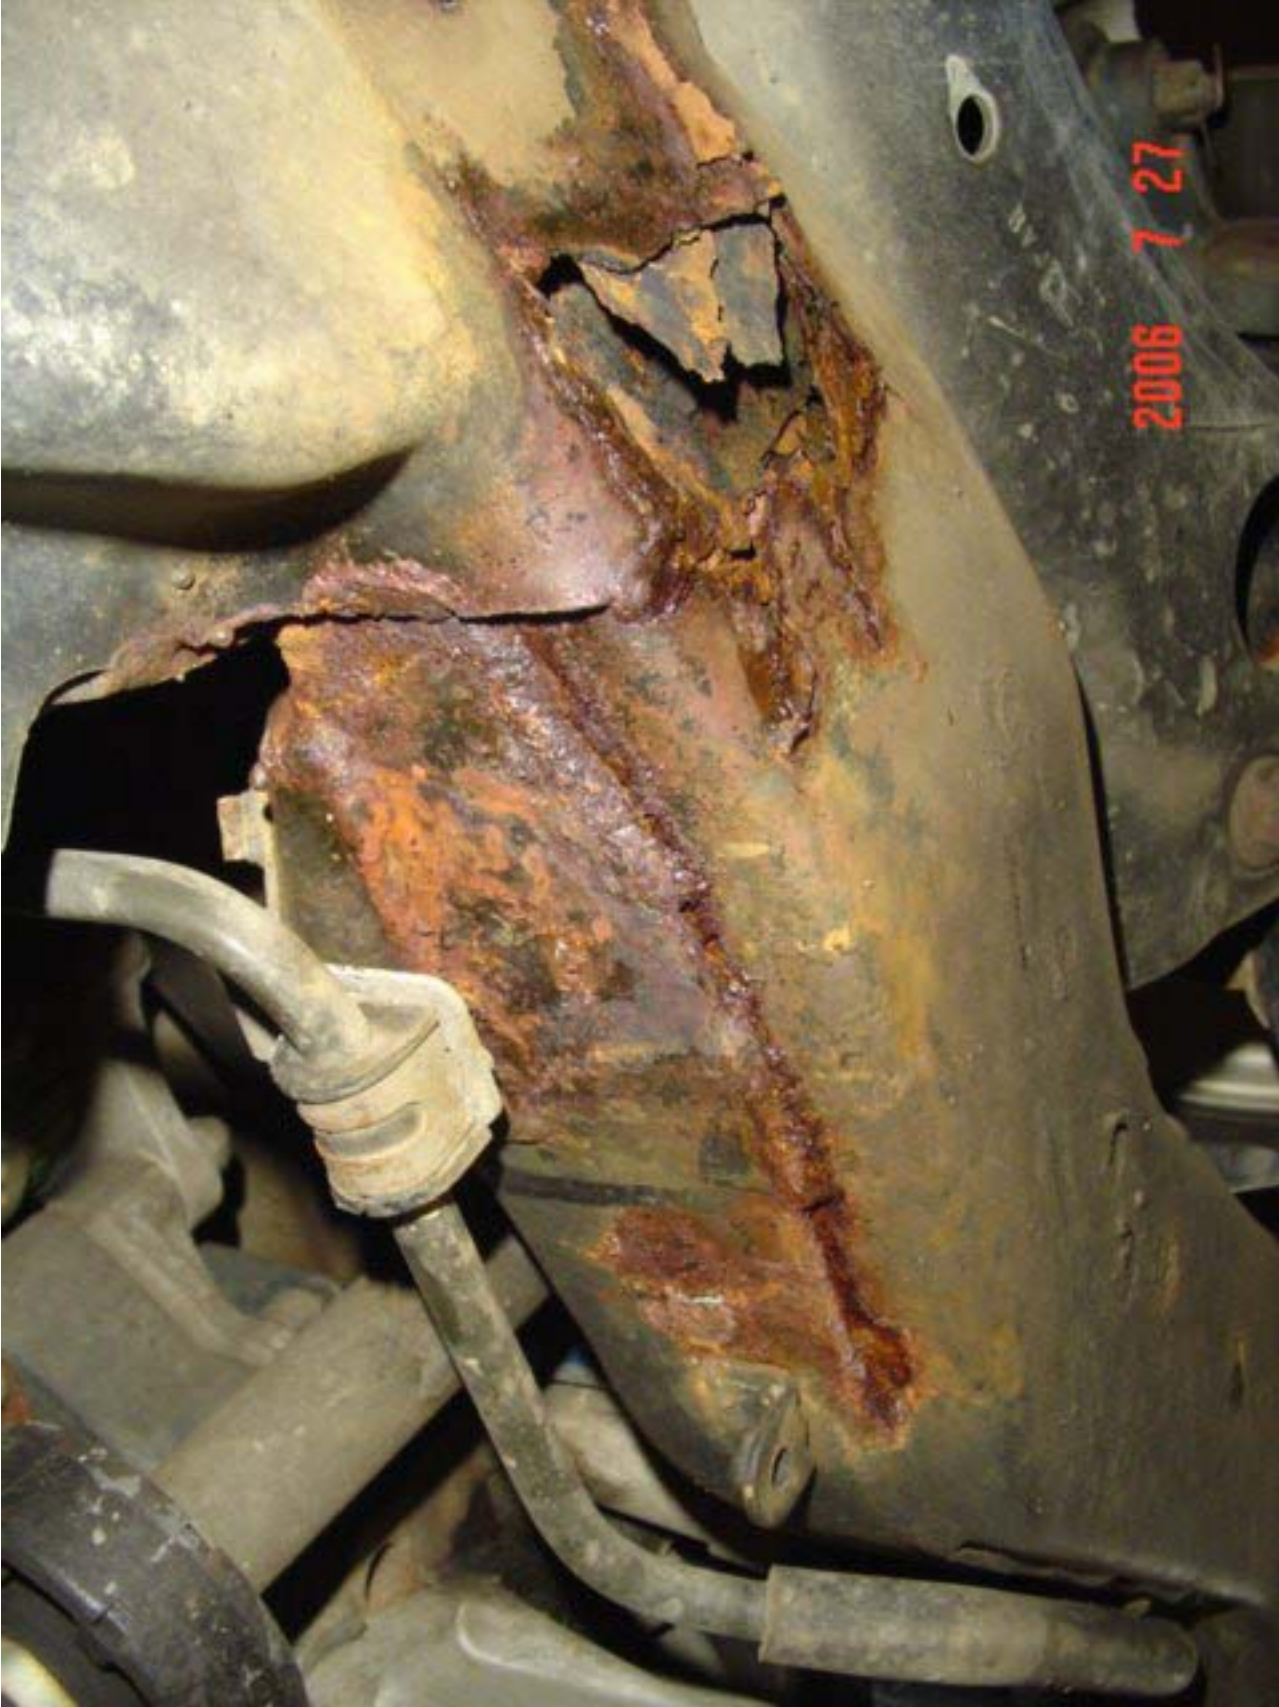
DSC02434.jpg DSC02427.jpg DSC02428.jpg DSC02430.jpg DSC02431.jpg

To: FPOR <-- optional Note: An e-mail copy is always sent to National, in addition to above e-mail recipient(s).	
Subject: Crossmember	UPC:
Originator: Joe Oppedisano	Report #: 19
Dealer Code: ME007	Date: 08/23/2006
VIN: KMHWF25S21A [REDACTED]	Contact Person: Steve Crossman
Model: Sonata*	Mileage: 43444
Production Date: 10/24/2000	Model Year: 2001*
Part Name: Crossmember, Complete	Category: 16 Structure*
Part Number: 62405-38300	
Customer Complaint: Sub frame rusting.	
Dealer Observations: Verified rust on sub frame. See attached pictures.	
Corrective Action: Replace subframe as one-time goodwill gesture.	
Did this action resolve condition? <input checked="" type="radio"/> Yes <input type="radio"/> No	
Condition verified by personal inspection of company employee? <input checked="" type="radio"/> Yes <input type="radio"/> No	
Were Photos Taken? <input checked="" type="radio"/> Yes <input type="radio"/> No

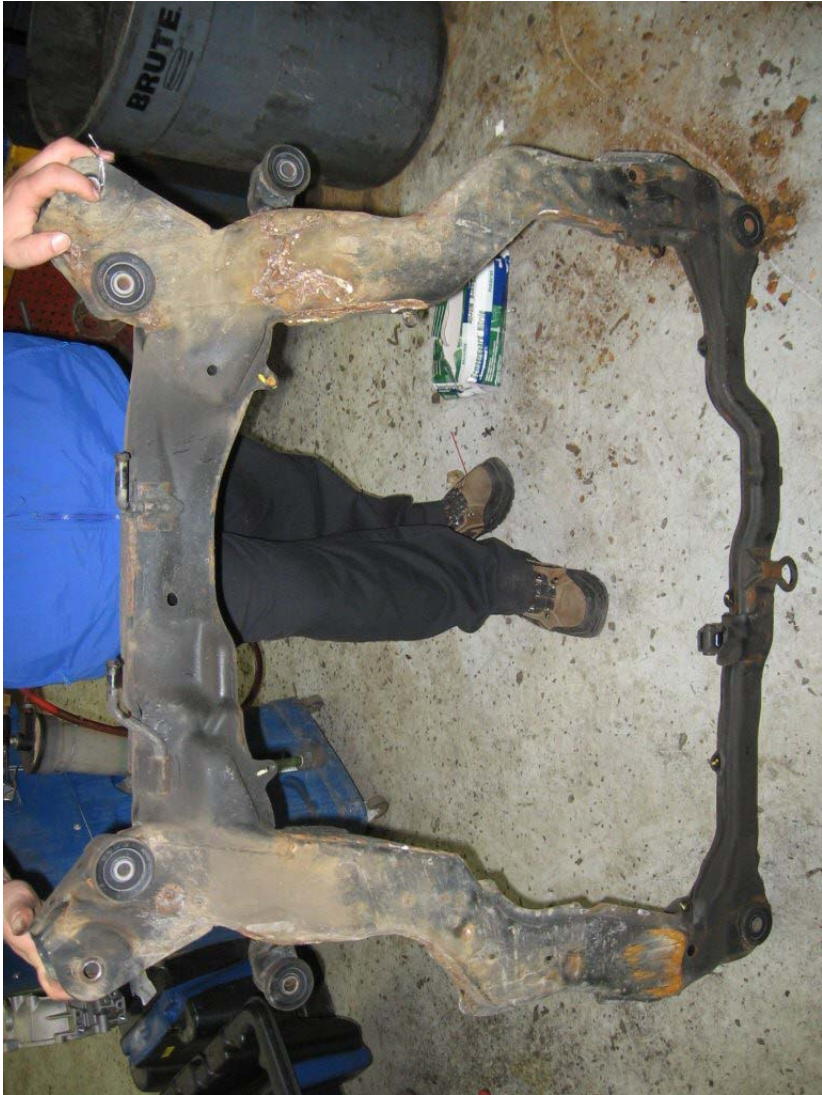
CROSSMEMBER 136887.JPG

To: Randy Craley; Roger LaFleur; Sharon Waxmundsky <-- optional Note: An e-mail copy is always sent to National, in addition to above e-mail recipient(s).	
Subject: RUSTED CROSSMEMBER	UPC:
Originator: Michael Stahl	Report #: 62
Dealer Code: MA034	Date: 02/14/2007
VIN: KMHWF35VX1A [REDACTED]	Contact Person: [REDACTED]
Model: Sonata*	Mileage: 85724
Production Date:	Model Year: 2001*
Part Name: CROSSMEMBER	Category: 16 Structure*
	Part Number: 62405-38300
Customer Complaint: HEAR RUBBING NOISE WHEN ACCELERTATING	
Dealer Observations: RUSTED OUT CROSSMEMBER	
Corrective Action: REPLACED CROSSMEMBER	
Did this action resolve condition? <input checked="" type="radio"/> Yes <input type="radio"/> No	
Condition verified by personal inspection of company employee? <input type="radio"/> Yes <input checked="" type="radio"/> No	
Were Photos Taken? <input checked="" type="radio"/> Yes <input type="radio"/> No	
Parts Inspected? <input type="radio"/> Yes <input checked="" type="radio"/> No

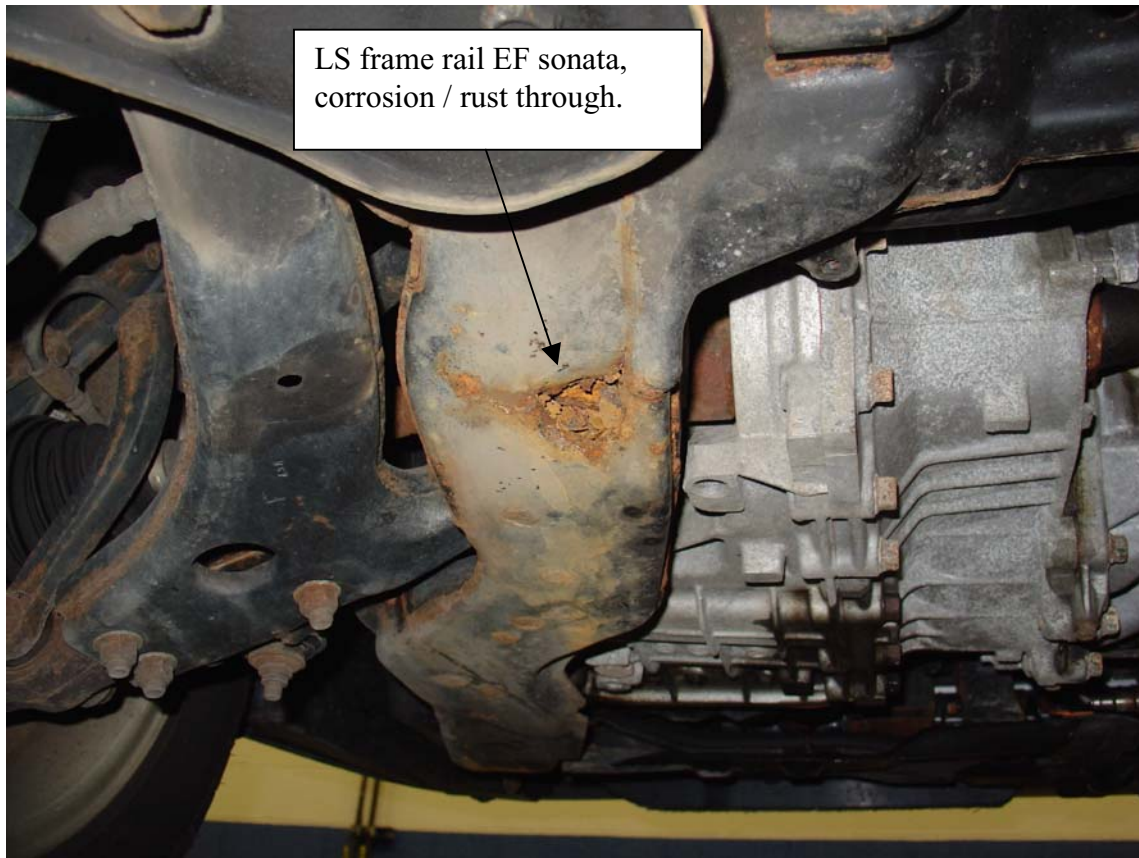
Technician observed a hole rusted through the left rear corner frame section of the engine crossmember.

Durability issue, frame rusting through at 53,492 miles on a 1999 vehicle.

The right side frame section sounds weak (not solid) as it was tapped with a hammer.

LS frame rail EF sonata,
corrosion / rust through.

Lack of anti-corrosive coating on frame.

Replace crossmember assembly.

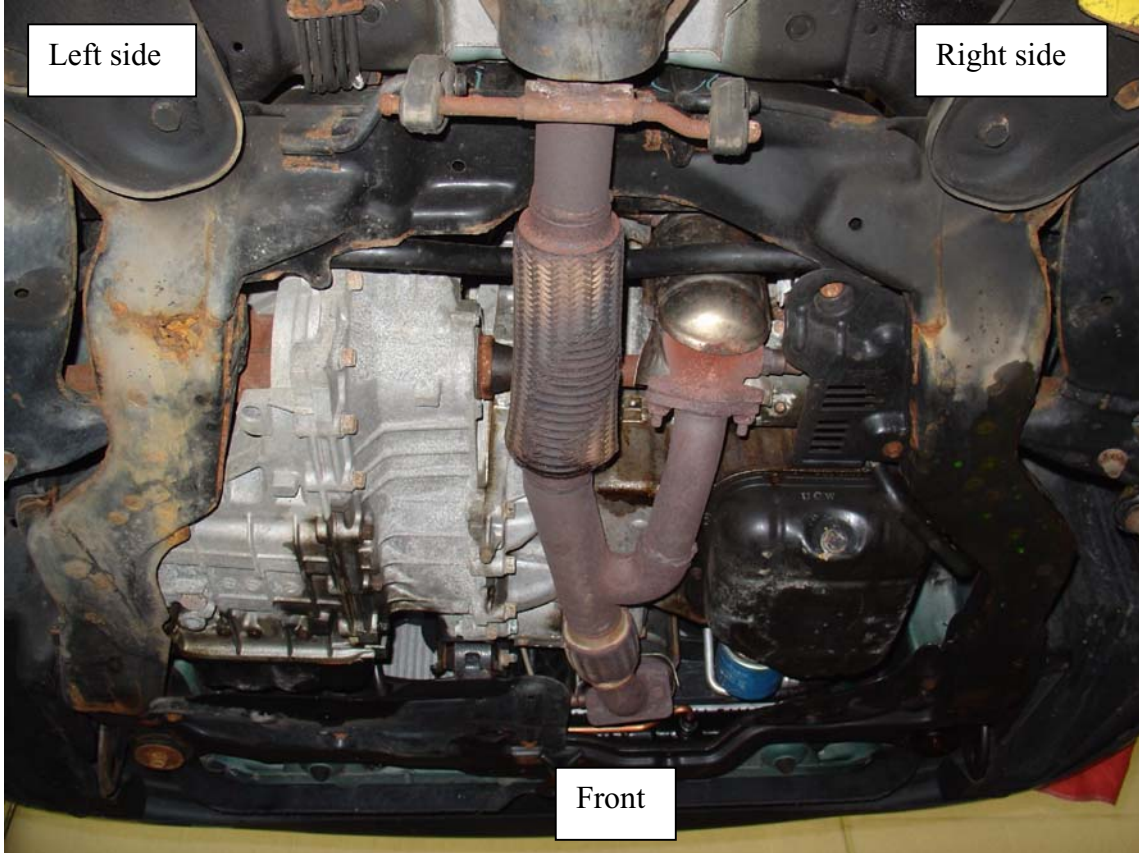
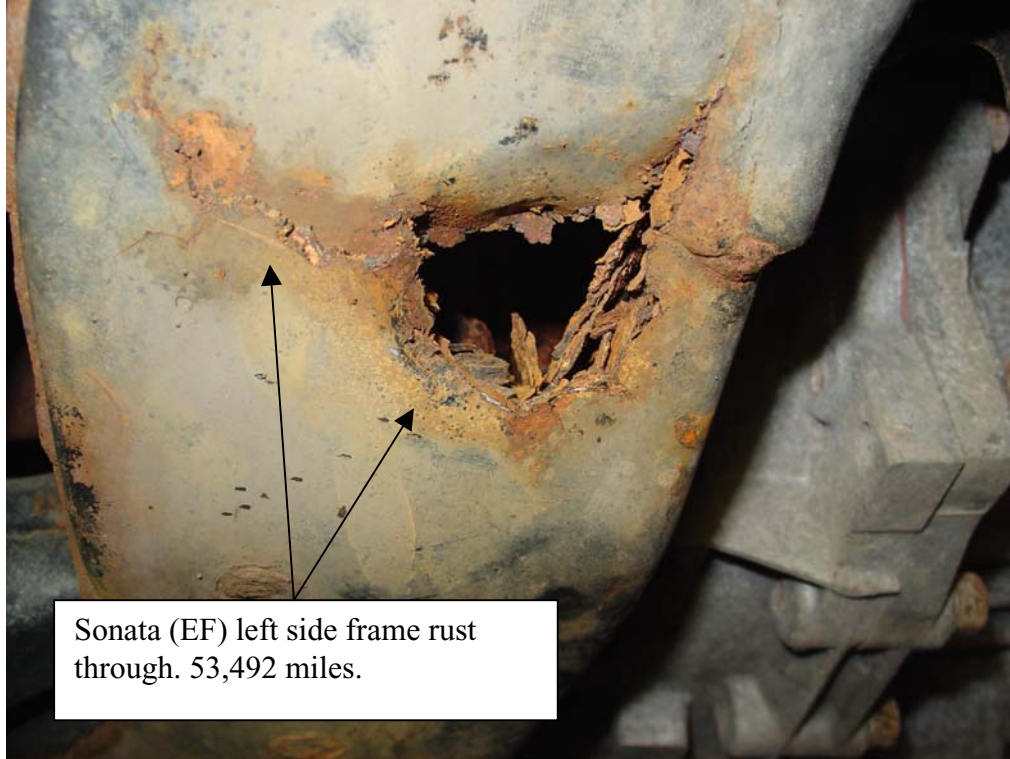
Sonata EF frame 027.jpg Sonata EF frame 033.jpg Sonata EF frame overview 029.jpg

Sonata (EF) left side frame rust through. 53,492 miles.
