**PE08029/HYUNDAI-KIA
2001 EF FIELD REPORTS**

HYUNDAI
Field Product Observation Report

**PE08029/HYUNDAI-KIA
1999 EF FIELD REPORTS**

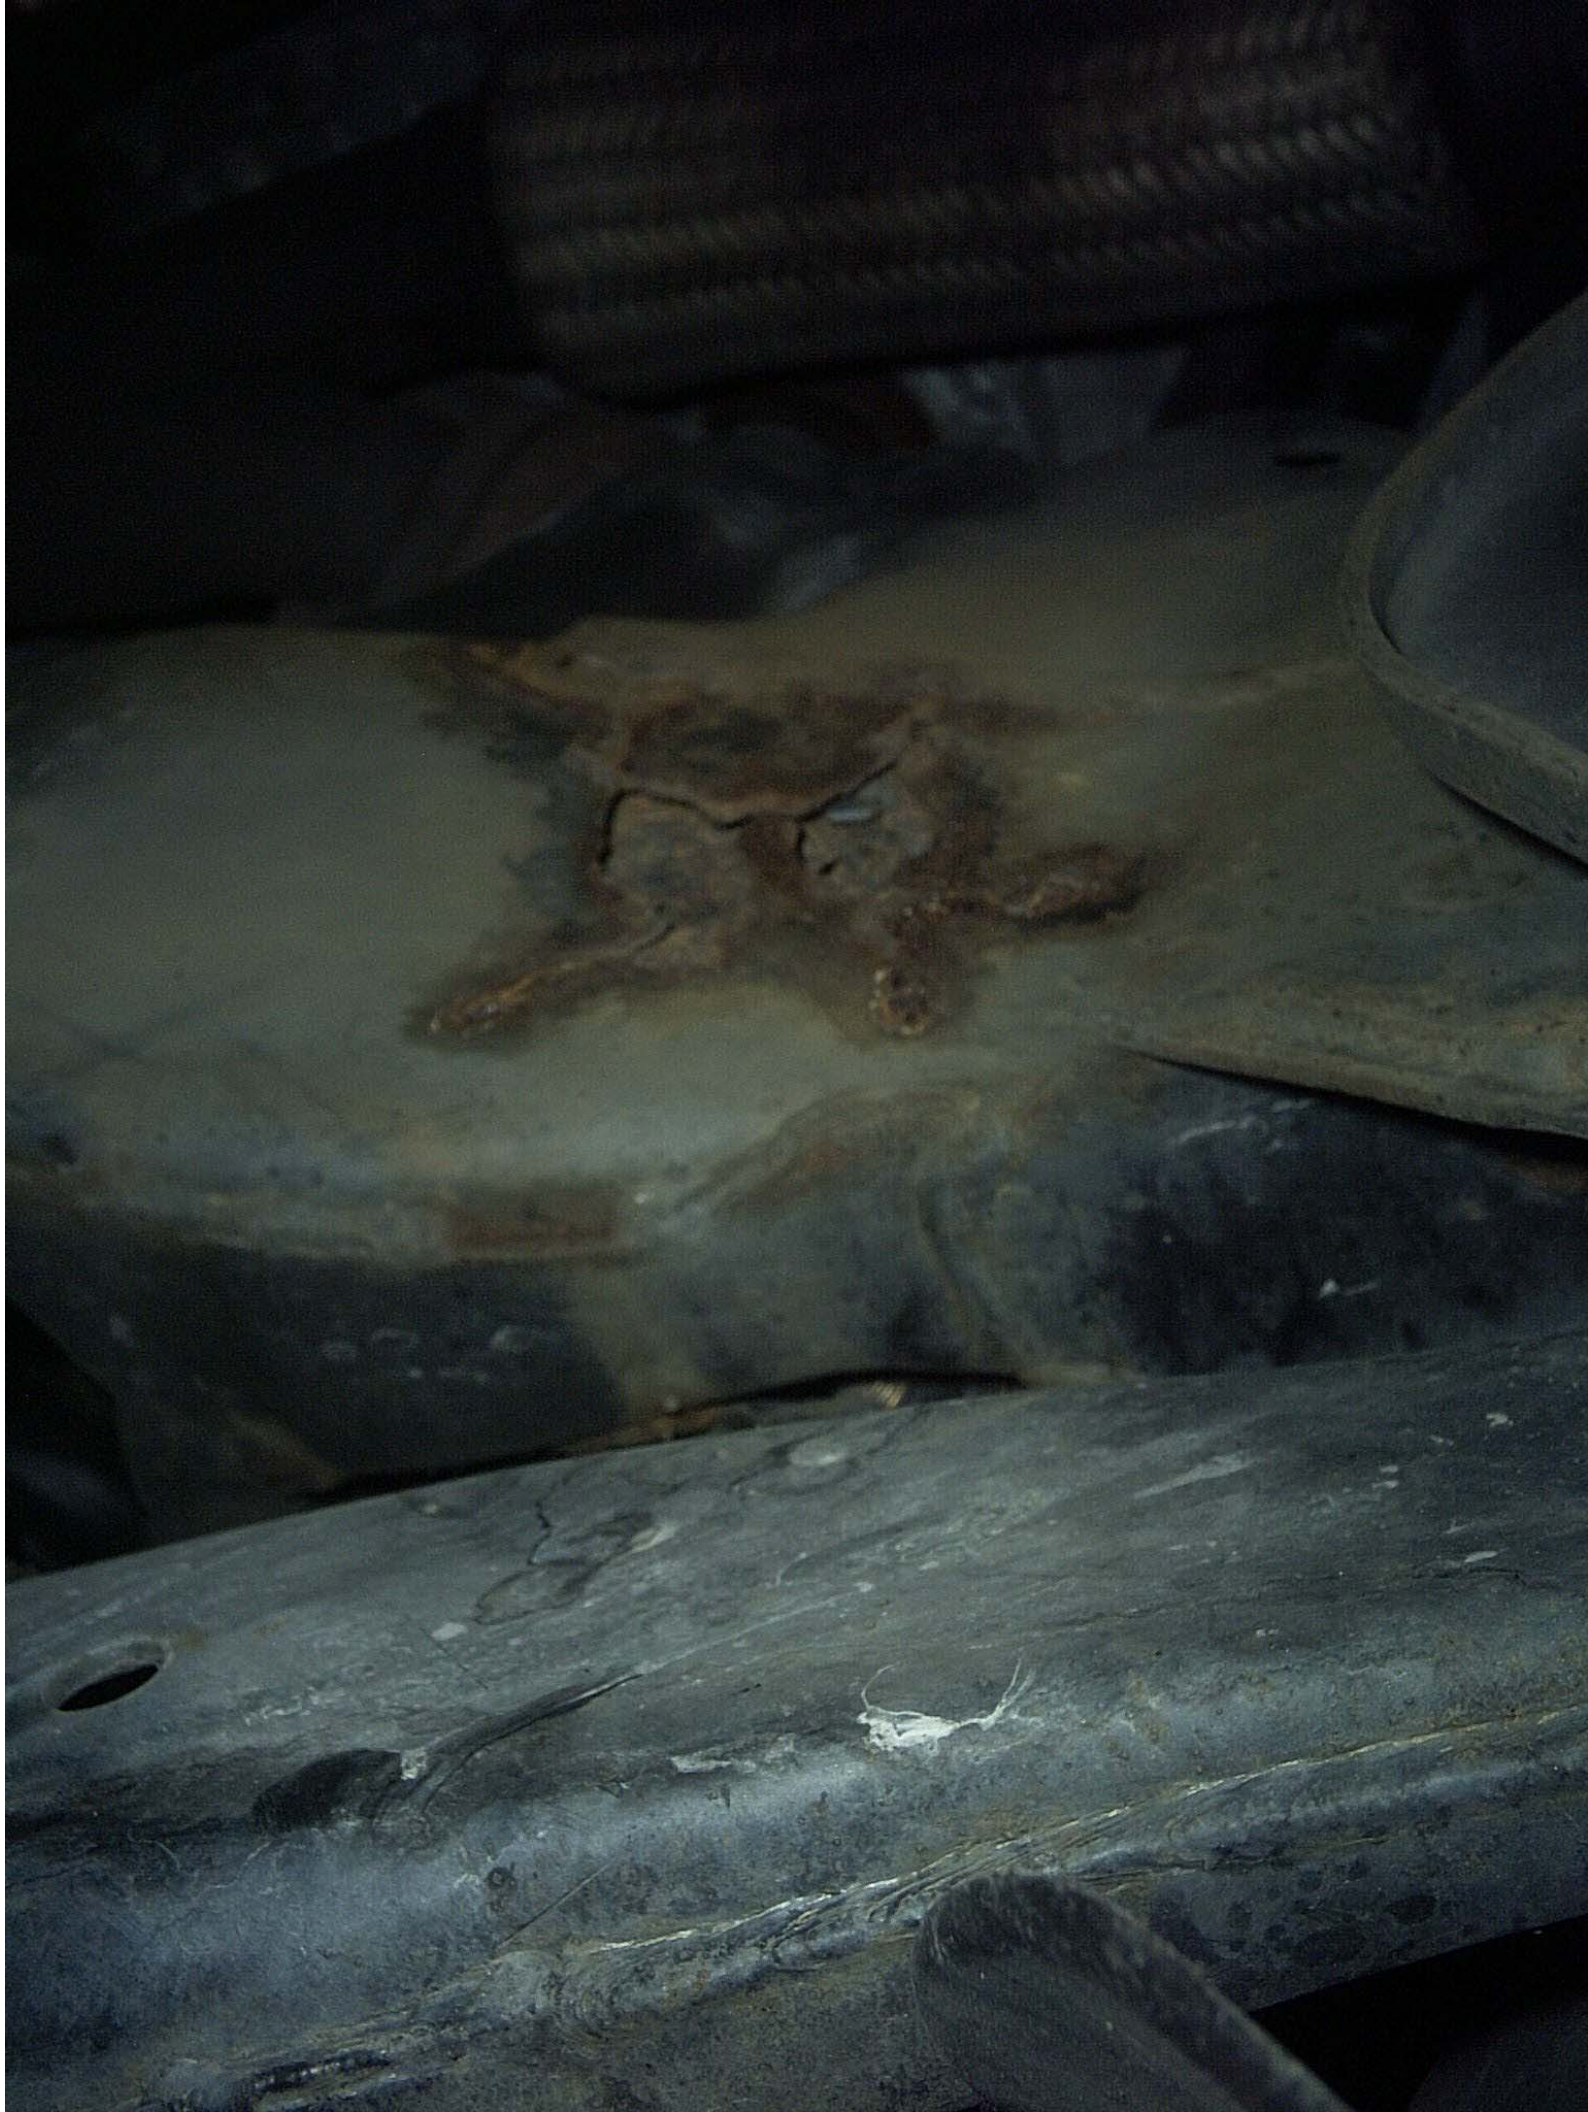
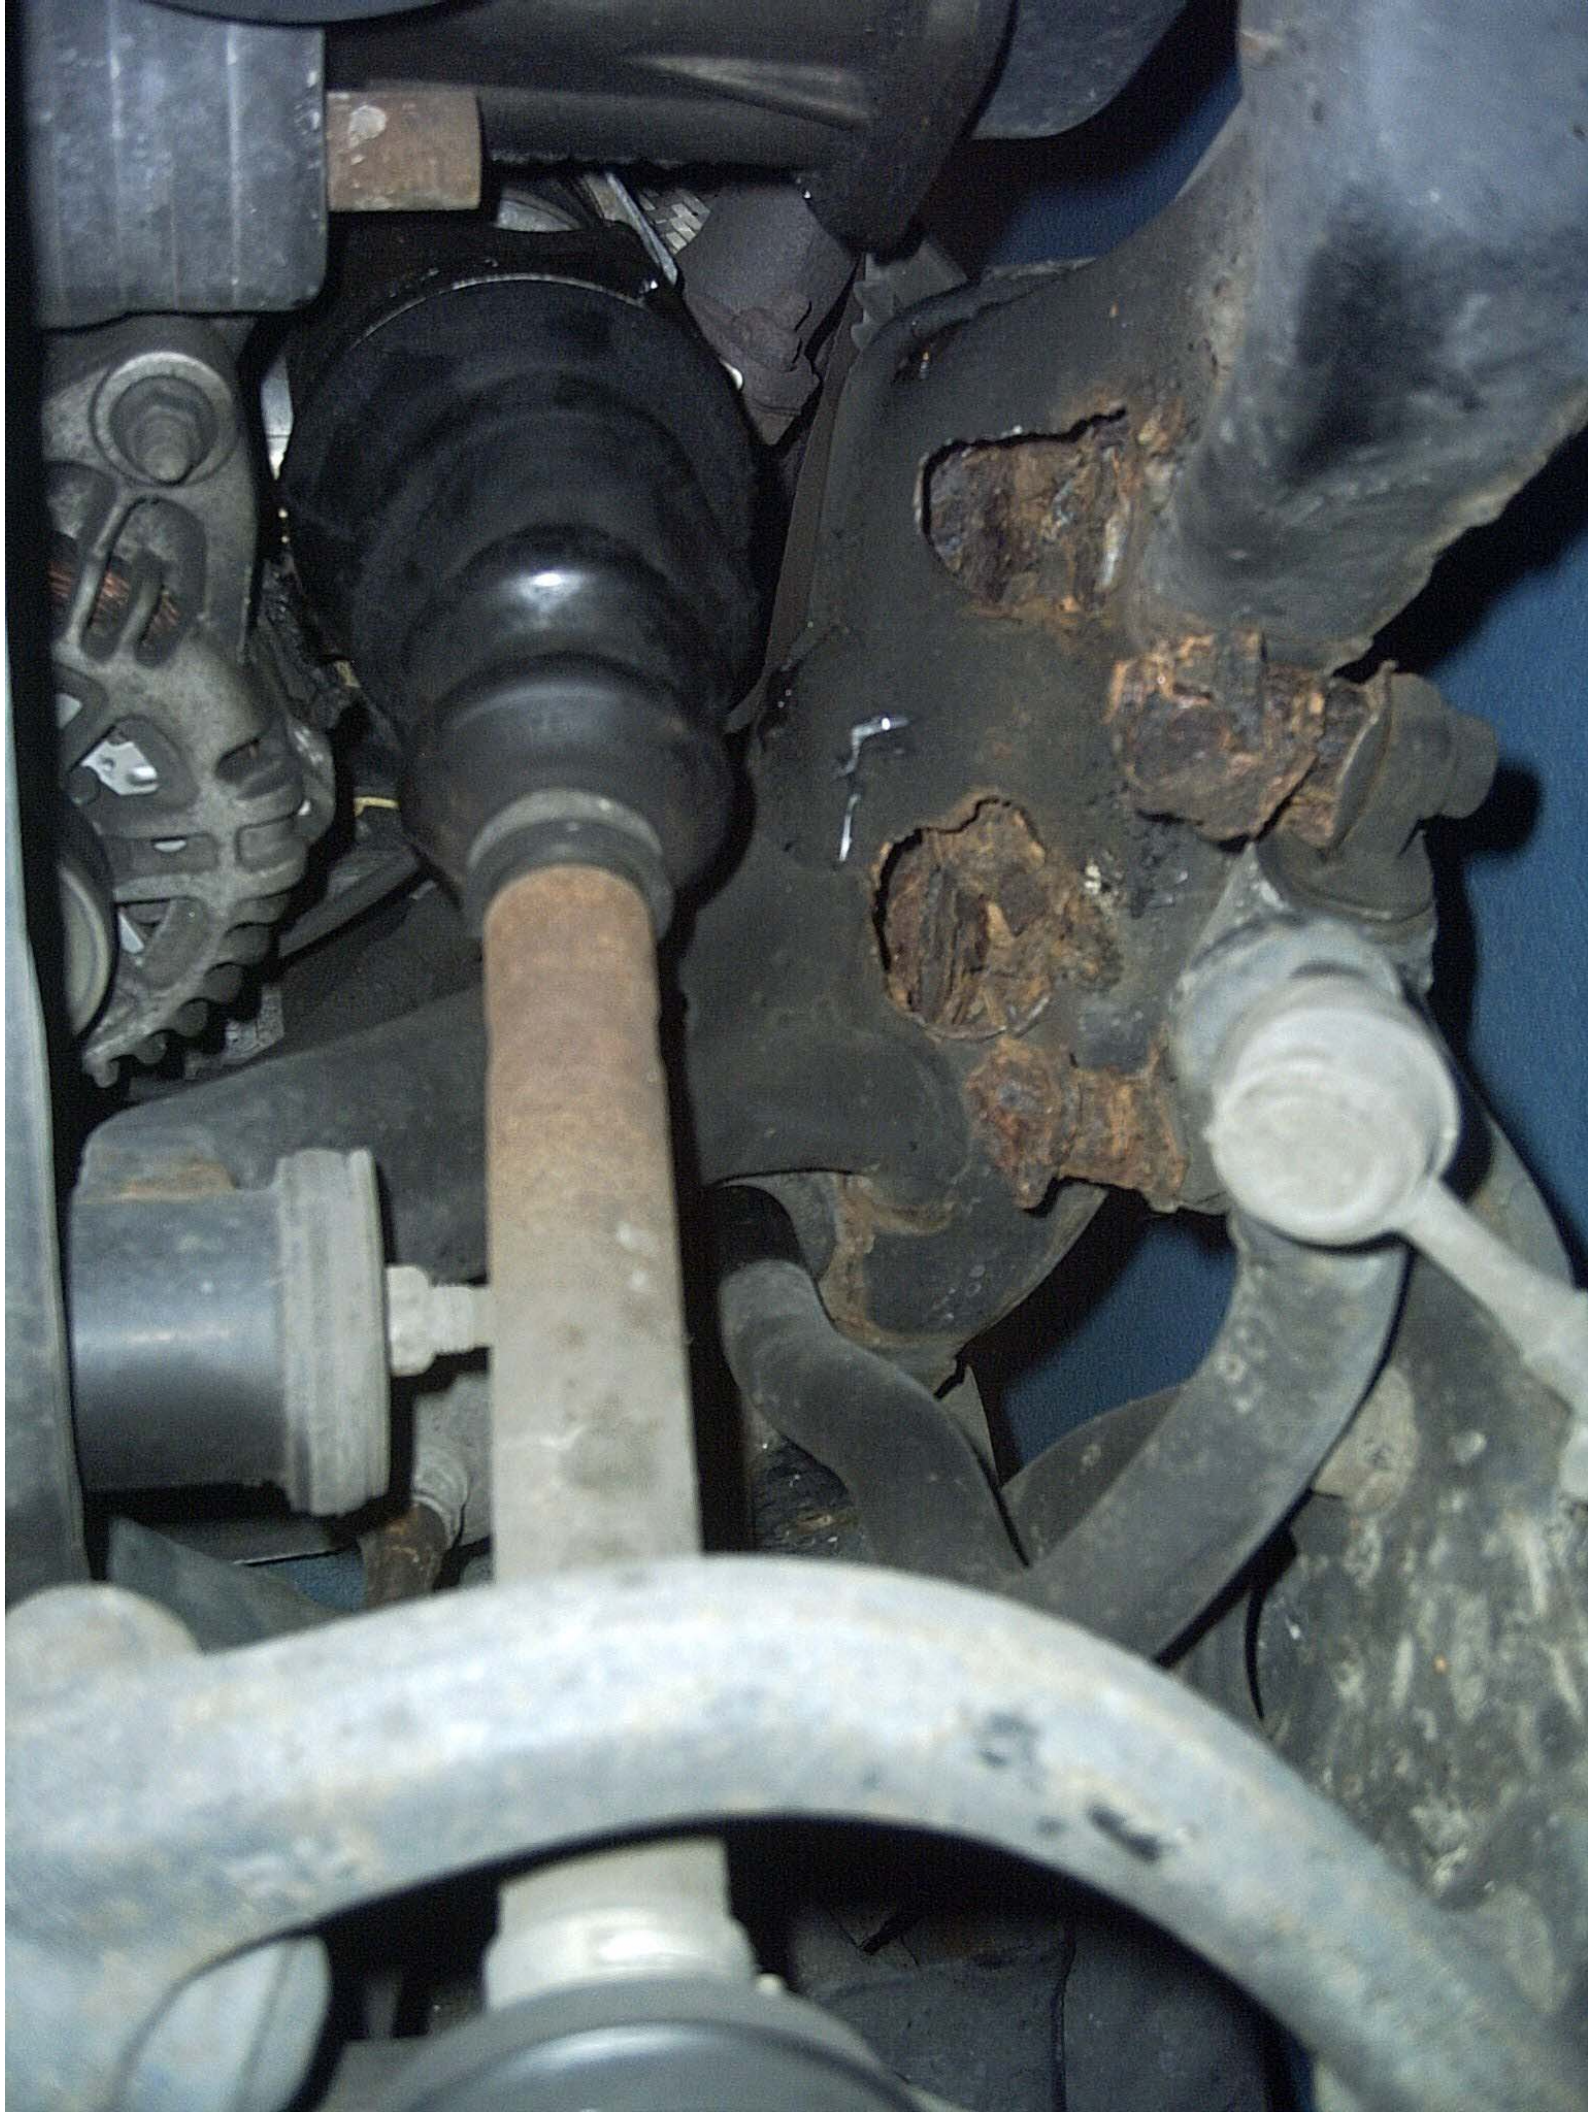
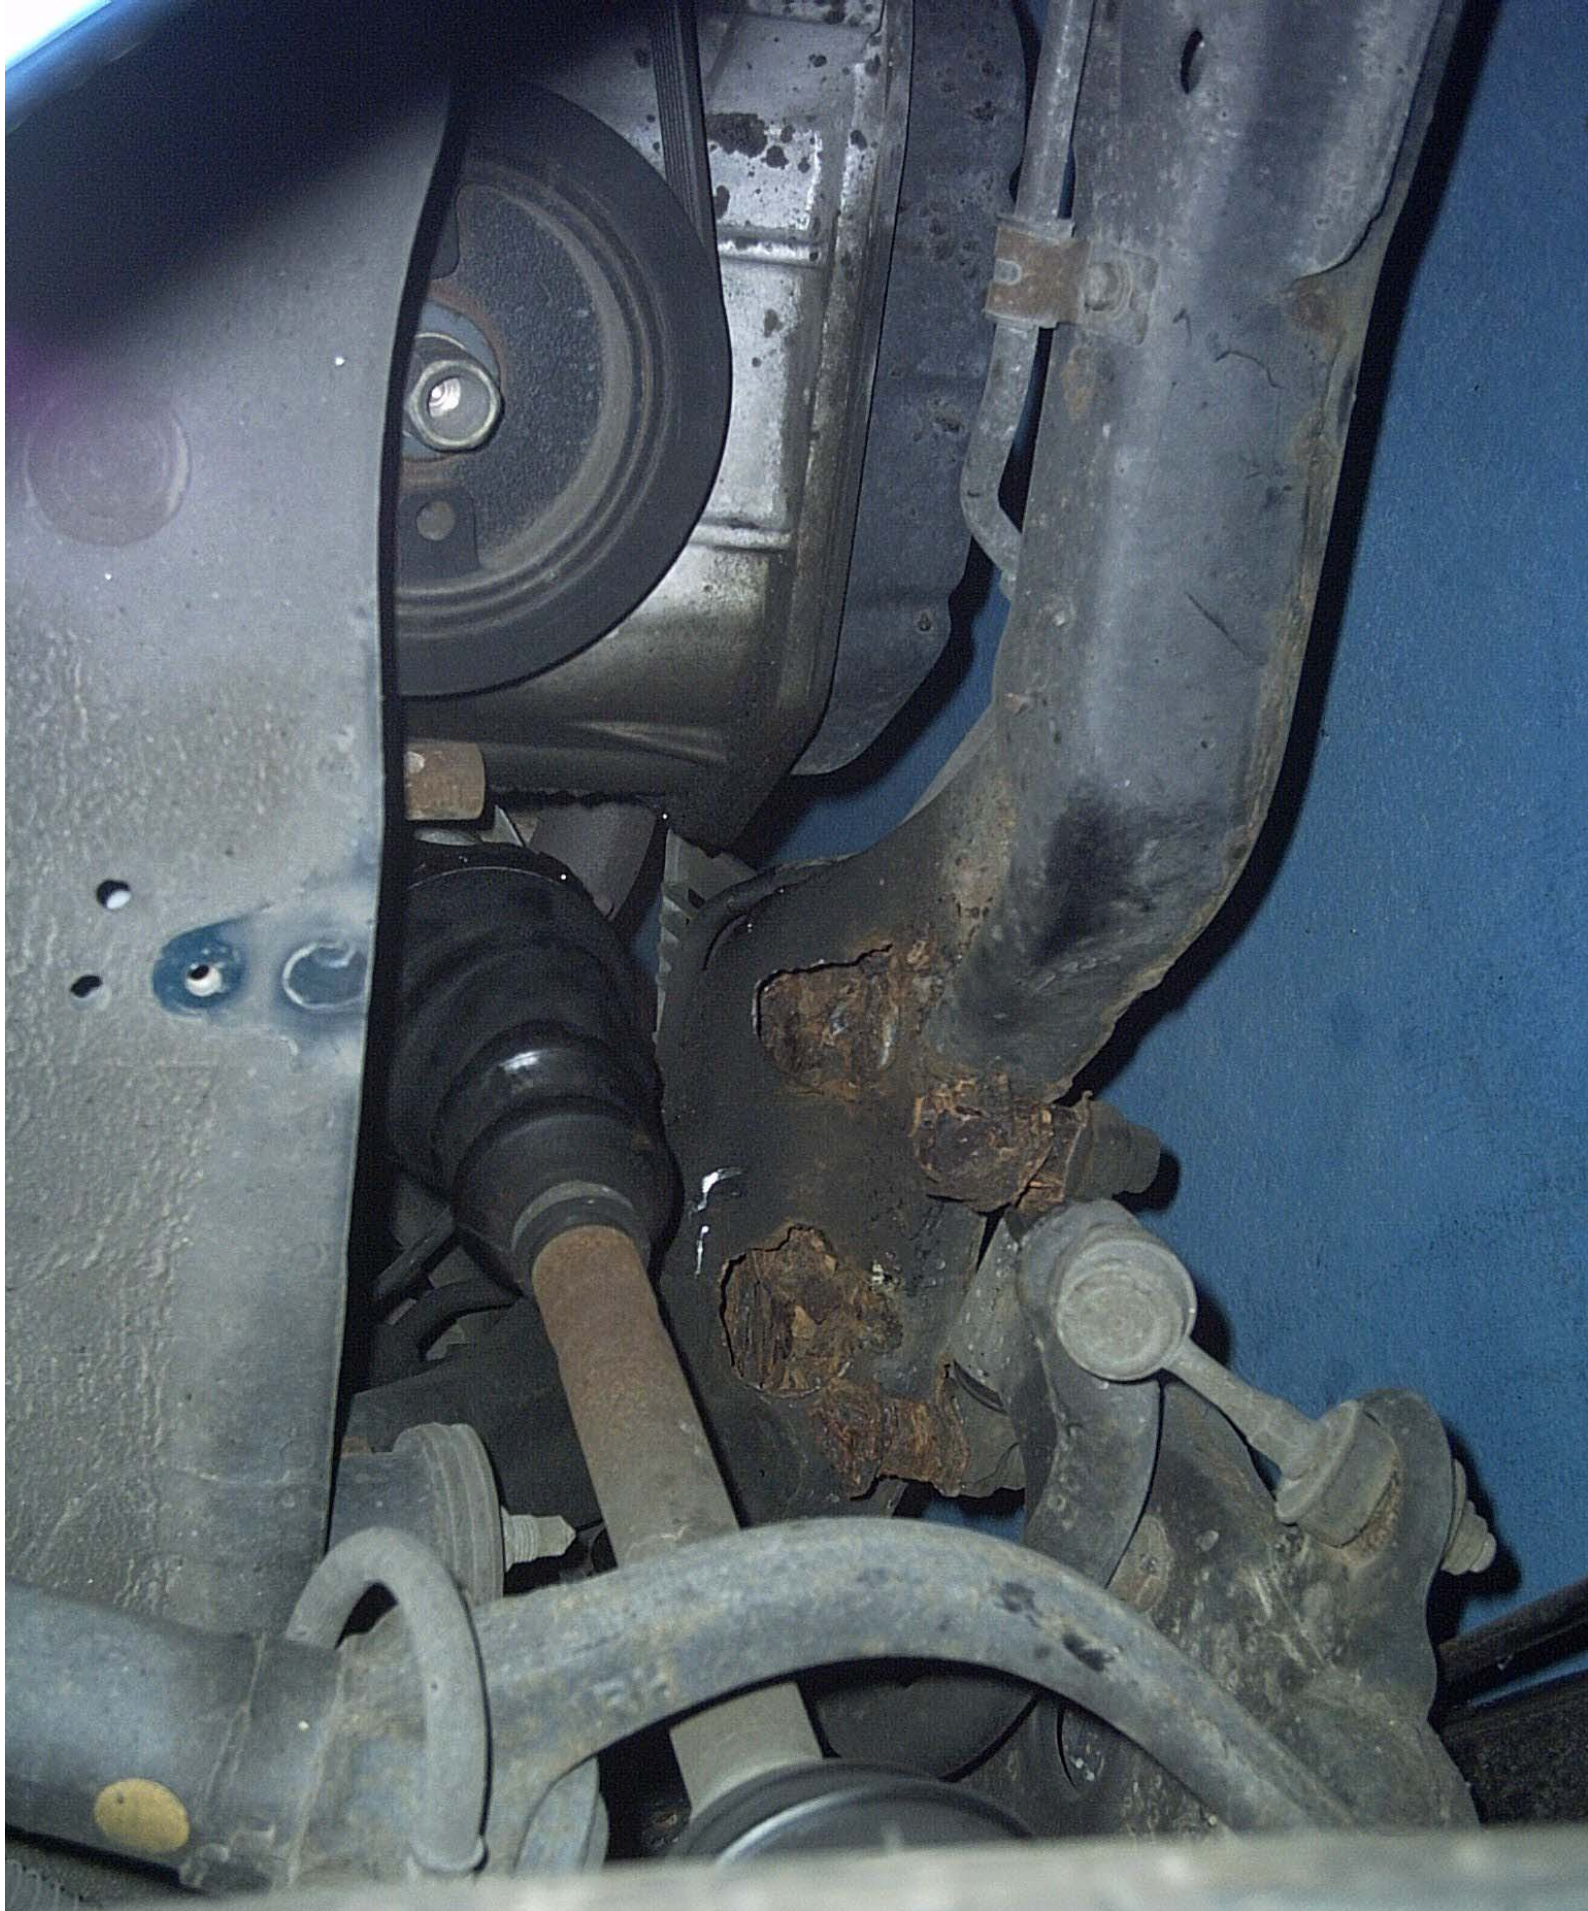
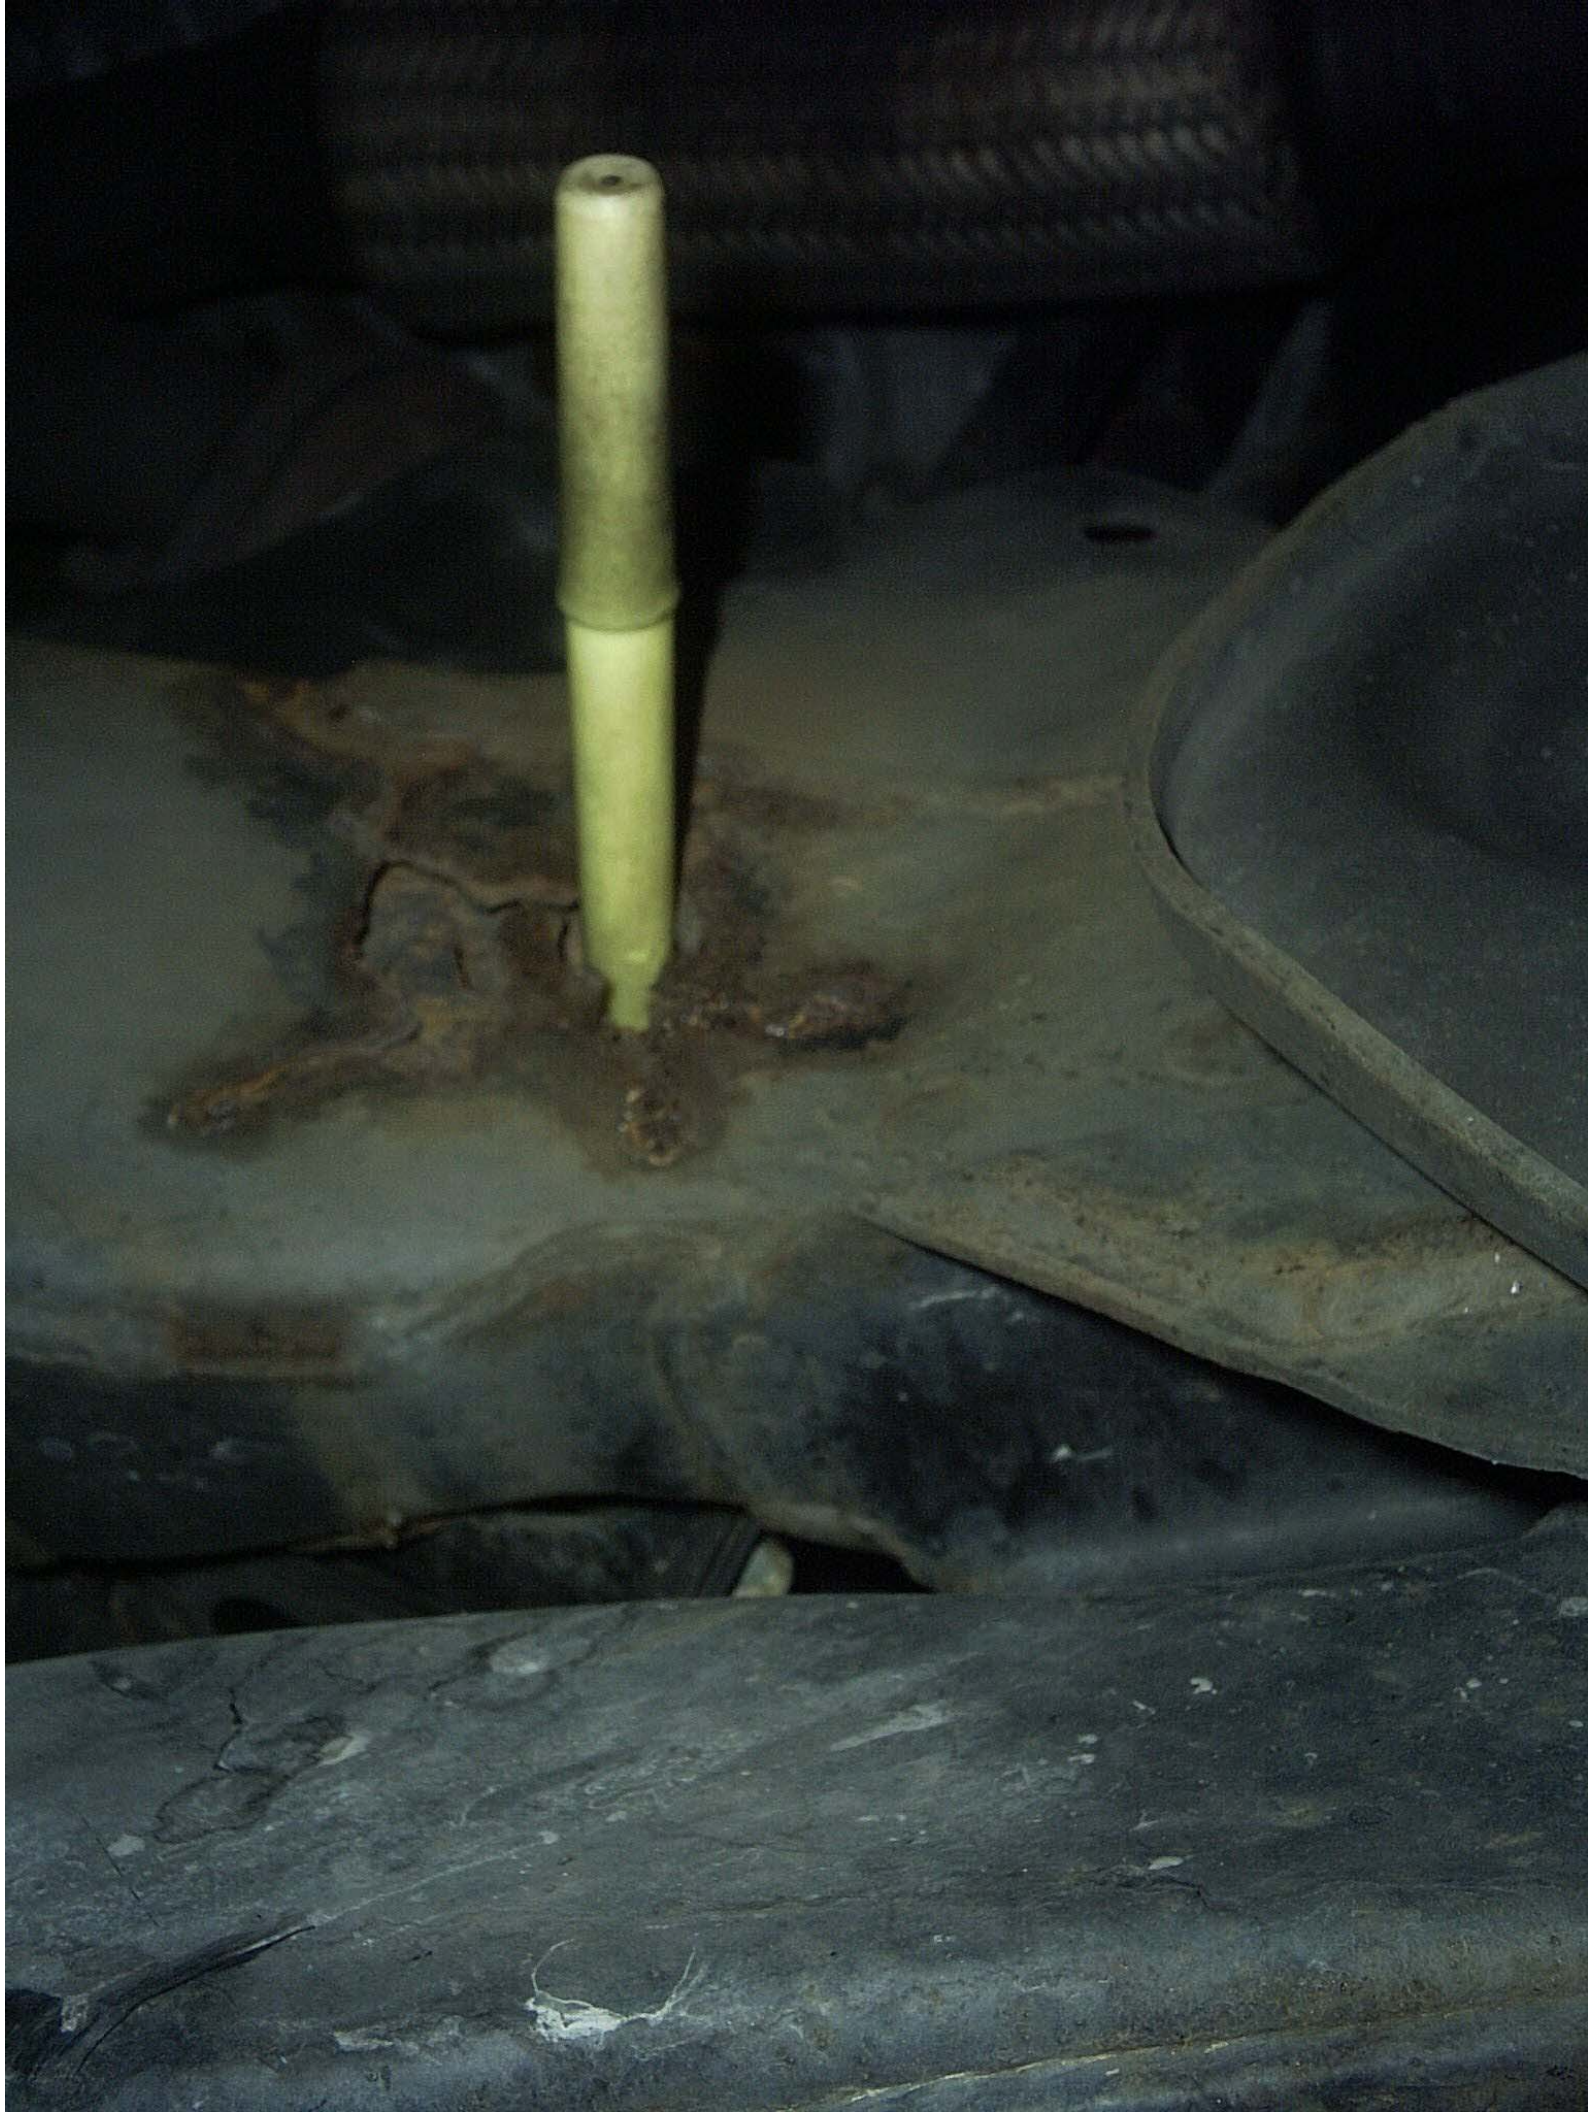
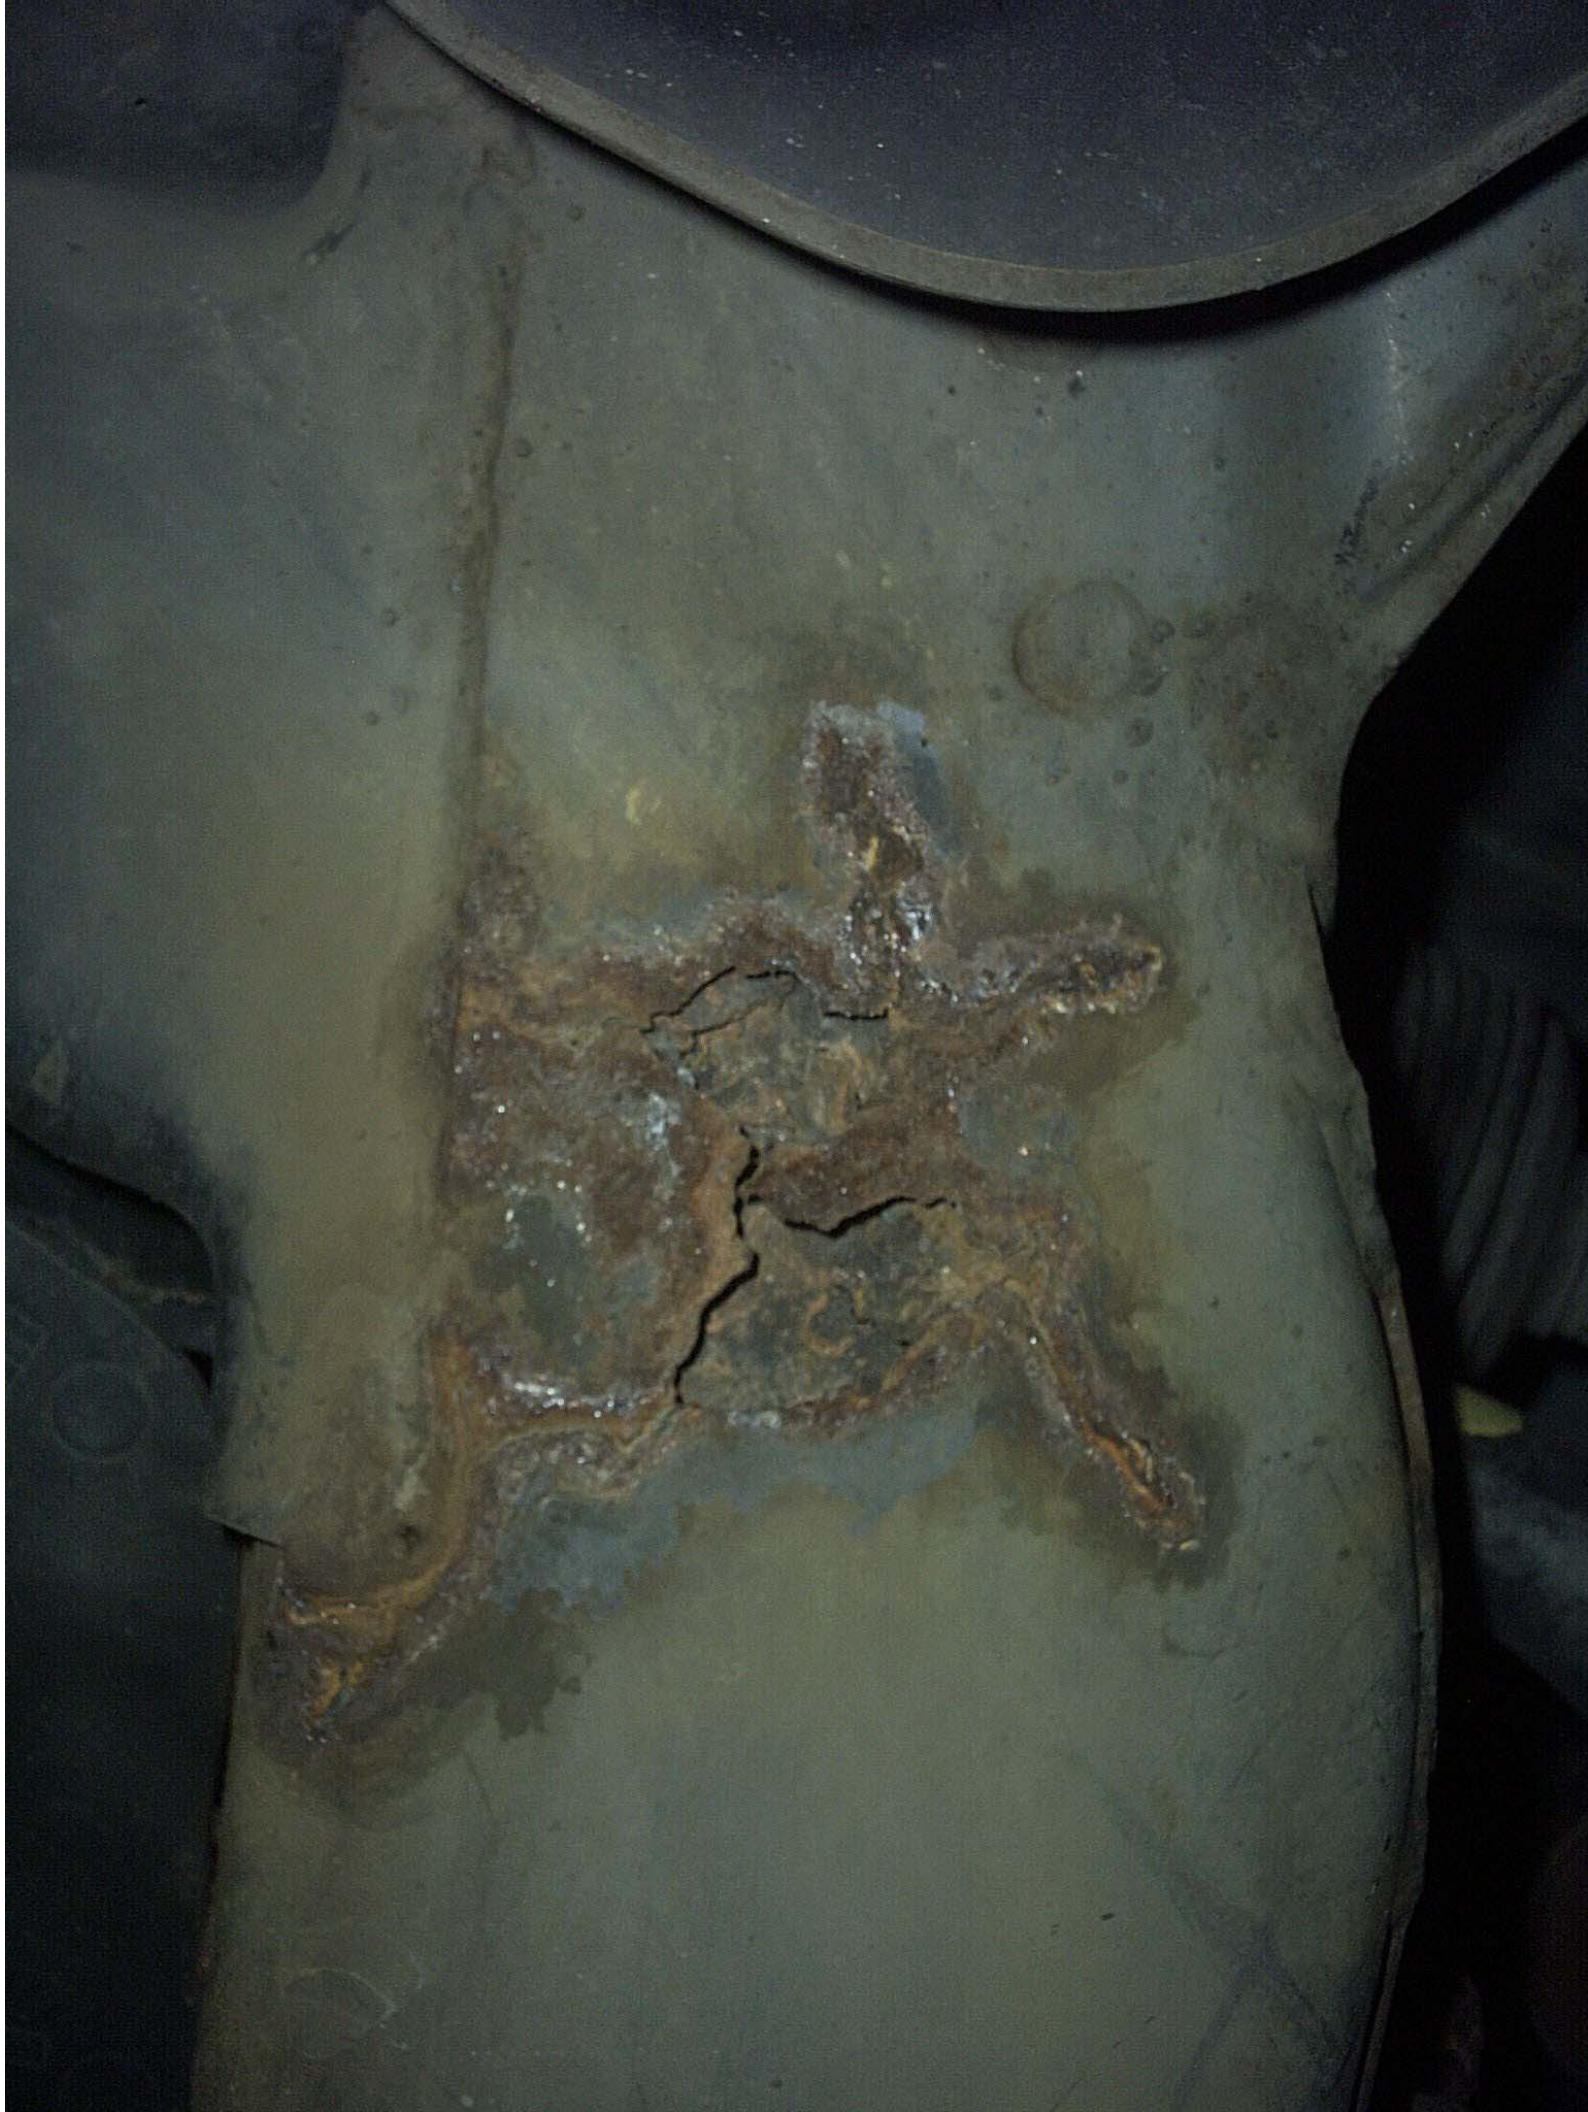
IL014 99SonataRust (5).JPG

To: <-- optional Note: An e-mail copy is always sent to National, in addition to above e-mail recipient(s).	
Subject: Safety/SUSPENSION	UPC:
Originator: Colin Carman	Report #: FPOR1102
Dealer Code: IL014	Date: 11/01/2005
VIN: KMHWF35V1XA [REDACTED]	Contact Person: KEVIN QUAYLE
Model: Sonata*	Mileage: 72421
Production Date: 04/23/1999	Model Year: 1999*
Part Name: FRAME	Category: 02 Suspension system*
Part Number:	
Customer Complaint: CUSTOMER STATES STEERING COLLAPSED APPEARS BROKEN.	
Dealer Observations: DEALER INSPECTION VERIFIED EXTENSIVE EXCESSIVE RUST OF FRAME ALLOWED CONTROL ARM BOLTS TO RIP THROUGH RUSTY METAL, SUSPENSION COLLAPSED STARTING ON RIGHT FRONT SIDE.	
Corrective Action: REPLACE FRAME AND CONTROL ARM.	
Did this action resolve condition? <input checked="" type="radio"/> Yes <input type="radio"/> No	
Condition verified by personal inspection of company employee? <input checked="" type="radio"/> Yes <input type="radio"/> No

Comment: ORIGINAL OWNER OF CAR, POLICY GOODWILL PAID FOR REPAIRS. IL014 99SonataRust.JPG

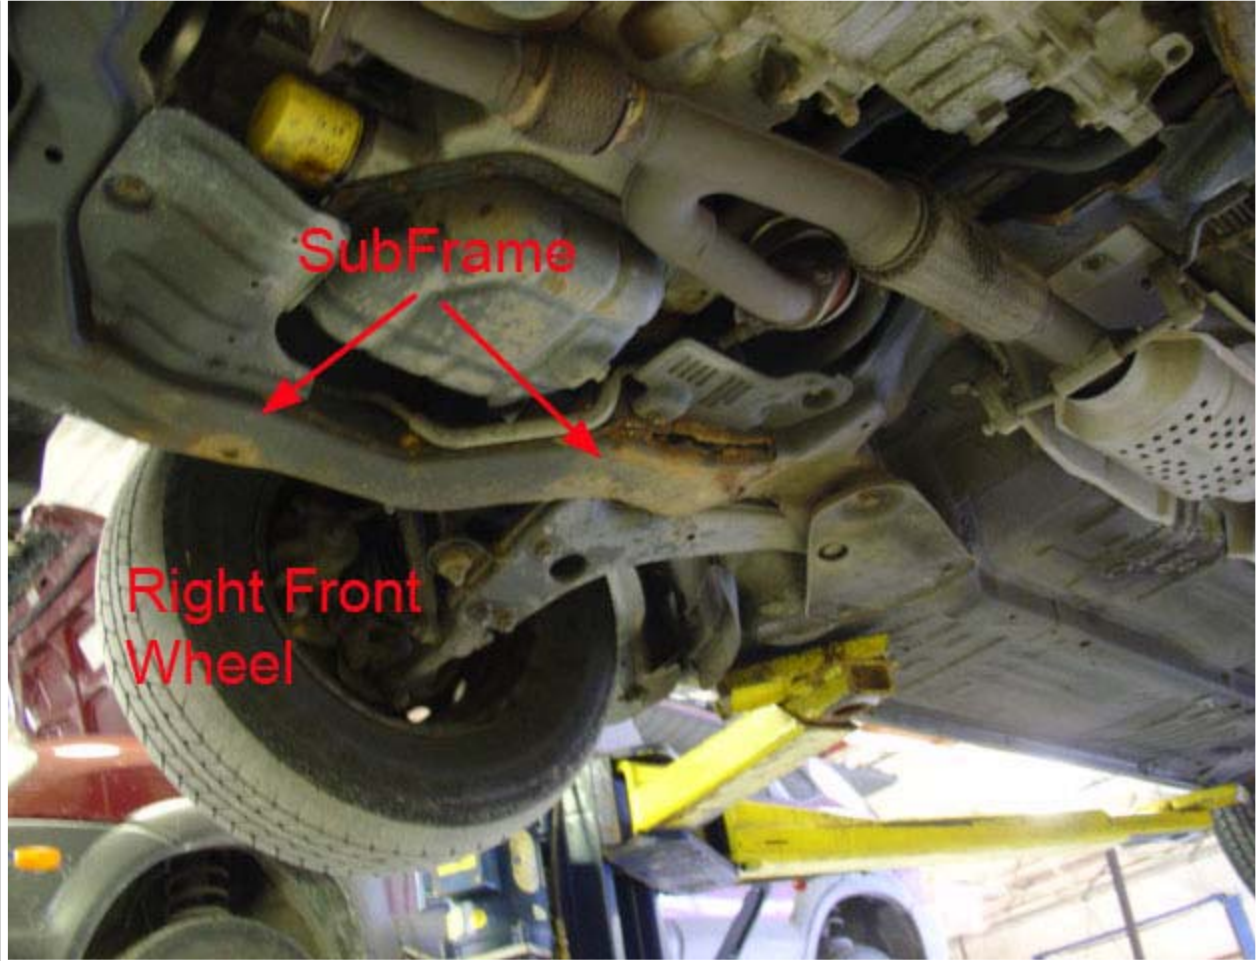
SubFrame

Target Date:	Comment:
12/14/2005	Dealer visit 12/15/05. FTS inspected vehicle and found rust/corrosion on subframe. Rust appears to be propagating from within subframe. FTS contacted DPSM and new subframe was ordered for vehicle.

Subframe corroding from within, due to moisture accumulating in subframe rails.

Replace subframe.

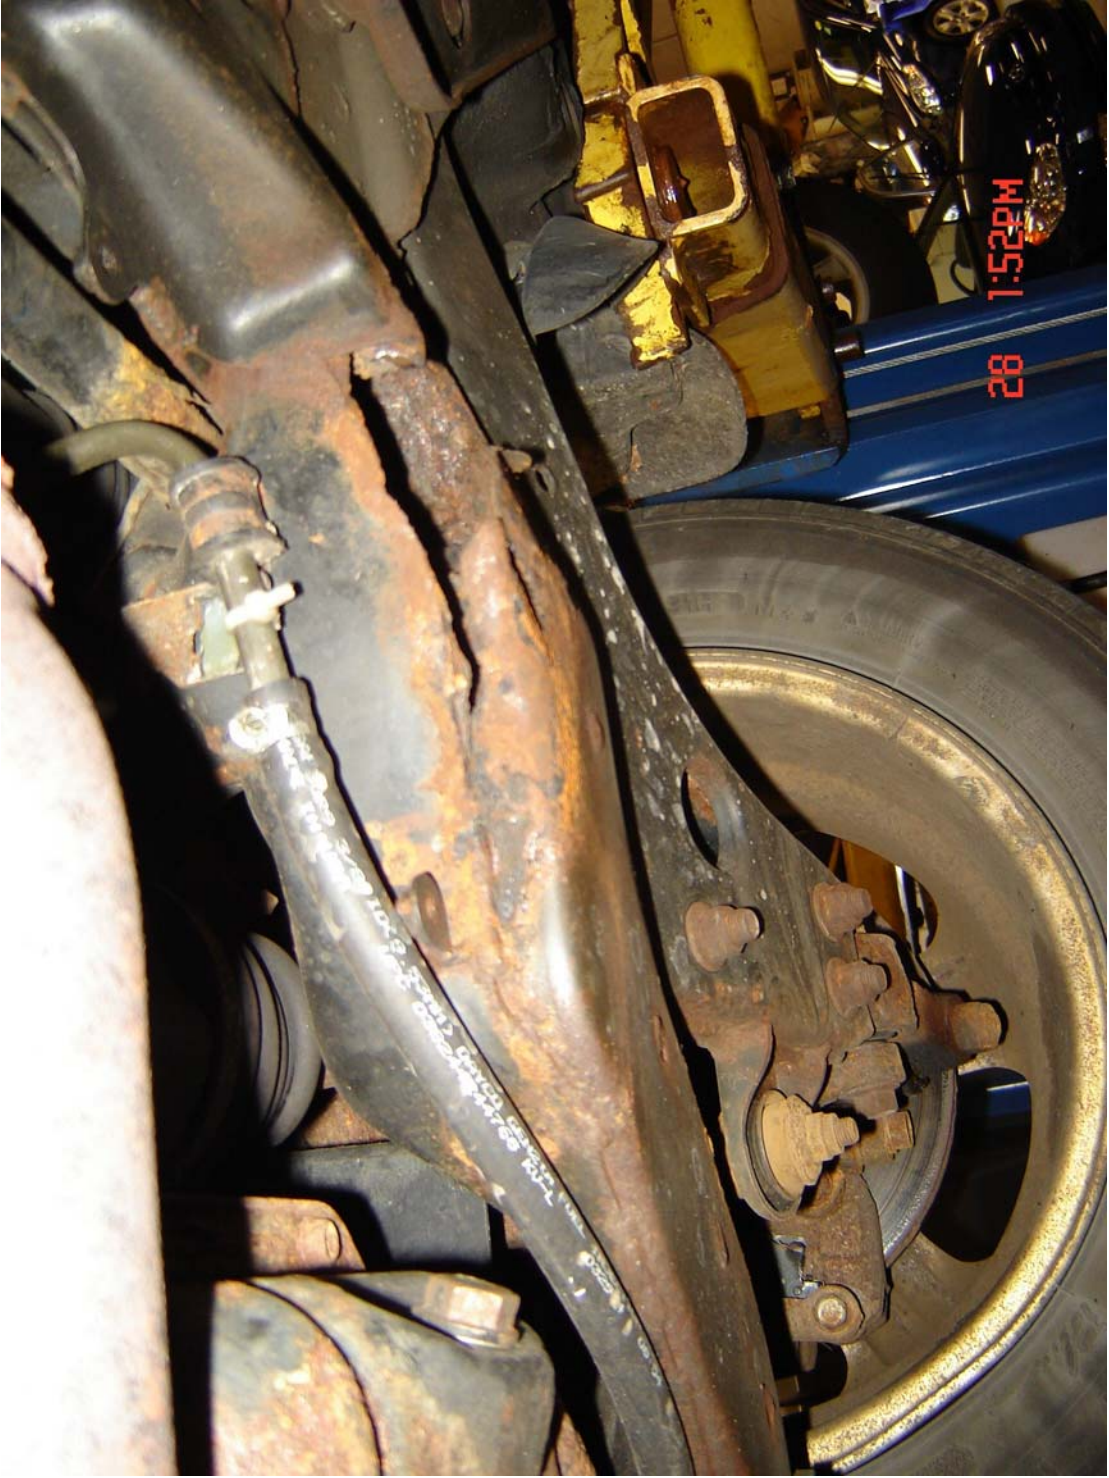
SONATA SUBFRAME.JPG

To: FPOR <-- optional Note: An e-mail copy is always sent to National, in addition to above e-mail recipient(s).	
Subject: RUSTED SUB FRAME	UPC:
Originator: Michael Stahl	Report #: 48
Dealer Code: MA021	Date: 09/29/2006
VIN: KMHWF35VXXA [REDACTED]	Contact Person: DAVID FROMENT
Model: Sonata*	Mileage: 109,000
Production Date: 10/20/1998	Model Year: 1999*
Part Name: SUB FRAME	Category: 16 Structure*
Part Number:	
Customer Complaint: VEHICLE WOULD NOT PASS STATE INSPECTION	
Dealer Observations: FOUND SUBFRAME RUSTED THROUGH	
Corrective Action: REPLACED SUBFRAME	
Did this action resolve condition? <input checked="" type="radio"/> Yes <input type="radio"/> No	
Condition verified by personal inspection of company employee? <input type="radio"/> Yes <input checked="" type="radio"/> No	
Were Photos Taken? <input checked="" type="radio"/> Yes <input type="radio"/> No	
Parts Inspected? <input checked="" type="radio"/> Yes <input type="radio"/> No
