**PE08029/HYUNDAI-KIA
2001 EF FIELD REPORTS**

HYUNDAI
Field Product Observation Report

**PE08029/HYUNDAI-KIA
1999 EF FIELD REPORTS**

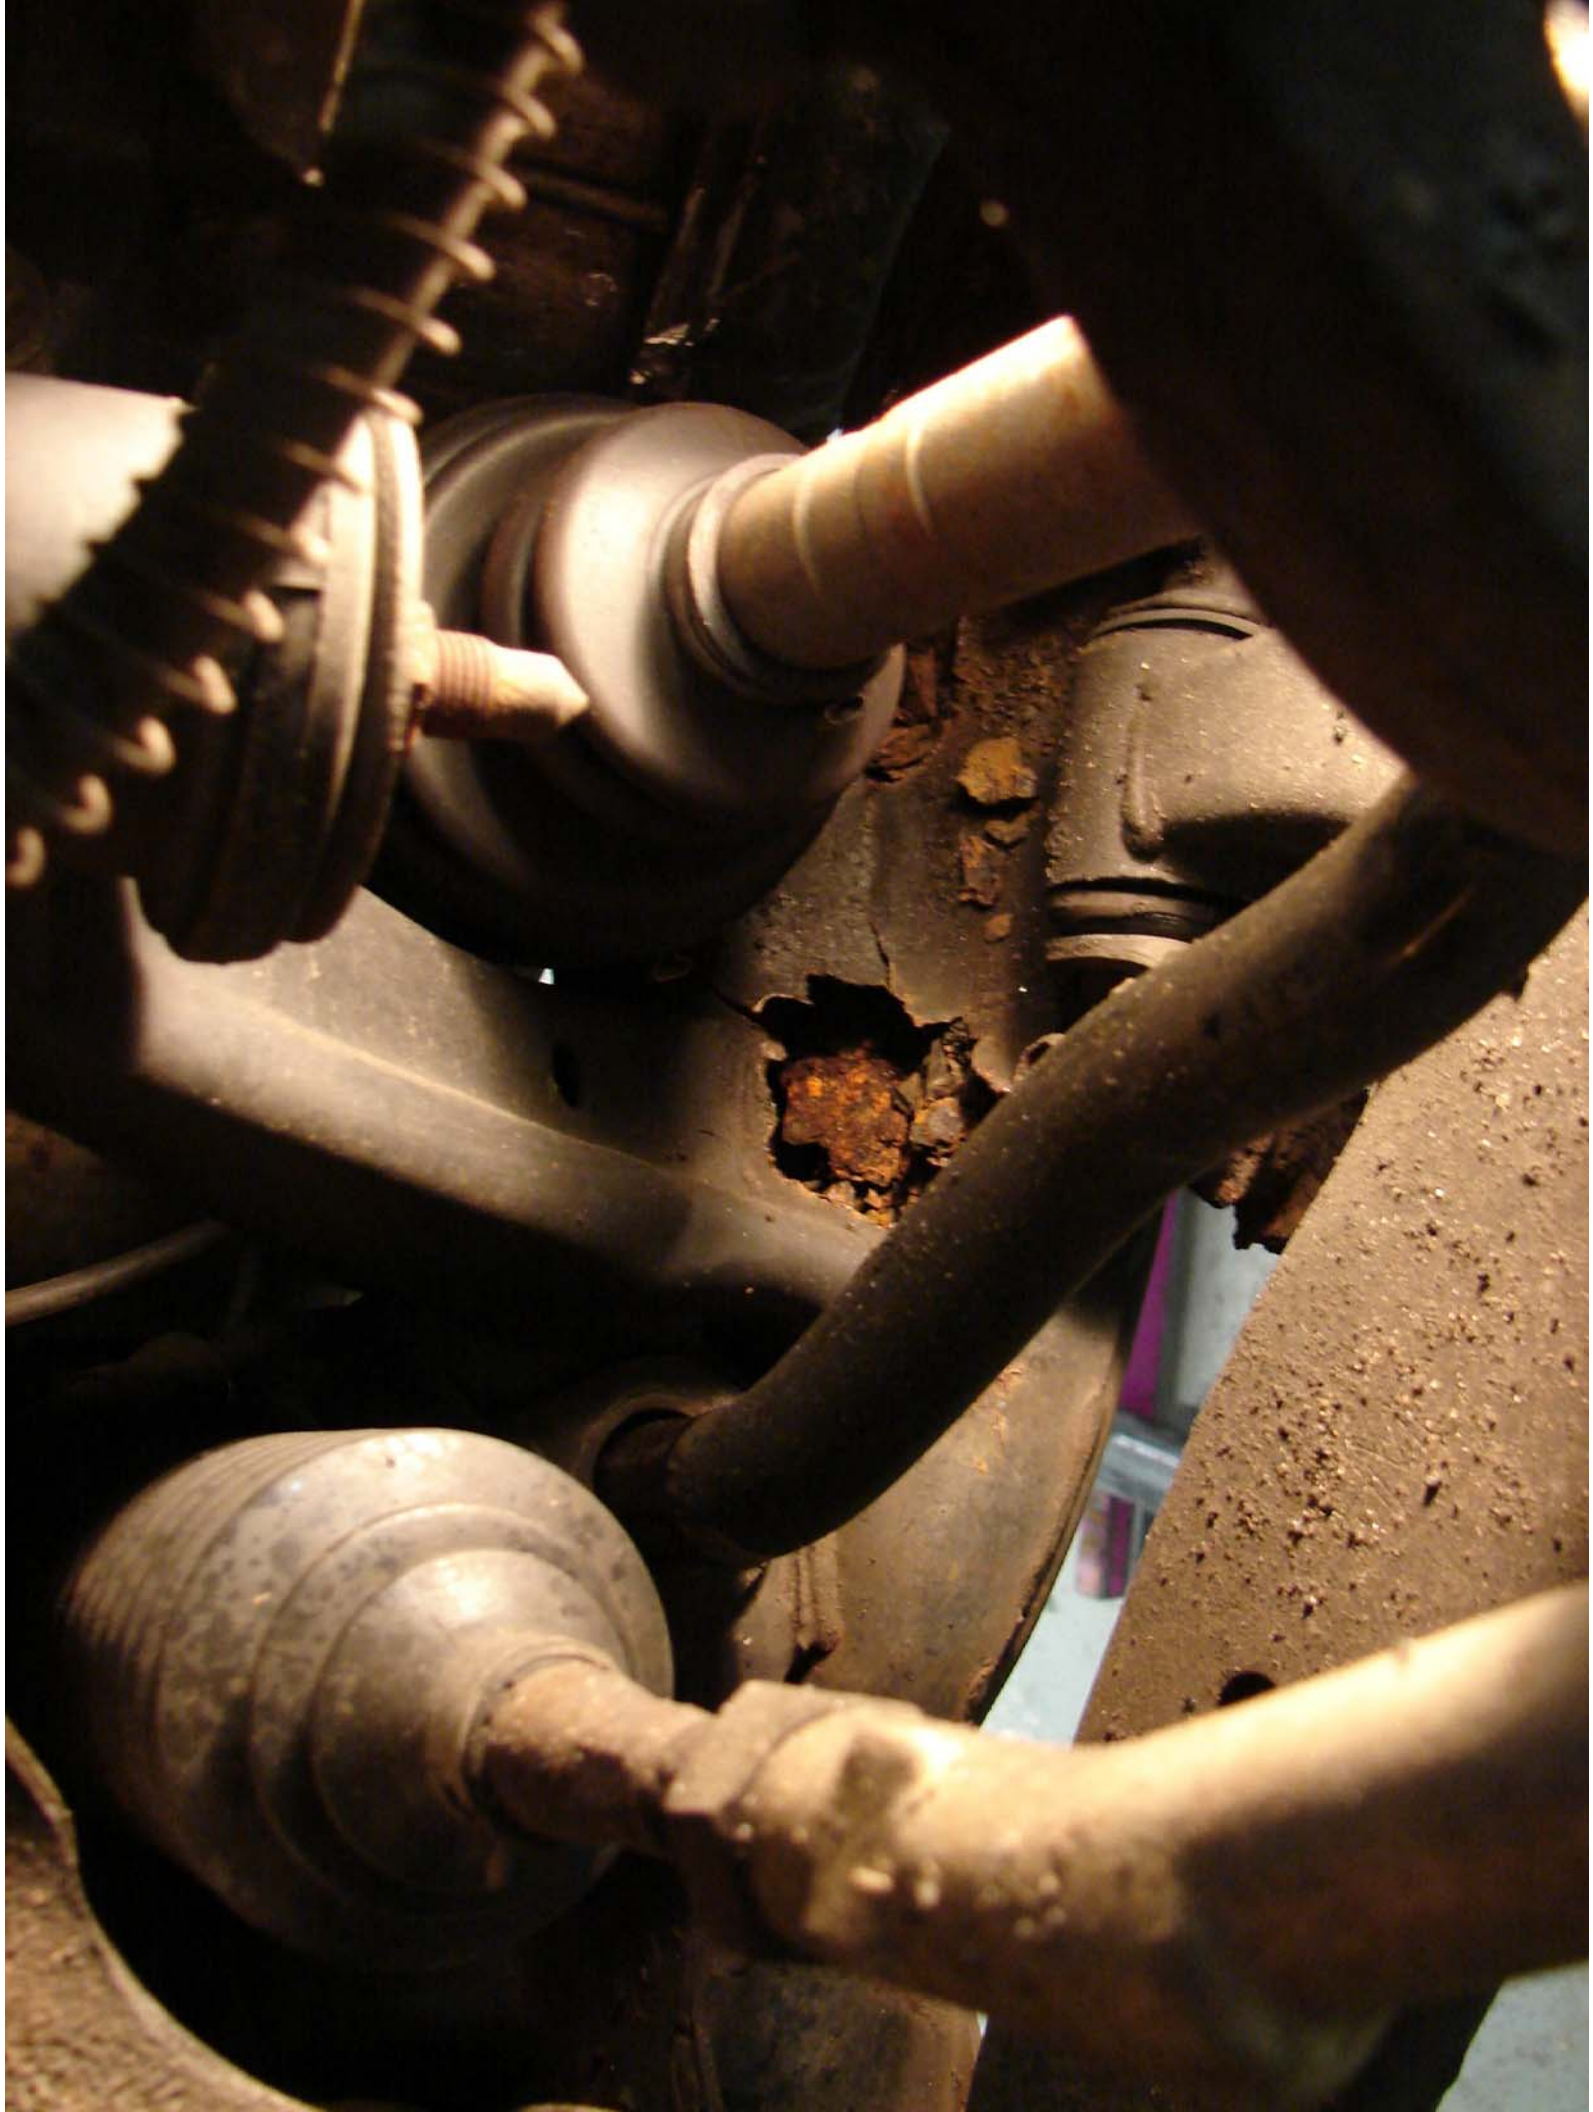
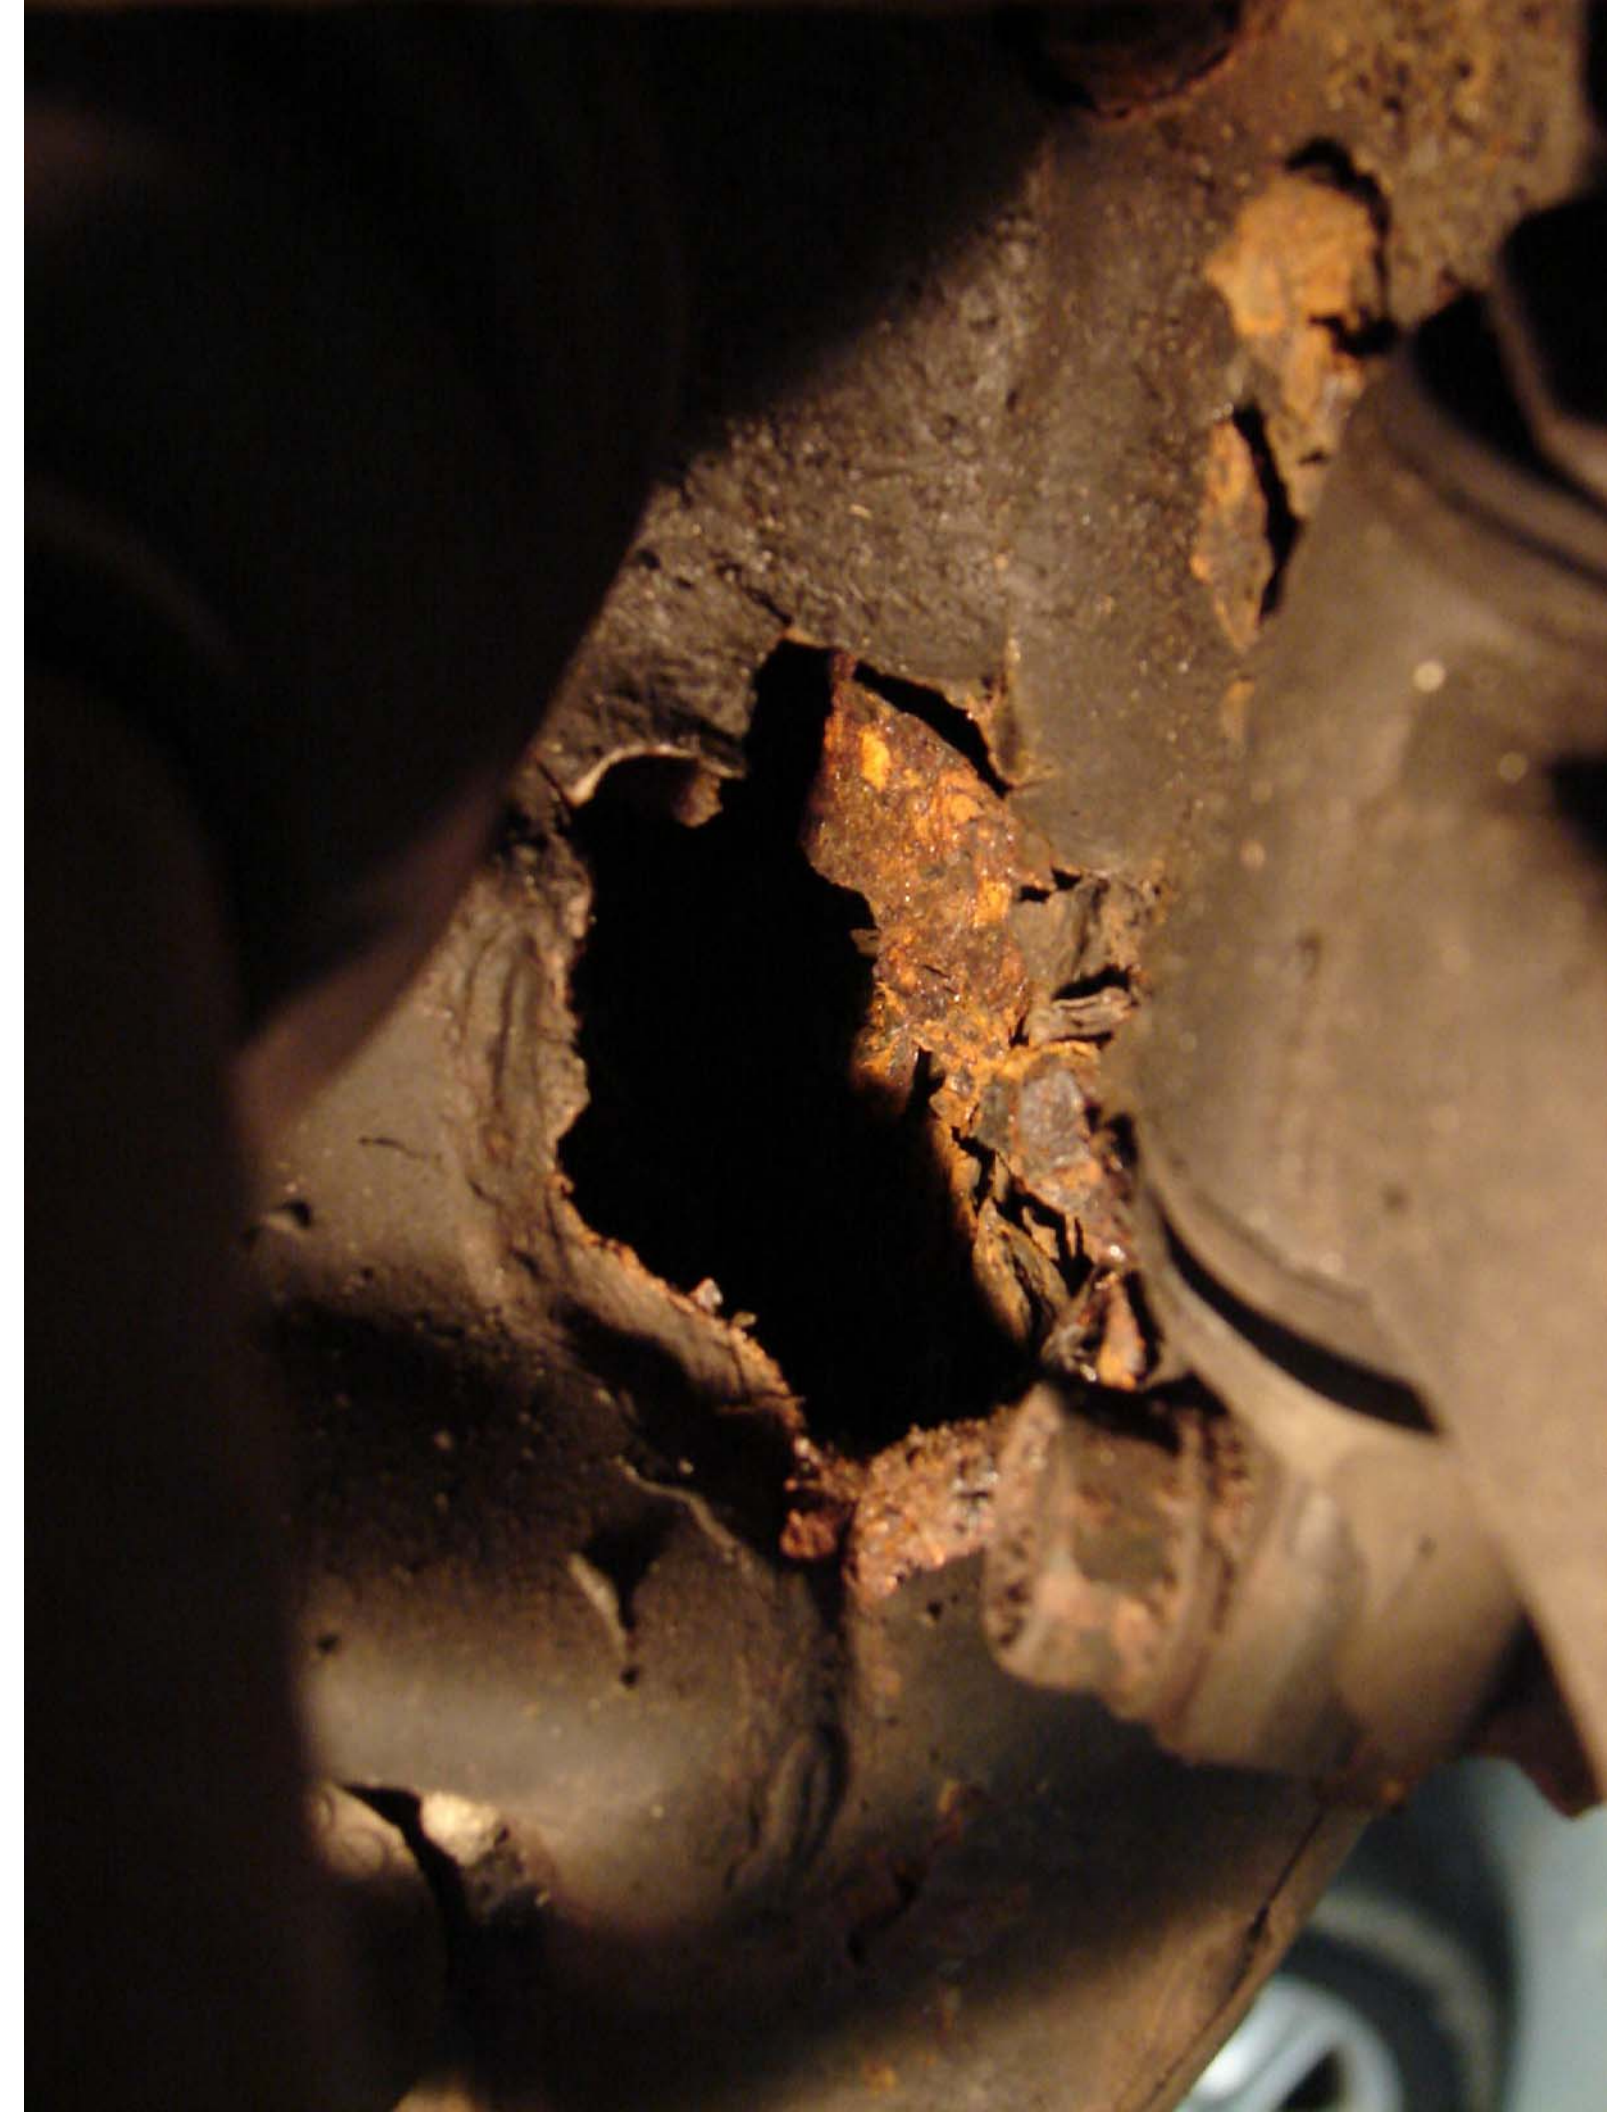
Randy Craley from Eastern Region to pick up parts. DSC00178.JPG DSC00182.JPG DSC00187.JPG

To: FPOR <-- optional Note: An e-mail copy is always sent to National, in addition to above e-mail recipient(s).			
Subject: front sub frame			UPC:
Originator: Bob Ritter	Report #:	Date: 12/06/2006	
Dealer Code: nj039	Contact Person: scott perine		
VIN: KMHWF35V2XA [REDACTED]	Mileage: 74507		
Model: Sonata*	Model Year: 1999*		
Production Date: n/a	Category: 02 Suspension system*		
Part Name: front sub-frame	Part Number:		
Customer Complaint: lower control arm pulled out of frame			
Dealer Observations: dpsm and dealer verified concern. right side front control arm mountong bolts pulled out of frame due to rust.			
Corrective Action: replace front frame, replace damaged right front fender and alll misc. parts.			
Did this action resolve condition? <input checked="" type="radio"/> Yes <input type="radio"/> No			
Condition verified by personal inspection of company employee? <input checked="" type="radio"/> Yes <input type="radio"/> No
