**PE08029/HYUNDAI-KIA
2002 EF FIELD REPORTS**

2002 Sonata SUBFRAME RUSTED THROUGH- POTENTIAL VDS ISSUE

**PE08029/HYUNDAI-KIA
2000 EF FIELD REPORTS**

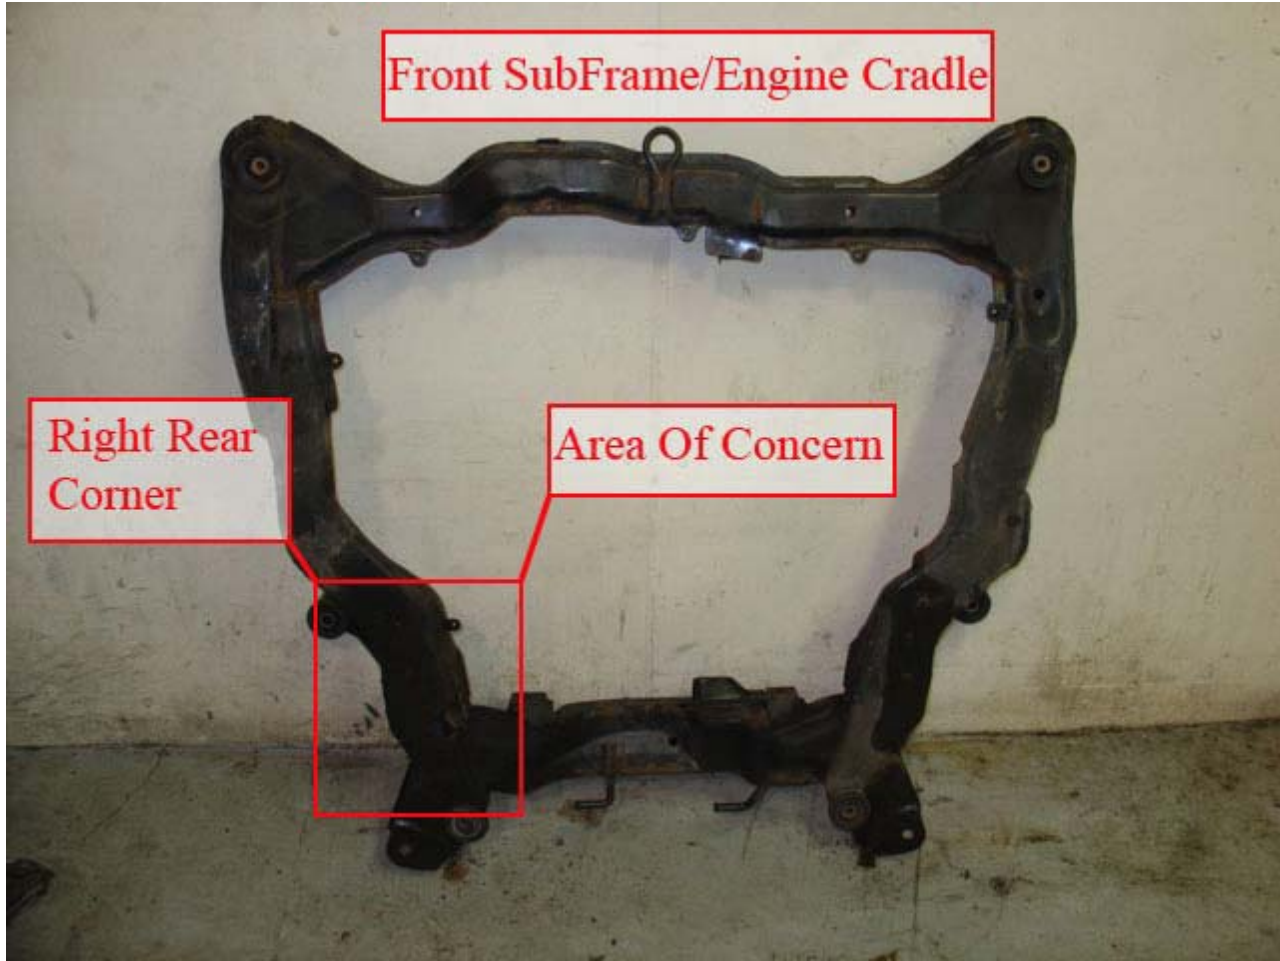
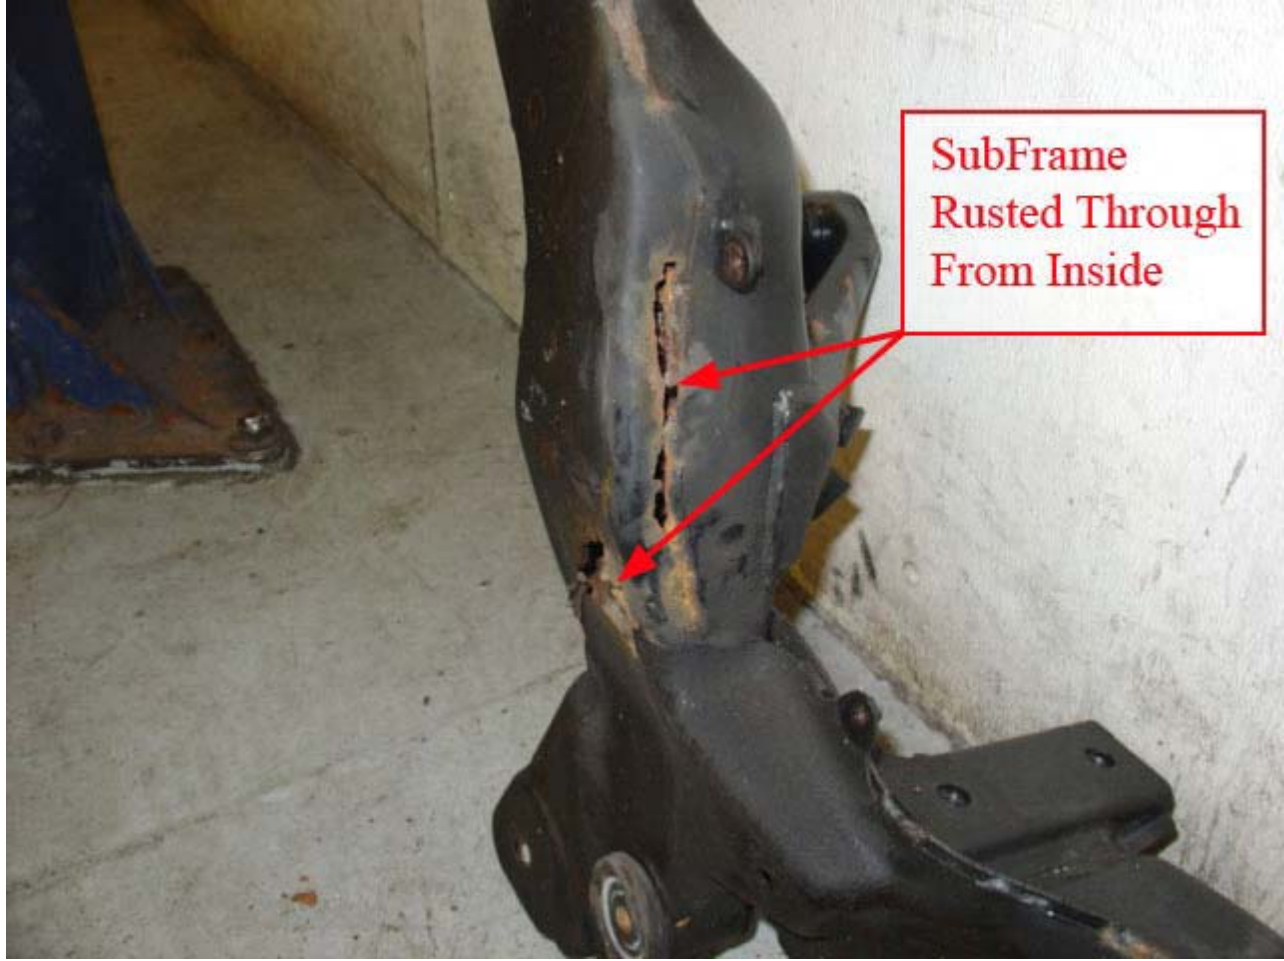
Technician noticed right rear corner of front subframe was rusted through completely.

Front SubFrame/Engine Cradle

Right Rear
Corner

Area Of Concern

Subframe rusting through from inside subframe assembly.

Replace subframe assembly.

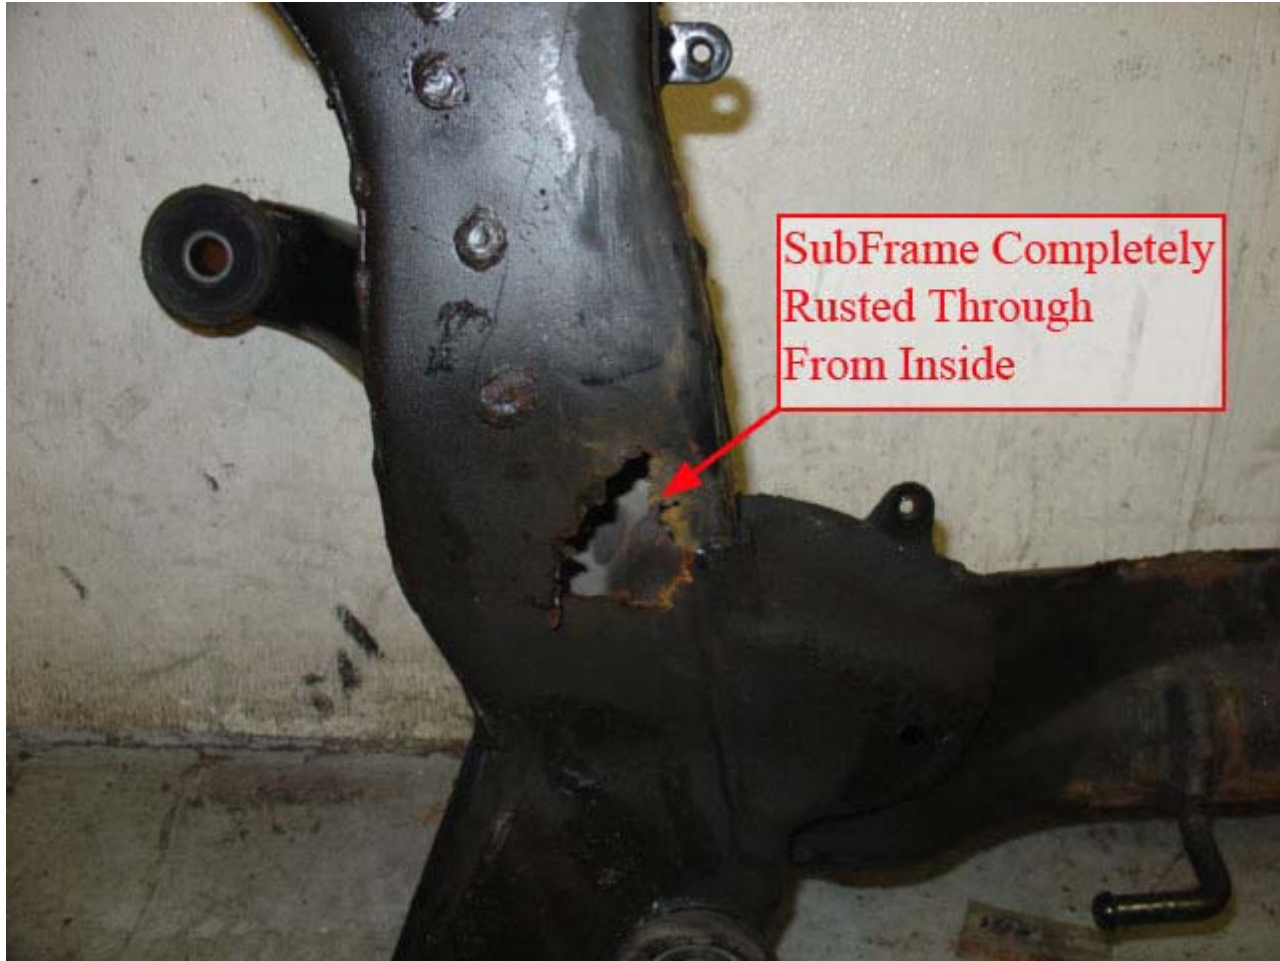
**SubFrame
Rusted Through
From Inside**

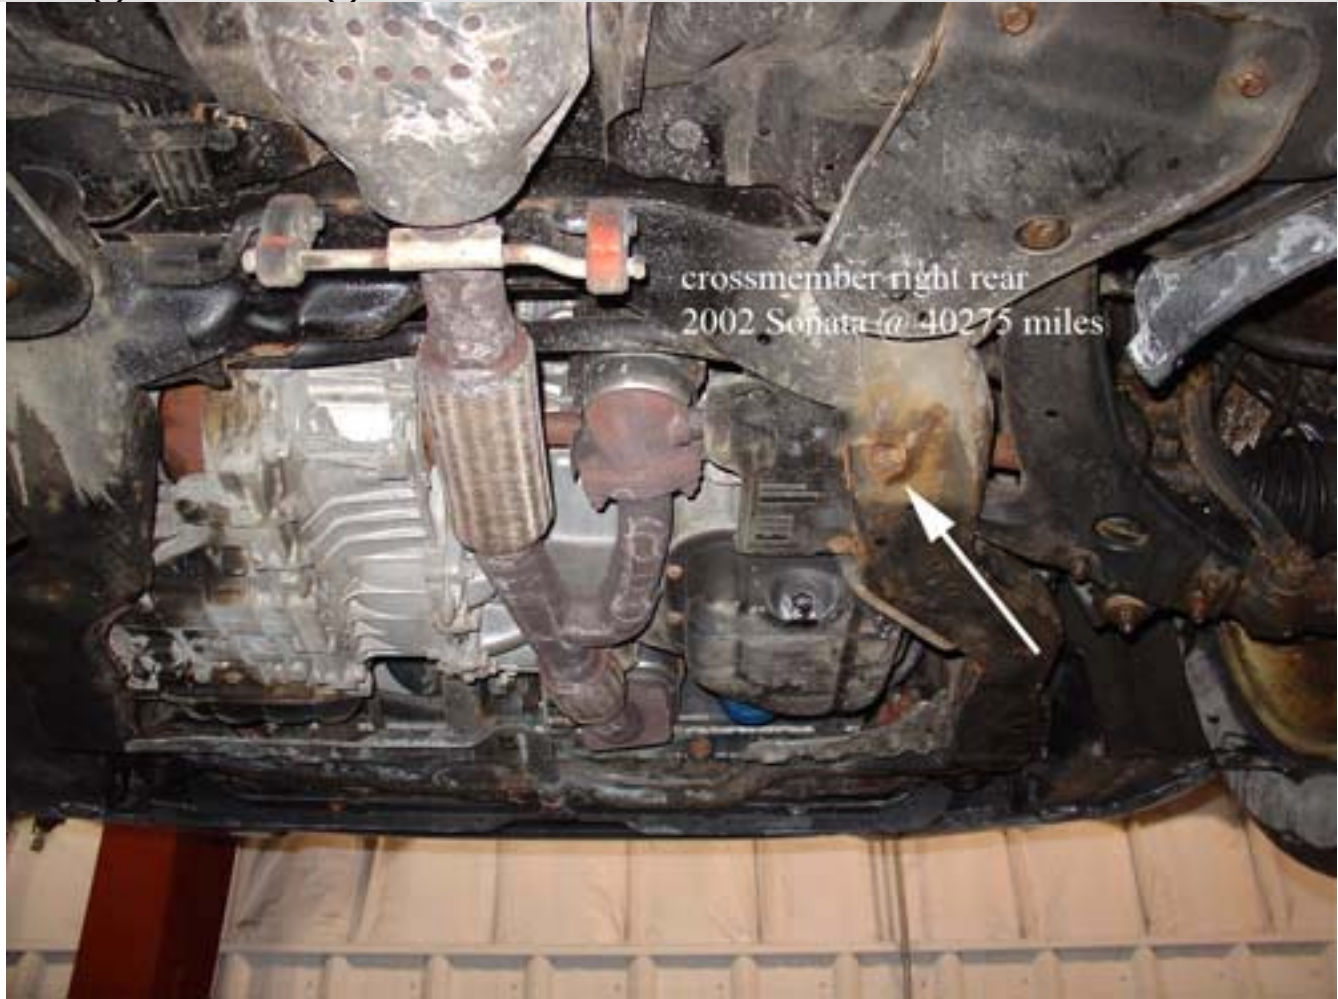
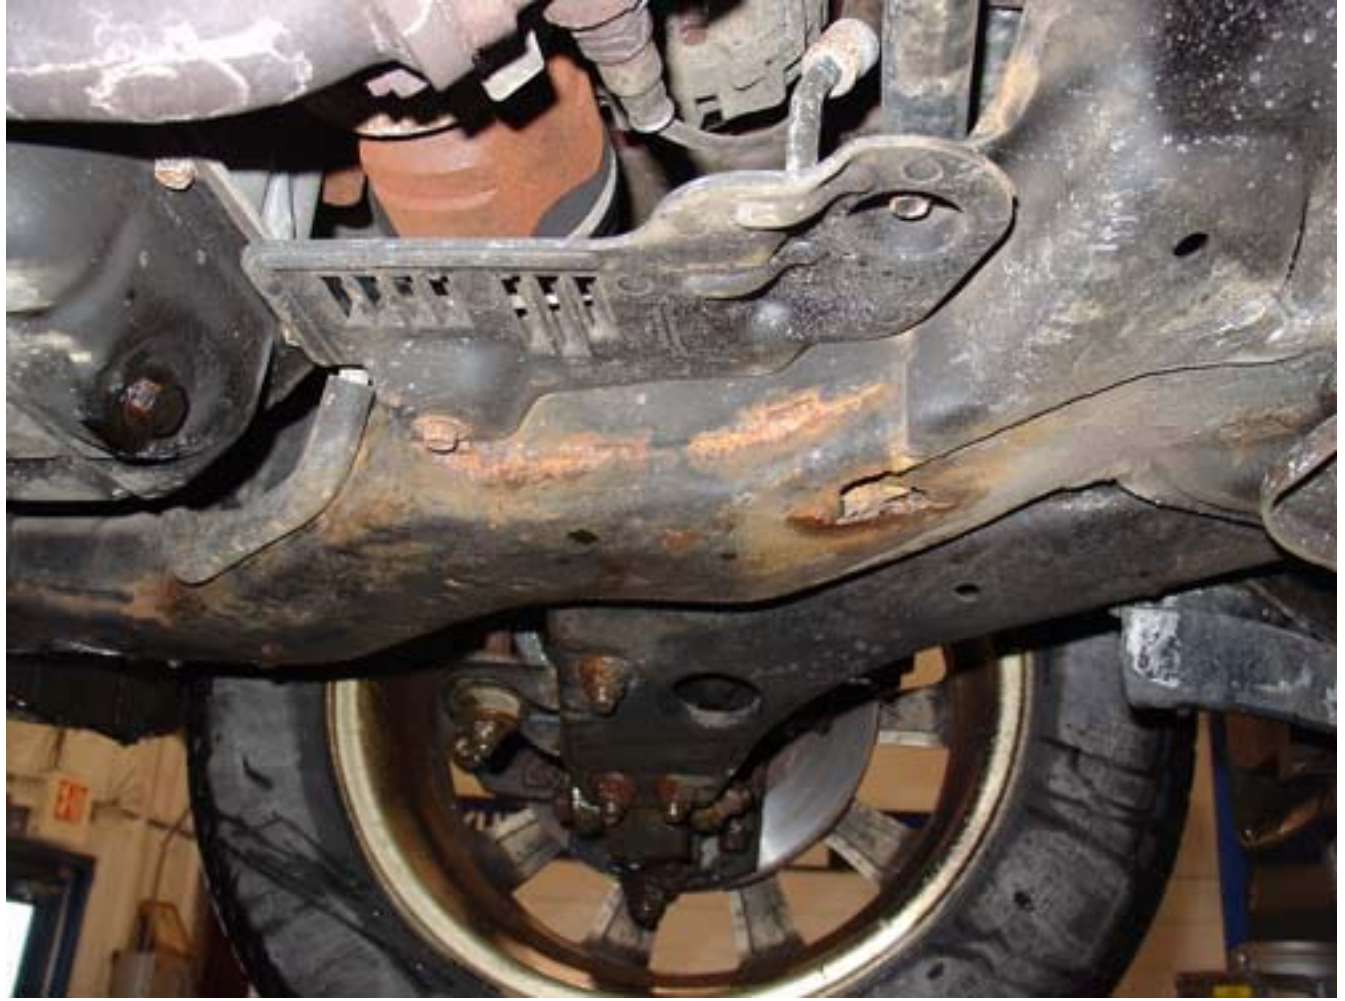
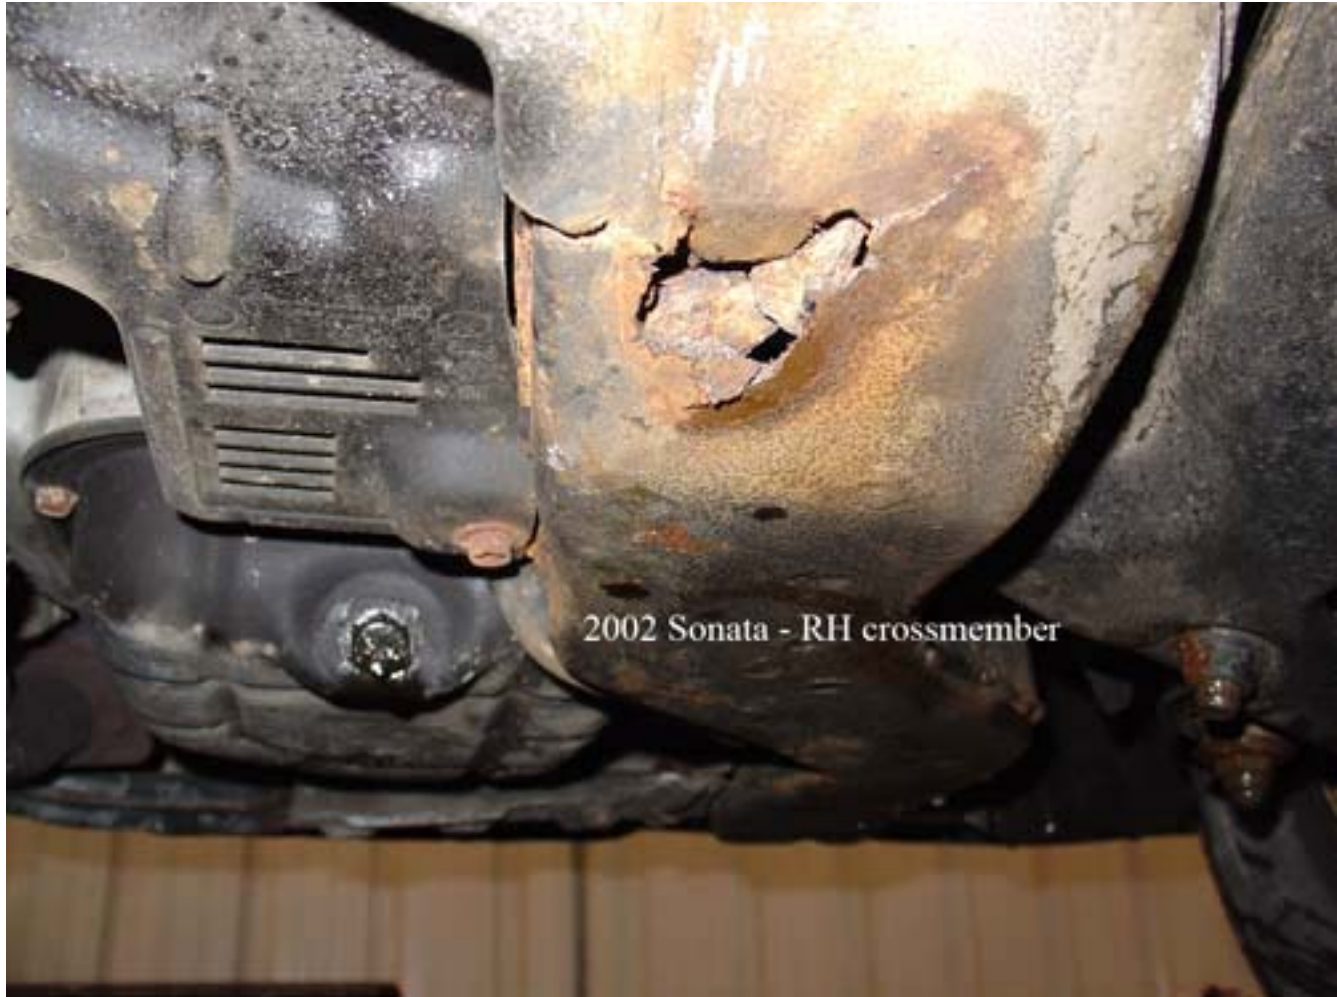
Vehicle failed PA state inspection due to rusted frame crossmember. Right rear side rail at the corner is rusted thru.

Poor metal protection - lack of frame protective coating.

2002 Sonata - RH crossmember

Dealer to replace crossmember complete assembly.

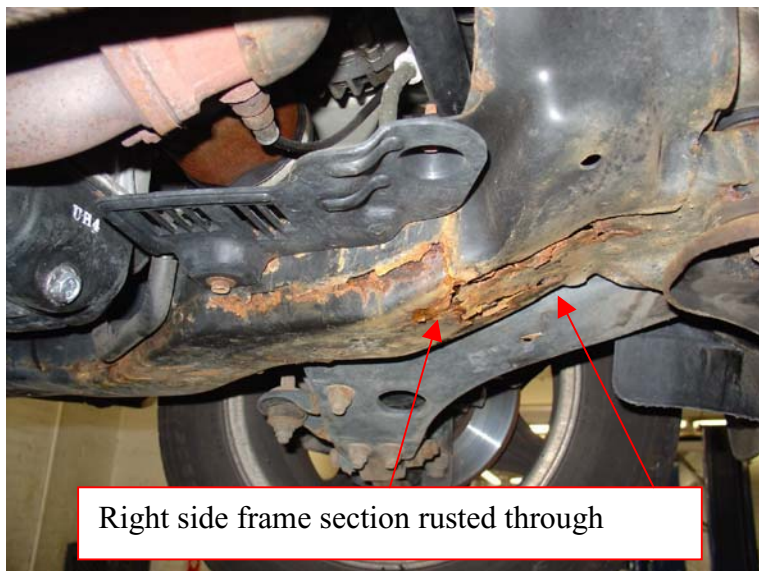
Lack of protective coating on metal.

Right side frame section rusted through

Replace complete crossmember assembly.

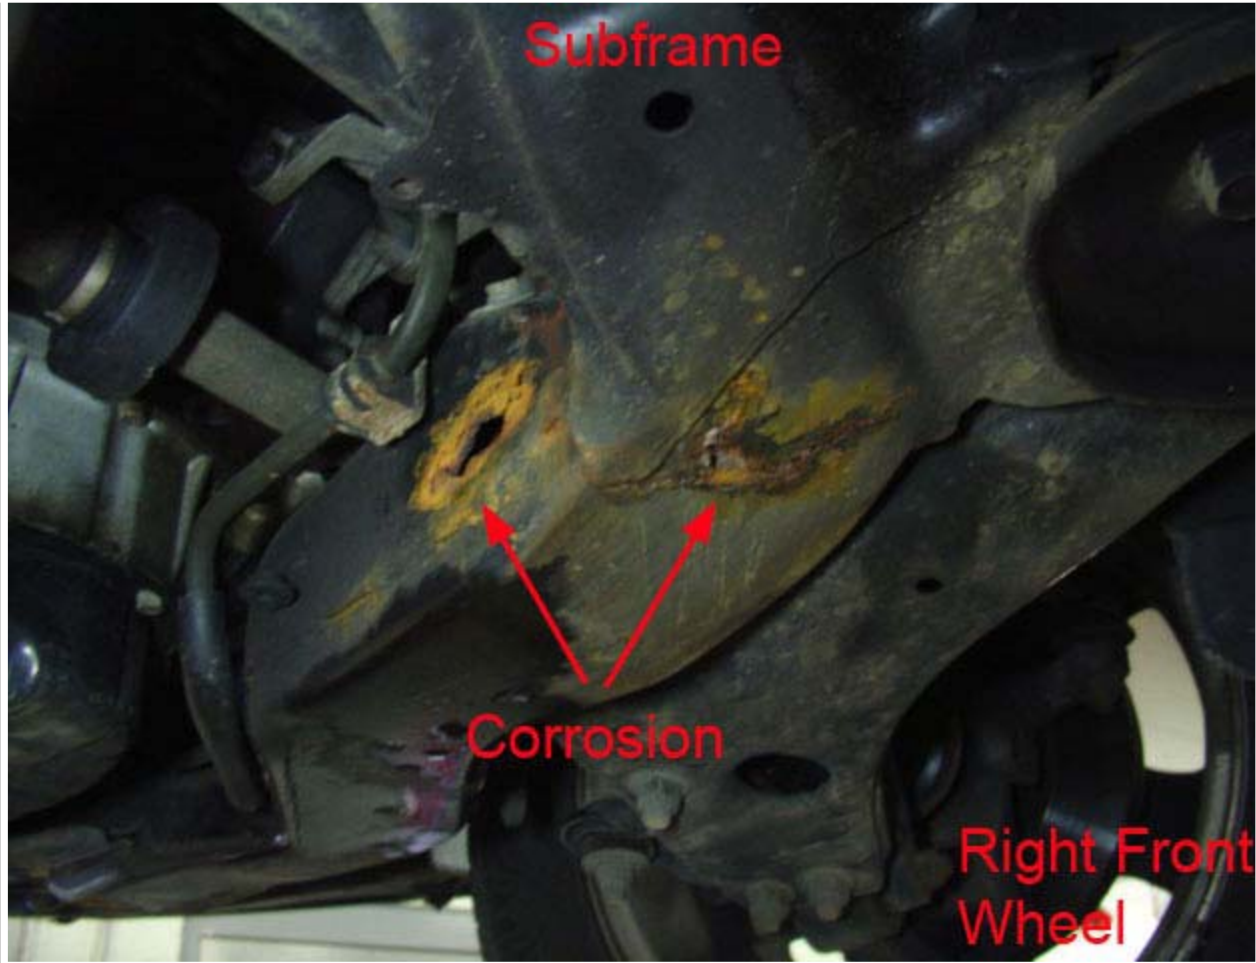
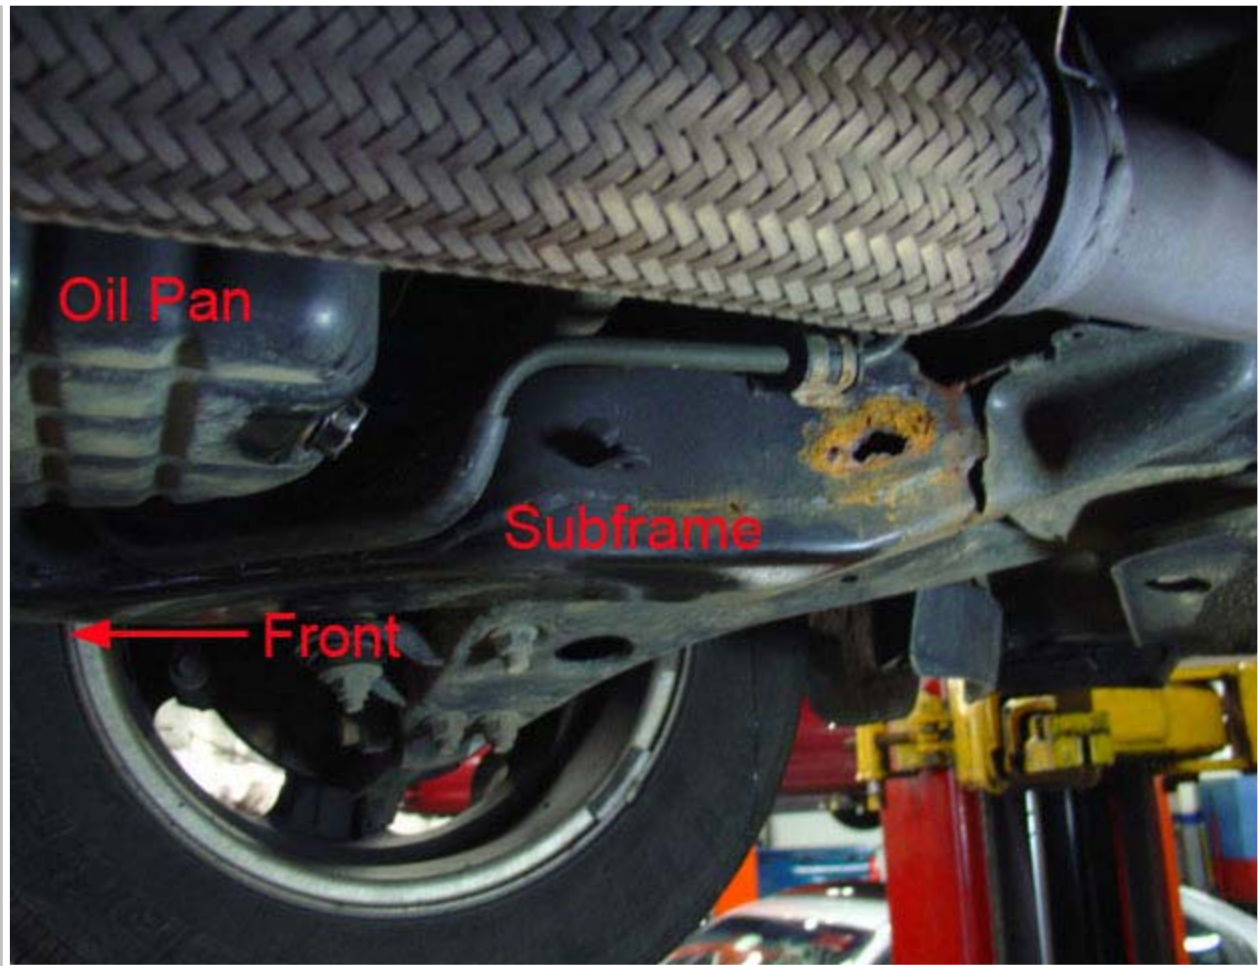
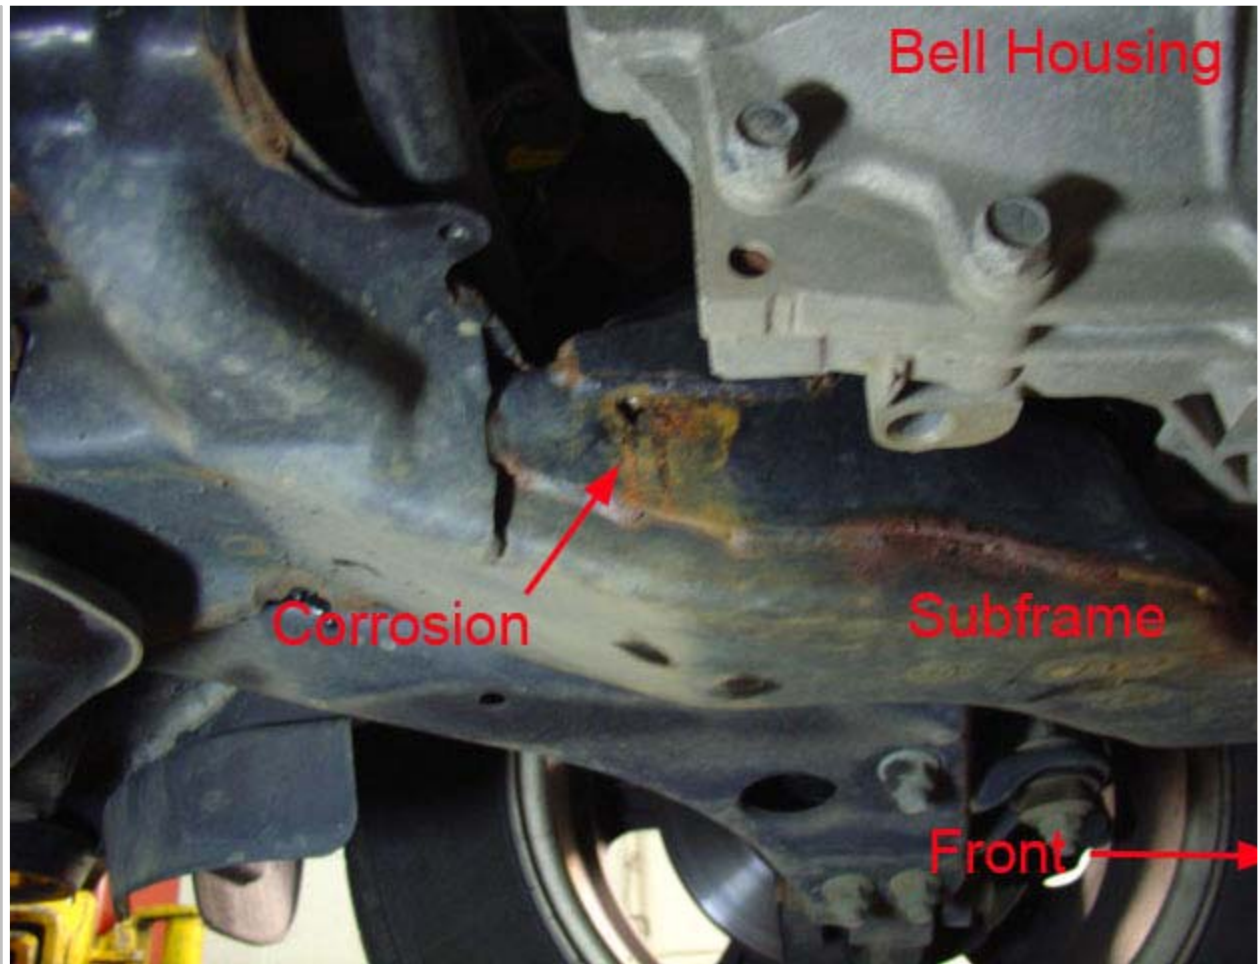
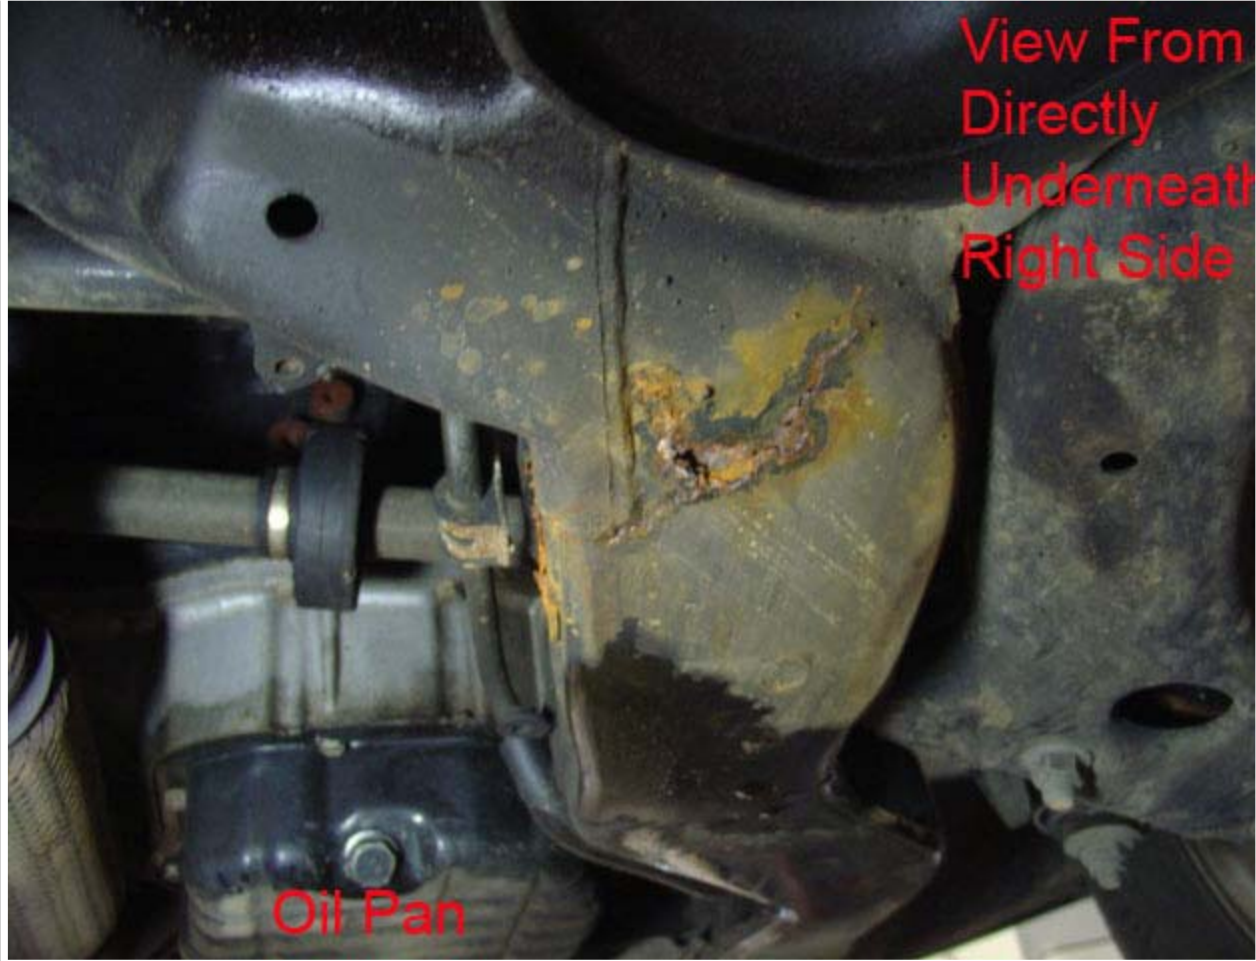
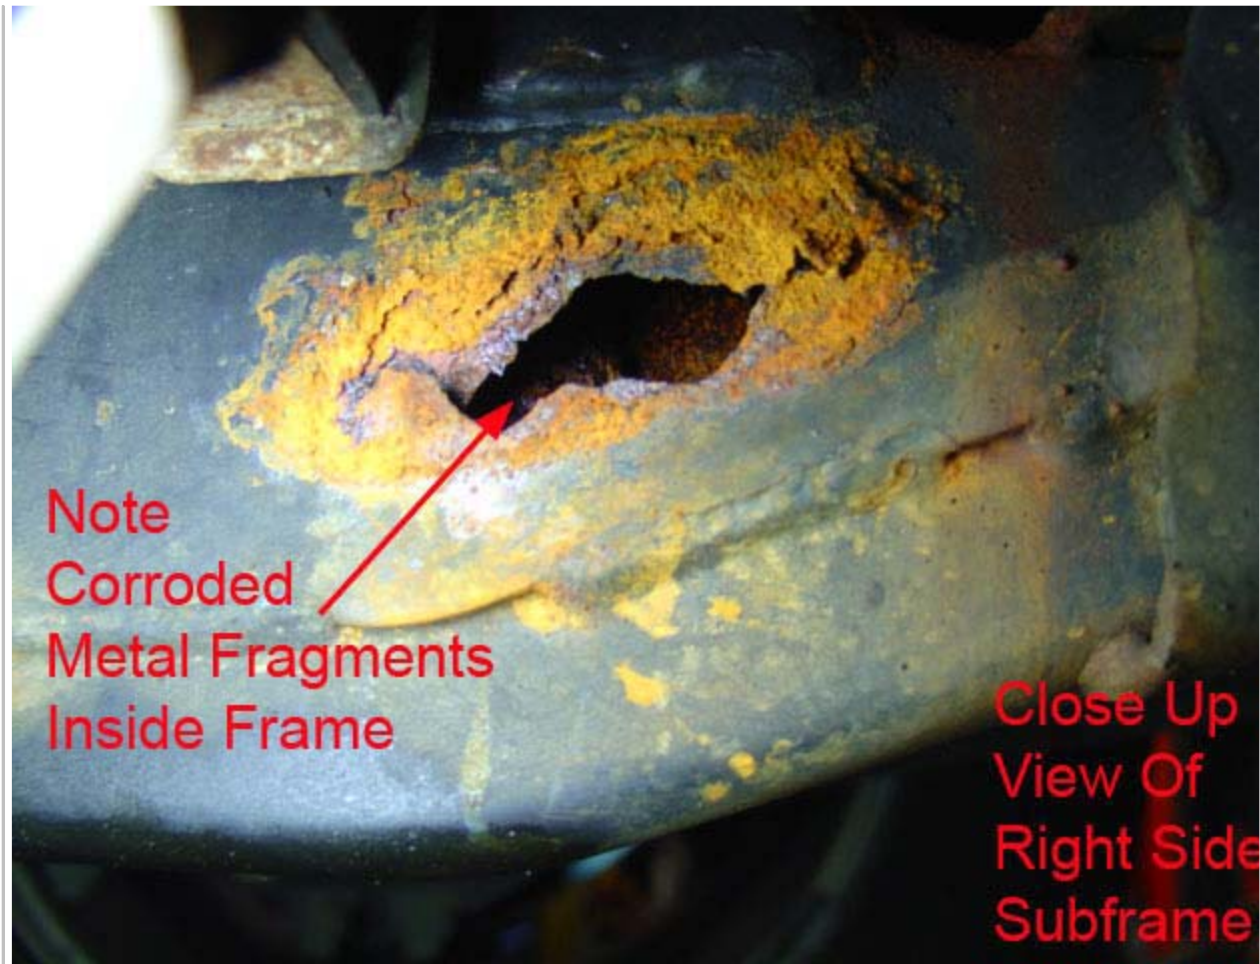
Target Date:	Comment:
12/06/2005	Dealer visit 12/8/05. FTS inspected vehicle. Rust is evident on both left and right sides of vehicle subframe. Rust appears to be propagating from within subframe. FTS contacted DPSM and new subframe was ordered for vehicle.

View From
Directly
Underneath
Right Side

Opportunity to Repair - Engine cradle rusted through on both sides.

Subframe corroding from within, due to moisture accumulating in subframe rails.

Replace subframe.

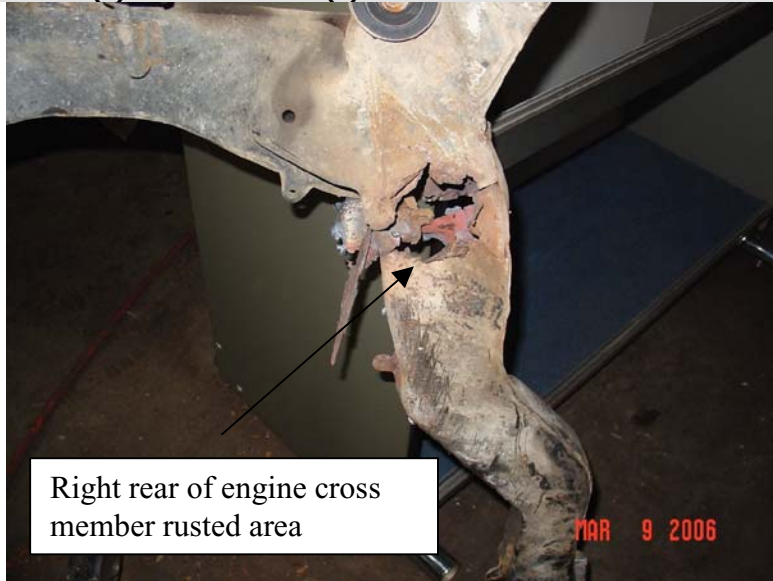
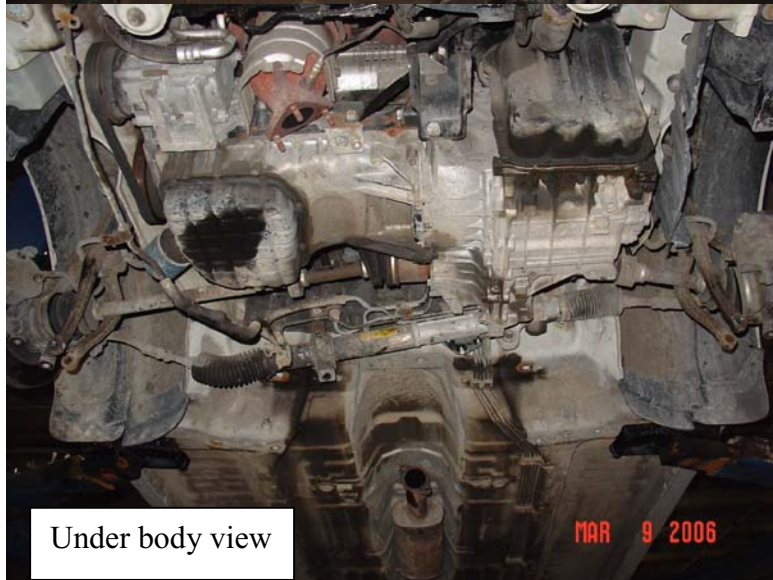
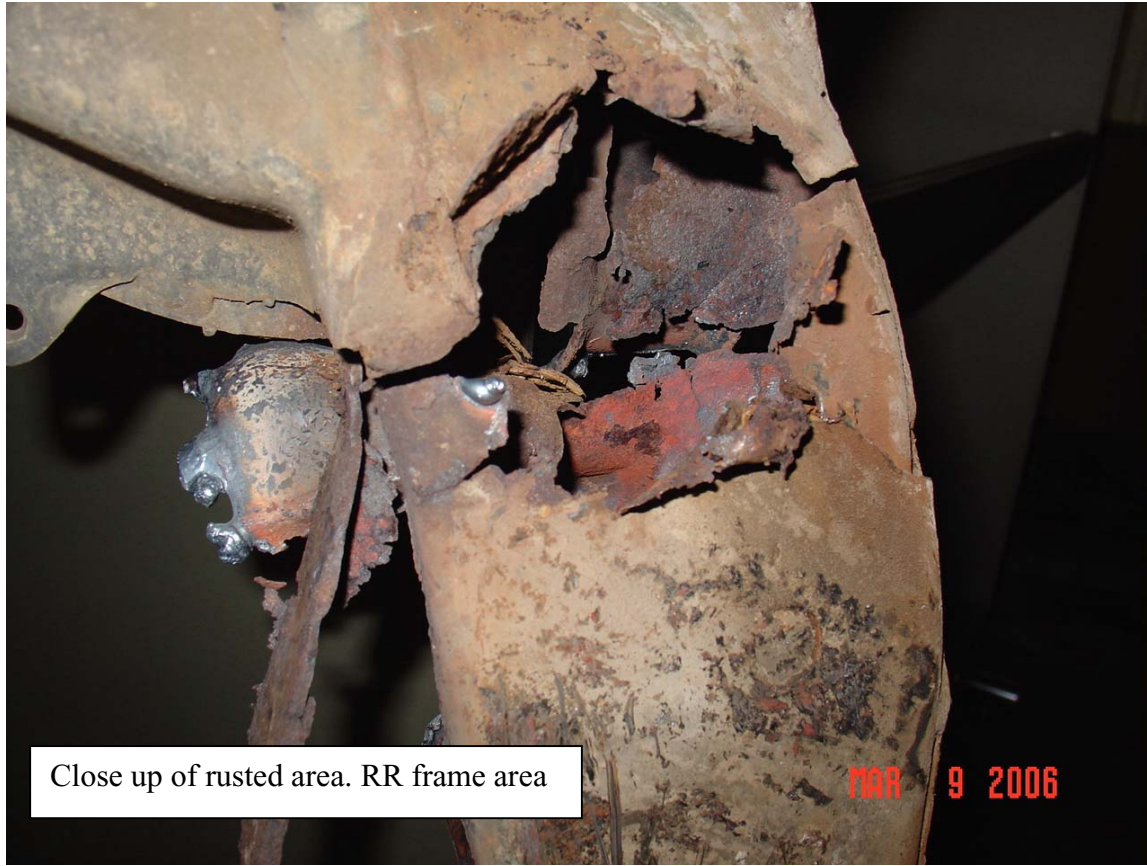
Customer was advised of a large amount of rust on the engine cradle. This was observed during a state inspection.

Lack of protective coating on metal.

Close up of rusted area. RR frame area

Replace complete crossmember assembly.

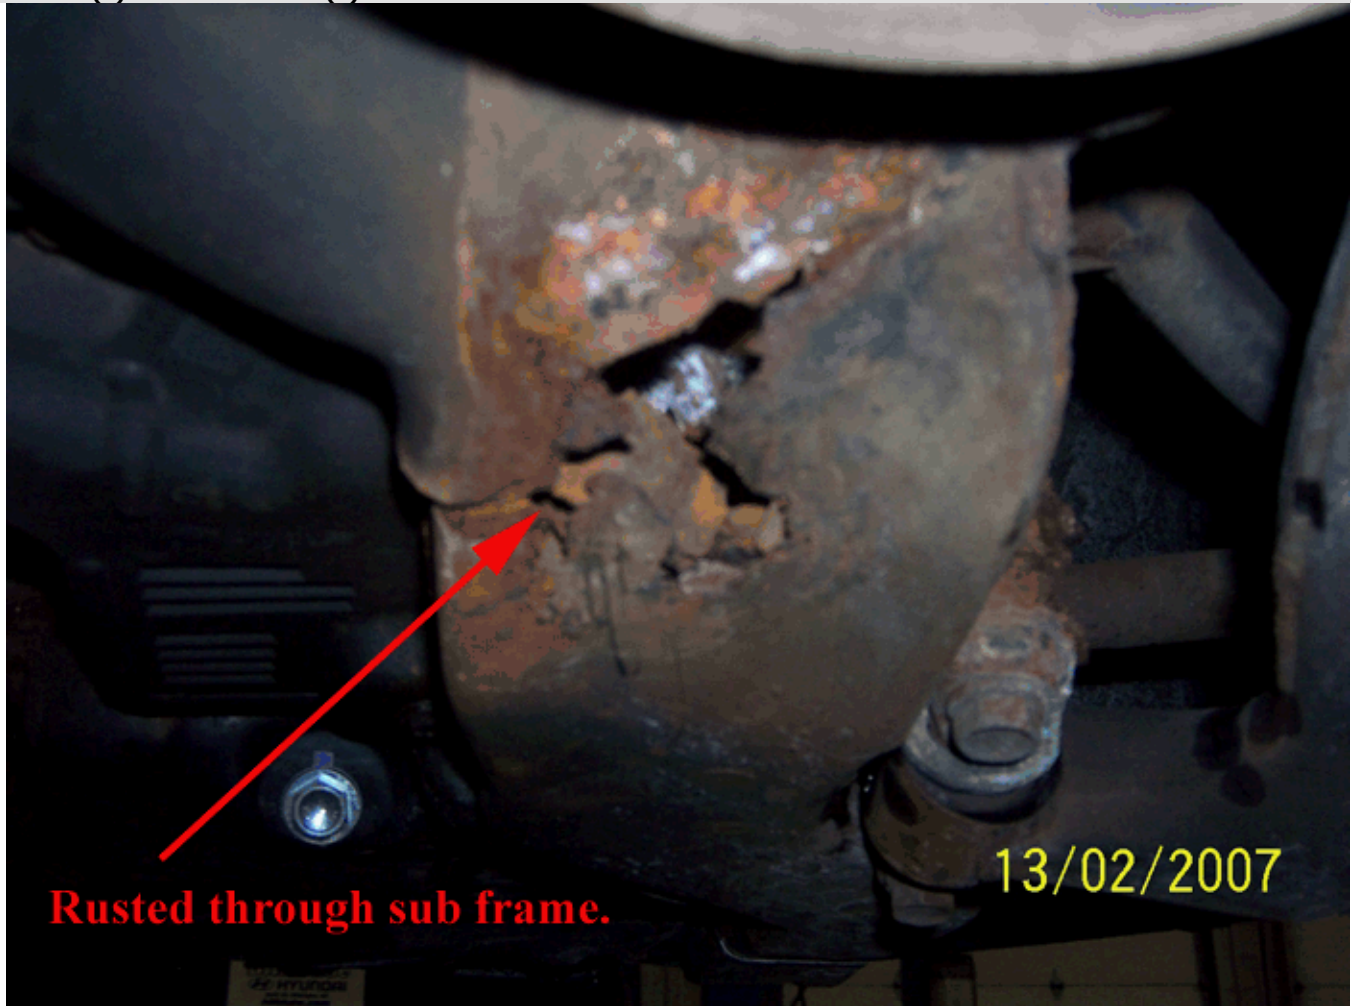
Sub frame rusted through causing the lower control arm mounting points to separate.

Axle was pulled apart and broken during the breakage.

Replace sub frame, lower control arms, axles and right side spindle and strut.

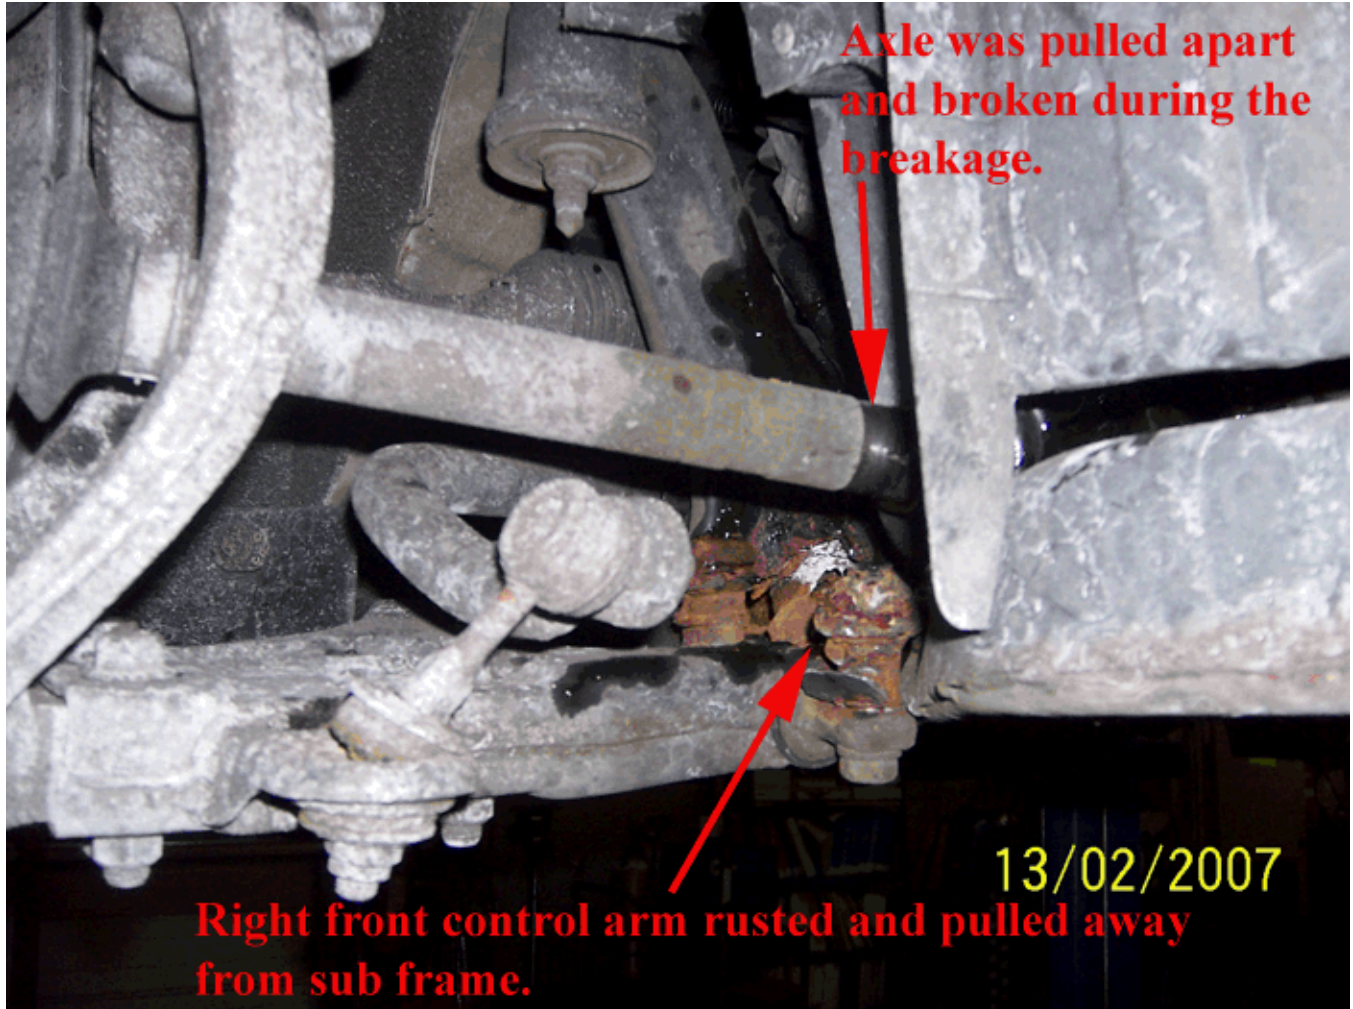
Right front control arm rusted and pulled away from sub frame.

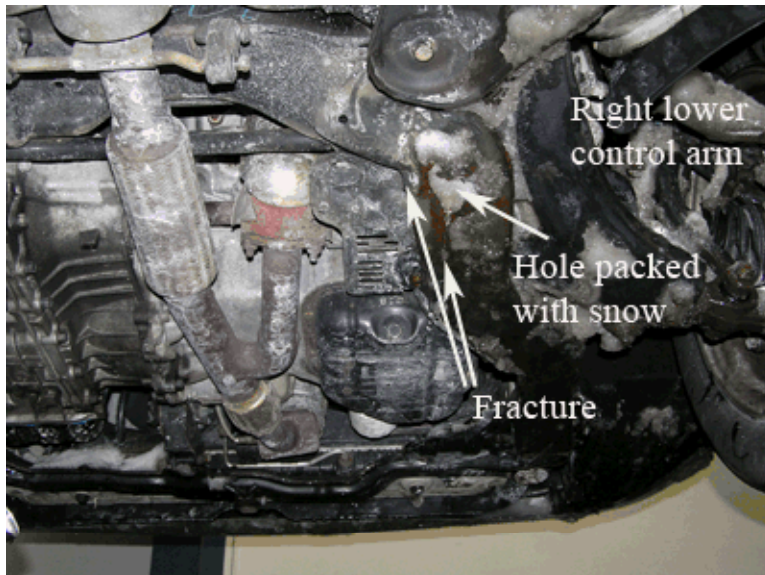
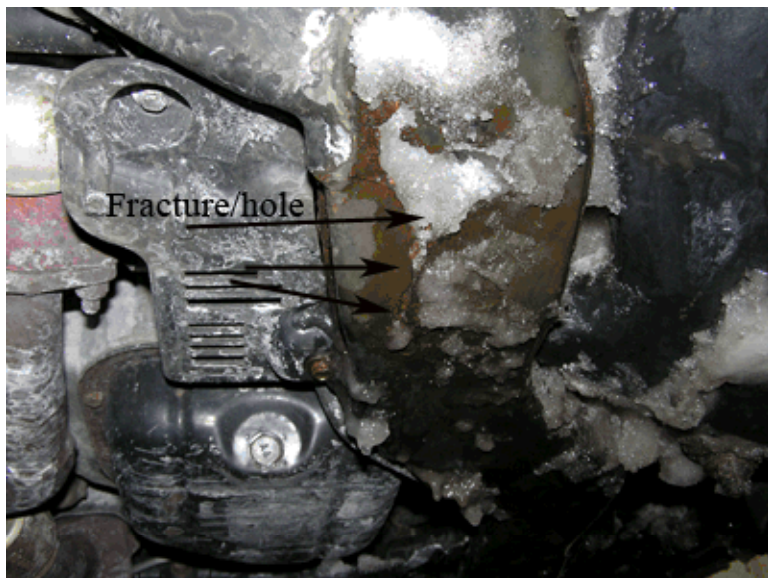
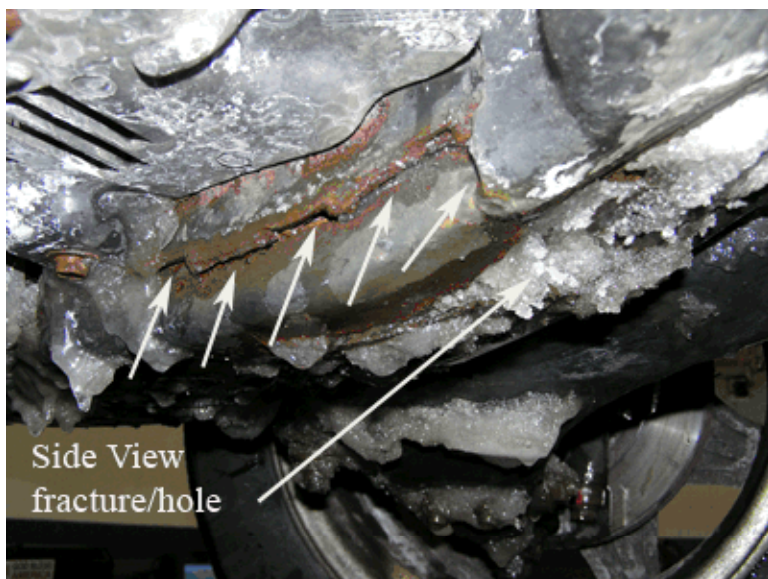
Right side of subframe is corroded and exhibits a hole. Snow packing has occurred inside the subframe box via entry of corrosion hole. Corrosion point is near right lower control arm mounting. Snow

Corrosion.

FTS advised DPSM of condition.
