**PE08029/HYUNDAI-KIA
CROSSMEMBER
ASSEMBLY CORROSION
01**

PE08029/HYUNDAI-KIA
QAEF-C-050701

Report Number : QA EF - C - 050701

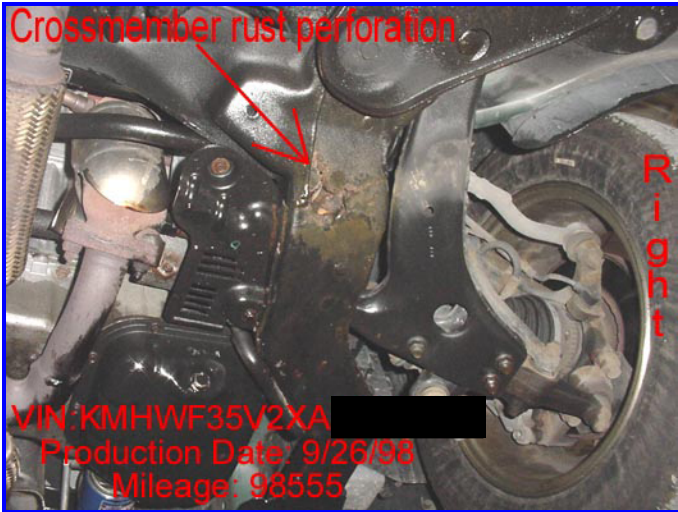
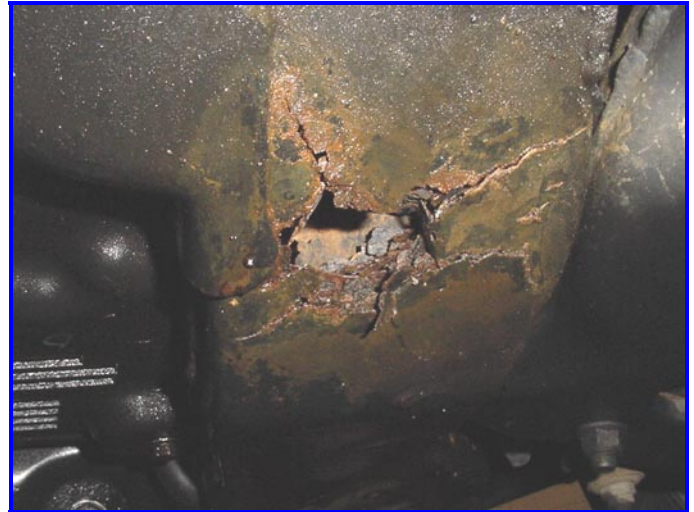
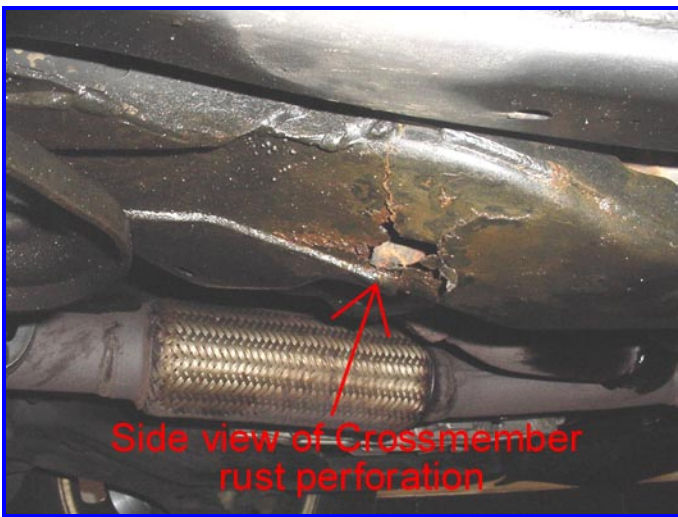
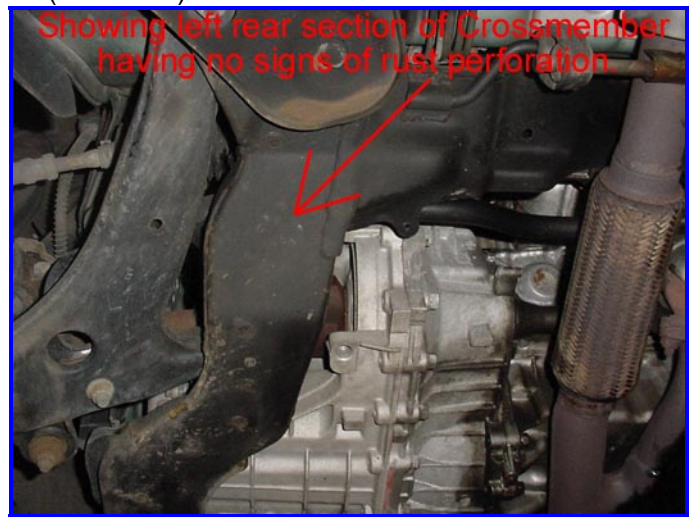
KMHWF35V2XA(REDACT)

- Incident vehicle is registered and licensed in the state of Delaware. Customer is the original owner.
- Complete inspection of the vehicle did not reveal any signs of having been involved in an accident.
- Warranty coverage for the Crossmember assembly is 5 years and / or 60,000 miles.

- Replace the Crossmember Assembly P/N (62405-38100)
- Repair cost \$ 1,116.61

- HMC should investigate the Crossmember rust perforation condition and take necessary corrective action.
- Customers who experience this condition may perceive an image of poor quality and durability.

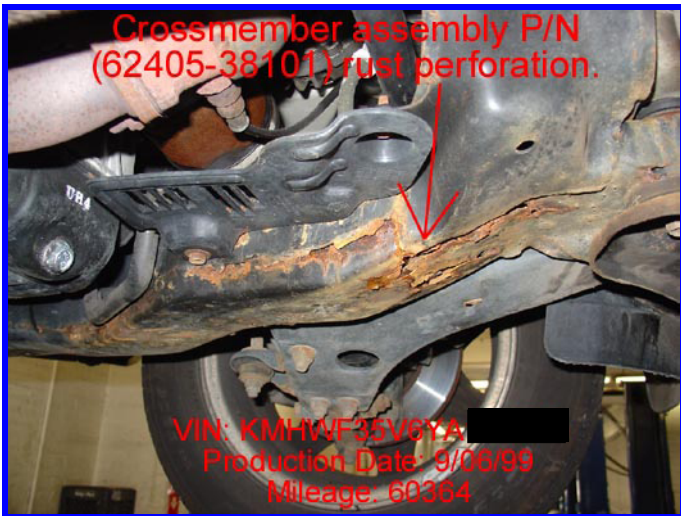
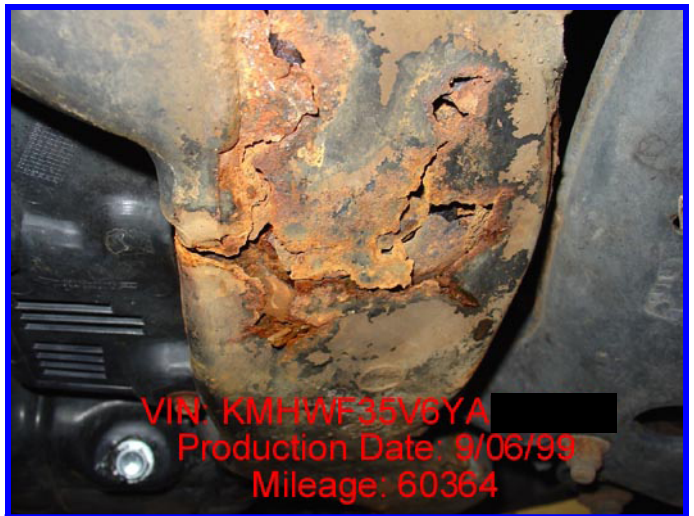
No.	VIN	Production Date	Mileage	Condition
1	* KMHWF35V2XA [REDACTED]	9/26/98	98555	Crossmember rust perforation
2	* KMHWF35V7YA [REDACTED]	12/17/99	60370	Crossmember rust perforation
3	* KMHWF35V6YA [REDACTED]	9/06/99	60364	Crossmember rust perforation
4	KMHWF35V9XA [REDACTED]	4/30/99	53053	Crossmember rust perforation
5	KMHWF35V1YA [REDACTED]	8/24/99	58298	Crossmember rust perforation

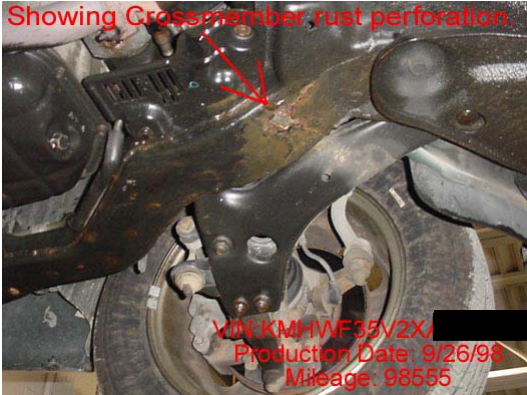
Showing Crossmember rust perforation.
