**PE08029/HYUNDAI-KIA
EF LOWER A ARM
SEPARATION 01**

QUALITY INFORMATION REPORT

Model Code		Subject Code		HMA Report Number	
EF		CHASSIS			
Creation date/time/user:		Analyst:		Co-analyst(s):	
12/06/06 08:11:34 AM by Randy Craley		RANDY CRALEY			
Distributor*		Country*		Date	
HMA		USA		12/06/06	
Model*		Engine or Transmission Number*		Production Date*	
SONATA		G6BVX039963		06/02/99	
Vehicle Identification Number*		Mileage*		Delivery Date*	
KMHWF35V2XA [REDACTED]		74507		08/10/99	
Subject*					
[A] 1999 SONATA RIGHT FRONT LOWER ARM SEPARATION FROM CROSSMEMBER ASSEMBLY - DURABILITY ISSUE - HMC					
Attachments					
<input checked="" type="checkbox"/> Photo					
<input checked="" type="checkbox"/> Part					
<input type="checkbox"/> Other

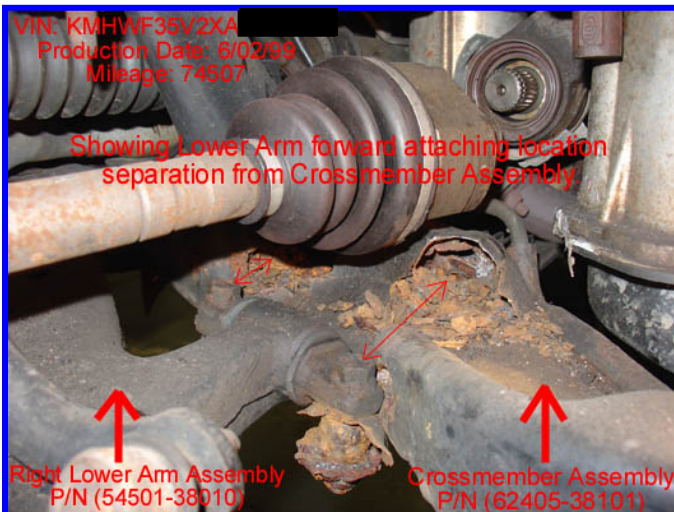
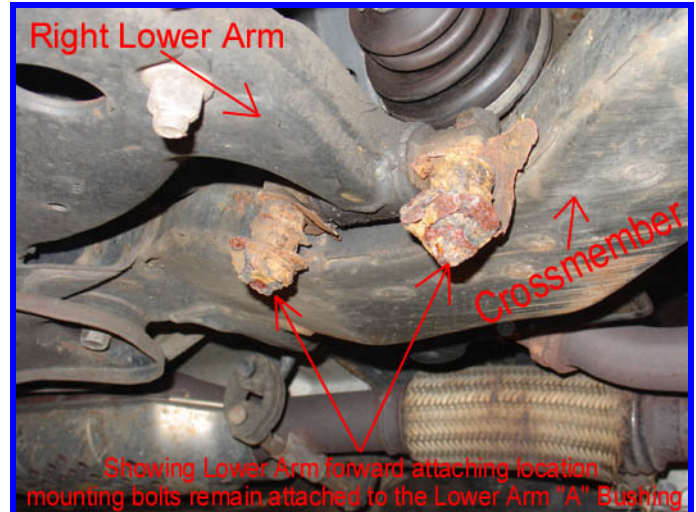
- Inspection of the crossmember assembly P/N (62405-38101) revealed the area around the right side lower arm assembly forward attaching location was corroded.

- Right front lower arm was separated from the crossmember assembly at the forward mount attaching location.

- Found right front lower arm forward mount bushing bolts remain attached to the arm.

- Root cause of the right front lower arm P/N (54501-38010) forward attaching location separating from the crossmember assembly appears to be as a result of corrosion to the crossmember assembly. See attached photographs.

- Replace crossmember assembly P/N (62405-38101) and Right Front Lower Control Arm P/N (54501-38010).

- HMC should investigate the Front Suspension Crossmember Assembly corrosion condition resulting in the Right Front Lower Control Arm separation.
- Customers who experience this condition may perceive an image of poor quality and durability.

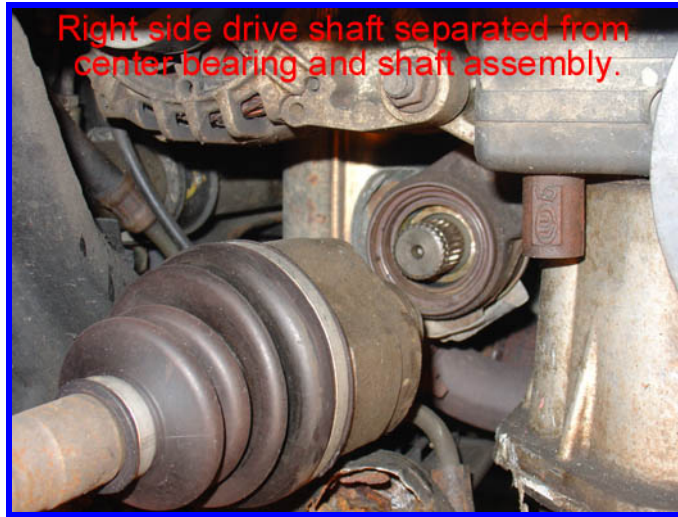
- Right Drive Shaft separated from the Center Bearing and Shaft Assembly as a result of the Lower Arm forward attaching location separating from the Crossmember Assembly. See attached photograph below.

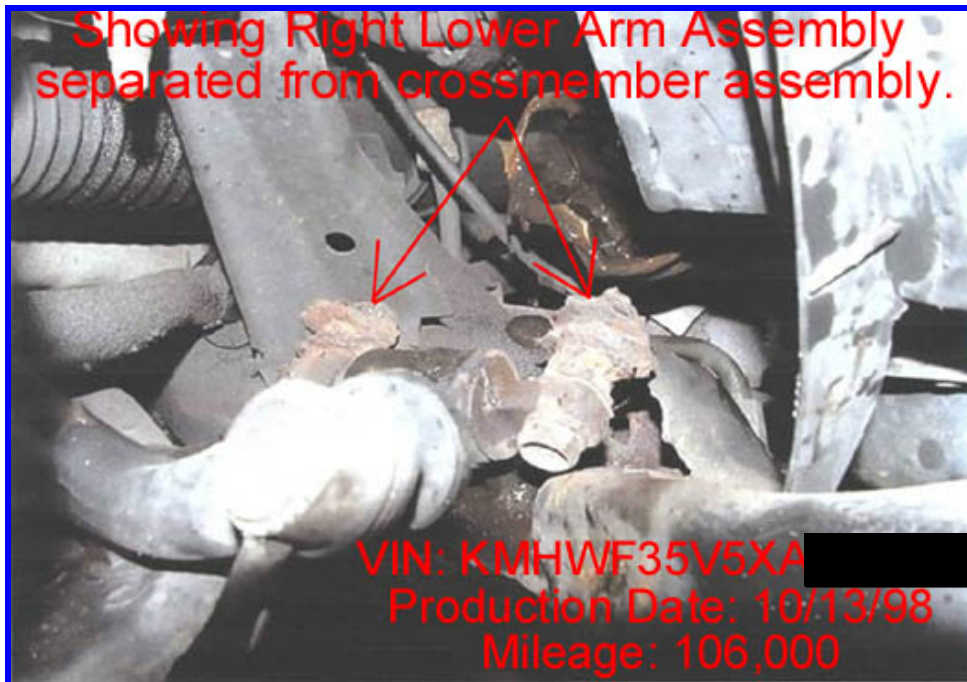
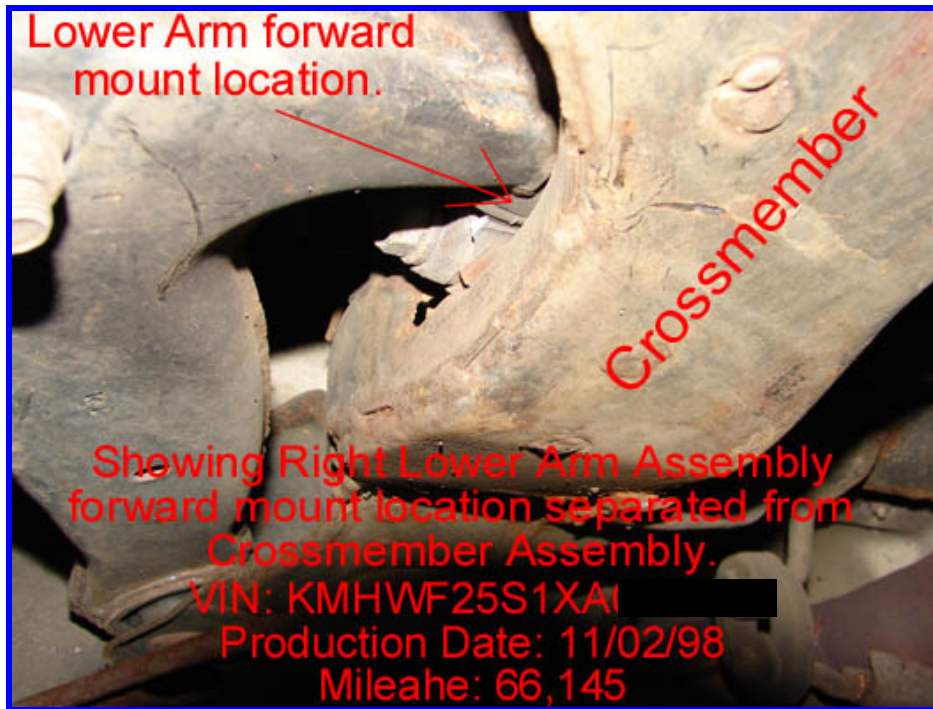
ADDITIONAL VEHICLES WITH SIMILAR CONDITION			
VIN	Production Date	Mileage	Condition
* KMHWF35V2XA [REDACTED]	6/02/99	74,507	Right front Lower Arm separated from the Crossmember Assembly at the forward mount attaching location.
KMHWF35V5XA [REDACTED]	10/13/98	106,000	
KMHWF25S1XA [REDACTED]	11/02/98	66,145	
KMHWF25V5XA [REDACTED]	2/24/99	94,982	
KMHWF35VXXA [REDACTED]	12/29/98	92,395	
* Incident vehicle Crossmember Assembly and Lower Arm Assembly will be forwarded to HMA

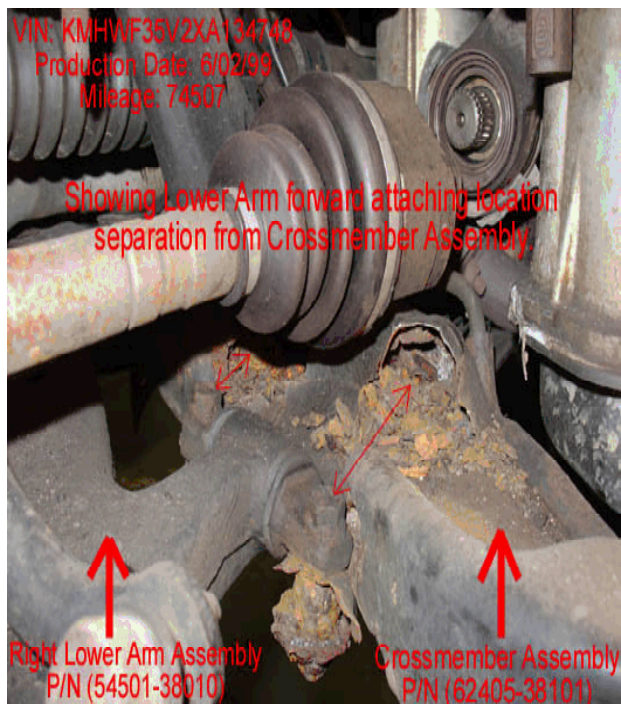
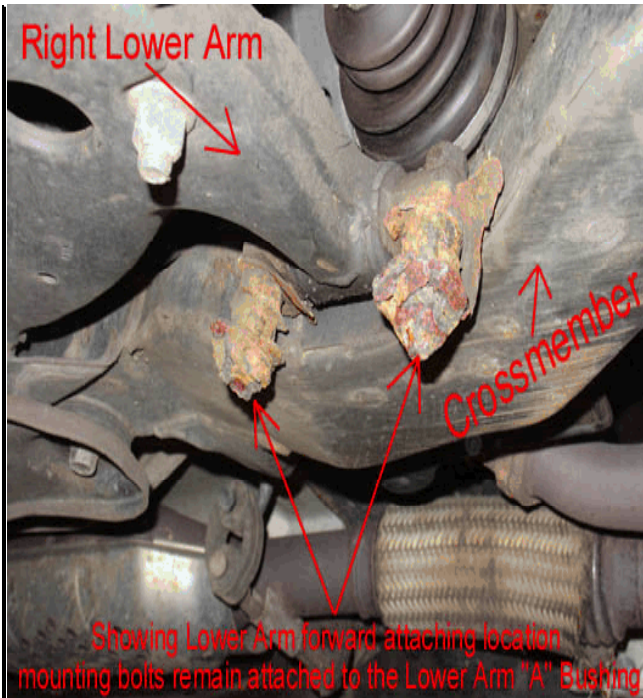
- Inspection of the crossmember assembly P/N (62405-38101) revealed the area around the right side lower arm assembly forward attaching location was corroded.
- Right front lower arm was separated from the crossmember assembly at the forward mount attaching location.
- Found right front lower arm forward mount bushing bolts remain attached to the arm.
- Root cause of the right front lower arm P/N (54501-38010) forward attaching location separating from the crossmember assembly appears to be as a result of corrosion to the crossmember assembly. See attached photographs.

- Replace crossmember assembly P/N (62405-38101) and Right Front Lower Control Arm P/N (54501-38010).

- HMC should investigate the Front Suspension Crossmember Assembly corrosion condition resulting in the Right Front Lower Control Arm separation.
- Customers who experience this condition may perceive an image of poor quality and durability.

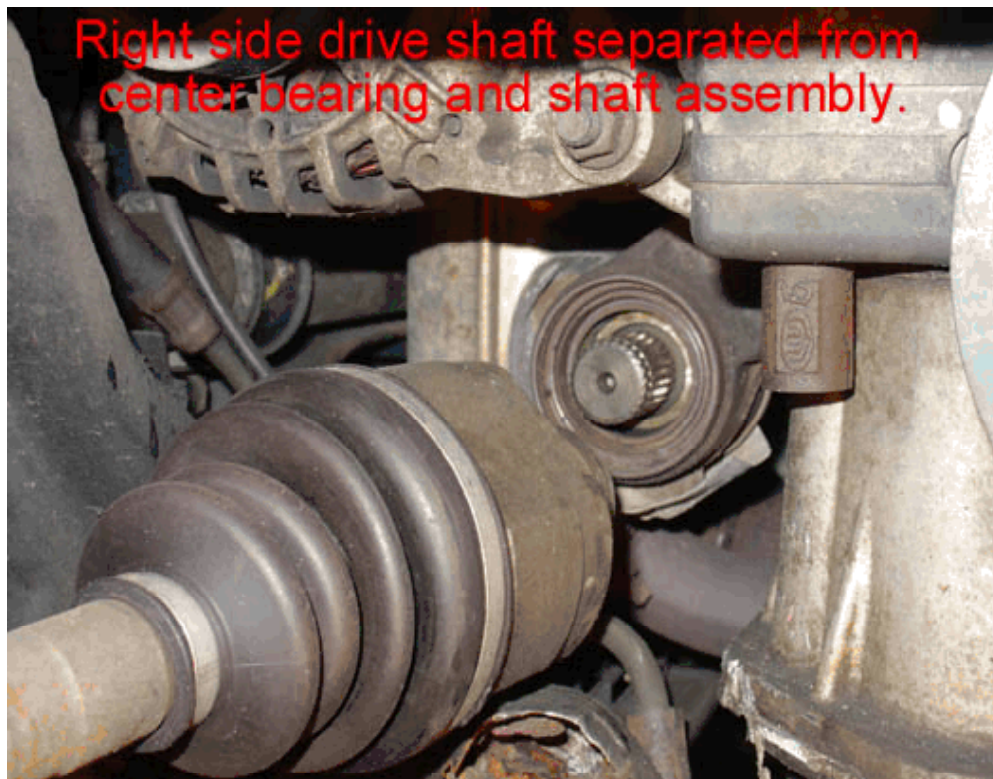
- Right Drive Shaft separated from the Center Bearing and Shaft Assembly as a result of the Lower Arm forward attaching location separating from the Crossmember Assembly. See attached photograph below.

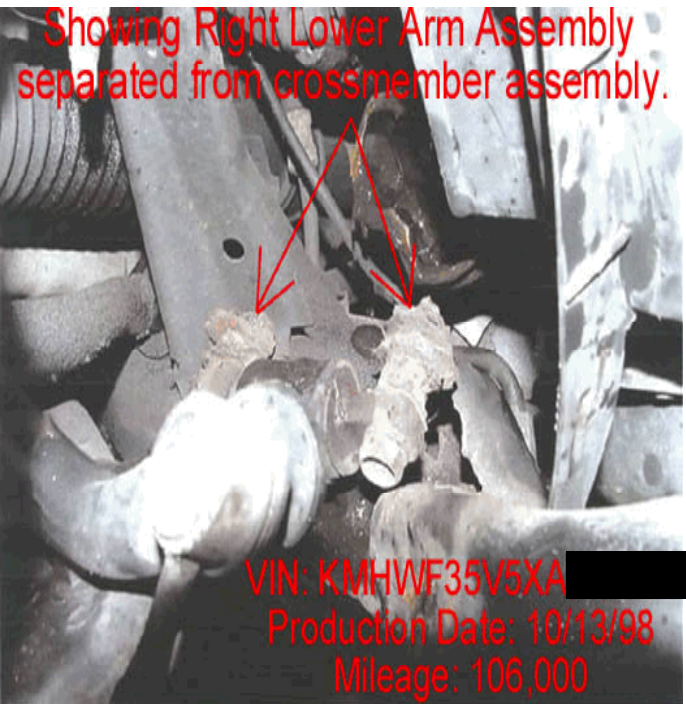
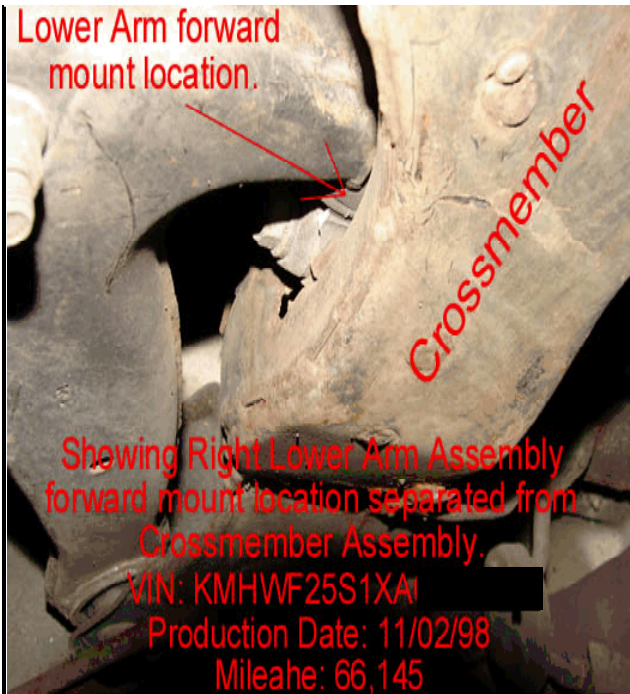
VIN	Production Date	Mileage	Condition
* KMHWF35V2XA [REDACTED]	6/02/99	74,507	Right front Lower Arm separated from the Crossmember Assembly at the forward mount attaching location.
KMHWF35V5XA [REDACTED]	10/13/98	106,000	
KMHWF25S1XA [REDACTED]	11/02/98	66,145	
KMHWF25V5XA [REDACTED]	2/24/99	94,982	
KMHWF35VXXA [REDACTED]	12/29/98	92,395

* Incident vehicle Crossmember Assembly and Lower Arm Assembly will be forwarded to HMA
