**PE08029/HYUNDAI-KIA
EF 1999 CROSSMEMBER
UPDATE 01**

- Purpose of this QIR is to provide updated information regarding the crossmember corrosion condition.

PE08029/HYUNDAI-KIA
QAEF-C-061202

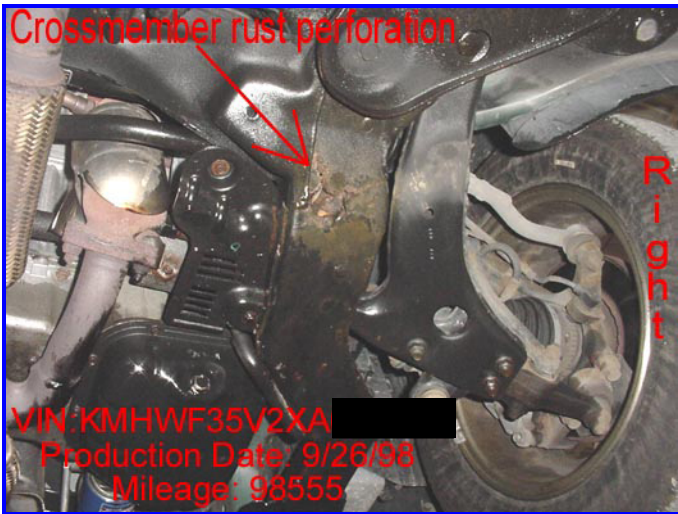
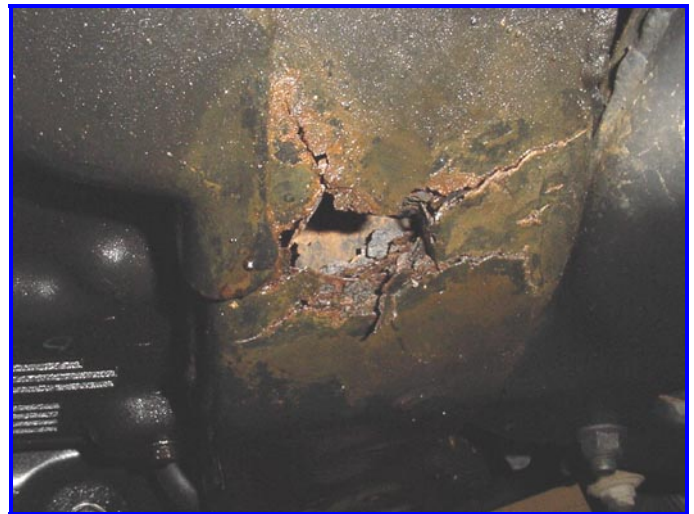
- Attached photographs below of incident vehicle (KMHWF35V2XA [REDACTED]) is registered and licensed in the state of Delaware. Customer is the original owner. Crossmember is corroded at the right rear location.

- Complete inspection of the vehicle did not reveal any signs of having been involved in an accident.

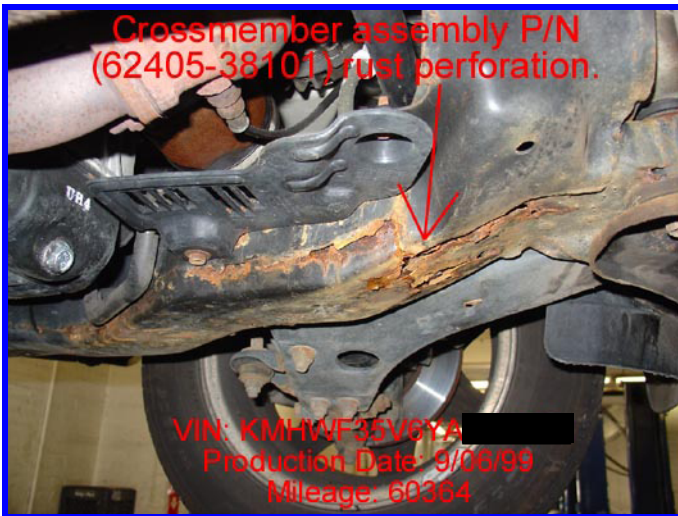
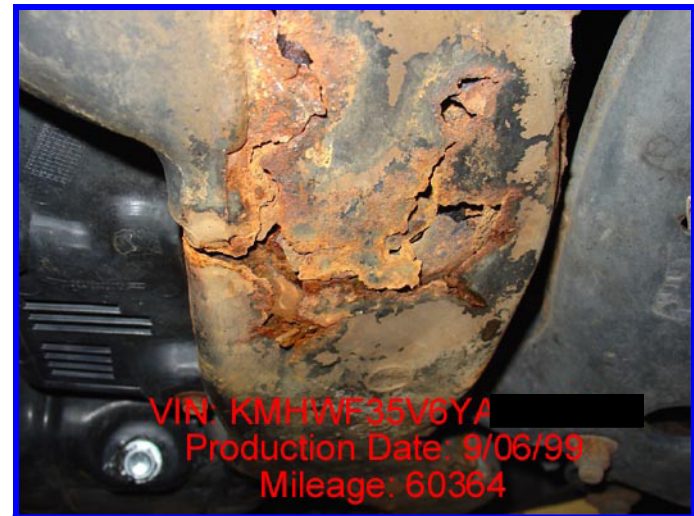
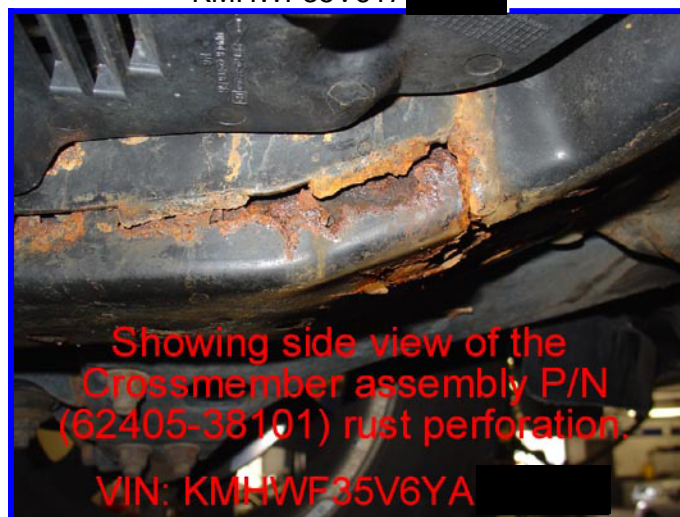
KMHWF35V6YA [redacted]

- Additional incident vehicle (VIN: KMHWF35V6YA [redacted]) below, showing corrosion to the right rear section of the crossmember assembly.

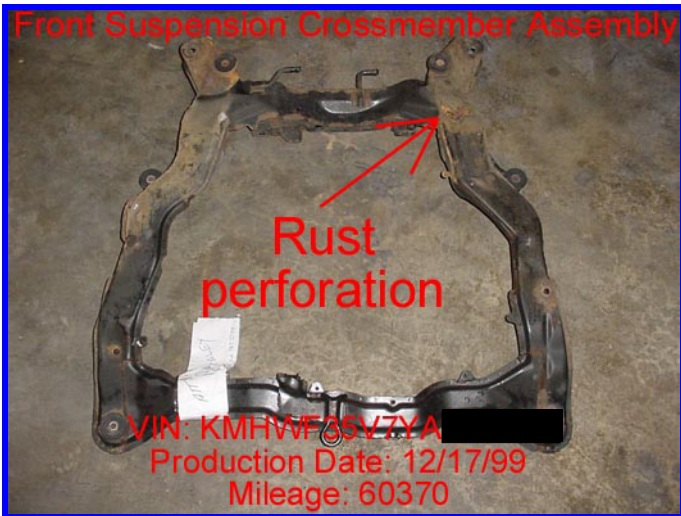
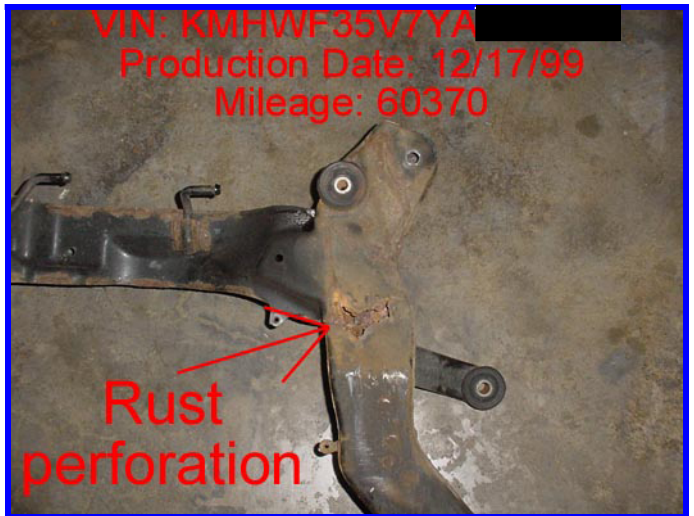
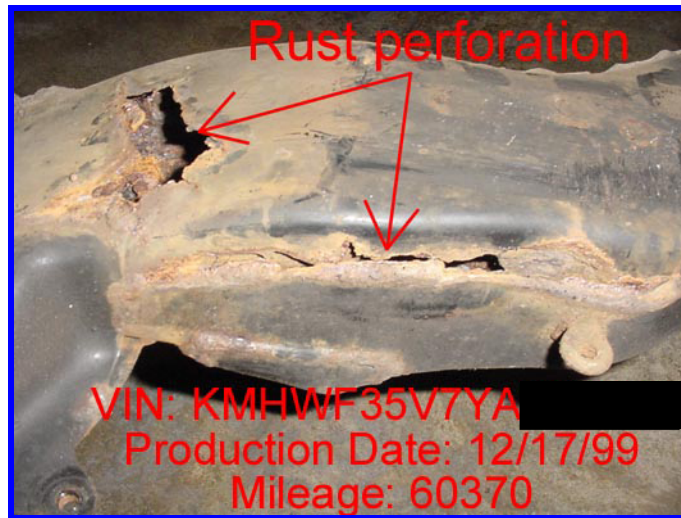
KMHWF35V7YA237911

- Additional incident vehicle (VIN: KMHWF35V7YA [redacted]) below shows corrosion location on crossmember assembly.

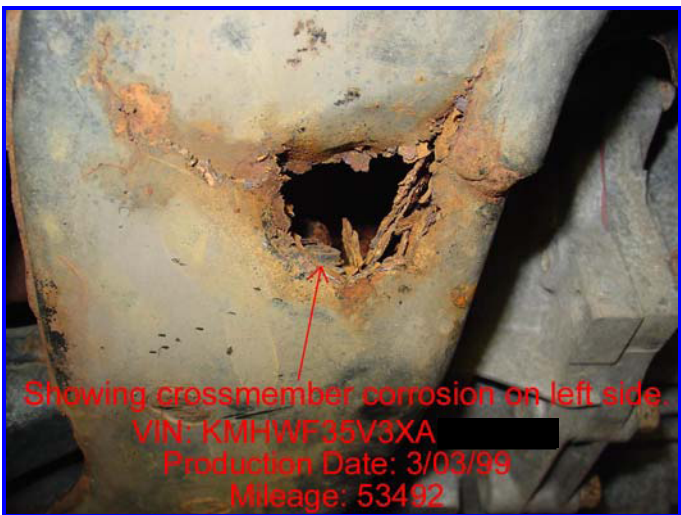
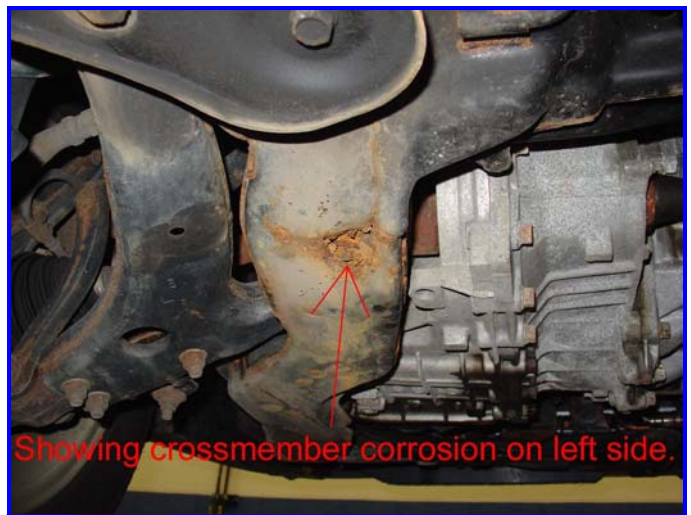
KMHWF35V3XA [REDACTED]

- Additional incident vehicle (VIN: KMHWF35V3XA [REDACTED]) below shows crossmember corrosion on the left rear section.

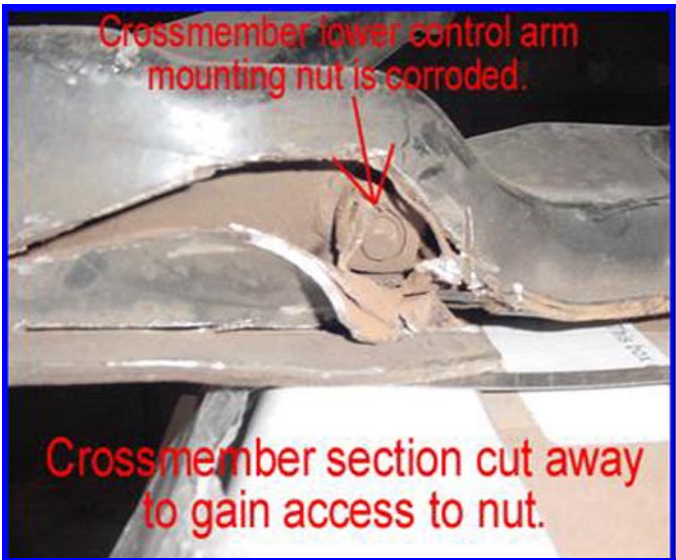
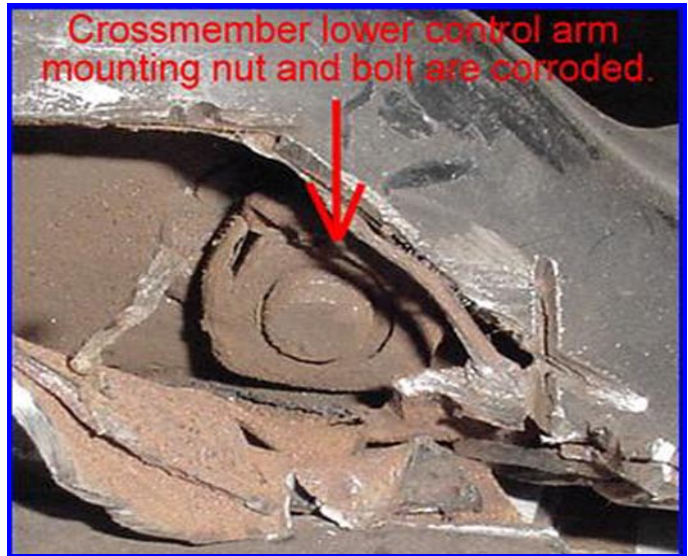
2). Technicians complain that when they are removing the lower control arm assembly to perform a ball joint replacement procedure the forward mount attaching bolts are seized to the fixed nut welded inside the crossmember assembly. When removing the 17mm attaching bolts the fixed nut inside the crossmember assembly separates from the assembly and spin freely.

- Additional incident vehicle (VIN: KMHWF35V0XA [REDACTED]) below shows Crossmember Assembly Lower Control Arm forward mount attaching bolt seized to the fixed weld nut.

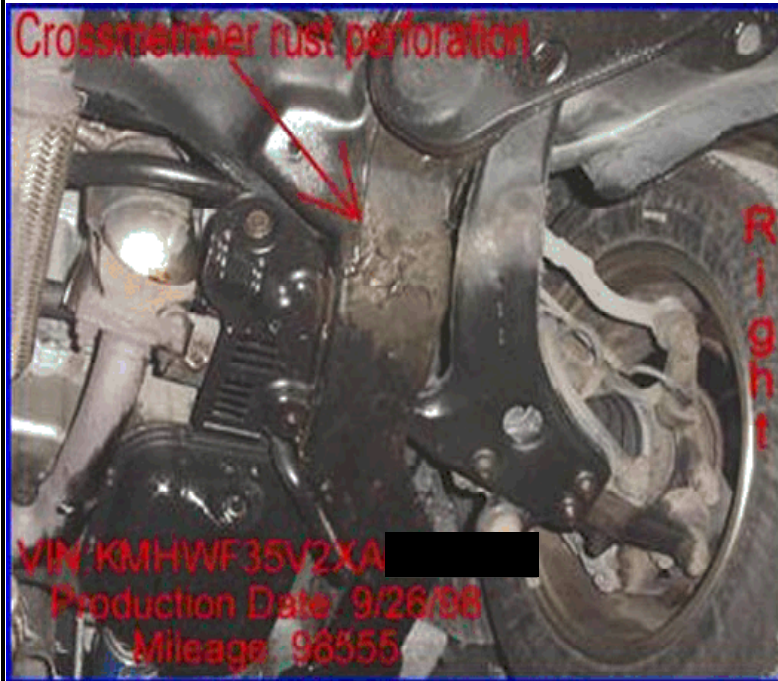
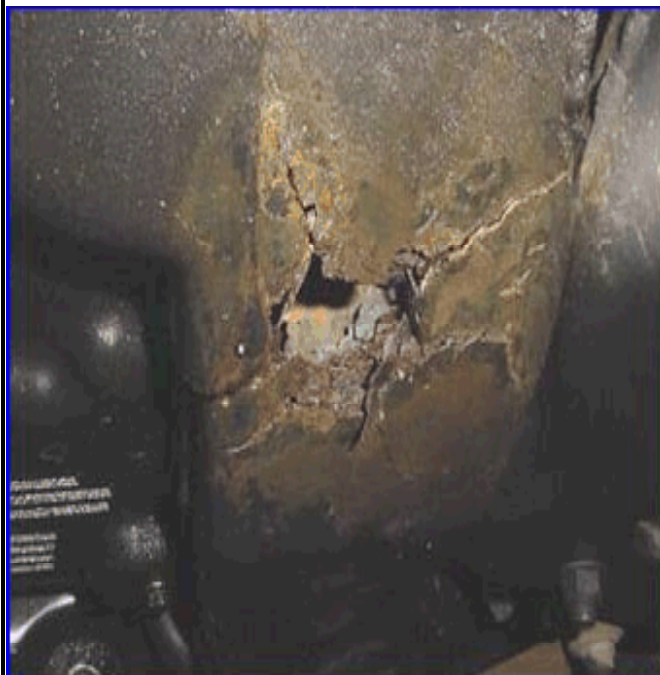
- Attached photographs below of incident vehicle (KMHWF35V2XA [REDACTED]) is registered and licensed in the state of Delaware. Customer is the original owner. Crossmember is corroded at the right rear location.

- Complete inspection of the vehicle did not reveal any signs of having been involved in an accident.

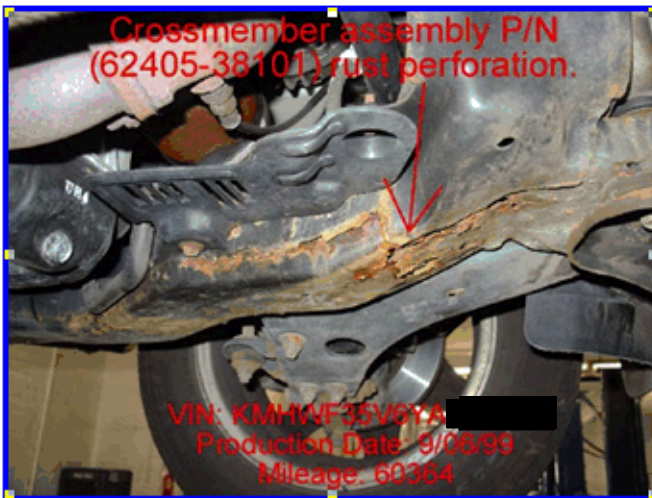
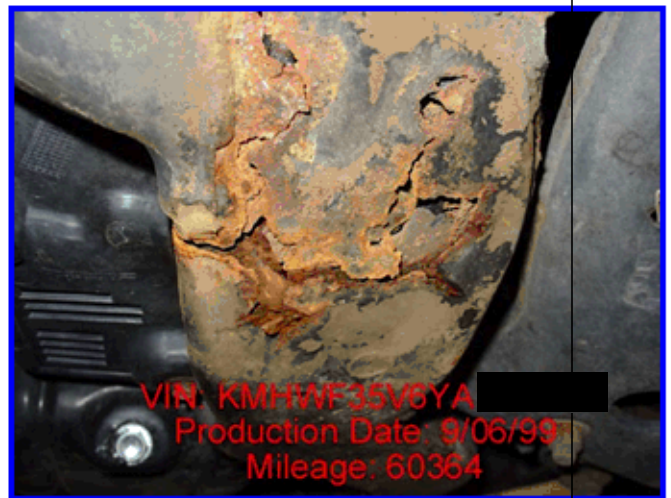
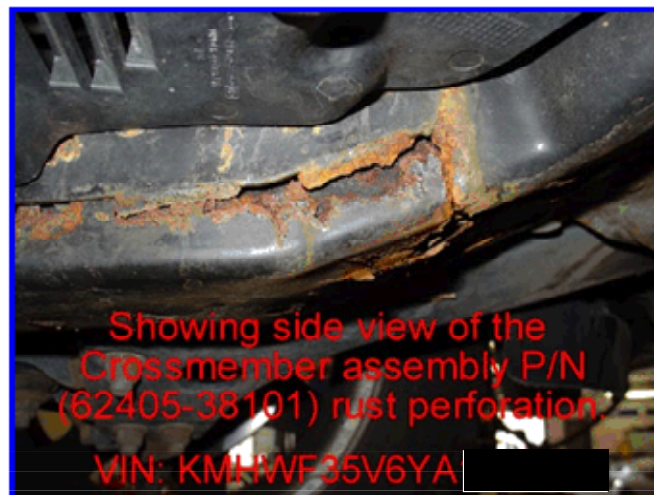
- Additional incident vehicle (VIN: KMHWF35V6YA [REDACTED]) below, showing corrosion to the right rear section of the crossmember assembly.

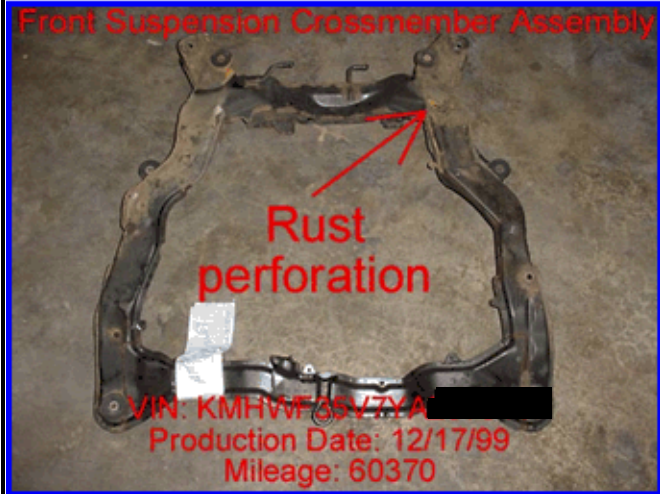
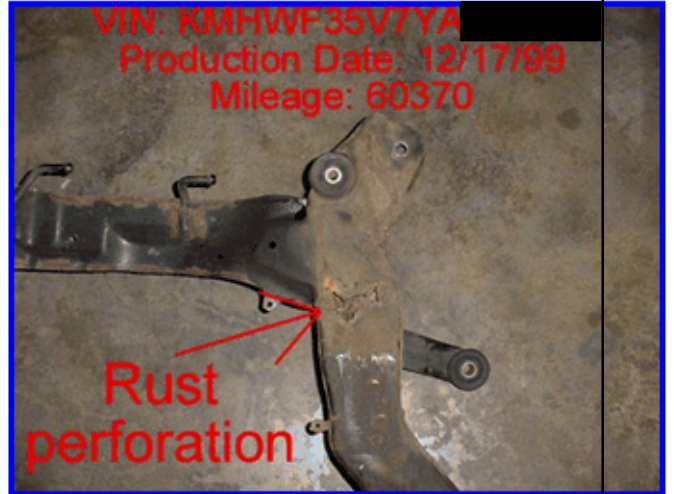
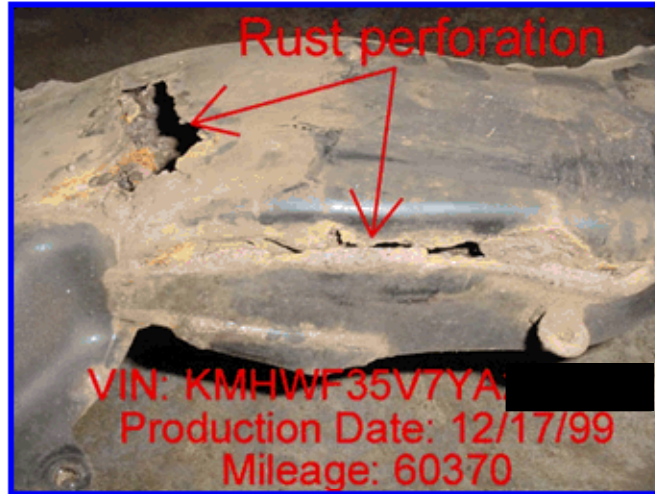
KMHWF35V7YA237911

- Additional incident vehicle (VIN: KMHWF35V7YA) below shows corrosion location on crossmember assembly.

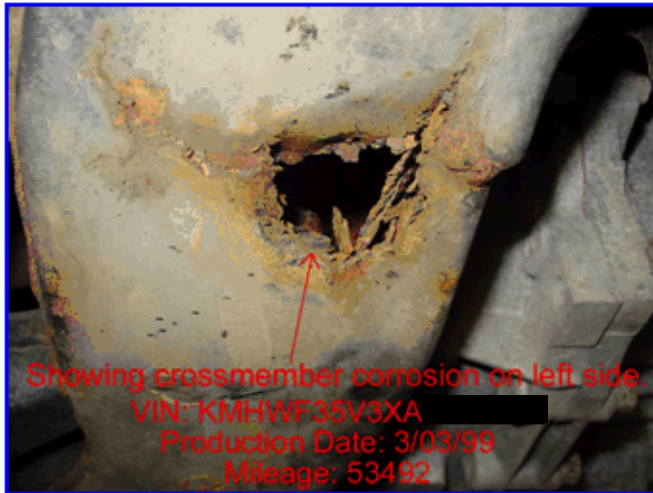
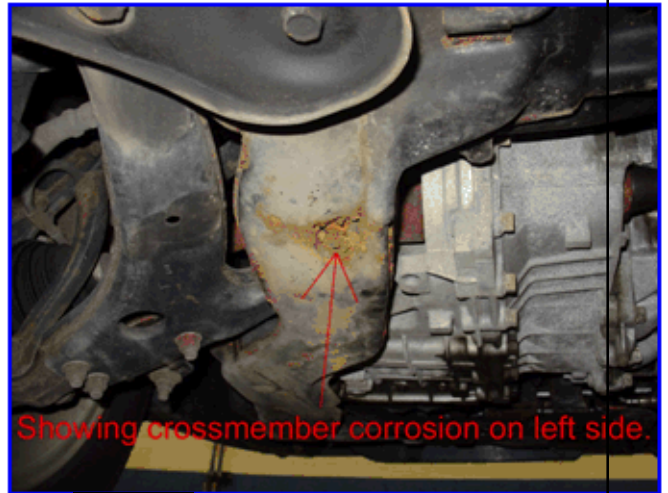
- Additional incident vehicle (VIN: KMHWF35V3XA [REDACTED]) below shows crossmember corrosion on the left rear section.

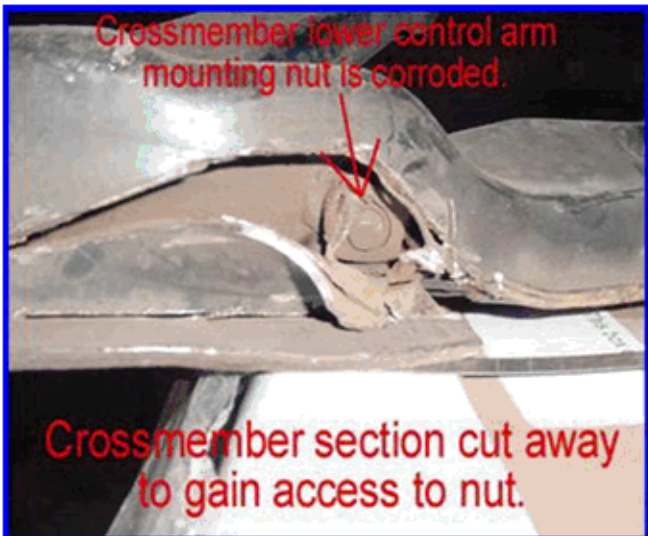
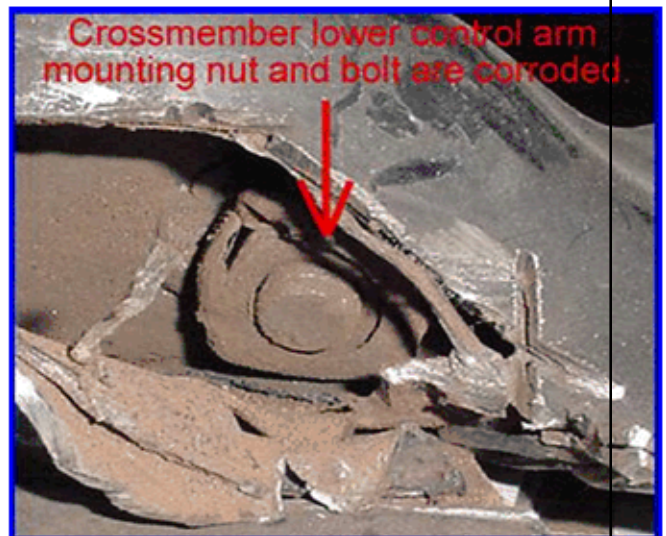
2). Technicians complain that when they are removing the lower control arm assembly to perform a ball joint replacement procedure the forward mount attaching bolts are seized to the fixed nut welded inside the crossmember assembly. When removing the 17mm attaching bolts the fixed nut inside the crossmember assembly separates from the assembly and spin freely.

- Additional incident vehicle (VIN: KMHWF35V0XA) below shows Crossmember Assembly Lower Control Arm forward mount attaching bolt seized to the fixed weld nut.
