- Customer states right front lower arm assembly separated from crossmember assembly.

**Analysis:**

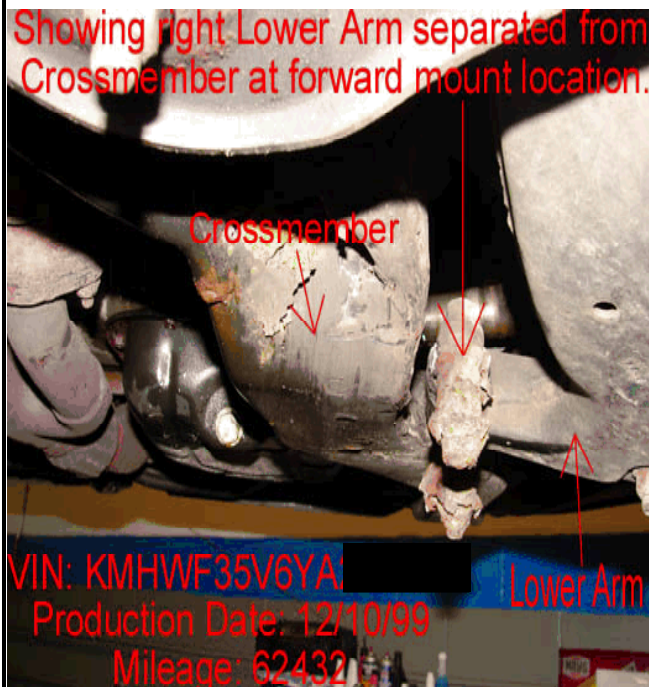
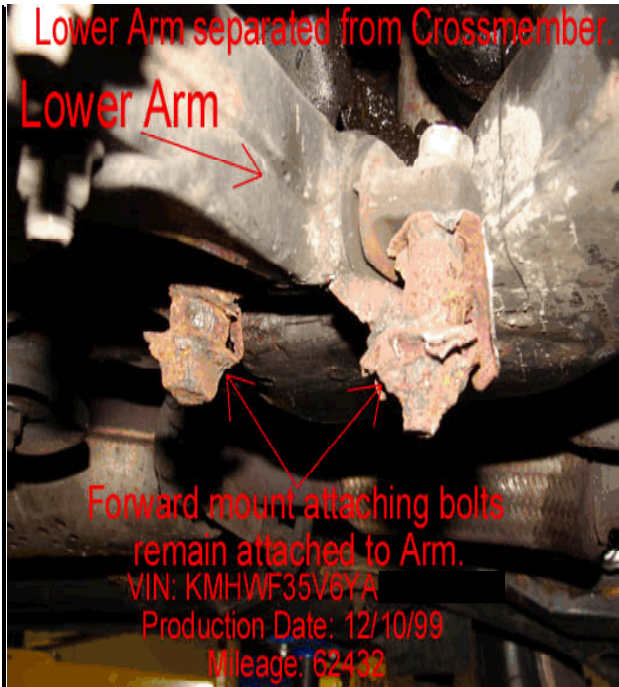
- Inspection of the crossmember assembly P/N (62405-38101) revealed the area around the right side lower arm assembly forward attaching location was corroded.
- Right front lower arm was separated from the crossmember assembly at the forward mount attaching location.
- Found right front lower arm forward mount bushing bolts remain attached to the arm.
- Root cause of the right front lower arm P/N (54501-38010) forward attaching location separating from the crossmember assembly appears to be as a result of corrosion to the crossmember assembly. See attached photographs.

- Replace crossmember assembly P/N (62405-38101) and Right Front Lower Control Arm P/N (54501-38010).

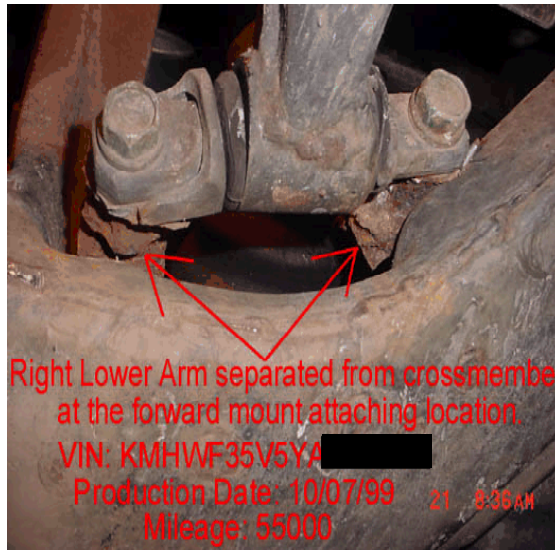
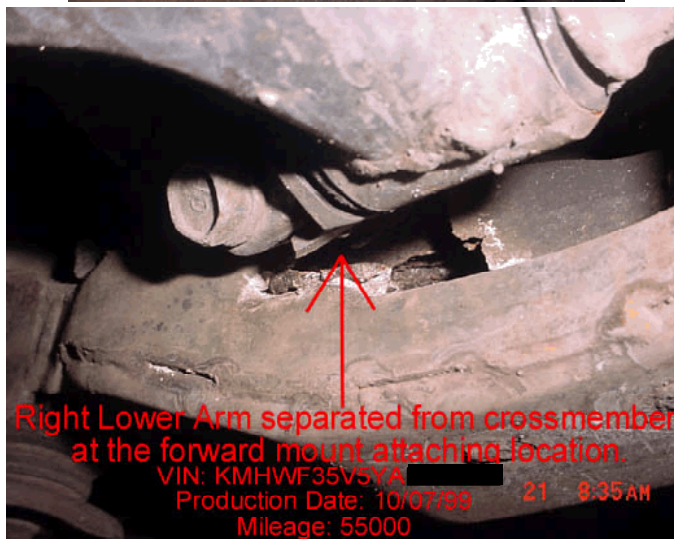
VIN	Production Date	Mileage	Condition
KMHWF35V6YA	12/10/99	62432	Right front Lower Arm separated from the Crossmember Assembly at the forward mount attaching location.
KMHWF35V9YA	10/05/99	54370	
KMHWF35V5YA	10/07/99	55000	
KMHWF35V0YA	9/13/99	104134	
KMHWF35V9YA	10/20/99	90561	
KMHWF35V8YA	8/13/99	103533	
KMHWF35V9YA	7/27/99	93719	
KMHWF35V1YA	8/25/99	89234

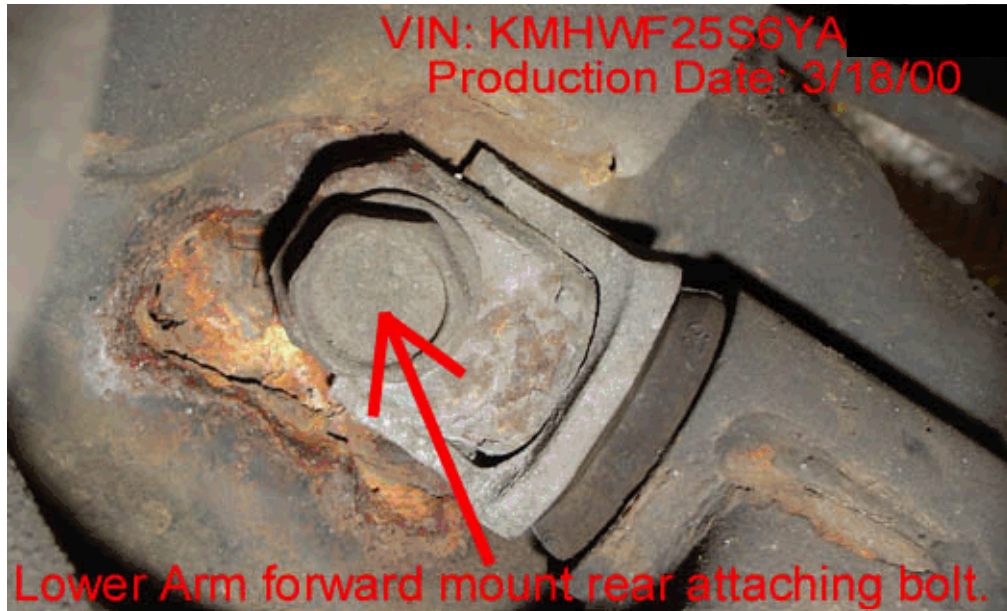
- Inspection of vehicle KMHWF25S6YA [REDACTED], Production Date: 3/18/00, Delivery Date: 10/05/00, Mileage: 135429 shows corrosion of the crossmember assembly around the Lower Arm forward mount rear positioned attaching bolt. See attached photographs below.

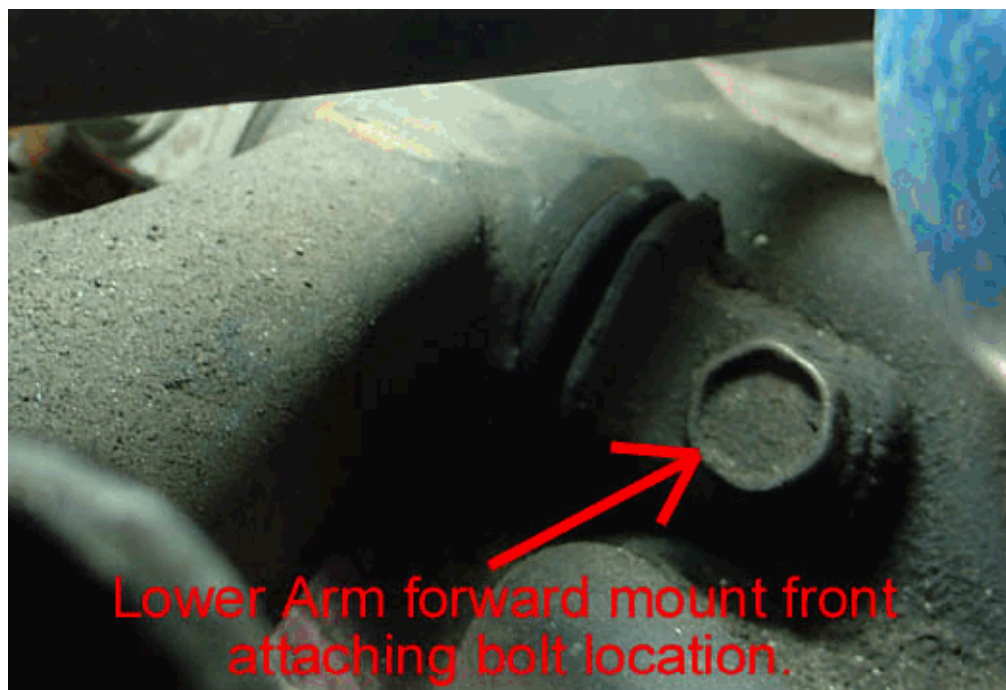
- Lower Arm forward mount front bolt location shows no external evidence of crossmember corrosion. See attached photograph.

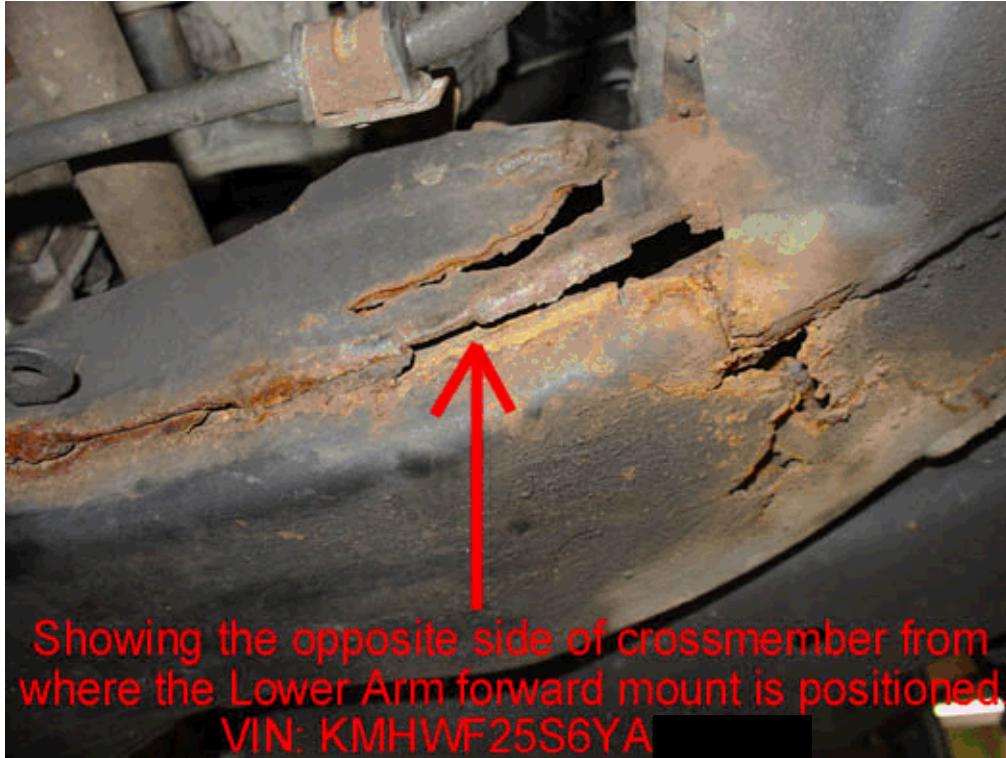
- Photograph below shows the opposite side of the crossmember from where the Lower Arm forward mount position is located.
