**PE08029/HYUNDAI-KIA
EF 2000 CROSSMEMBER
CORROSION 01**

PE08029/HYUNDAI-KIA
QAEF-C-061204

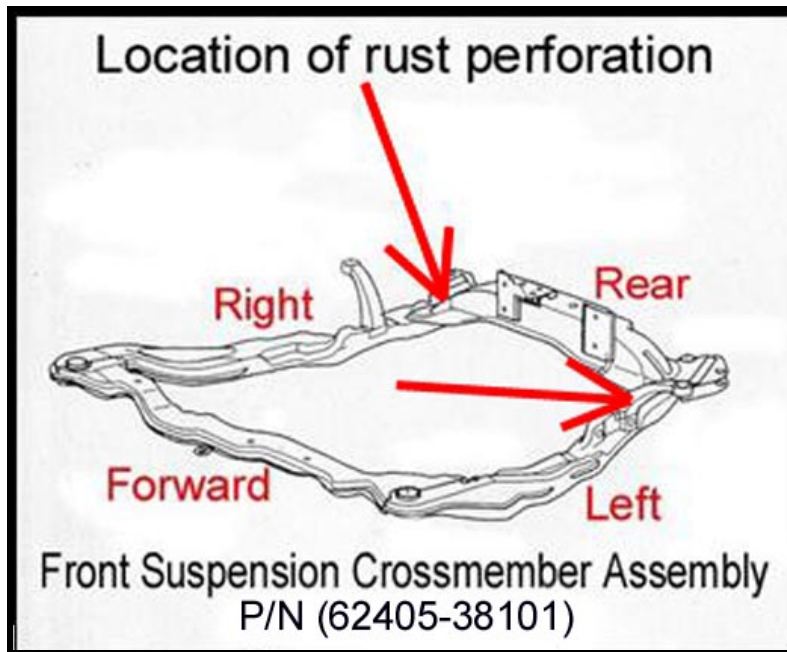
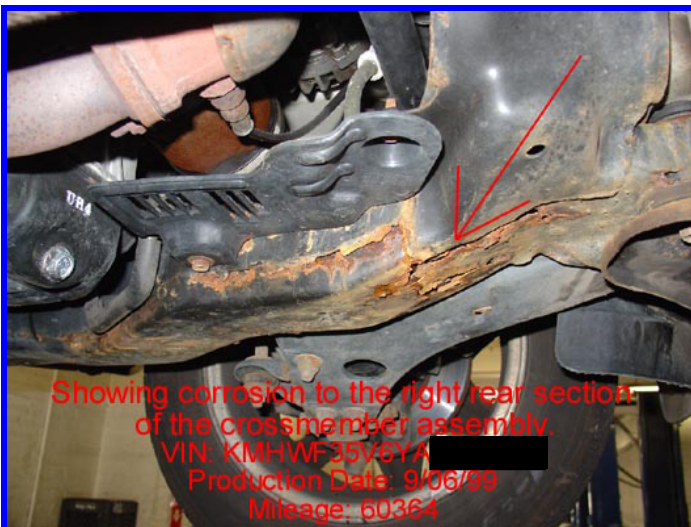
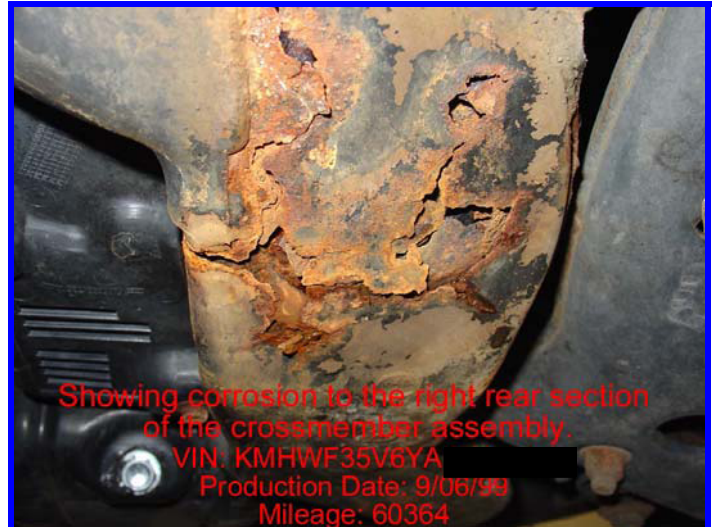
- Corrosion to right section of crossmember assembly VIN: KMHWF35V6YA

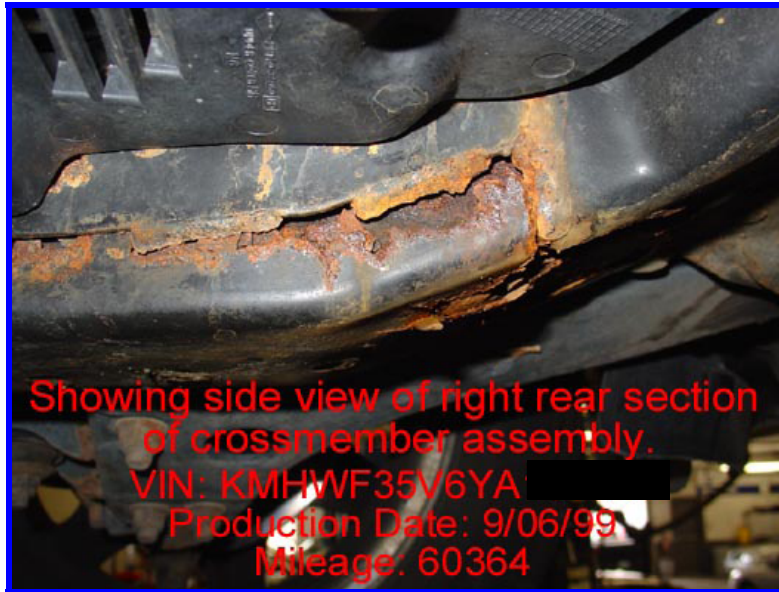
- Crossmember corrosion to both sides. VIN: KMHWF35V6YA [REDACTED]

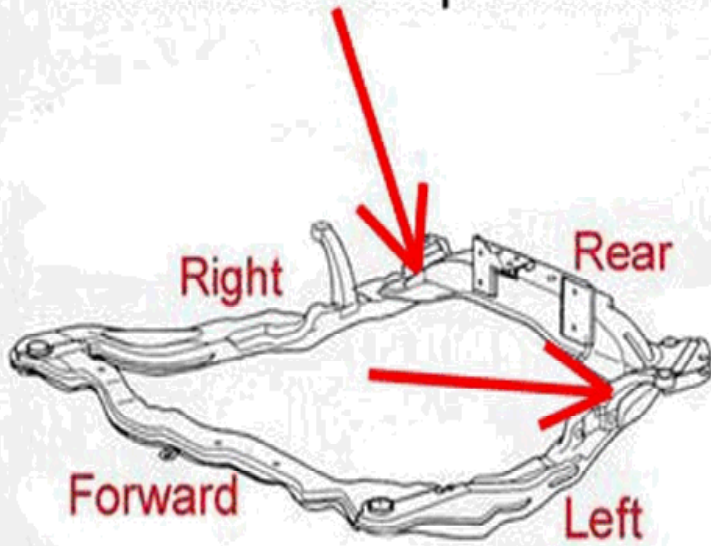
Location of rust perforation

- Inspection revealed corrosion at the right rear section of the crossmember assembly P/N (62405-38101).

- Corrosion of the crossmember assembly is more evident at the right rear section of the crossmember assembly which may possibly be related to the air conditioning evaporator water dripping onto it.

- Replace crossmember assembly P/N (62405-38101).

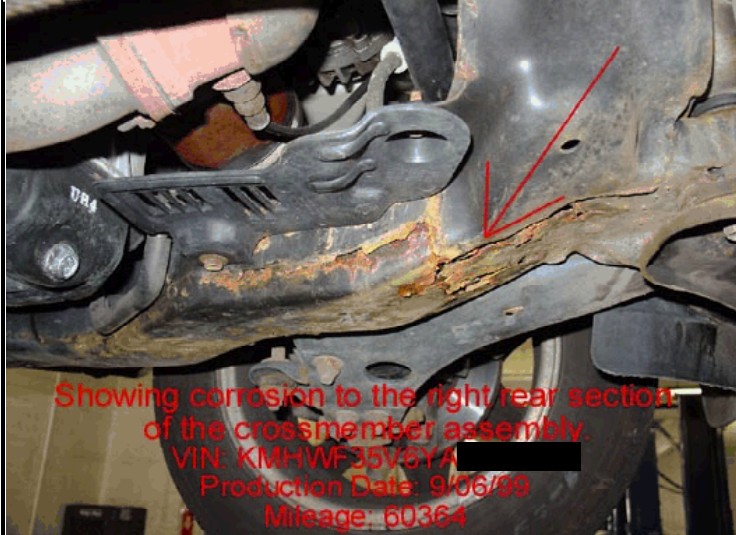
- Corrosion to right section of crossmember assembly VIN: KMHWF35V6YA [REDACTED]

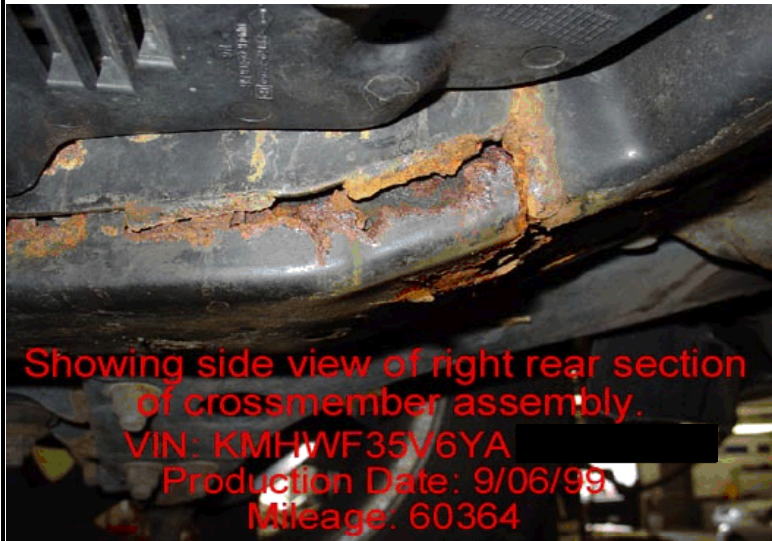
- Crossmember corrosion to both sides. VIN: KMHWF35V6YA [REDACTED]
