**PE08029/HYUNDAI-KIA  
EF 2001 CROSSMEMBER  
CORROSION 01**

<b>Model Code</b> EF	<b>Subject Code*</b> CHASSIS	<b>Severity Code</b>	<b>HMA Report Number</b> QAEF-C-061205	
<b>Creation date/time/user:</b> 12/18/2006 12:22:36 by Randy Craley		<b>Analyst:*</b> Randy Craley	<b>Co-analyst(s):</b>	<b>Modified date/time/user:</b> 12/18/2006 12:51:45 PM by Randy Craley
<b>Distributor*</b> HMA	<b>Country*</b> USA	<b>Vendor Info</b>	<b>Causal part No</b>	<b>Attachments</b>  Yes <input type="checkbox"/> Movie <input checked="" type="checkbox"/> Photo <input type="checkbox"/> Part <input type="checkbox"/> Other
<b>Model*</b> EF SONATA	<b>Engine or Transmission #*</b> G4JSY363855	<b>Lot #</b>	<b>Production Date*</b> (MM/DD/YY) 10-24-2000	
<b>VIN*</b> KMHWF25S21A390671	<b>Mileage*</b> 43444	<b>Repair Date</b> (MM/DD/YY)	<b>Delivery Date*</b> (MM/DD/YY) 07-23-2001	
<b>Subject*</b> [A] 2001 SONATA FRONT SUSPENSION CROSSMEMBER ASSEMBLY CPRROSION / RUST PERFORATION – DURABILITY / SERVICEABILITY ISSUE - HMC

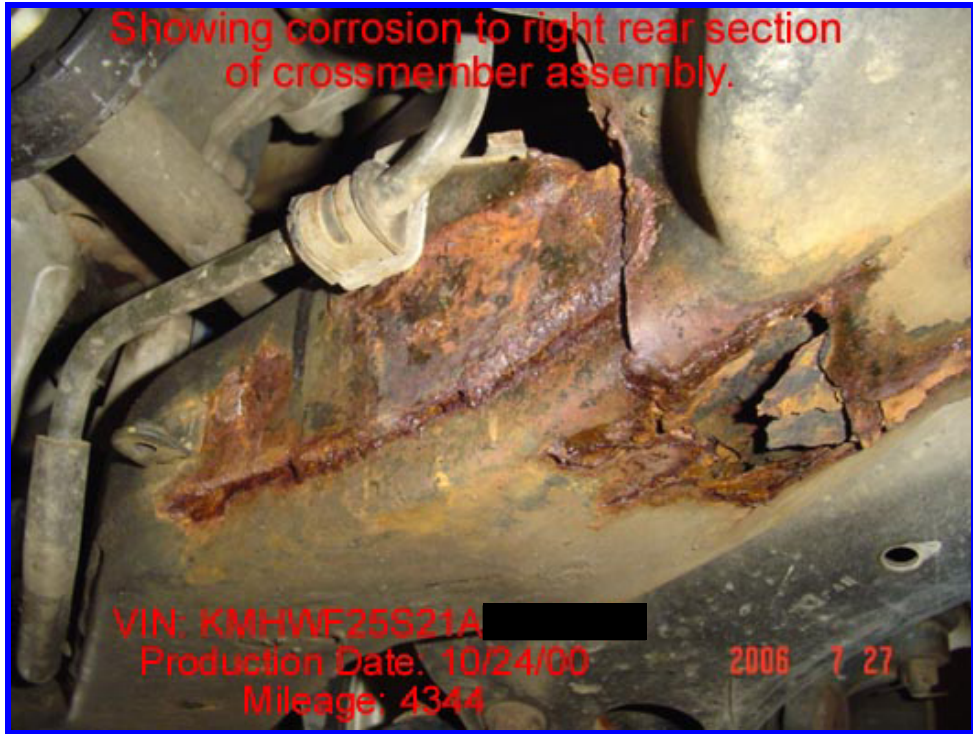
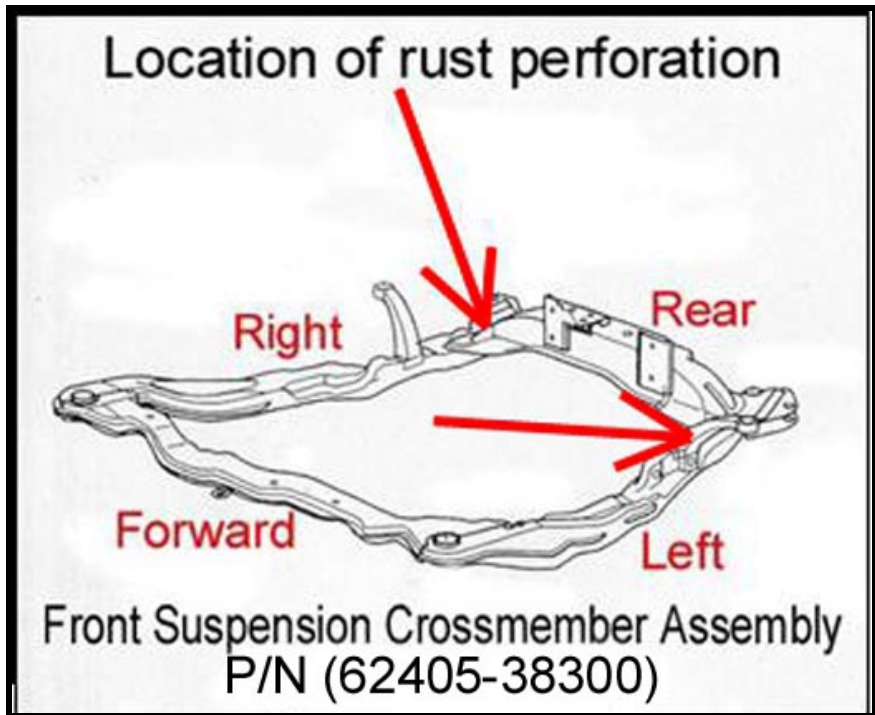
- Inspection revealed corrosion at the right rear section of the crossmember assembly P/N (62405-38300).
- Corrosion of the crossmember assembly is more evident at the right rear section of the crossmember assembly which may possibly be related to the air conditioning evaporator water dripping unto it.
- However additional incident vehicles have corrosion to the left rear section of the crossmember and or both left and right rear sections.

- Replace crossmember assembly P/N (62405-38300).

- HMC should investigate the Crossmember corrosion condition and take necessary corrective action.
- HMC countermeasure of increasing the paint thickness inside the crossmember assembly on 11/20/03 production vehicles may not be an effective solution for those vehicles produced after that date.
- HMA would like to know internal crossmember paint thickness measurements before and after countermeasure.
- Additionally HMA requests HMC to provide an effective countermeasure for vehicles produced prior to the countermeasure date.
- Customers who experience this condition may perceive an image of poor quality, long term durability and technician serviceability.

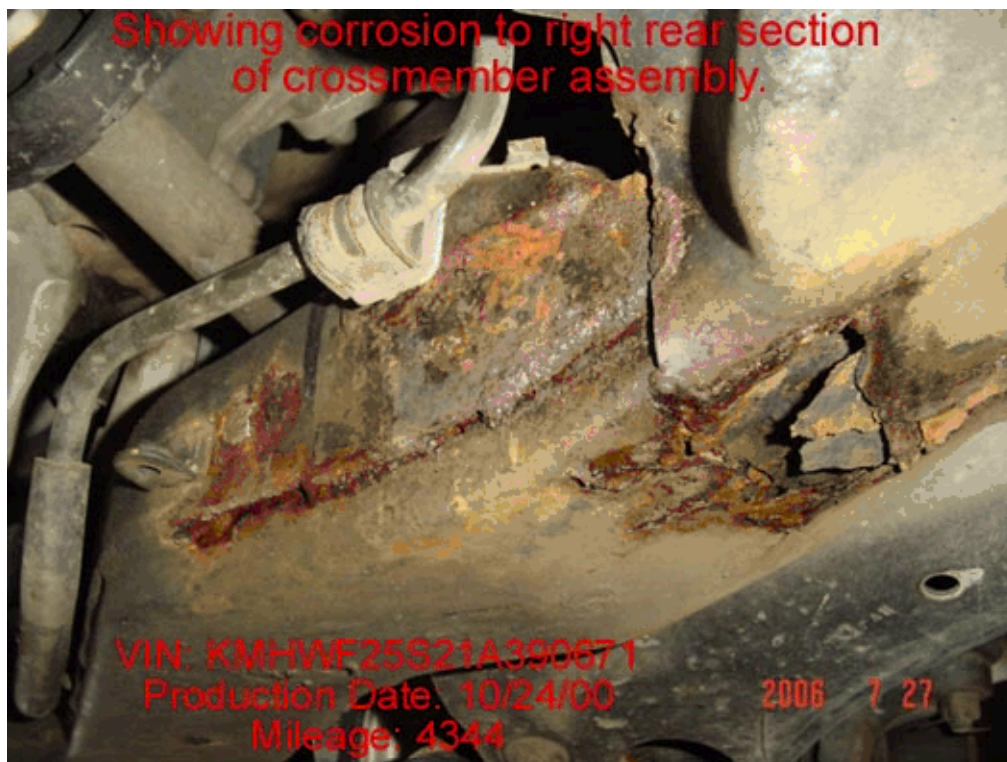
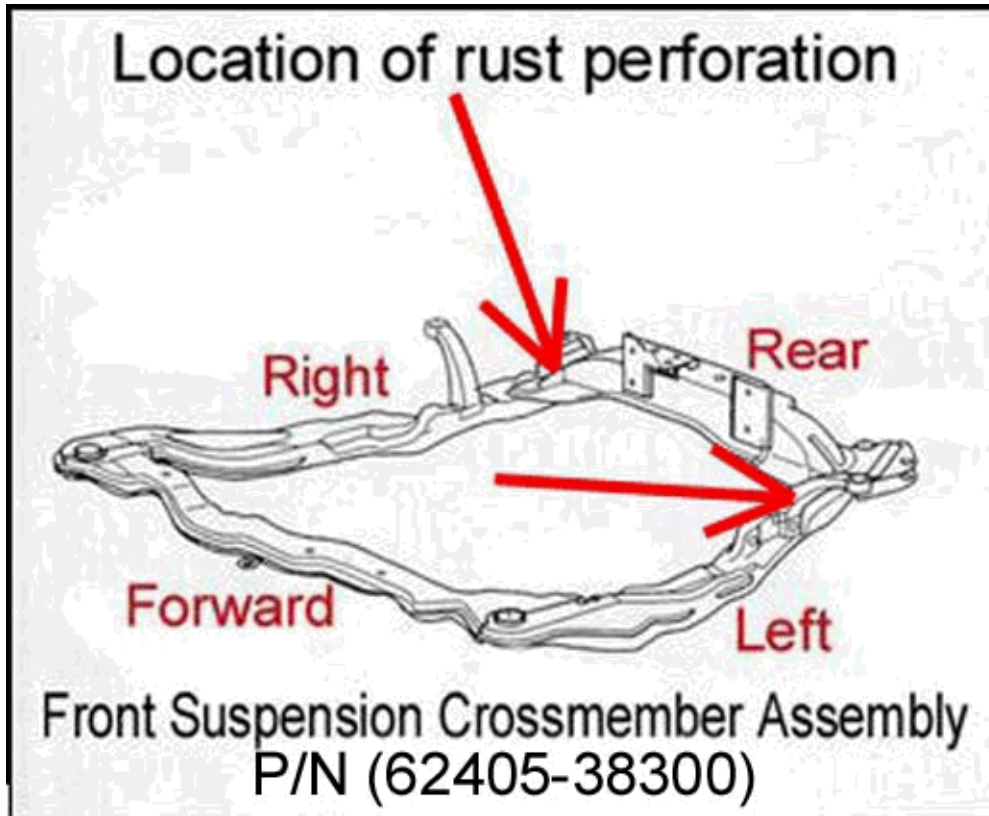
- Corrosion condition is not limited to the right rear section of the crossmember assembly
- Crossmember corrosion condition may result in the following customer and or servicing dealer complaints.
  - 1). Vehicle will not pass State Inspection.
  - 2). Technicians complain that when they are removing the lower control arm assembly to perform a ball joint replacement procedure the forward mount attaching bolts are seized to the fixed nut welded inside the crossmember assembly. When removing the 17mm attaching bolts the fixed nut inside the crossmember assembly separates from the assembly and spin freely.
- Central and Eastern regions of the USA represent 87% of the repairs. This is the "snow belt" area which have highly corrosive environments from salt and chloride materials used for snow removal.
- See attached photographs and illustration.

- Replace crossmember assembly P/N (62405-38300).

- HMC should investigate the Crossmember corrosion condition and take necessary corrective action.
- HMC countermeasure of increasing the paint thickness inside the crossmember assembly on 11/20/03 production vehicles may not be an effective solution for those vehicles produced after that date.
- HMA would like to know internal crossmember paint thickness measurements before and after countermeasure.
- Additionally HMA requests HMC to provide an effective countermeasure for vehicles produced
