**PE08040/HYUNDAI-KIA  
HM8SC83D61U006498**

**PE08040/HYUNDAI-KIA  
FSE REPORT**

2001 SM - SANTAFE - REAR TRAILING ARMS (LR & RR)

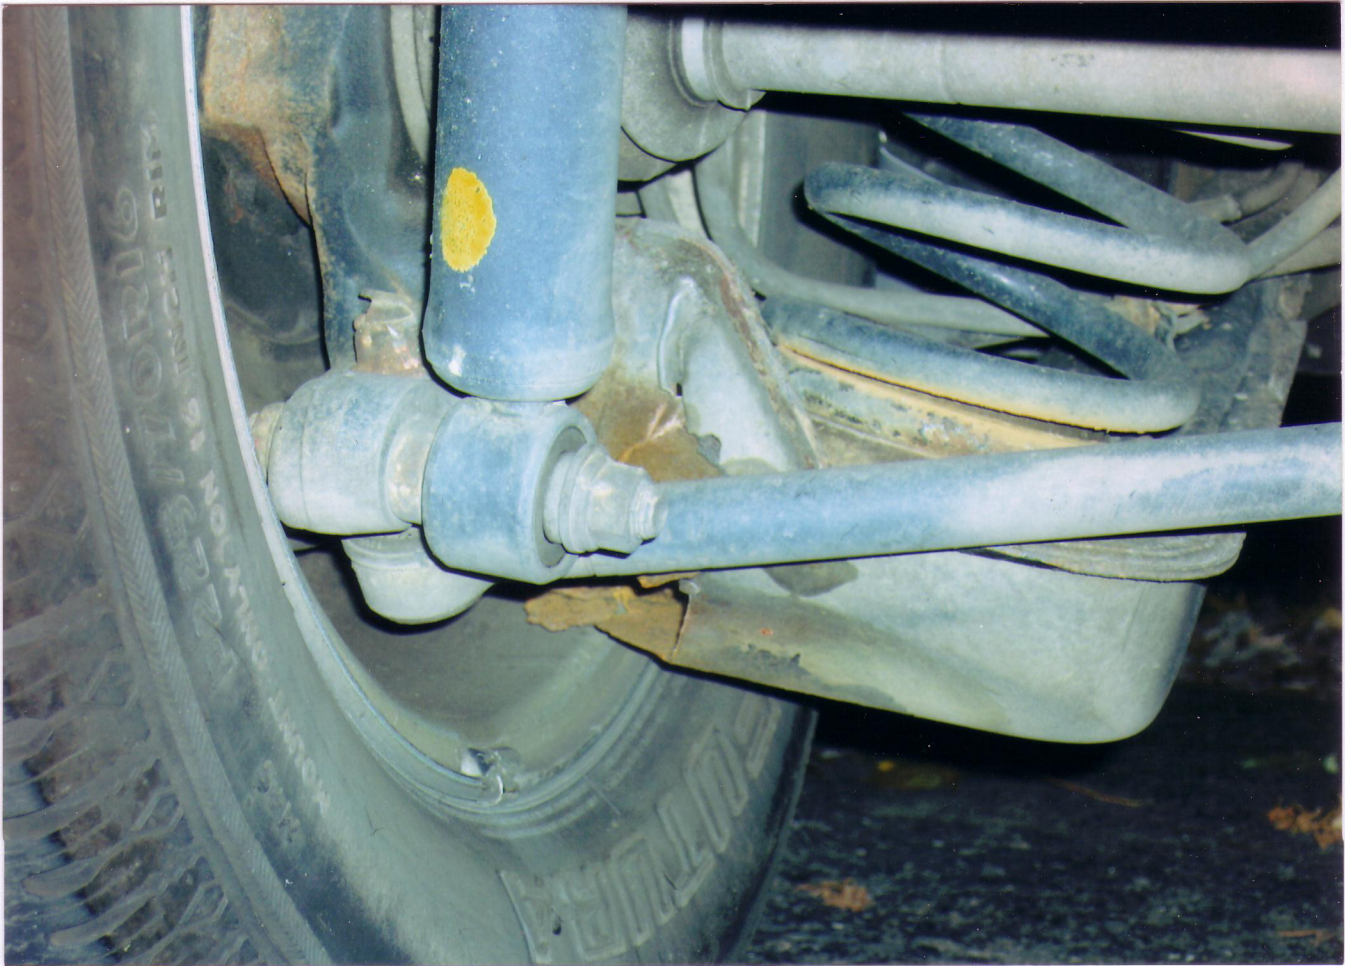
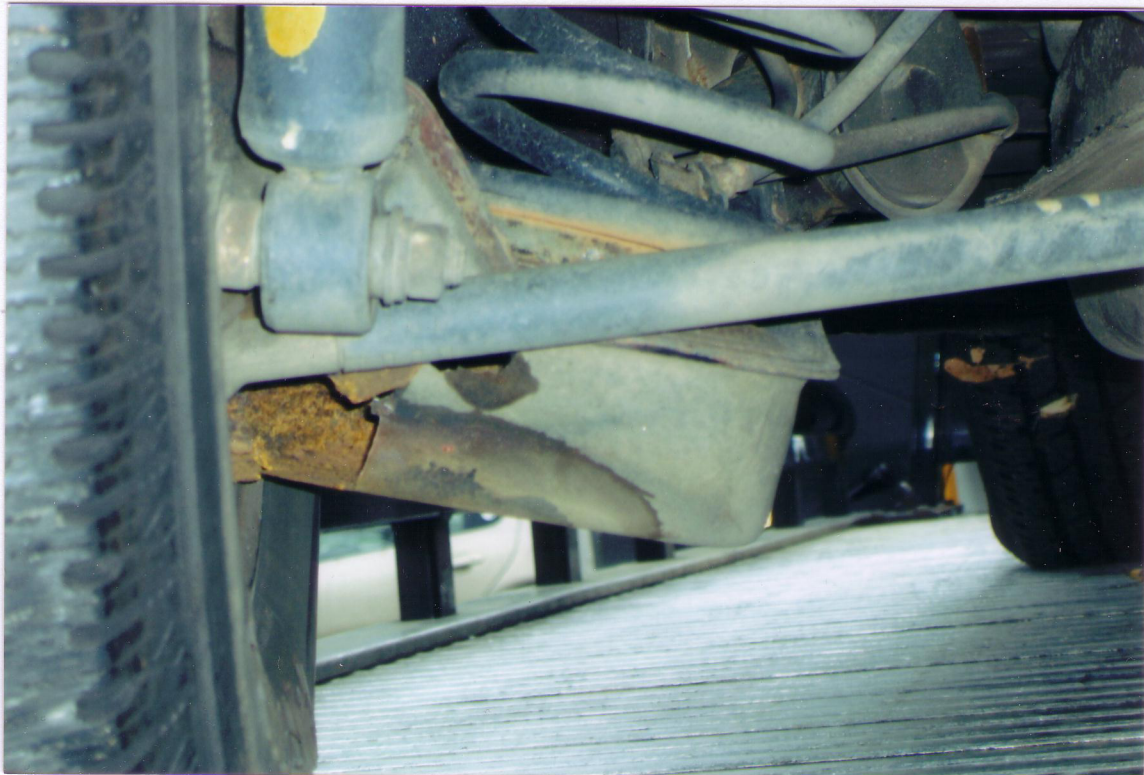
Please find the enclosed photos of the rear control arm of our 2001 Hyundai Santa Fe, which has rusted and corroded. The control arm rusted so badly that it broke in half as the vehicle was being driven causing the vehicle to dog-leg and nearly flip over, and ultimately rendering it unable to be driven.

LABOR & PARTS  
 J# 1.28HYZ014 CONTROL ARM (S) UNITS: 3.00 TECH(S):7661 258.00  
 CUSTOMER STATES: REAR CONTROL ARM RUSTED CORRODED  
 DIAGNOSE REAR SUSPENSION  
 REPLACE LFET LOWER CONTROL ARM  
 TRUCK NEEDS REAR BRAKES SOON

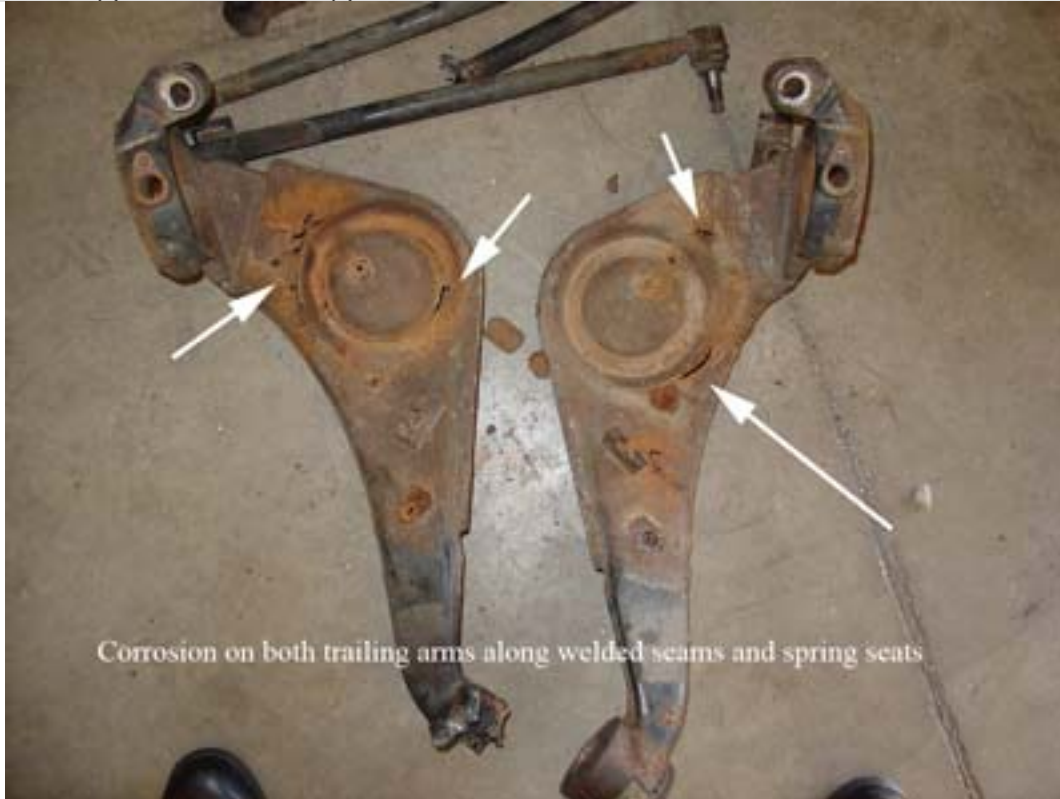
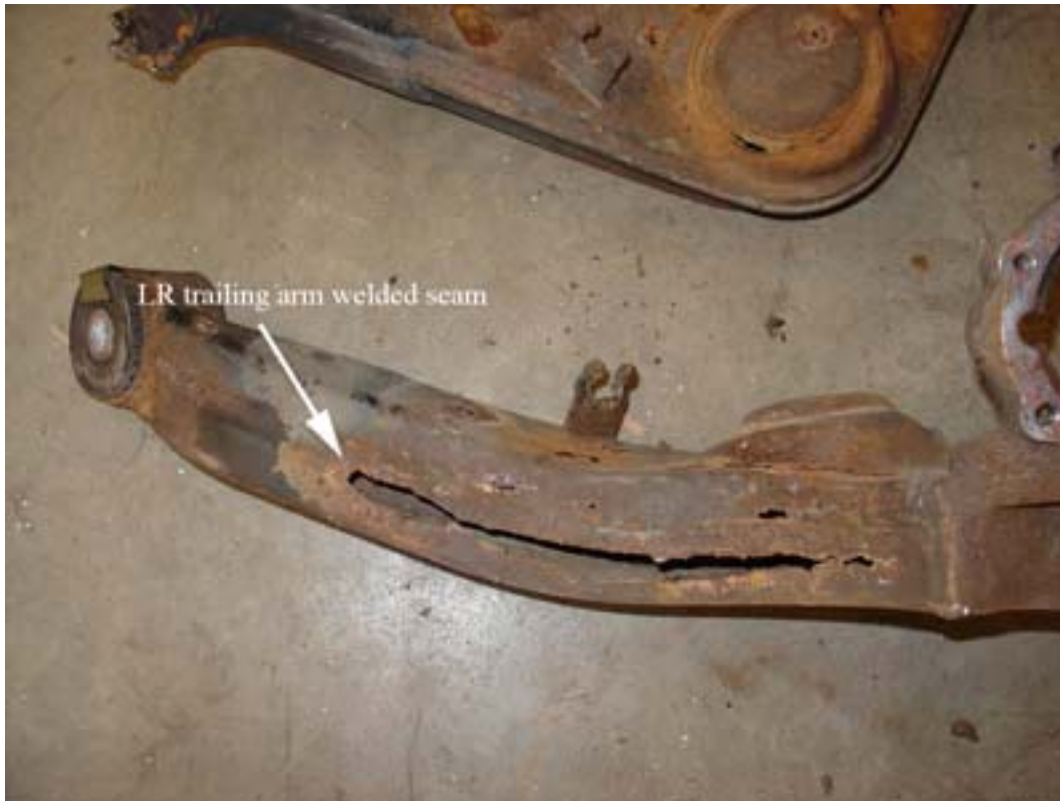
Both rear trailing arms were corroded. Lack of anti corrosive material applied to the lower control arms.

Replace both rear trailing arms.
