Facsimile Cover Sheet
DaimlerChrysler Vehicle Investigation Report (VIR)

Owner:	[REDACTED]
EAA No:	DF01- 47903
CAIR No:	9510901

Supplemental Memo to File
CAIR 9510901 - Miller

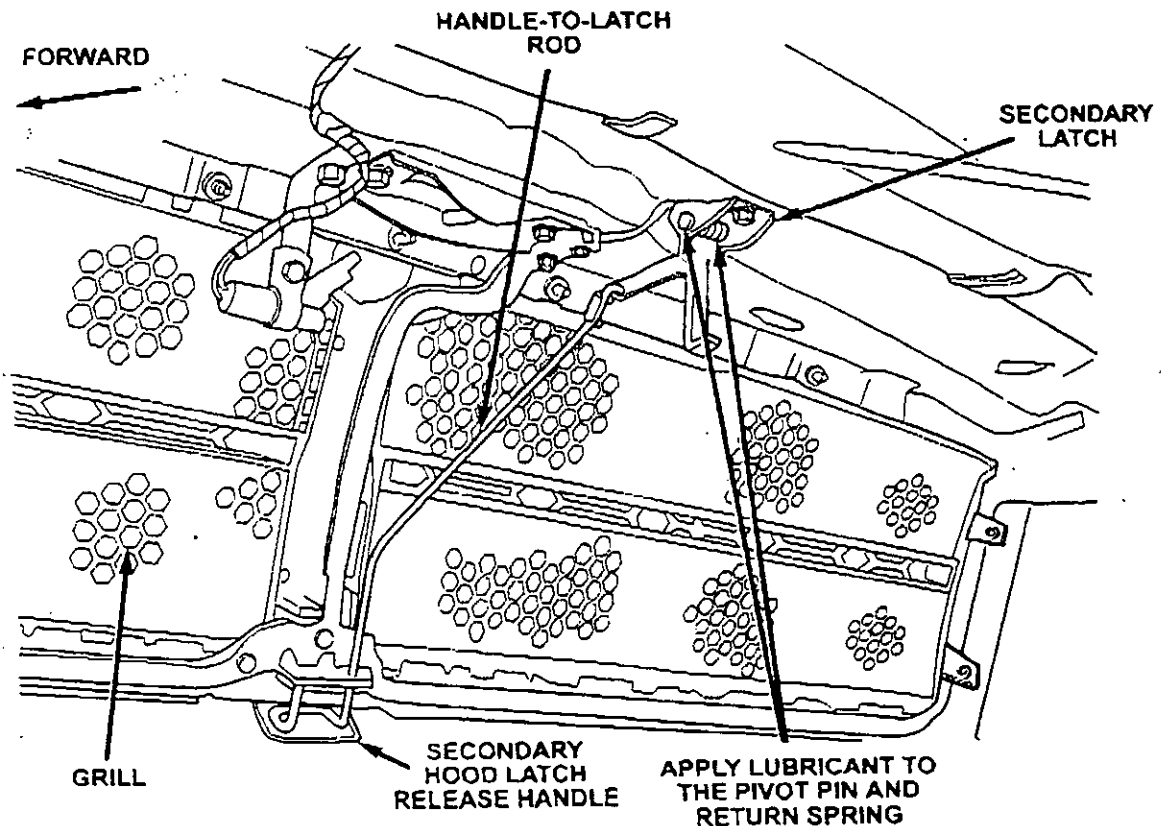
Figure 1 – Underhood View Shown

ATTACHMENT 1

- With the engine OFF, open the hood.
- Using Mopar Spray White Lube (Lithium Grease) or equivalent, spray the secondary hood latch pivot pin and return spring (Figure 1).
- Activate the secondary latch several times to ensure that the latch fully returns to the closed position and does not bind or stick.
- Close the hood, making sure that the primary latch is engaged.

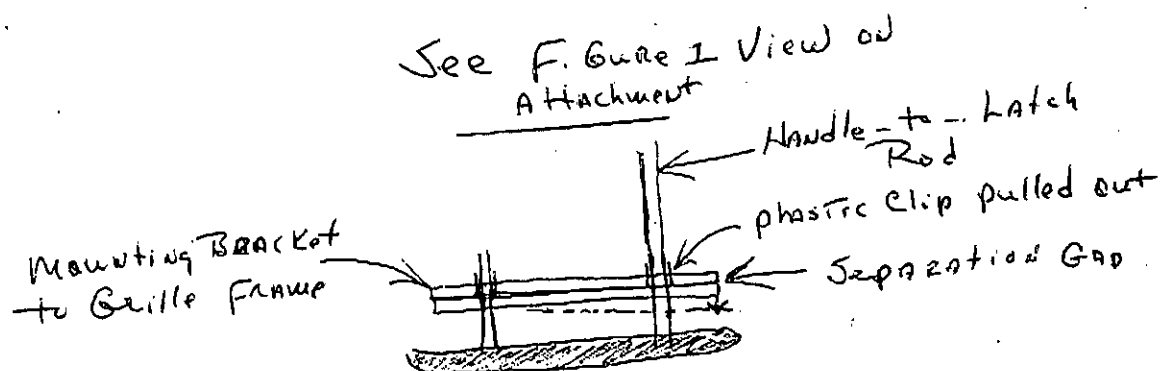
CAIR 9510901 ATTACHMENT 2

However the secondary hood latch release handle LOWER BRACKET has separated which causes the secondary latch to stick in an open position. Attachment 1 is a diagram which displays the components of the secondary hood latch mechanism. Attachment 2 is a drawing which shows the lower bracket and identifies the point of the referenced separation.

Whenever these two layers are attached, the handle-to-latch rod slides through the hole with no binding. However, when the lower layer (plastic) pulls away from the upper layer, this causes a misalignment of the handle-to-latch rod access hole and the rod binds, leaving the secondary latch in an open position.

This is view from engine position, looking forward.
