Section 2  
Copies required by Question 6  
(Service, Warranty, and other  
documents)

NUMBER: 6430.301  
DATE: 000608  
SUBJECT: Steering Linkage Inspection  
MODEL(S): All  
ISSUED BY: Kevin Pollock  
APPROVED: Guenter Schlottmann

# TRW Engineering Analysis Report

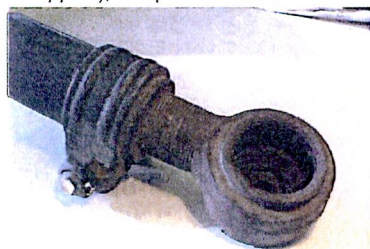
**2. Description of Problem:** Customer complains a separated ball pin from a.m. ball joint (see foto 1). This separation resulted in misfunction of the truck steering. The complaint drag link was cutted (for transportation) and sent to TRW Chassis Systems Germany for analysis. The screw-in side shows the separation (*only the housing was reshipped*), the press-in side shows corrosion on the ball pin and a disassembled sealing (foto 2).

Foto 1: screw-in side of drag link.

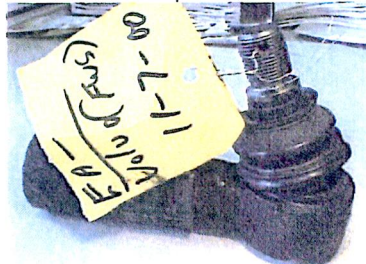
Foto 2: press-in side with disassembled sealing

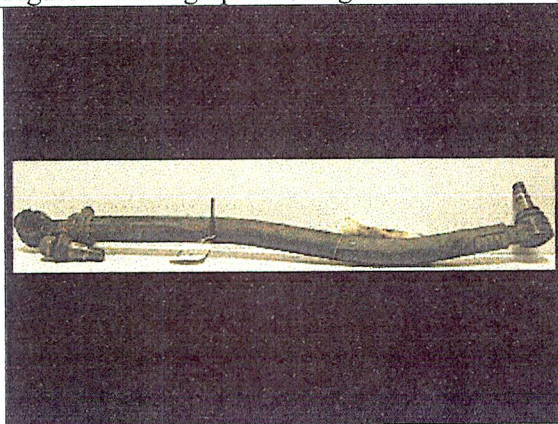
**VISUAL EXAMINATION:** The 544,000 mile draglink assembly with the separated socket is shown as received in figure 1a. The axle end socket components are shown in figure 1b. Close up views of the ball stud and socket housing are shown in figures 1c and 1d respectively. As can be seen in the photographs, the boot seal was torn and the socket components were covered with heavy rust. No lubricant/grease was evident in the socket. The separated ball stud and socket were cleaned in an ultrasonic cleaner to remove corrosion products on the surface and examined at higher magnifications with a stereomicroscope. The appearance of the cleaned components is shown in figure 2. Wear and heavy pitting due to corrosion are clearly evident on the surface of the ball. The socket housing also shows evidence of heavy corrosion products, which resulted from the damage to the boot seal and resultant ingress of road salts and other debris. The draglink with 102,700 miles appeared to be intact. No damage was observed to either socket assembly. The two socket ends of this draglink are shown in figures 1e and 1f.

(a) 544,000 mile drag link assembly as received

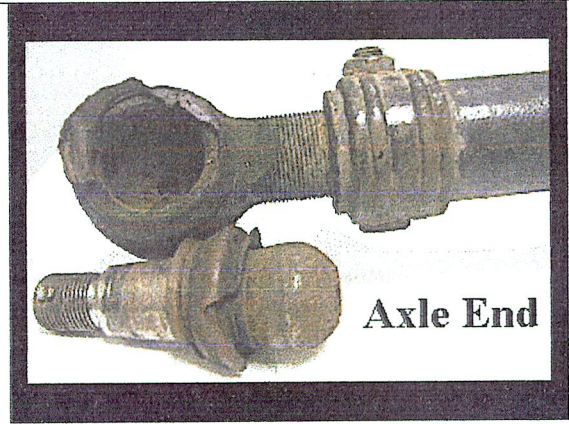
1. Visual examination of the separated socket components showed that contamination of the socket lead to corrosion and wear of the ball stud resulting in separation.
2. Materials evaluation showed the ball stud and socket housing conform to material and heat treatment specifications.

(b) Separated ball stud and socket

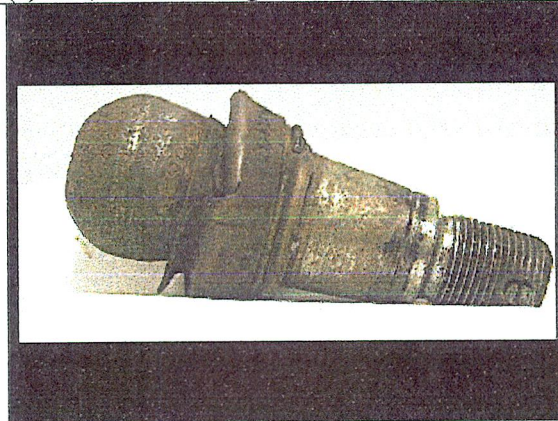
(c) Close up view of ball stud

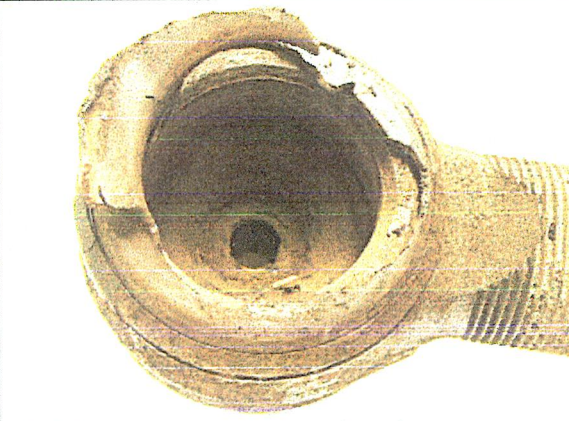
(d) Close up view of socket housing

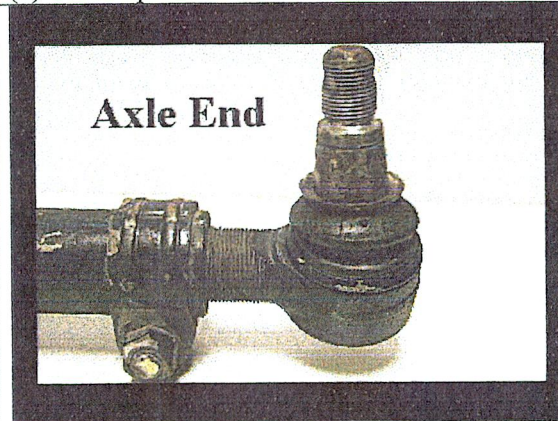
(e) Axle end of 102,700 mile drag link

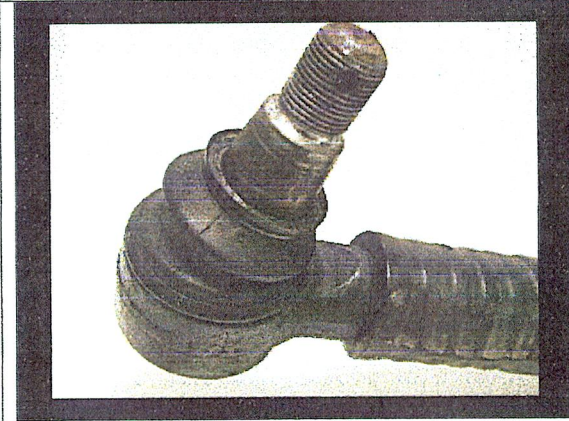
(f) Other end of 102,700 mile drag link

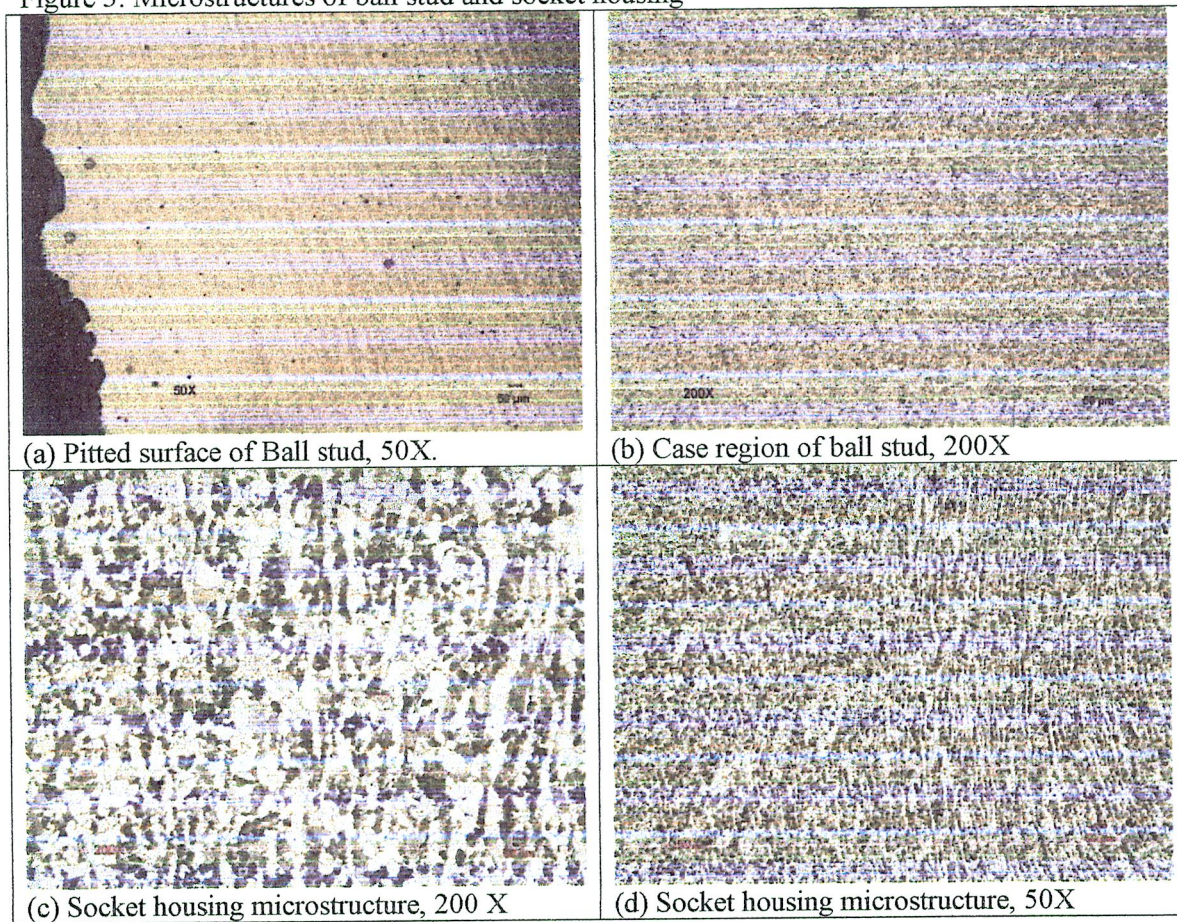
Figure 3: Microstructures of ball stud and socket housing

**Metallographic Evaluation:** Axial metallographic sections through the ball and socket housing were prepared for metallographic evaluation. Figure 3a and 3b shows the induction hardened case of the ball stud. The cross section also exhibits the pitting profile observed at the surface. The microstructure of the case consisted of fine medium Carbon tempered martensite. Micro hardness measurements were made 0.010 inches below the surface with a Knoop indenter and 500 gram load. Hardness was equivalent to HRC 56 (Knoop hardness 644-653). Core hardness was equivalent to HRC 30-32 (Knoop hardness 311-324). The microstructure of the socket housing consisted of a mixture of fine lamellar pearlite and ferrite, indicative of a low Carbon steel as expected. Hardness of the socket housing material was measured to be equivalent to HB 162 (Knoop hardness 176).

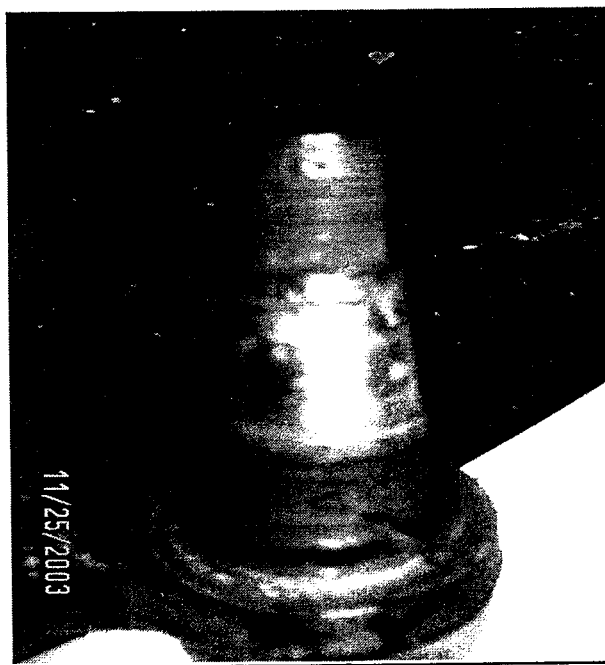
Photo: (738:C) UNIT: 348053

On the adjustable end, 11 of the 15 axial compliance results warranted removal. The axial compliance results range from .042-.180 inches. TRW's inspection criteria for draglink removal and replacement is wear at or greater than .060 inches. In addition, 3 of the 4 draglinks with acceptable axial compliance, had damaged seals and/or notable contamination. In all cases, there was grease degradation.

1. TRW recommends a review of maintenance procedures and intervals to ensure timely wear detection and proper seal inspections.
2. The socket wear is due to contamination from a variety of environmental factors combined with the inability to purge contamination from the socket. The rate of wear is increased when contamination is introduced in the socket cavity.

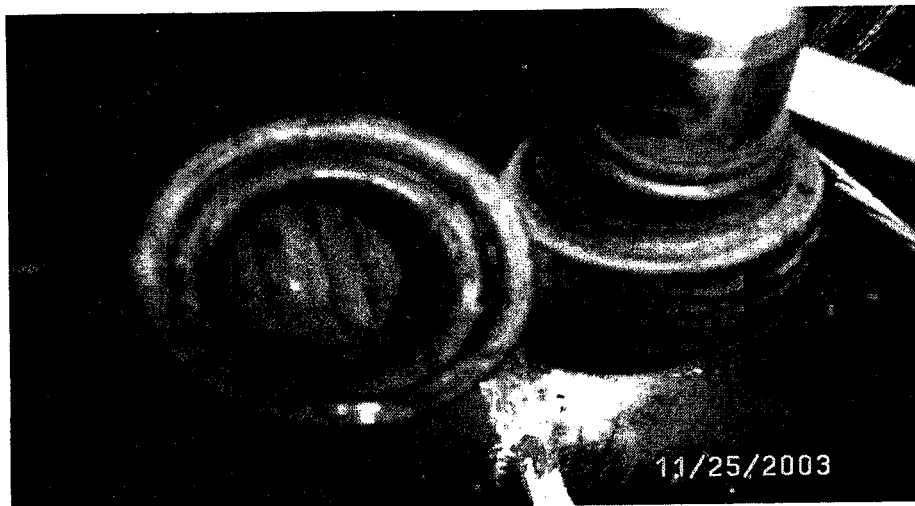
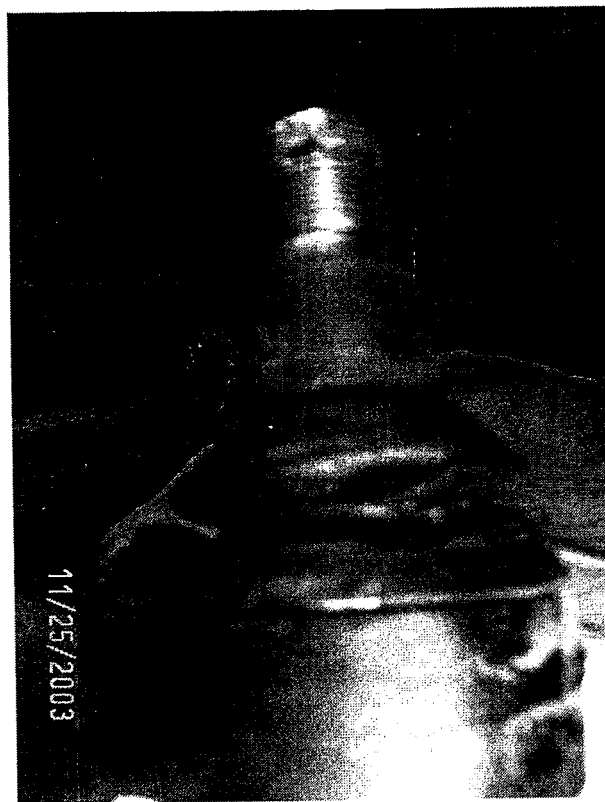
Photo (739:N) UNIT 766313:

The adjustable end of the draglink experienced higher levels of wear when compared to the non-adjustable ends. The non-adjustable end axial compliance indicates that the parts were not worn to a level recommended for removal. However, upon inspection of the seals, five were found to be damaged and in one case the seal was not returned. Due to the difficulty in determining the cause of the seal damage, the condition of the grease was taken into consideration. There is grease degradation in 10 of the 15 non-adjustable drag link ends, indicating contamination in the socket for an undetermined period of time.

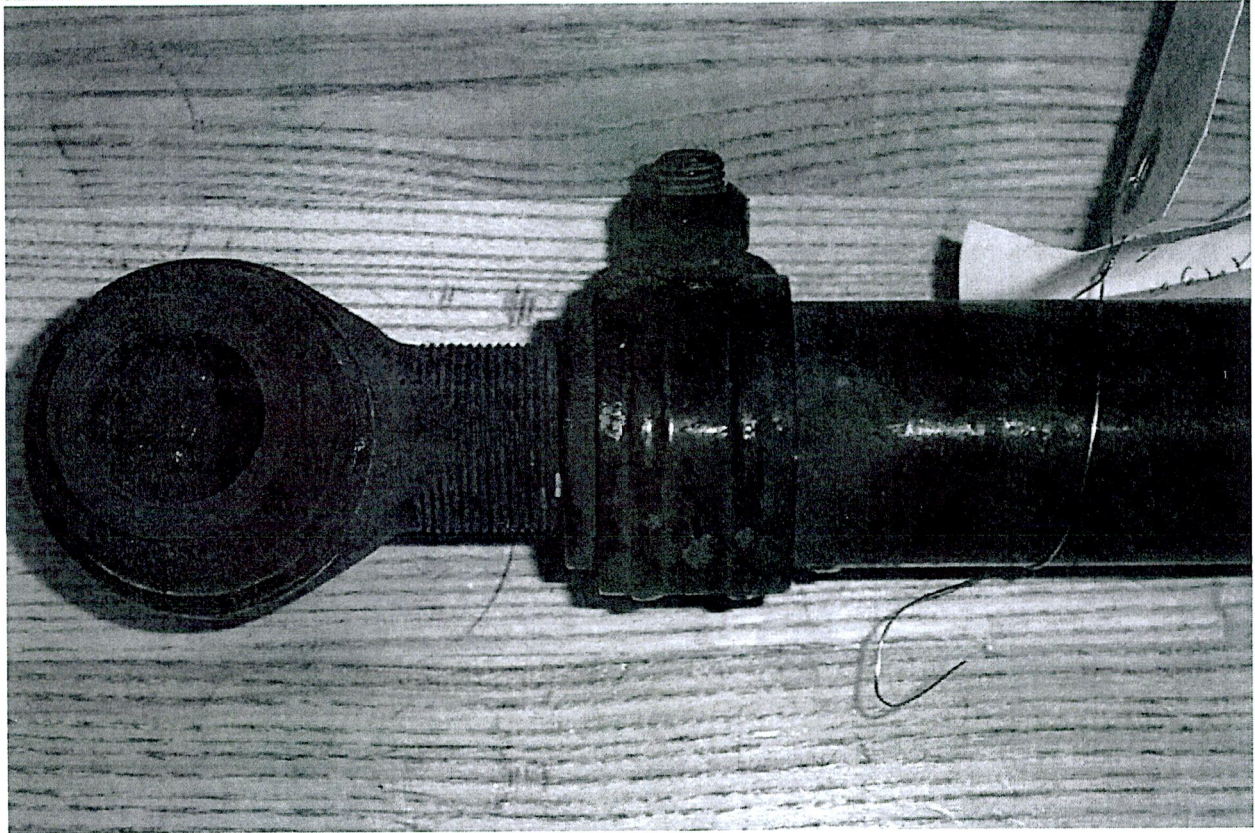
**Visual Examination:** The sockets were examined in the as-received condition. The socket with the ball stud separation, Figure 1, was dry of grease and was corroded. The boot seal was not damaged. After visual examination, the closure cap was cut away in order to remove the inner components for evaluation:

Figure 1: Photograph of the socket with the separated ball stud threaded socket end as-received showing the condition of the socket.

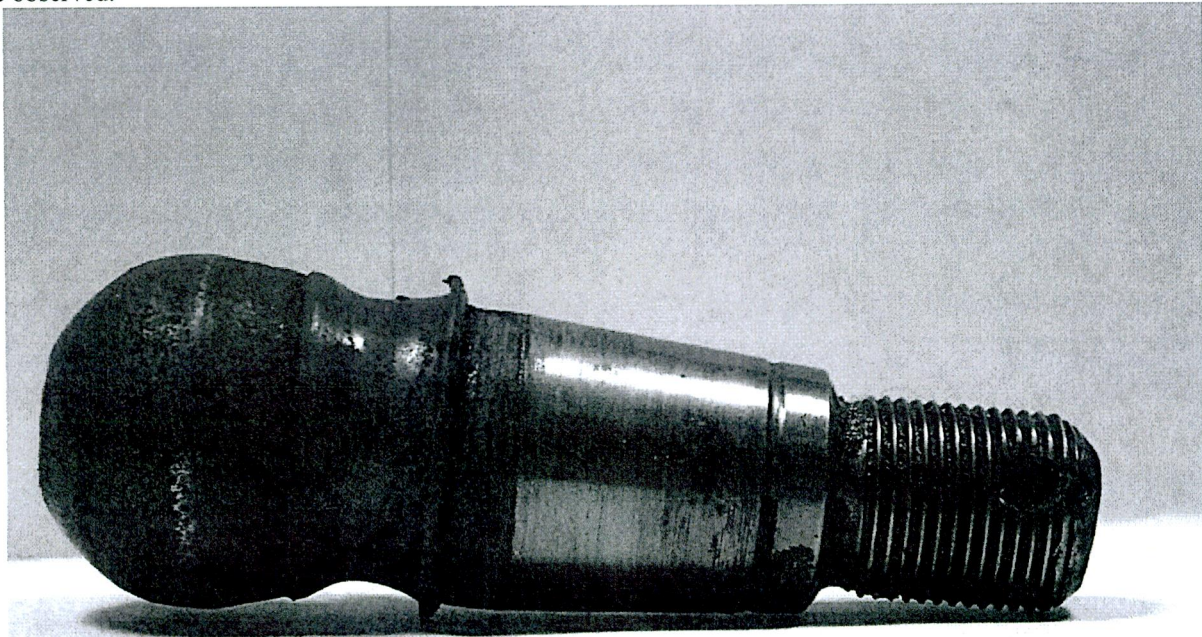
- Ball Stud: The ball stud, Figure 2, exhibited significant wear. The ball, undercut, and upper shank areas were heavily corroded.
- Steel Bearing: The bearing exhibited significant wear and was heavily corroded
- Spring and Spring Seat: Each of these components was heavily corroded. The inside of the socket is shown in Figure 3.

Figure 2: Photograph of the ball stud removed from the right hand socket, light polishing of the bearing surface can be observed.

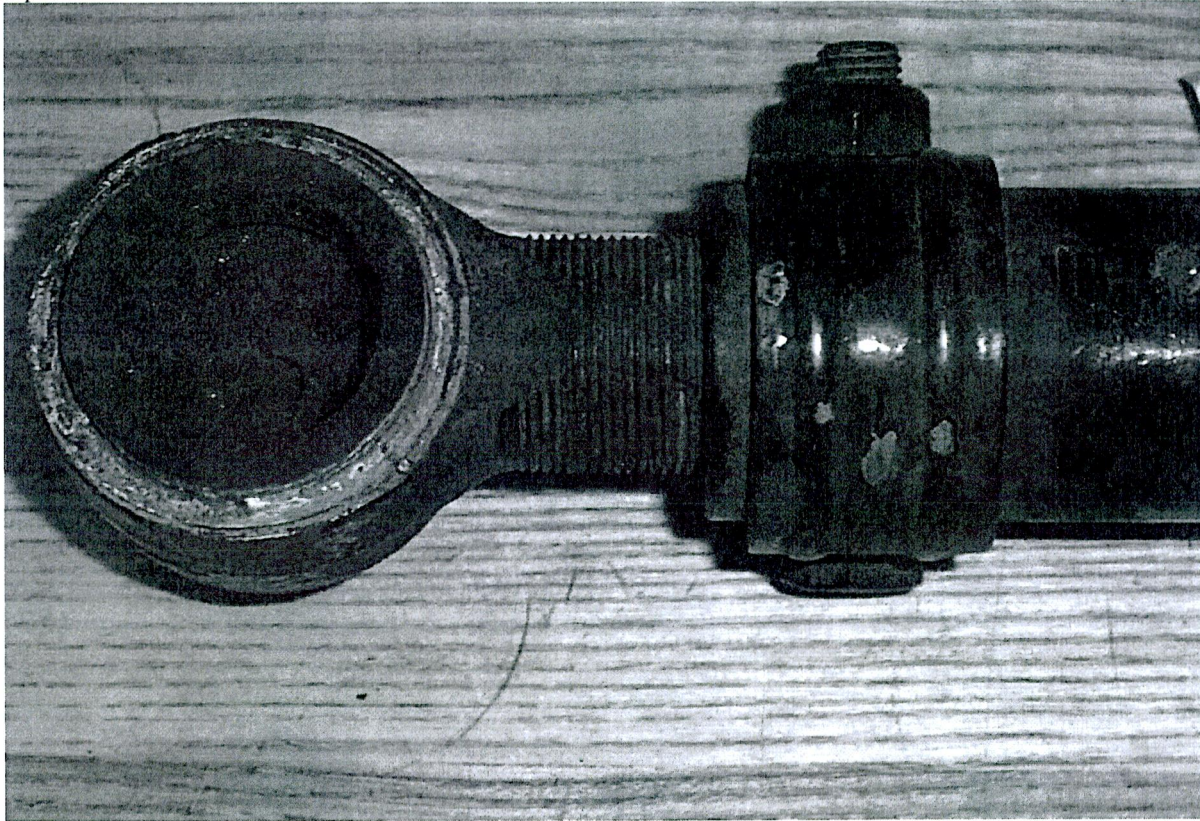
Figure 3: Photograph of the socket after the boot seal was removed indicating the condition of the internal components.

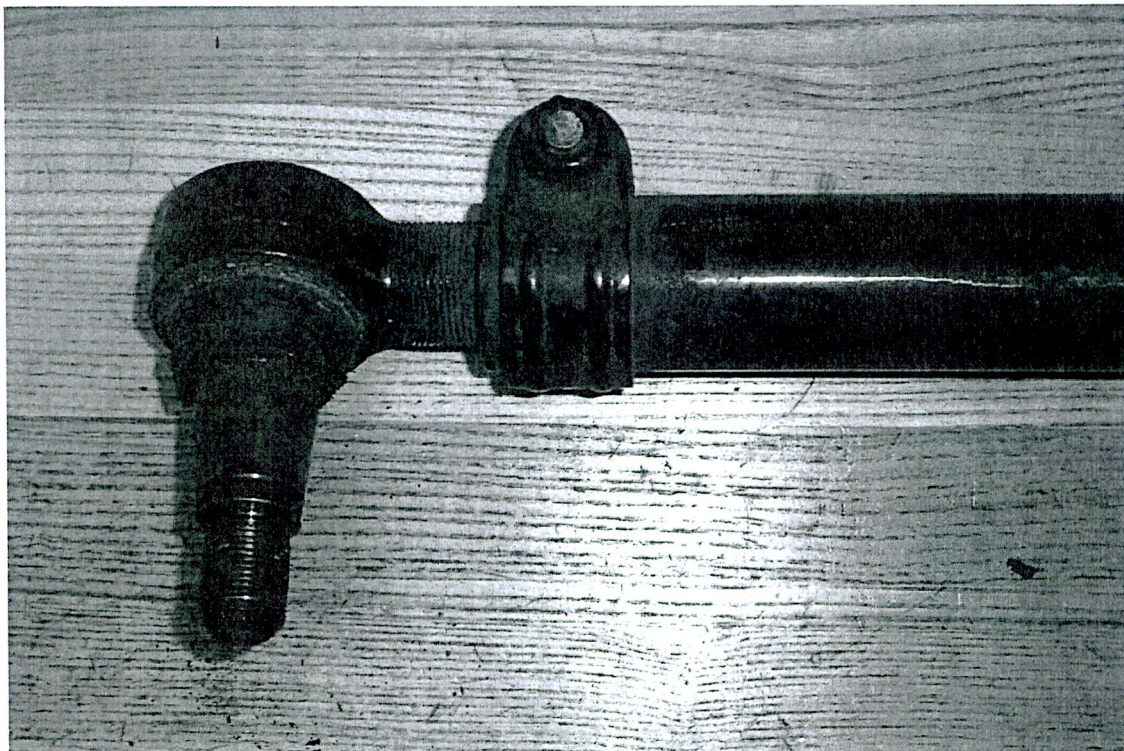
The socket with the non-separated ball stud, Figure 4, contained some grease. The grease was relatively dry and contaminated. The boot seal was not damaged. After the visual examination, the closure cap was cut away in order to remove the inner components for evaluation:

Figure 4: Photograph of the socket with the non-separated ball stud with the boot seal removed showing its as-received condition.

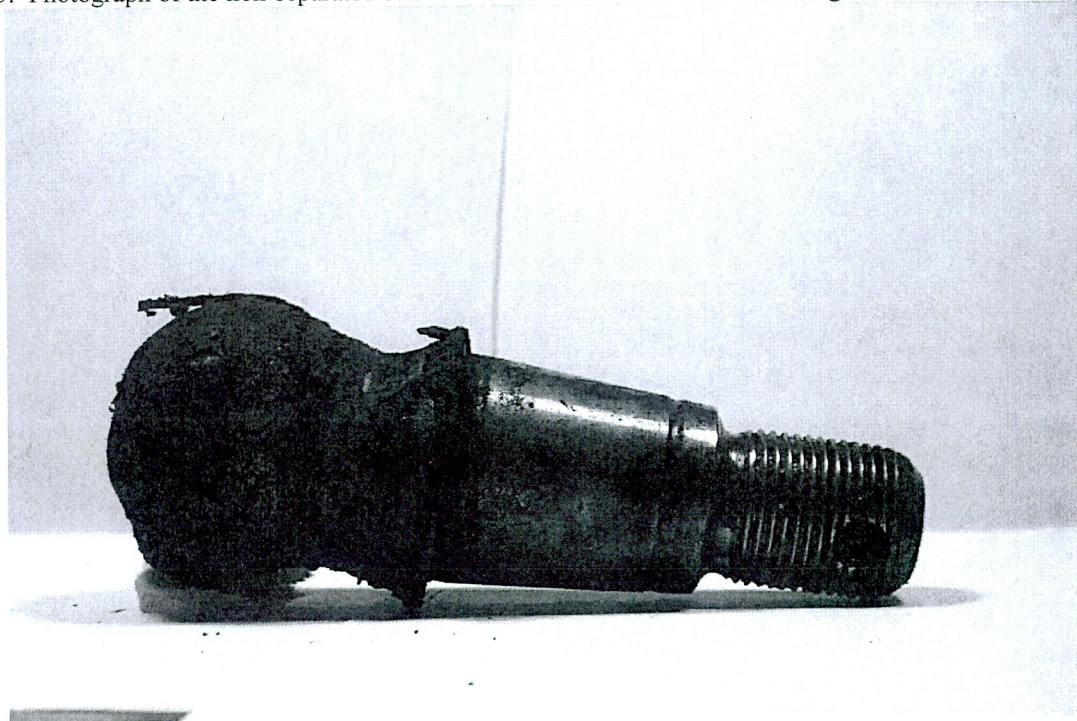
- Ball Stud: The ball stud, Figure 5, exhibited significant wear. The ball, undercut, and upper shank areas were heavily corroded.
- Steel Bearing: The bearing exhibited significant wear and was heavily corroded
- Spring and Spring Seat: Each of these components was heavily corroded. The inner components were coated with dry, caked grease.

Figure 5: Photograph of the non-separated ball stud removed from the socket showing the condition of the grease.

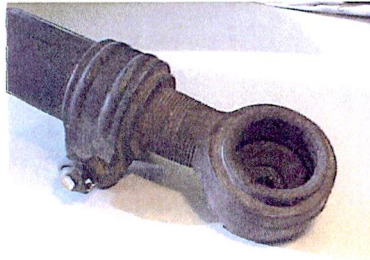
**2. Description of Problem:** Customer complaints a separated ball pin from a.m. ball joint (see foto 1). This separation resulted in misfunction of the truck steering. The complaint drag link was cutted (for transportation) and sent to TRW Chassis Systems Germany for analysis. The screw-in side shows the separation (*only the housing was reshipped*), the press-in side shows corrosion on the ball pin and a disassembled sealing (foto 2).

**Foto 1:** screw-in side of drag link.

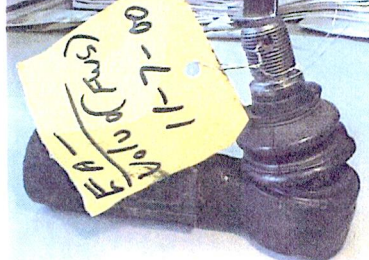
**Foto 2:** press-in side with disassembled sealing

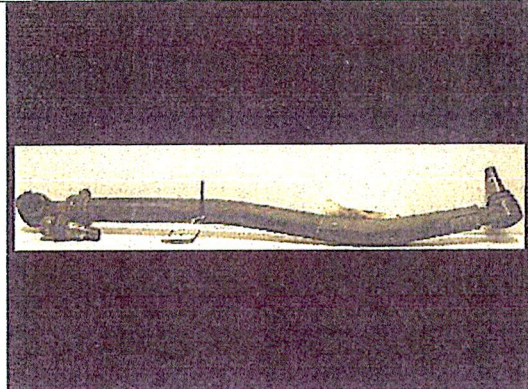
(a) 544,000 mile drag link assembly as received

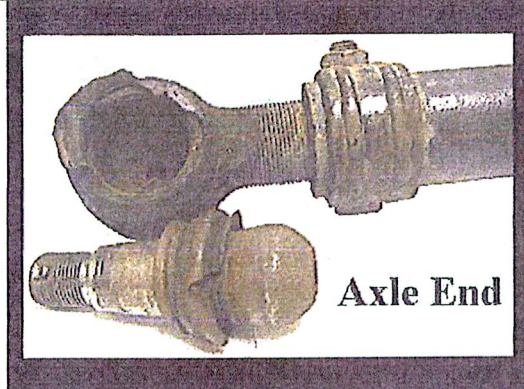
(b) Separated ball stud and socket

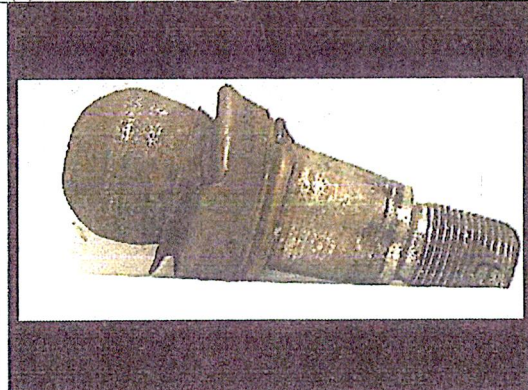
(c) Close up view of ball stud

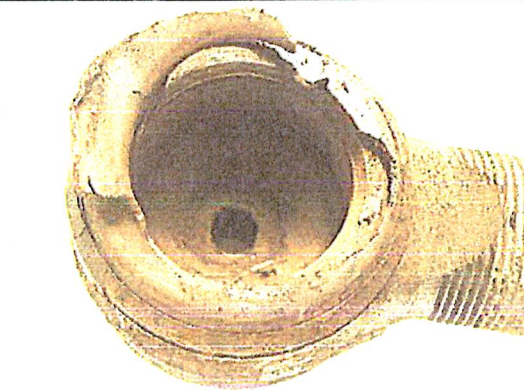
(d) Close up view of socket housing

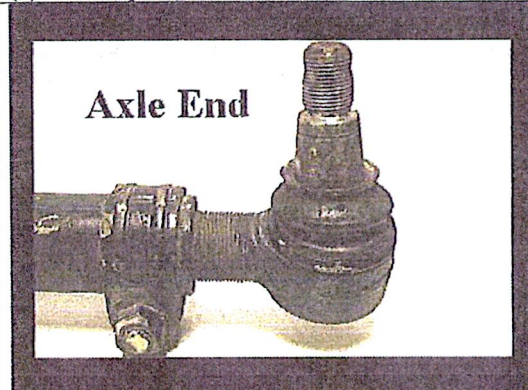
(e) Axle end of 102,700 mile drag link

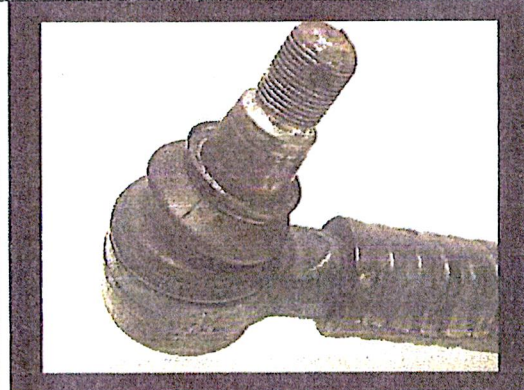
(f) Other end of 102,700 mile drag link

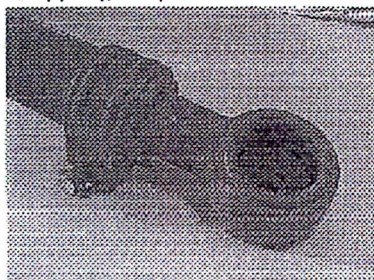
**2. Description of Problem:** Customer complains a separated ball pin from a.m. ball joint (see foto 1). This separation resulted in misfunction of the truck steering. The complaint drag link was cutted (for transportation) and sent to TRW Chassis Systems Germany for analysis. The screw-in side shows the separation (*only the housing was reshipped*), the press-in side shows corrosion on the ball pin and a disassembled sealing (foto 2).

Foto 1: screw-in side of drag link.

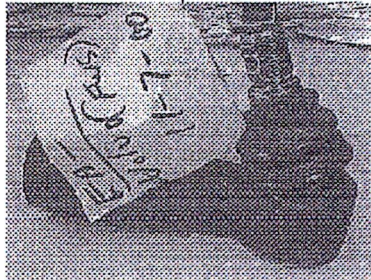
Foto 2: press-in side with disassembled sealing

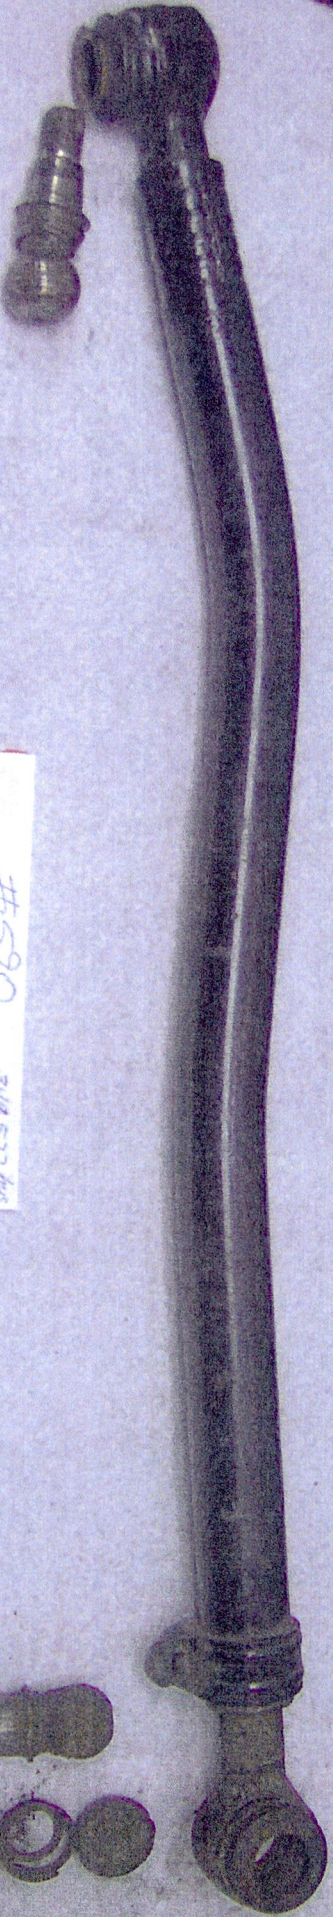
#590 348,522/MS  
- 0.20 REAR PLAY  
- .001 FRONT PLAY  
- NO RUBBER BUSHING  
- DIFFERENTIAL BEAT  
- NO GREASE / REAR  
- RUSTING / REAR

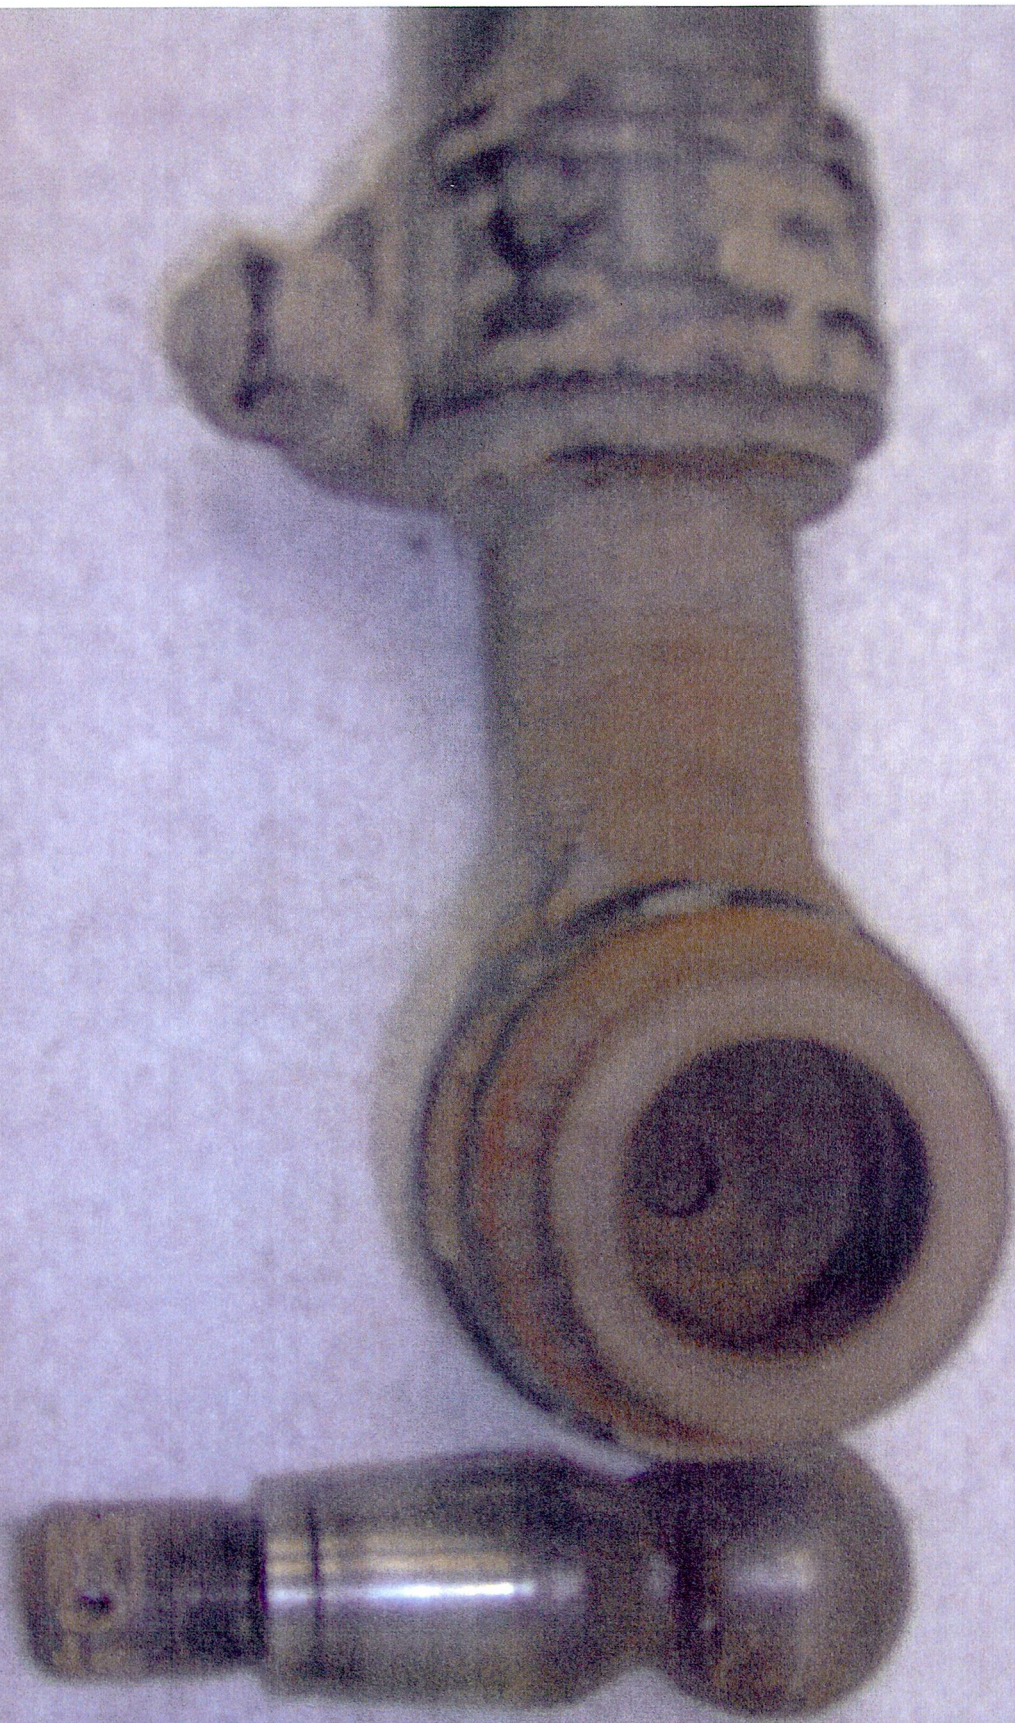
586 FAILED

- BOOT INTACT

- NO GREASE

- OLD DESIGN - NO RUBBER  
SEAL
