# Service Bulletin

Bulletin No.: 06-02-35-002A

**Subject:** Diagnostic Trouble Code (DTC) C0710 Steering Wheel Position Sensor (SWPS) Signal, Service Stability System Message on Driver Information Center (DIC) (Inspect and Secure Wires in SWPS Connector)

**Models:** 2004-2006 Cadillac XLR  
2005-2006 Chevrolet Corvette  
with Steering Wheel – Tilt, Telescoping (RPO N37)

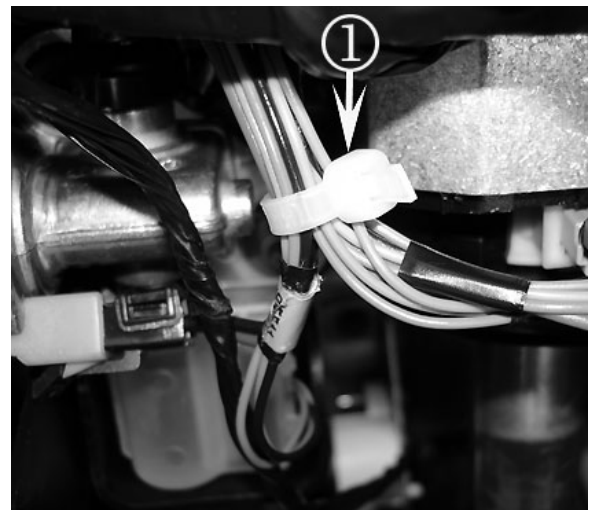
1714896

The most likely cause of a DTC C0710 on a vehicle equipped with telescoping/tilt steering wheel is high resistance in SWPS connector C202. Fretting terminal corrosion maybe present in the SWPS connector due to the telescoping motion of the steering column. When the steering column is telescoped in and out, the female terminals within the SWPS connector may move on the male terminals of the SWPS. This movement between the terminals may cause a high resistance condition in the SWPS connector.

1. Remove the driver's side close out panel.
  - Cadillac XLR — Refer to Closeout/Insulator Panel Replacement - Left
  - Chevrolet Corvette — Refer to Closeout/Insulator Panel Replacement - Instrument Panel (I/P) Lower
2. On XLR models only, locate and remove the plastic strap (1) on the steering column harness that retains the three wiring harnesses. Discard this strap.

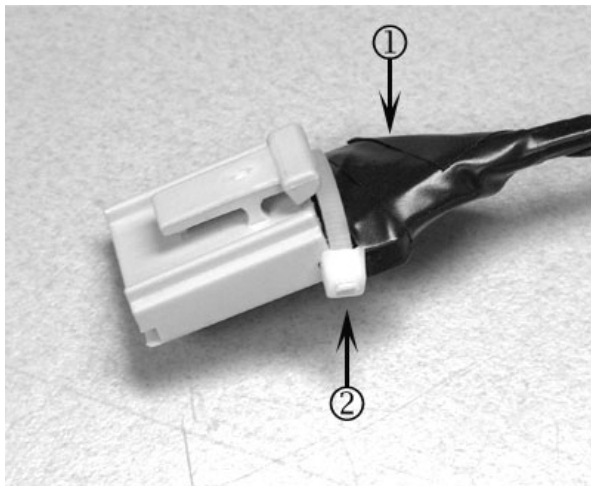
1743934

- Failure to properly tape the wires in the connector may result in additional concerns.
- Failure to use a small plastic strap 2.5-3.5 mm (0.10-0.14 in) in width may prevent the SWPS connector from properly seating, resulting in additional SWPS DTCs.
- Failure to position the plastic strap in the connector notch shown below may result in the strap becoming loose and allowing the terminal to move within the connector.

4. Using electrical tape (1), tape from the plastic strap up the wires a minimum of 2.5 cm (1 in).
5. Install a small plastic strap (2) 2.5-3.5 mm (0.10-0.14 in) wide around the SWPS sensor connector so that it retains the wires to the connector as shown.

**Important:** Install and remove the SWPS connector a minimum of three times to remove any possible terminal corrosion.
