Service Bulletin

File In Section:02 - SteeringBulletin No.:06-02-35-002BDate:October, 2007

- Subject: Stabilitrak/Active Handling Light On, Service Stabilitrak/Active Handling Message on DIC, DTC C0710 Steering Wheel Position Sensor (SWPS) Signal Set (Install Clip in SWPS Connector)
- Models: 2008 Buick Lucerne 2004–2008 Cadillac XLR 2006–2008 Cadillac DTS 2005–2008 Chevrolet Corvette with Steering Wheel – Tilt, Telescoping (RPO N37 or N38)

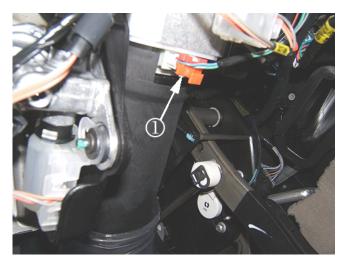
2030089

The most likely cause of a DTC C0710 on a vehicle equipped with telescoping/tilt steering wheel is high resistance in SWPS connector C202. Fretting terminal corrosion may be present in the SWPS connector due to the telescoping motion of the steering column. When the steering column is telescoped in and out, the female terminals within the SWPS connector may move on the male terminals of the SWPS. This movement between the terminals may cause a high resistance condition in the SWPS connector.

- Install the clip (1), P/N 19179794, into the connector. This clip will act as a terminal positive assurance (TPA) and prevent any movement of the terminals.
- 4. Reinstall the closeout panel.
- 5. Clear the DTC with a scan tool and road test the vehicle.
- 6. If DTC C0710 resets during the road test, refer to DTC C0710 in SI.
