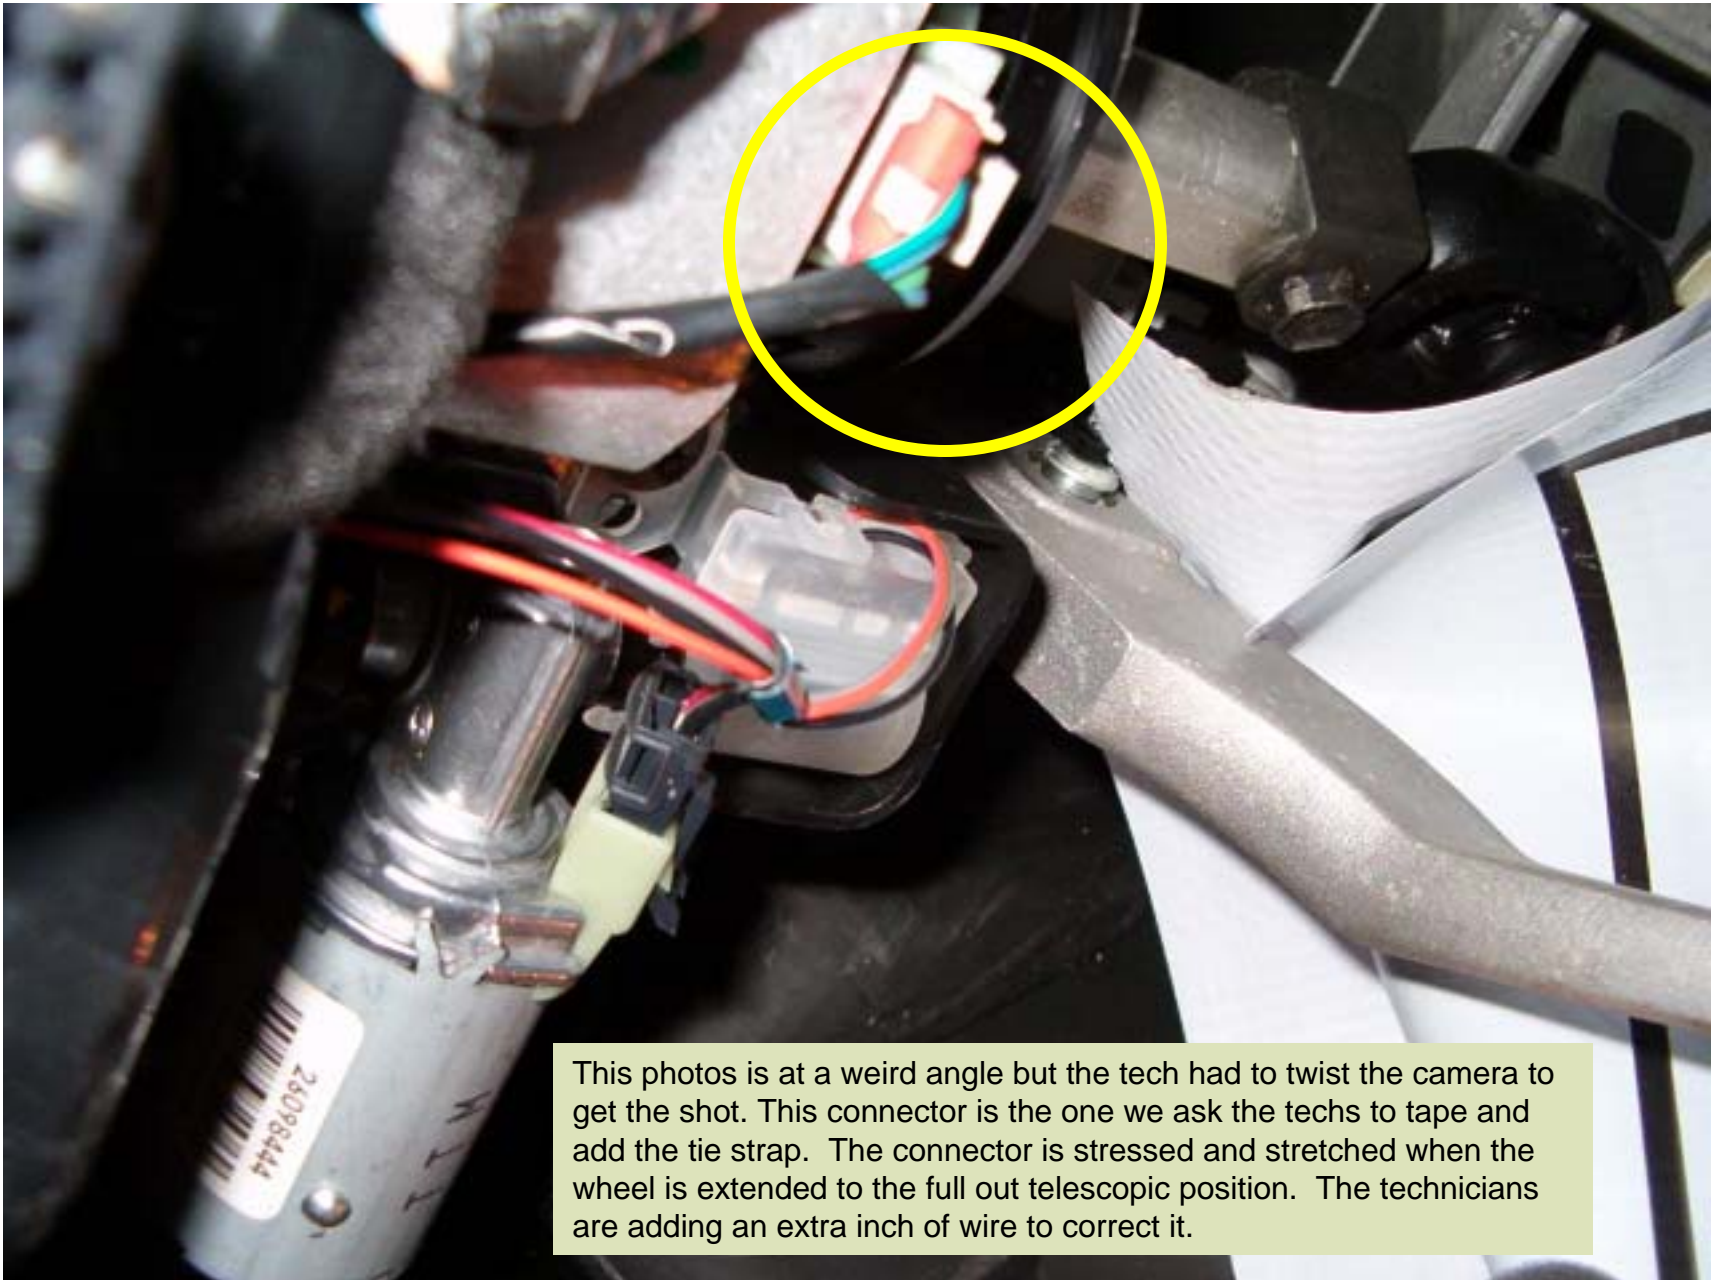
This photos is at a weird angle but the tech had to twist the camera to get the shot. This connector is the one we ask the techs to tape and add the tie strap. The connector is stressed and stretched when the wheel is extended to the full out telescopic position. The technicians are adding an extra inch of wire to correct it.
