# Service Request Detail Report

**SB531014****Date: 05/21/08****Model: MP8****(Also applies to Mack Trucks Australia)****Revised Air Compressor Discharge Line — MP8 Engines**

## Revised Air Compressor Discharge Line — MP8 Engines

**QJ Id:** 561-104  
**Description:** GU/CHU/CXU MP8 Air Compressor Discharge Line Leaks  
**Case Manager:** Brad Keller  
**Solving Responsible:** Tim Lancaster  
**VMT:** VMT048 : Powertrain Installation

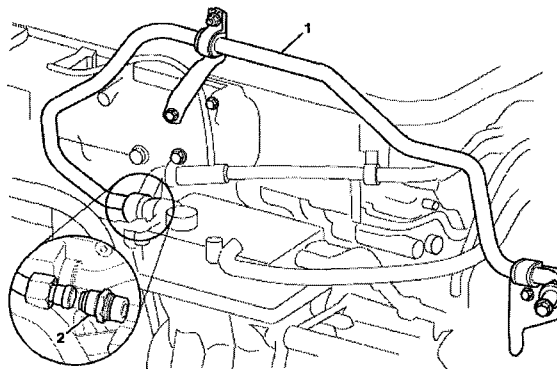
Revised Air Compressor Discharge Line and Fitting

The end of the line where it connects to the air compressor was changed from a ferrule-type fitting to a 37-degree flare compression-type fitting to address issues of air leakage at the discharge line, and also to prevent the line from "blowing-off" the compressor cylinder head. Should discharge line "blow-off" or air leakage from the discharge line fitting be encountered, the existing discharge line and fitting must be replaced with the revised line.

After removing the existing discharge line and fitting, install the replacement fitting (part No. 21206950) into the compressor cylinder head. Tighten the fitting to 130 N•Nm (96 lb-ft).

Install the replacement discharge line (part No. 21206841). Tighten the line end nut at the compressor cylinder head to 109 N•m (80 lb-ft).

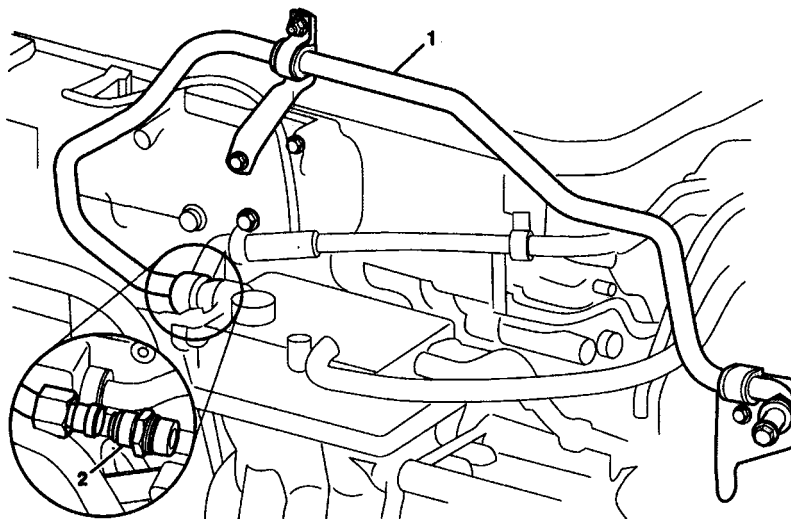
Figure 1 — Revised Air Compressor Discharge Line and Fitting

The end of the line where it connects to the air compressor was changed from a ferrule-type fitting to a 37-degree flare compression-type fitting to address issues of air leakage at the discharge line, and also to prevent the line from "blowing-off" the compressor cylinder head. Should discharge line "blow-off" or air leakage from the discharge line fitting be encountered, the existing discharge line and fitting must be replaced with the revised line.

Key	Qty.	Part No.	Description	Replaces
1	1	21206841	Tube, air compressor discharge, MP8 engines	17QE371M
2	1	21206950	Fitting, 37-degree flare, compression-type	63AM88

After removing the existing discharge line and fitting, install the replacement fitting (part No. 21206950) into the compressor cylinder head. Tighten the fitting to 130 N•m (96 lb-ft).

Install the replacement discharge line (part No. 21206841). Tighten the line end nut at the compressor cylinder head to 109 N•m (80 lb-ft).
