TQCN DOC# FTR-5YA212841		Affiliate TMS	Dept. QA-Chassis	Source FTS	Location REG-SET	Ref 22367-1	Date 5/7/2004
Problem Area Base Vehicle	Primary Model Sequoia	Model Year 2003	Production Date 03-2003	Odometer 6251 mi	VIN (confirm 17 characters): 5TDZT34A03S [REDACTED]		
Condition Title 03 Sequoia contaminated wheel speed sensor

FIELD TECHNICAL REPORT

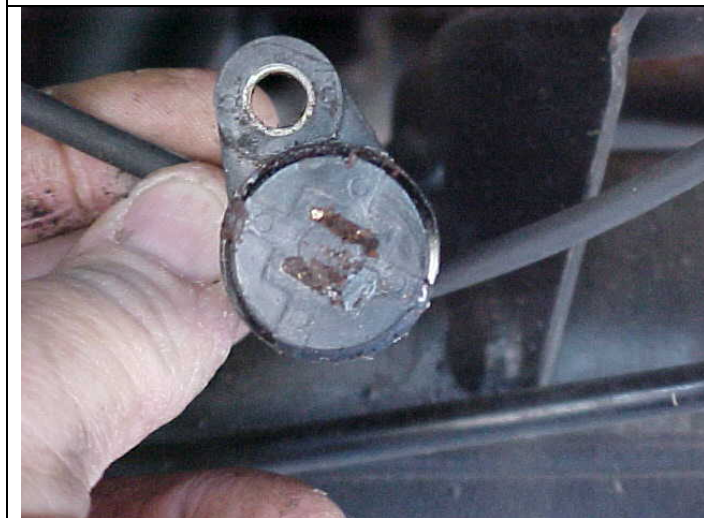
Technician removed and inspected all 4 ABS wheel speed sensors. The left rear wheel speed sensor was found to be contaminated with what appeared to be rust particles. Origin of the contamination/debris is unknown.

Debris found on left rear wheel speed sensor

Technician cleaned the sensor and reinstalled it. The condition no longer occurred after cleaning the left rear sensor.

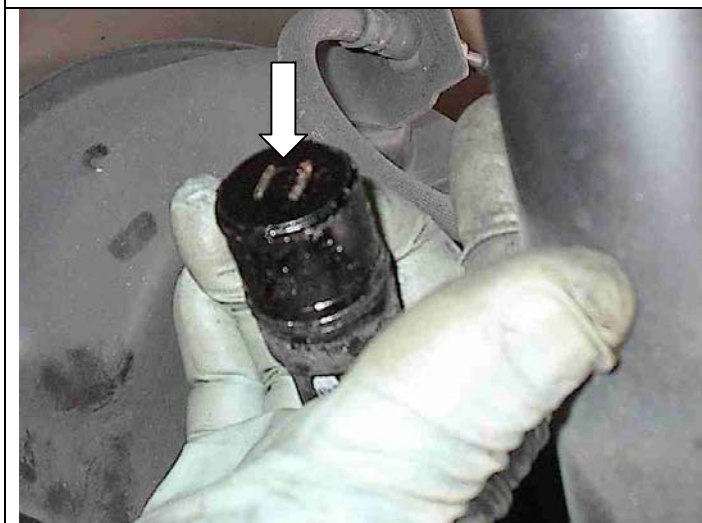
The right rear ABS wheel speed sensor was found to have an excessive amount of rust/debris and grease on the tip of the sensor. The right rear ABS wheel speed sensor reluctor was not rusted.

Debris/Rust on the right rear ABS wheel speed sensor.

The technician cleaned the sensor, reinstalled the sensor, and confirmed that the condition no longer occurred under the same driving conditions.

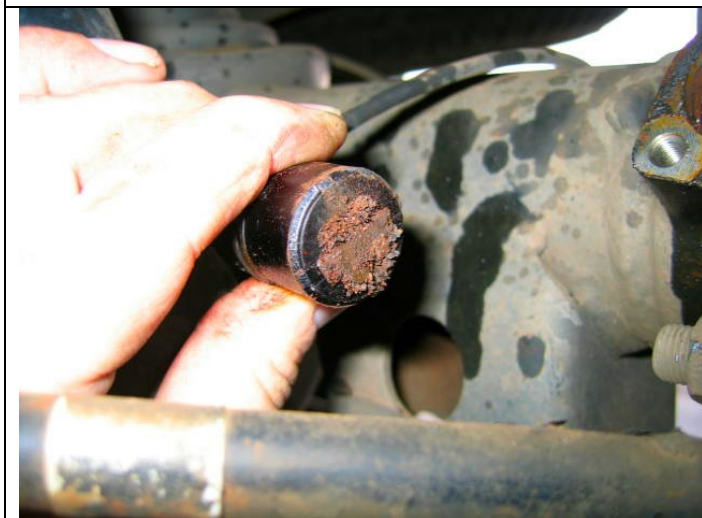
Tech confirmed condition. VSC is activating under above driving conditions.
No DTC's.
Debris was found on both rear ABS wheel speed sensors. The sensors were covered by the debris, which affected the sensor reading. There was some contamination on the ABS reluctor rings, also. Material looked to be a combination of dirt and rust.

Debris on rear ABS wheel speed sensor

It was necessary to clean the ABS wheel speed sensors and the ABS reluctor rings on the axle. This corrected the condition.

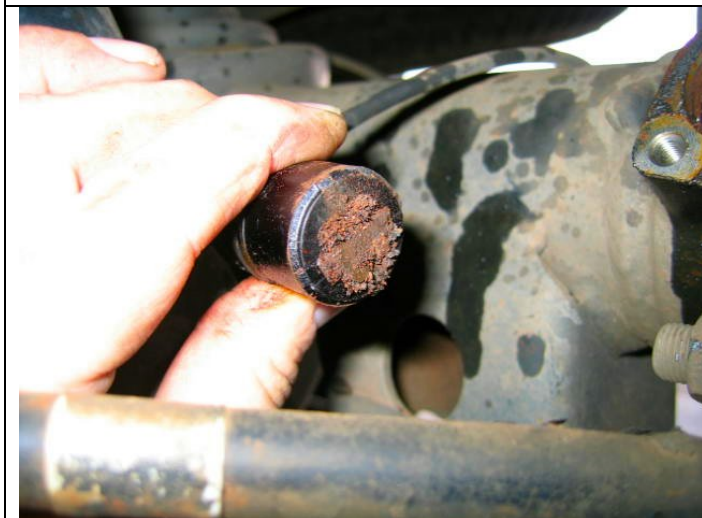
Debris was found on both rear ABS wheel speed sensors. The sensors were covered by the debris, which affected the sensor reading. There was some contamination on the ABS speed sensor rotors, also. Material looked to be a combination of dirt and rust.

Debris on rear ABS wheel speed sensor

Technician replaced both rear ABS speed sensors and speed sensor rotors to correct condition.

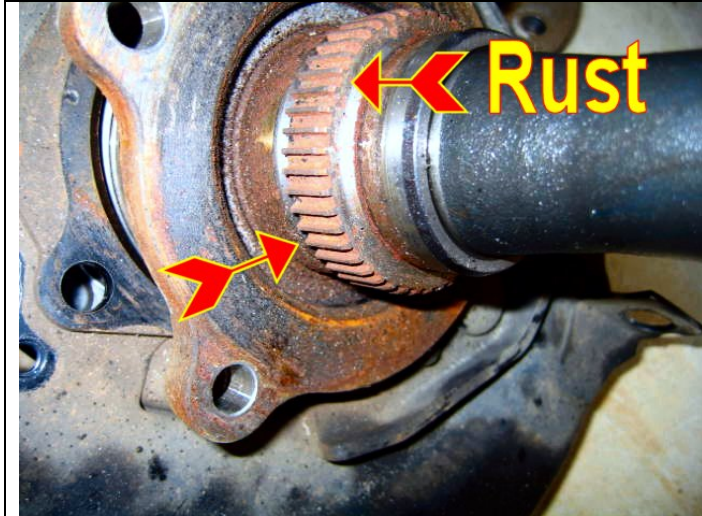
Corrosion on ABS speed sensor rotor

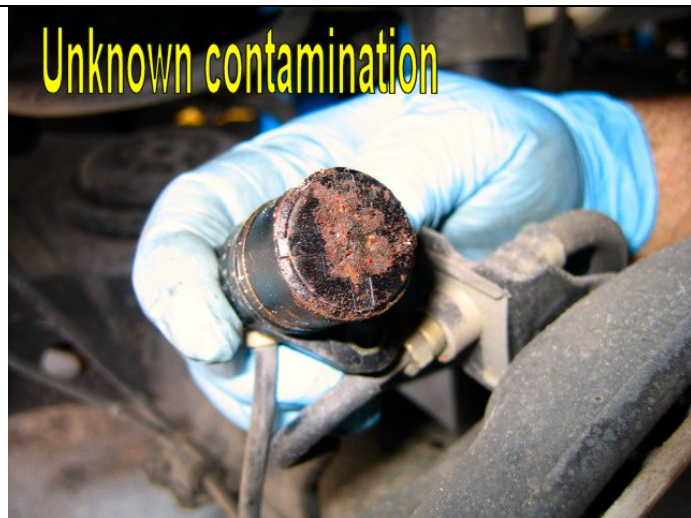
Each speed sensor was removed for inspection. Right rear sensor had an accumulation of rust/grease partially covering sensor tip. Origination of rust/grease is undetermined. Possible assembly lube? Gear oil in differential was normal, no evidence of leakage. The reluctor was not corroded.

Contaminated speed sensor

The substance was removed from the sensor. The sensor was cleaned and reinstalled.

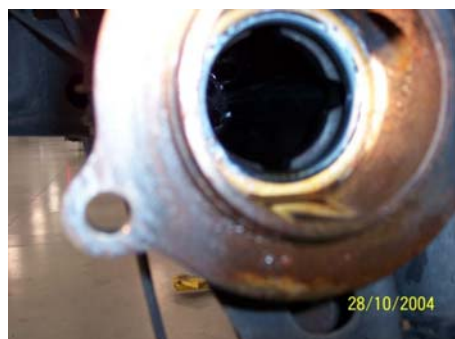
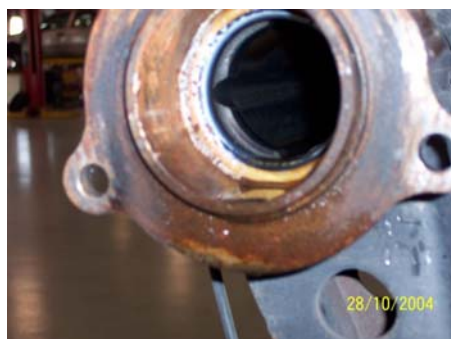
Rust on the rear speed sensor tips. Water is getting into the tube. Rust then develops.

Cleaned rust off inside of axle tube. Cleaned and painted inside of tube. Replace axle tube o-rings. Put FIPG around tube and sensor o-rings.

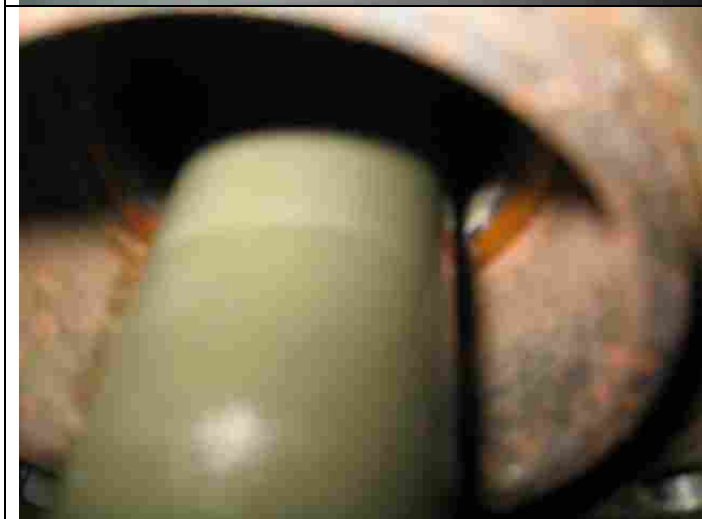
Right axle housing rust

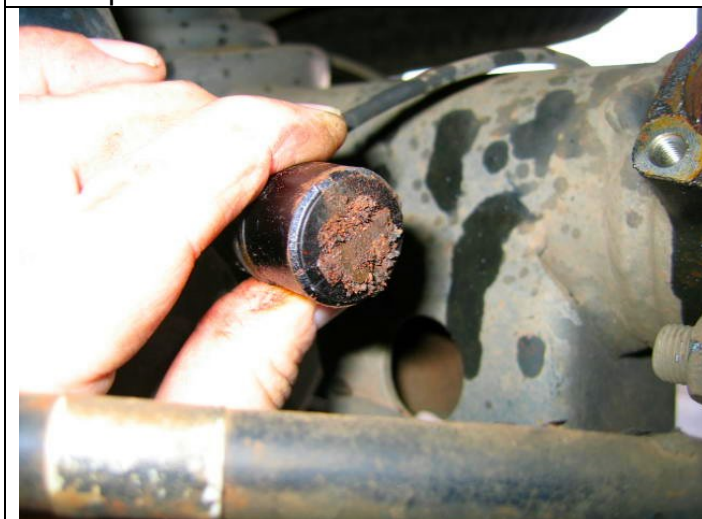
Tech was not able duplicate condition, but has experienced this condition on other Sequoias. No DTC. Tech found contamination on rear ABS speed sensors.

Contamination on speed sensor.

Tech replaced left rear ABS speed sensor and cleaned the contamination (rust) off of the right rear ABS speed sensor.
